EA02025

TEXAS INSTRUMENTS, INC.'S

09/10/03 LETTER TO ODI

FORD SWITCH COMMODITY TEAM VISIT
CRUISE CONTROL PRESSURE SWITCH

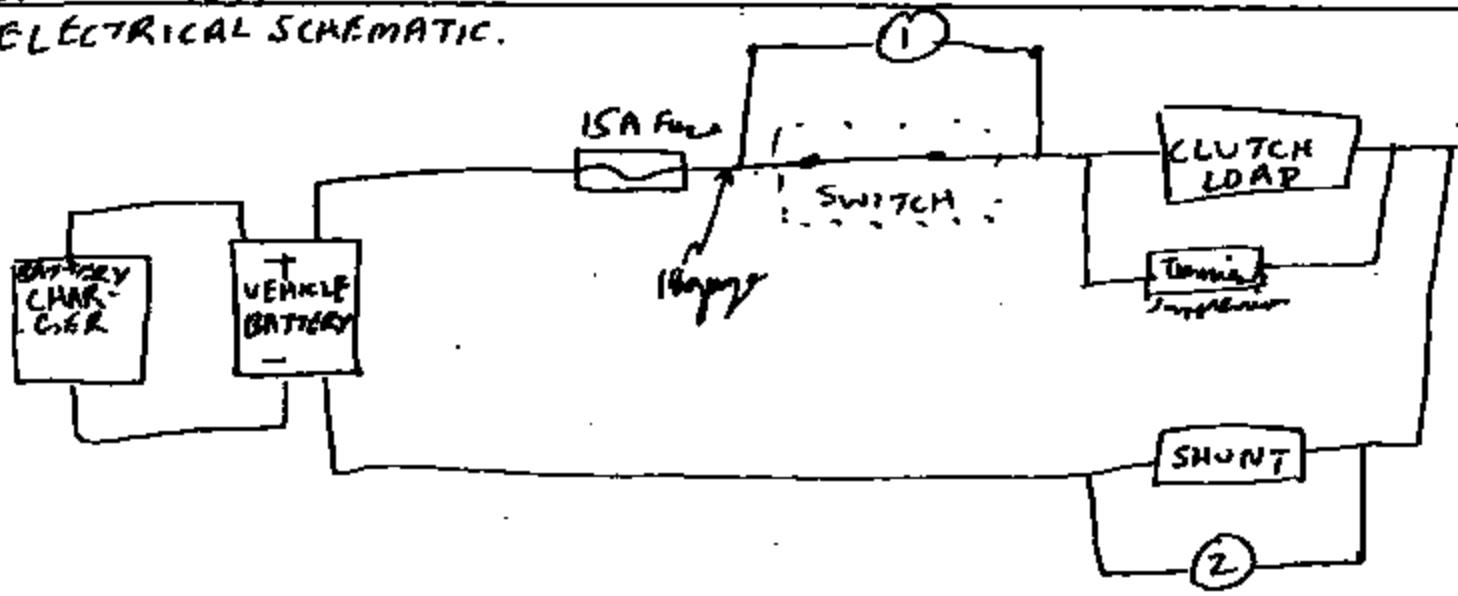
SPARK STUDY TEST
 ELECTRICAL SCHEMATIC.

- Channel ① = Voltage drop across switch
- ② = Current through switch
- ③ = Pressure transducer on manifold

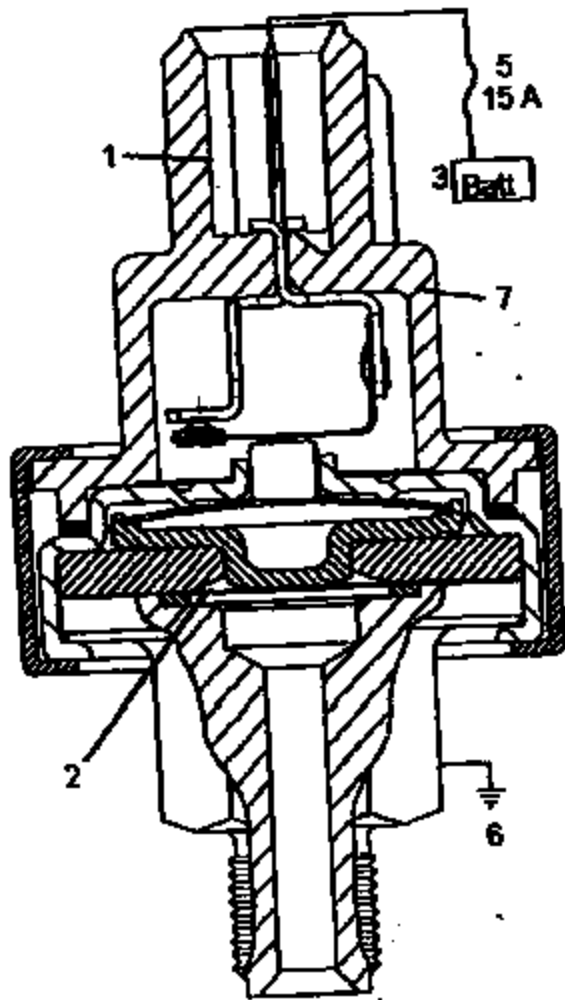
Contributing Factors

1. Connector Seal
2. Kapton Life
3. Continuous Power
4. Switch Orientation
5. Current Capability
6. Grounded Hex-Port
7. Plastic Parameters

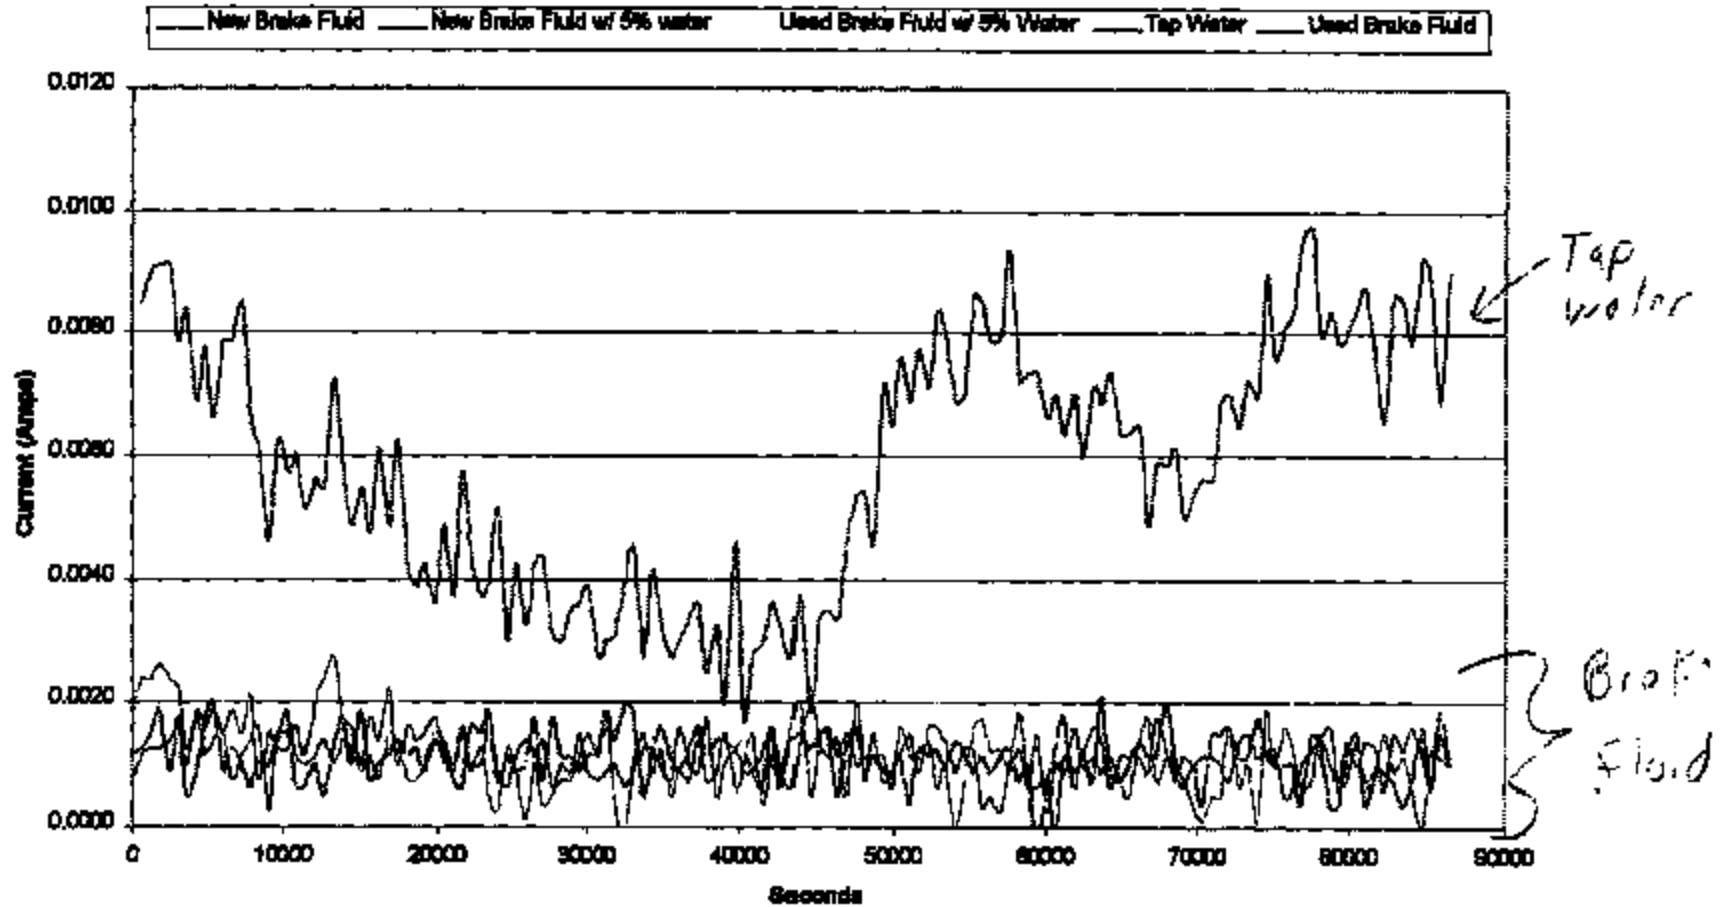
(24) Hour Fluid Ingress Test

Hexport Current vs. Time
Fluid Ingress Experiment

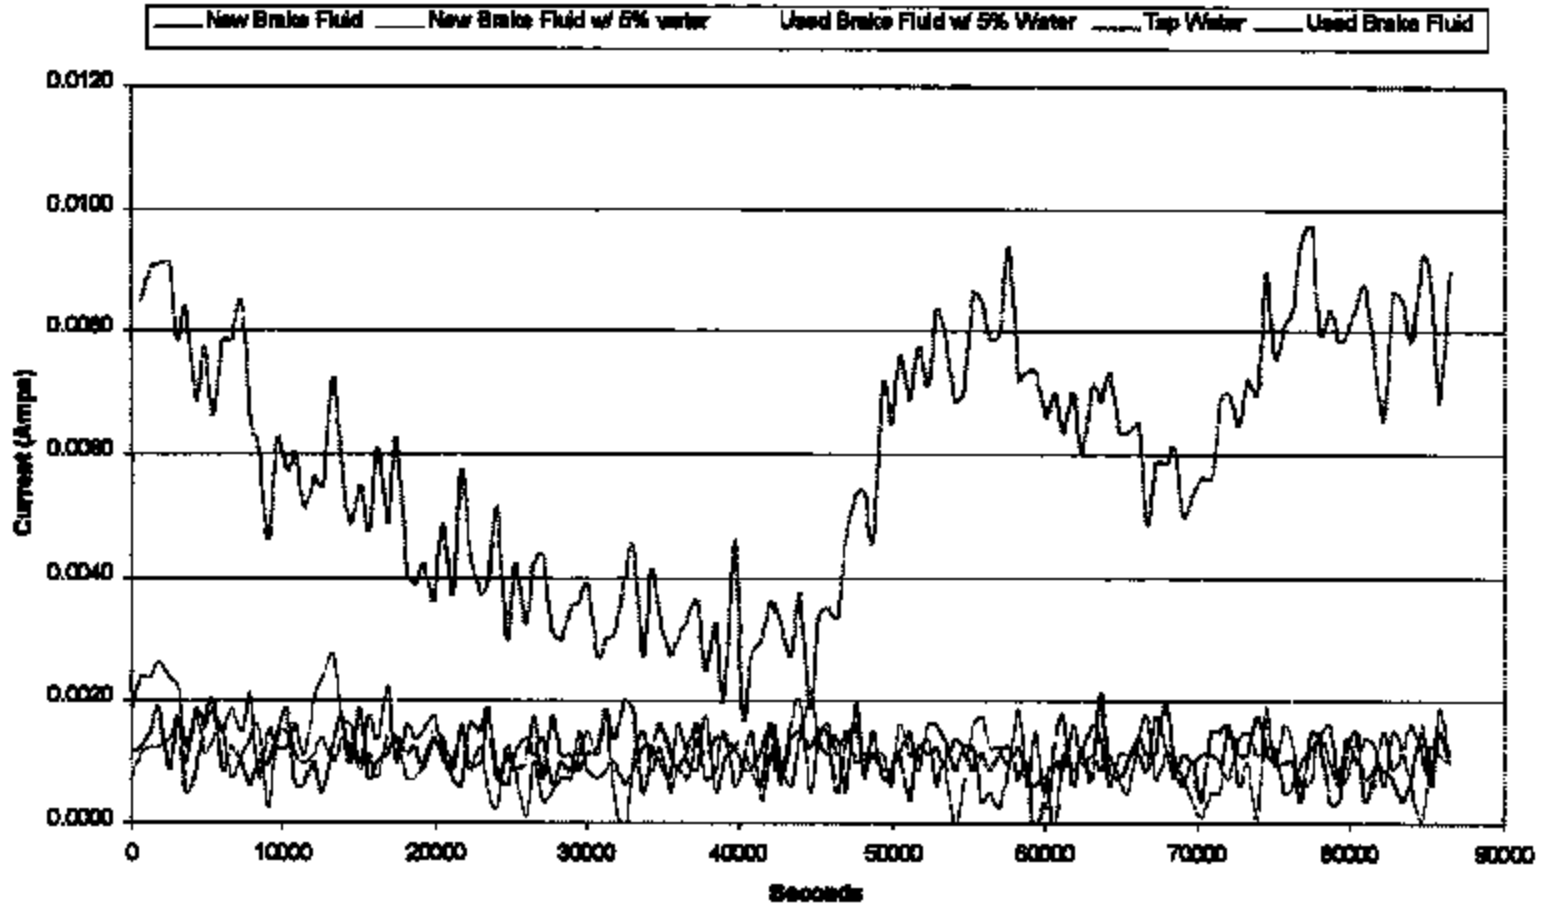
(24) Hour Fluid Ingress Test

Hexport Current vs. Time
Fluid Ingress Experiment
