**EA02-025**

**FORD 10/28/03  
LETTER TO ODI**

**PHOTOGRAPHS OF THE 1995 LINCOLN TOWN CAR  
AND THE ELECTRICAL WIRING**

**[REDACTED] 1995 LINCOLN TOWN CAR**

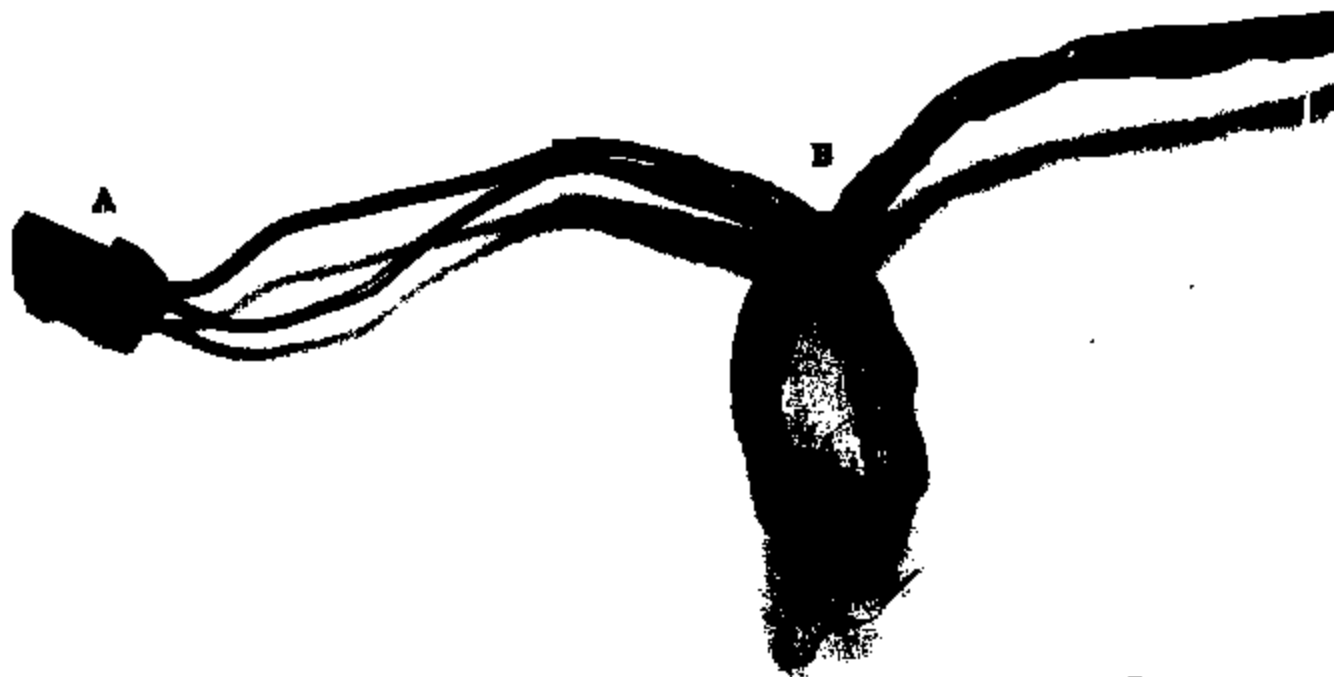
The photographs demonstrate that the damage initiated in a loop of wiring beneath the head liner on the left side of the car. The wiring terminated in a plug which connected to the driver's vanity mirror. The photographs show that the insulation on the green/orange wire is melted in the loop and throughout the length of the same wire leading to the loop. Significantly, there is no melting between the loop and the plug. This indicates that the electrical fault which caused the wire to overheat originated at the loop. Since there is no evidence of overheating of the black wire (the only other wire involved in the loop) it further can be concluded that the green/orange wire shorted to ground, the body of the car, rather than to the black wire. At the time of this examination, the head liner of the

- Figure 11. Overall view of the wiring harness leading to the driver's vanity mirror. The letters shown in the photograph correspond to the locations which are shown in greater detail in the photographs which follow. The connector leading to the driver's vanity mirror is located near the upper left corner of the photograph and is designated as "A". The loop of wiring which is the origin of the electrical fault that caused overheating of the green/orange wire is at location "B".
- Figures 12 through 14. Closer views of the loop of wiring at location "B," the origin of the electrical fault. The photographs show the insulation melted away from the underlying copper wire, in the green/orange conductor. The black wire which also leads to the driver's vanity mirror plug was found to have been undamaged except where its insulation was heated by contact with the
