EA02-025

**FORD 10/28/03
LETTER TO ODI**

FIRE CAUSE INVESTIGATION

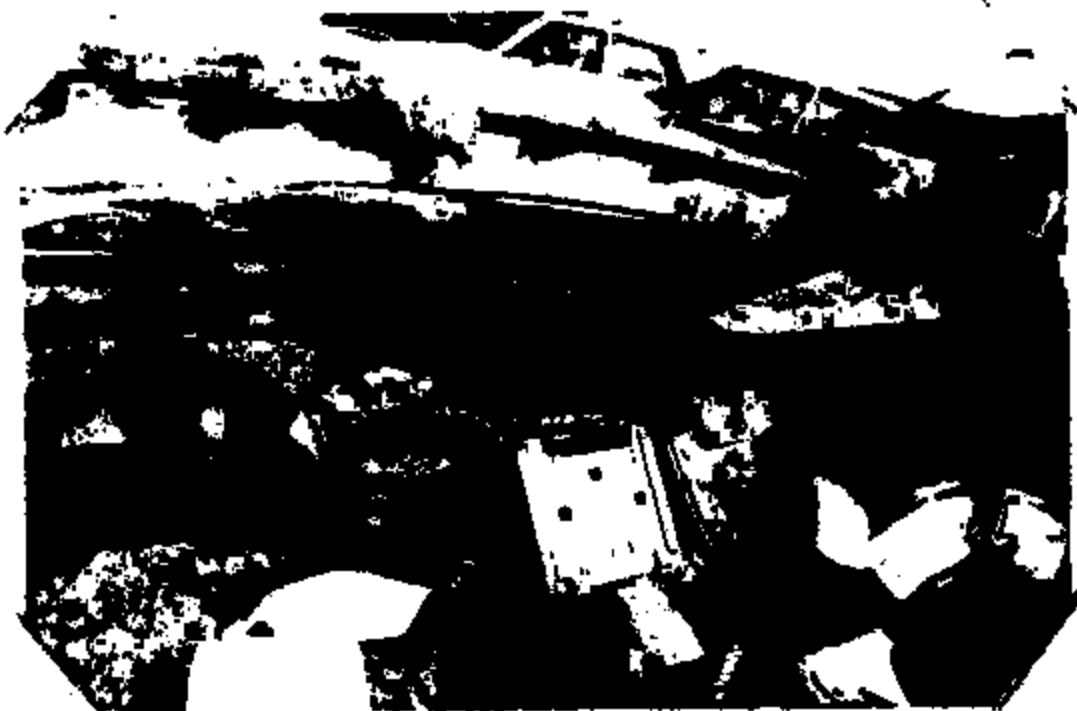
The left driver's seat area was further examined along with the dashboard which was damaged by fire, as seen in photographs #22 and #23.

23. Close-up view of steering column. NOTE: Heavy damage on right side of dashboard.

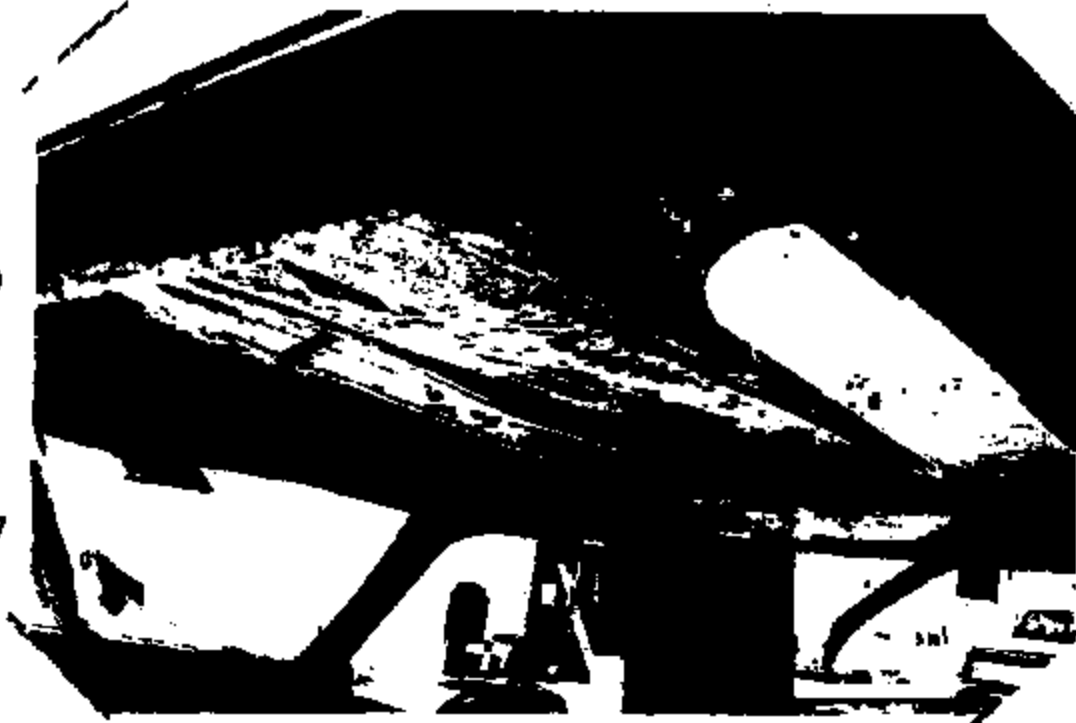
Examining the ceiling we found that the heaviest fire damage had occurred to the ceiling in the area of the dividing window, as seen in photographs #42 and #43.

42. Looking up at underside of roof.

43. Different view of underside of roof.

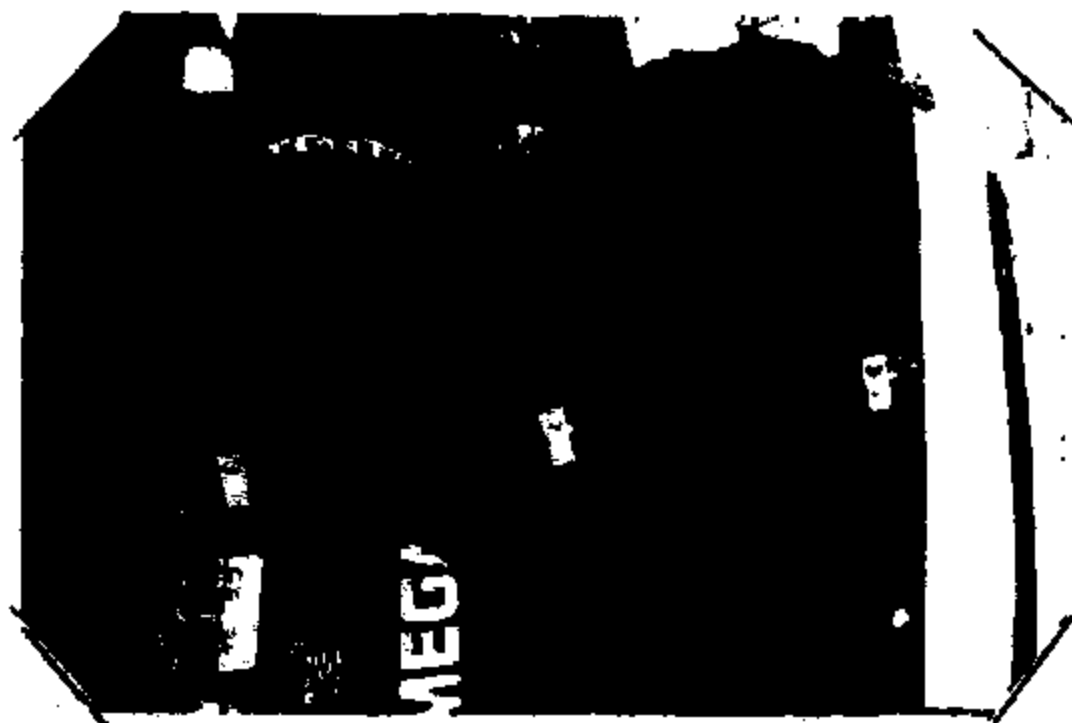
showing no damage along with the wiring in that area, however, when the wire went vertically up towards where the circuit board panels were located we found fire damage to the wiring, as seen in photographs #62 and #63.

62. Close-up view of wiring going to fan motors.

63. Rear view of fans showing no fire damage.
