EA02-025

**FORD 10/27/03
LETTER TO ODI**

the mechanical condition of a 1995 Ford, Crown Victoria, with special reference to valve cover gasket leakage.

ORIGIN AND CAUSE INVESTIGATION:

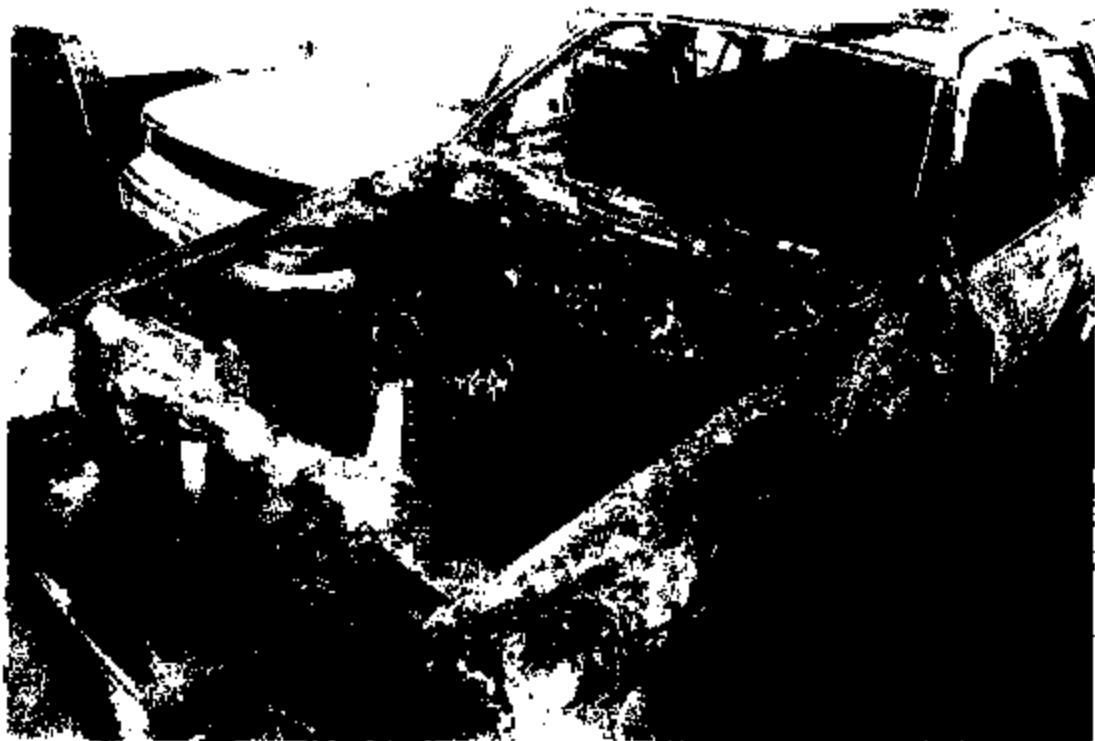
1. View of the vehicle from the left side.

2. View of the front of the engine.

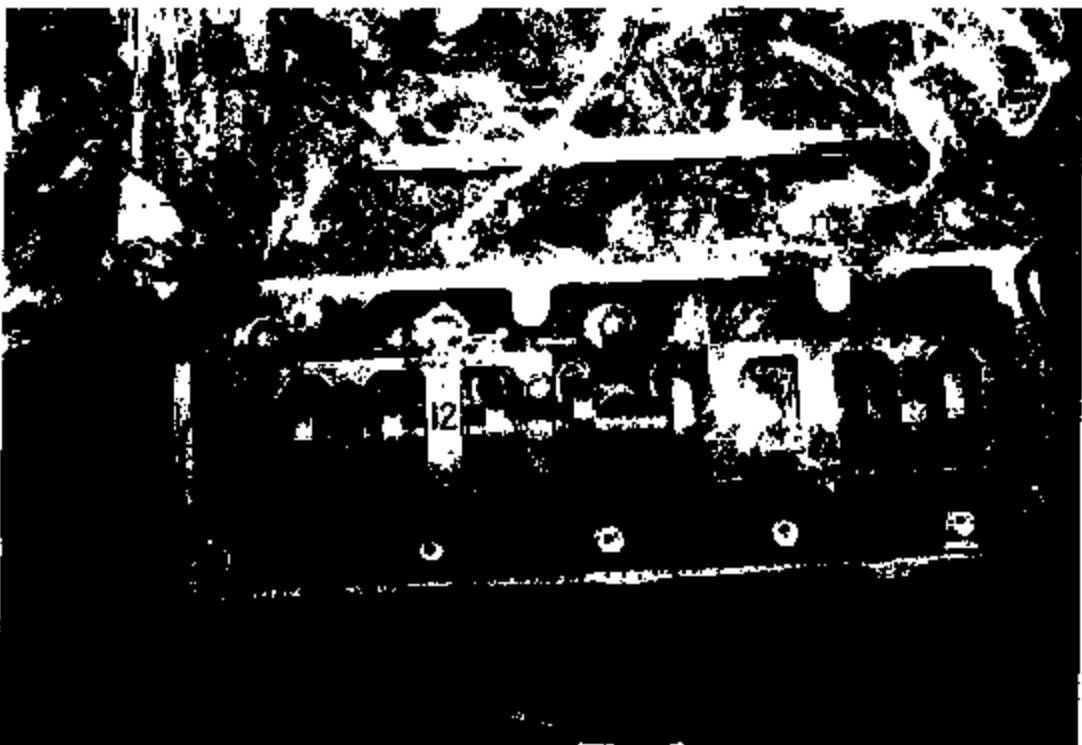
This investigation was then focused toward the right cylinder head, where the valve cover seats. Observations of the right cylinder head reveal traces of oil that were leaking past the gasket on the surface of the cylinder head. Furthermore, the right cylinder head near the front of the engine, there is residue build-up, which is wider near the front of the cylinder head than it is in the center, which verifies that the gasket has shifted from its original position. The side of the right cylinder head reveals charring from oil that has leaked prior to the fire, which the fire had consumed.

7. View of the valve cover cylinder head mounting surface.

.....
8. View of oil seepage at the center of the mounting surface.

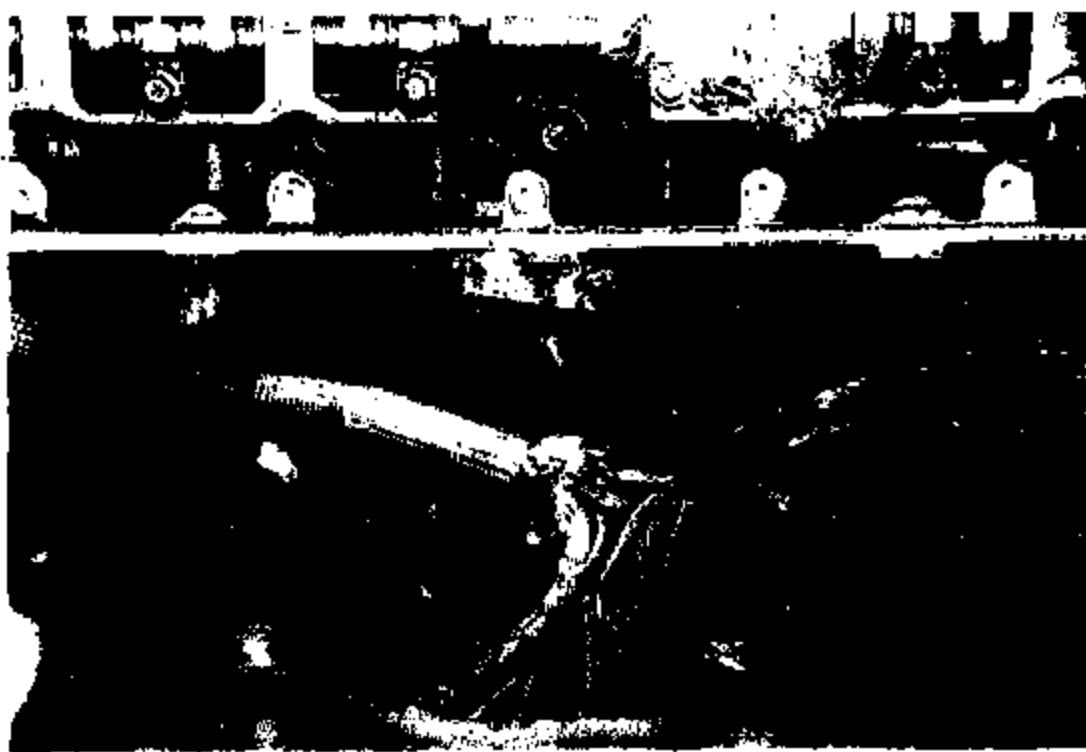
This investigation was then focused to the exhaust manifold on the right side. The right exhaust manifold reveals charring from oil that has leaked from the valve cover gasket onto the exhaust manifold.

10. View of charring on the right exhaust manifold.

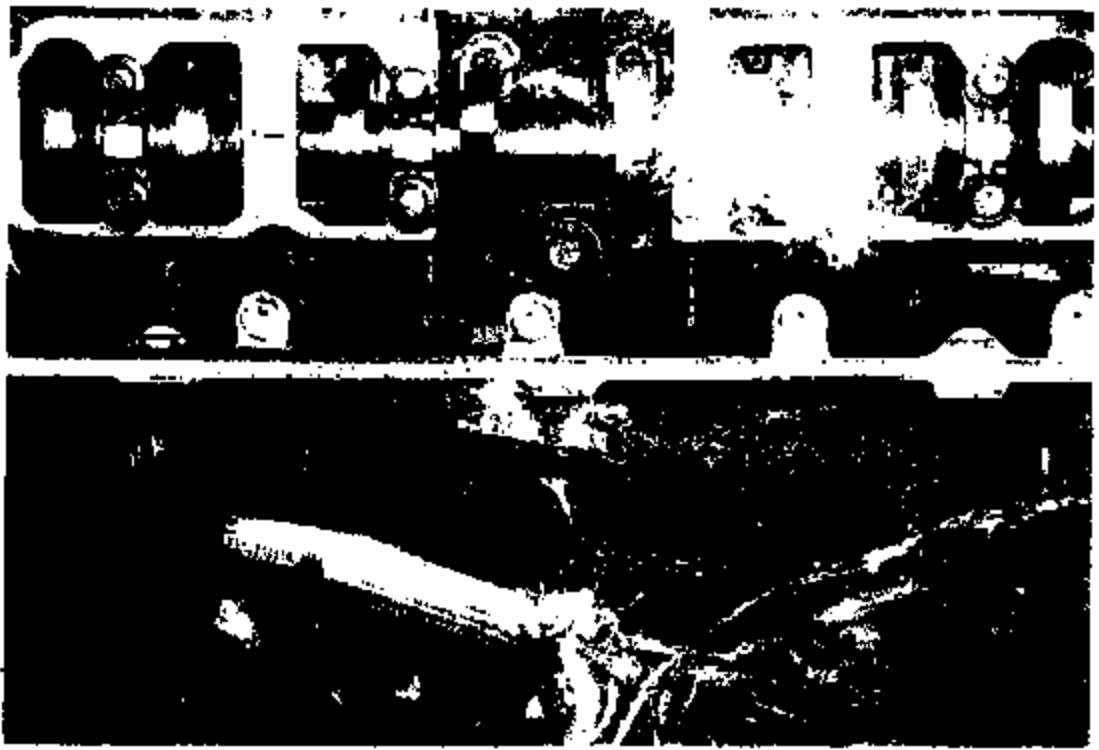
11. Is another view of charring on the top side of the exhaust manifold.
12. Is a view of the gasket seal which is wider towards the front from the gasket moving.

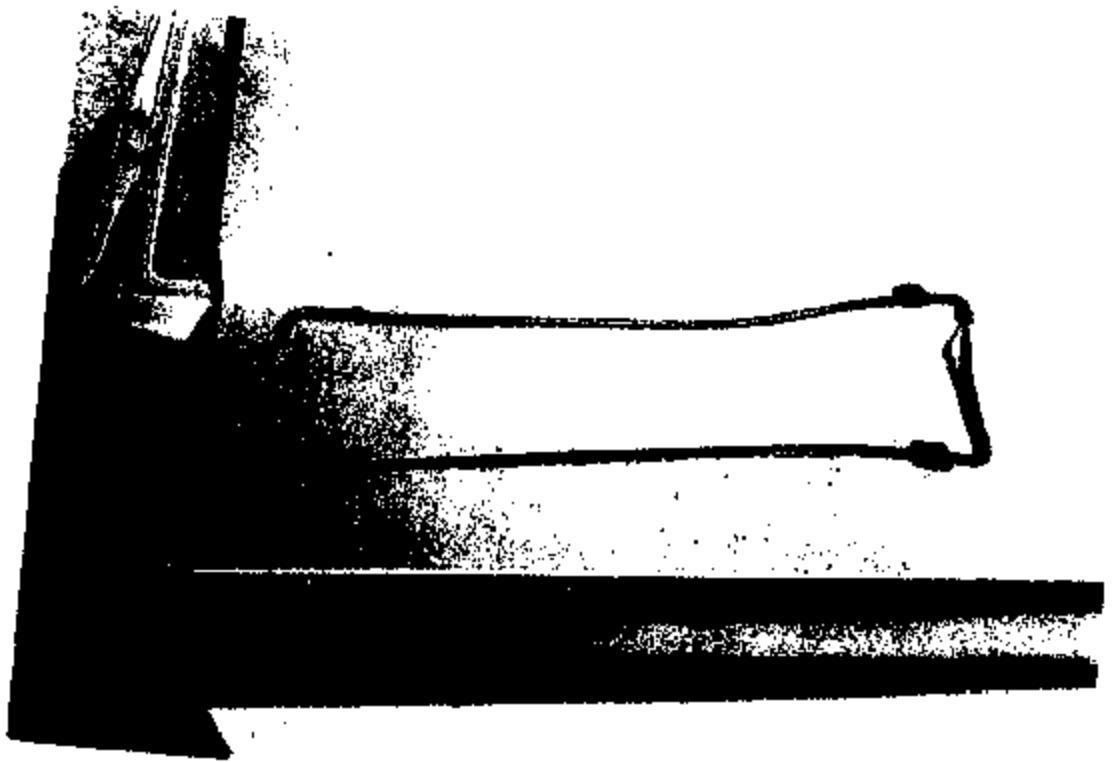
24. Is an overall view of the left valve cover
gasket.

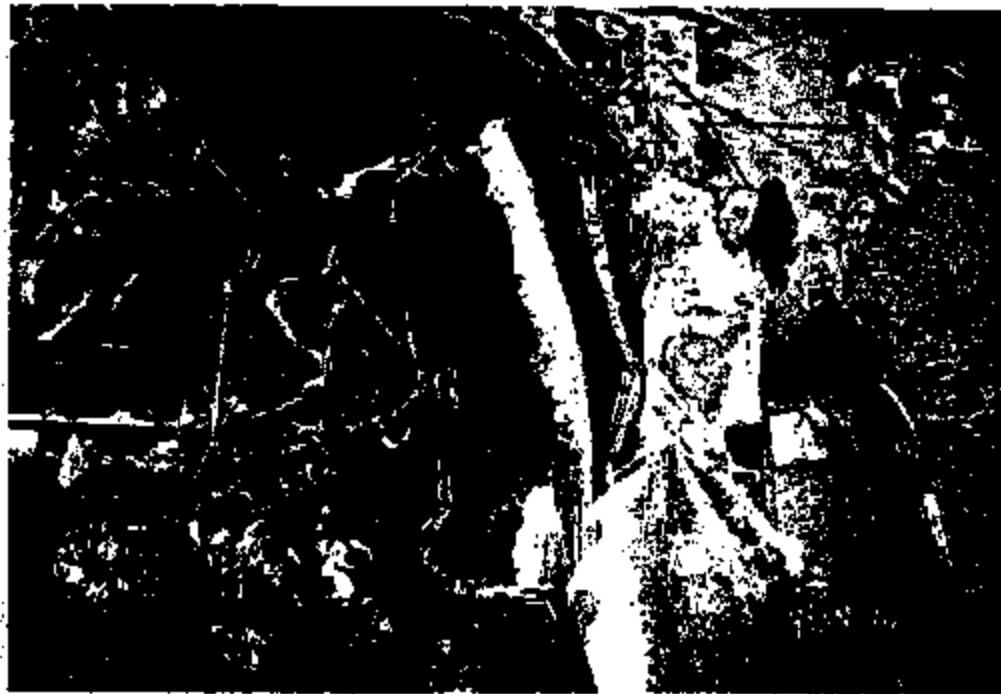
23. View of the front of the engine compartment as seen from the passenger side

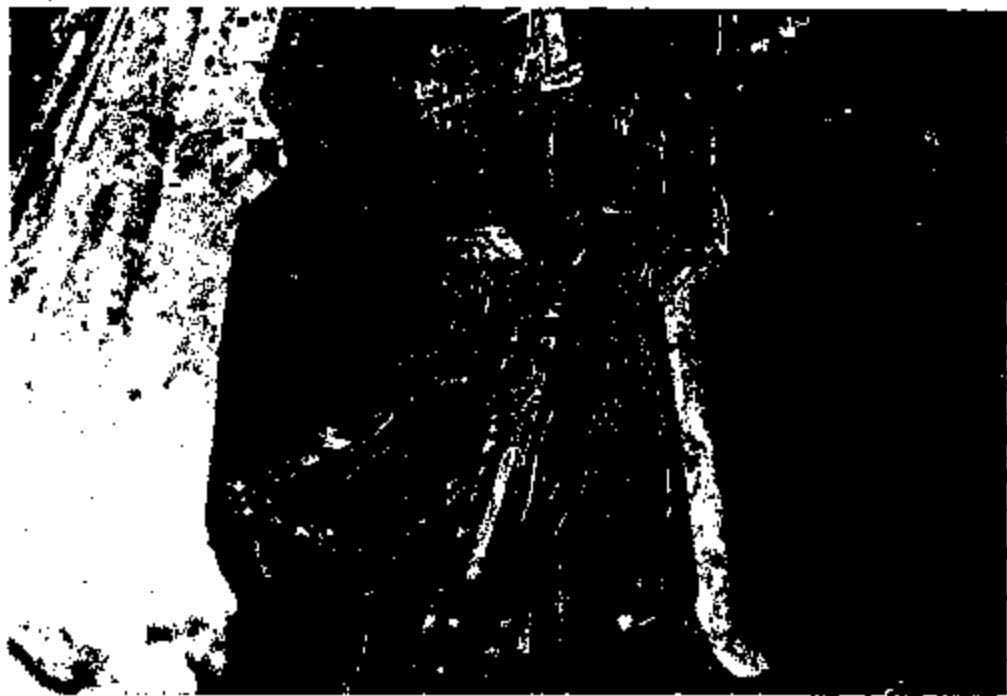
29. View of wiring with evidence of arcing

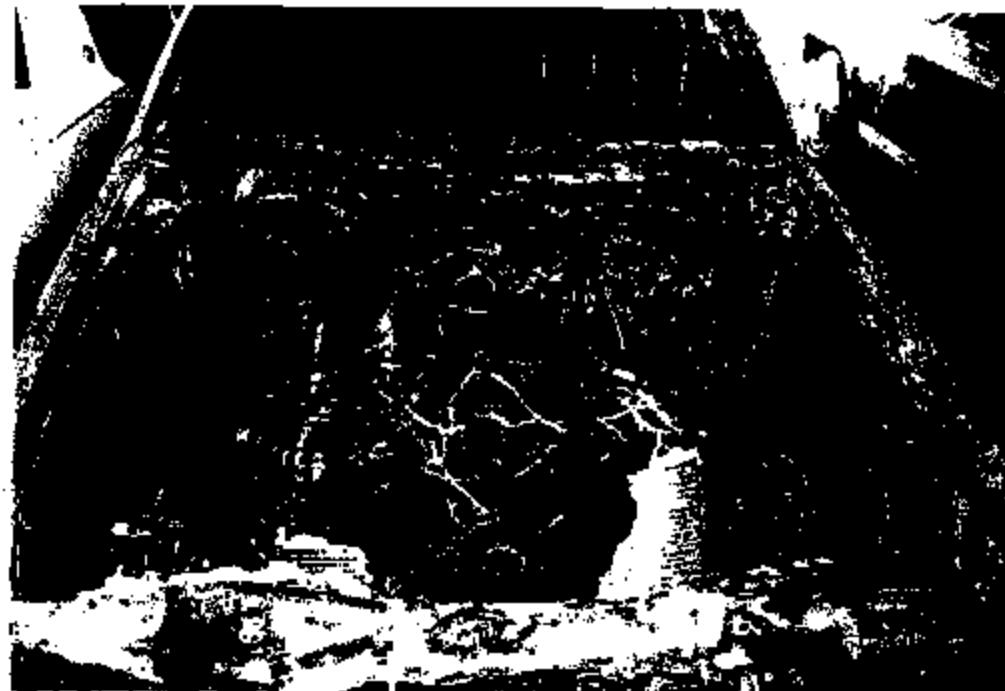
3. View of the right valve cover.
4. Closer view of the right valve cover.

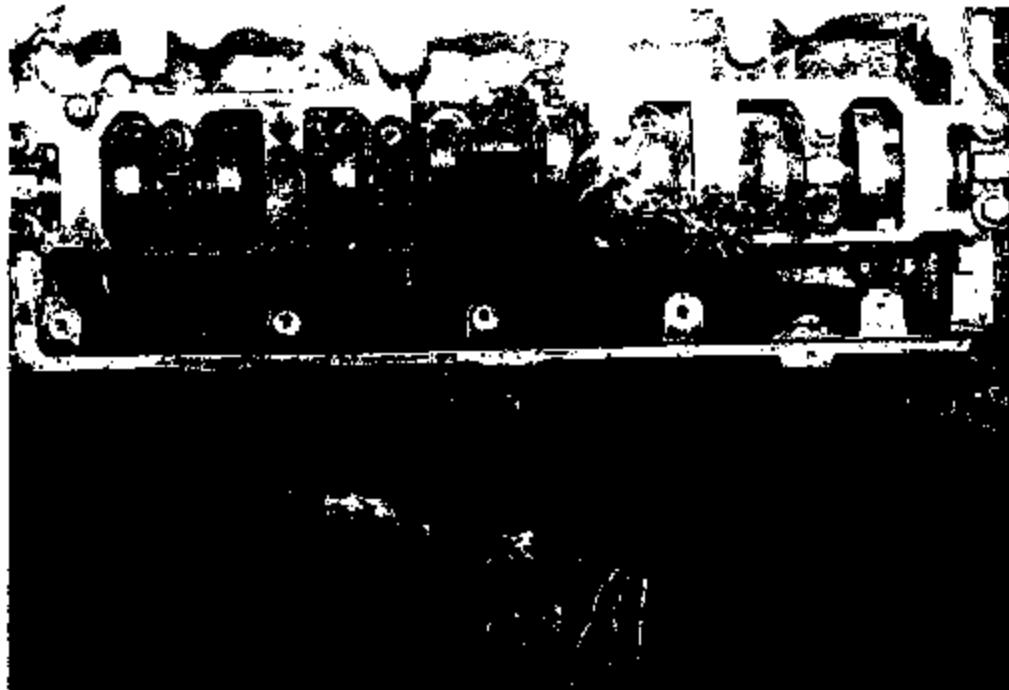
7. View of the valve cover cylinder head mounting surface.
8. View of oil seepage at the center of the mounting surface.

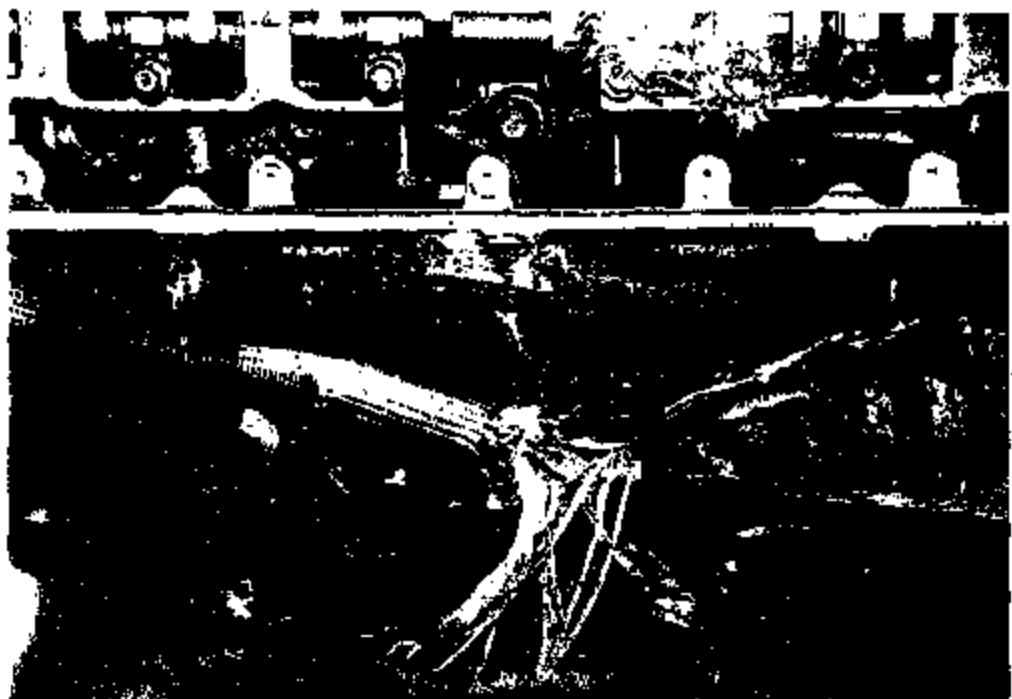
This investigation was then focused to the exhaust manifold on the right side. The right exhaust manifold reveals charring from oil that has leaked from the valve cover gasket onto the exhaust manifold.

10. View of charring on the right exhaust manifold.

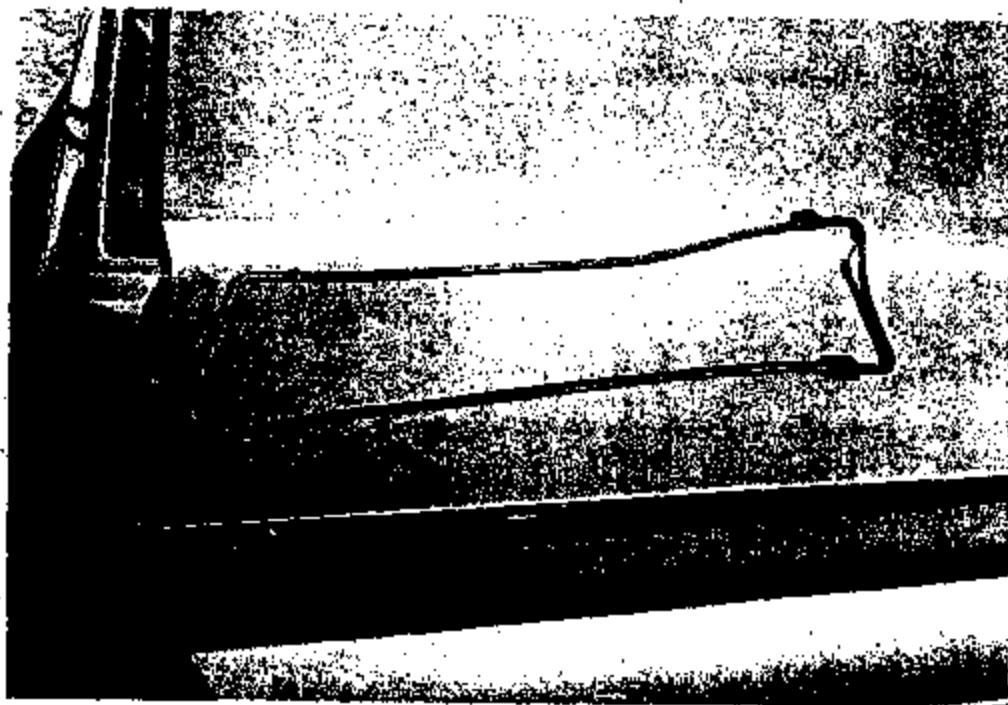
24. Is an overall view of the left valve cover gasket.
