**TEXAS INSTRUMENTS, INC.'S**

99-243: TSL #'S 151700 & 142010: 77PS SIMULATION SAMPLES **ROUGH DRAFT**  
ONLY

Characterize the samples with regards to contamination, corrosion, and arcing.

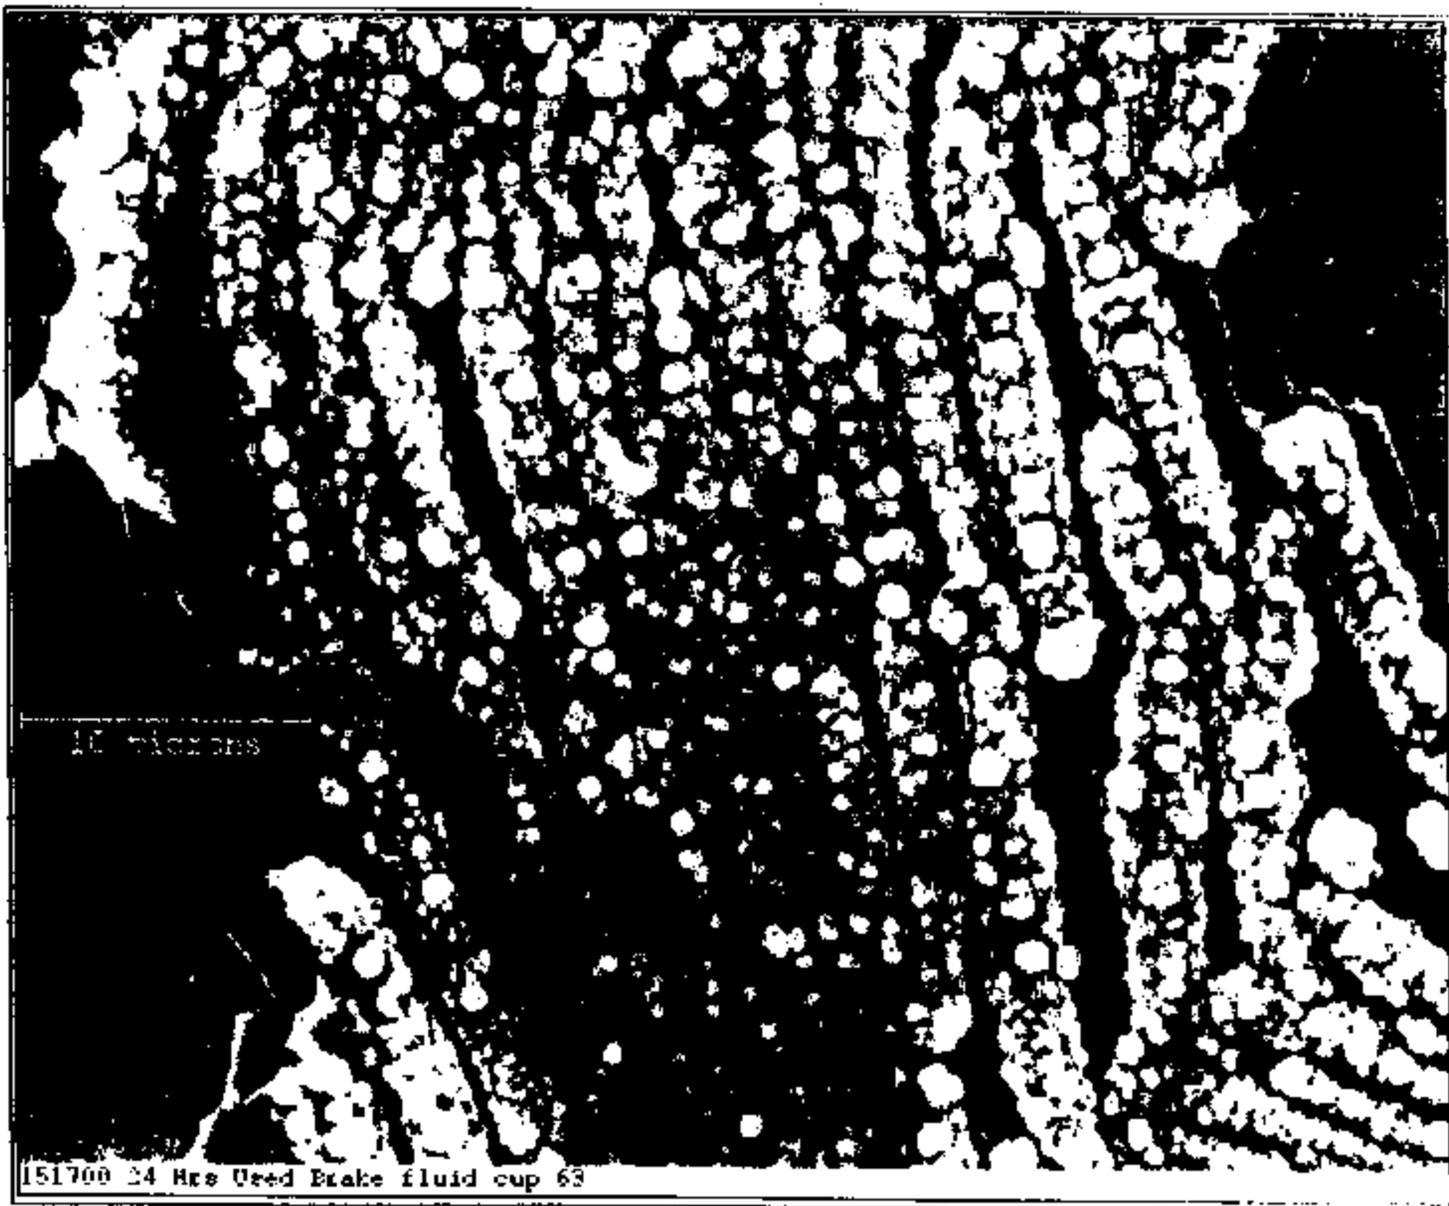
151700 24 Hrs Used Brake fluid cup 63

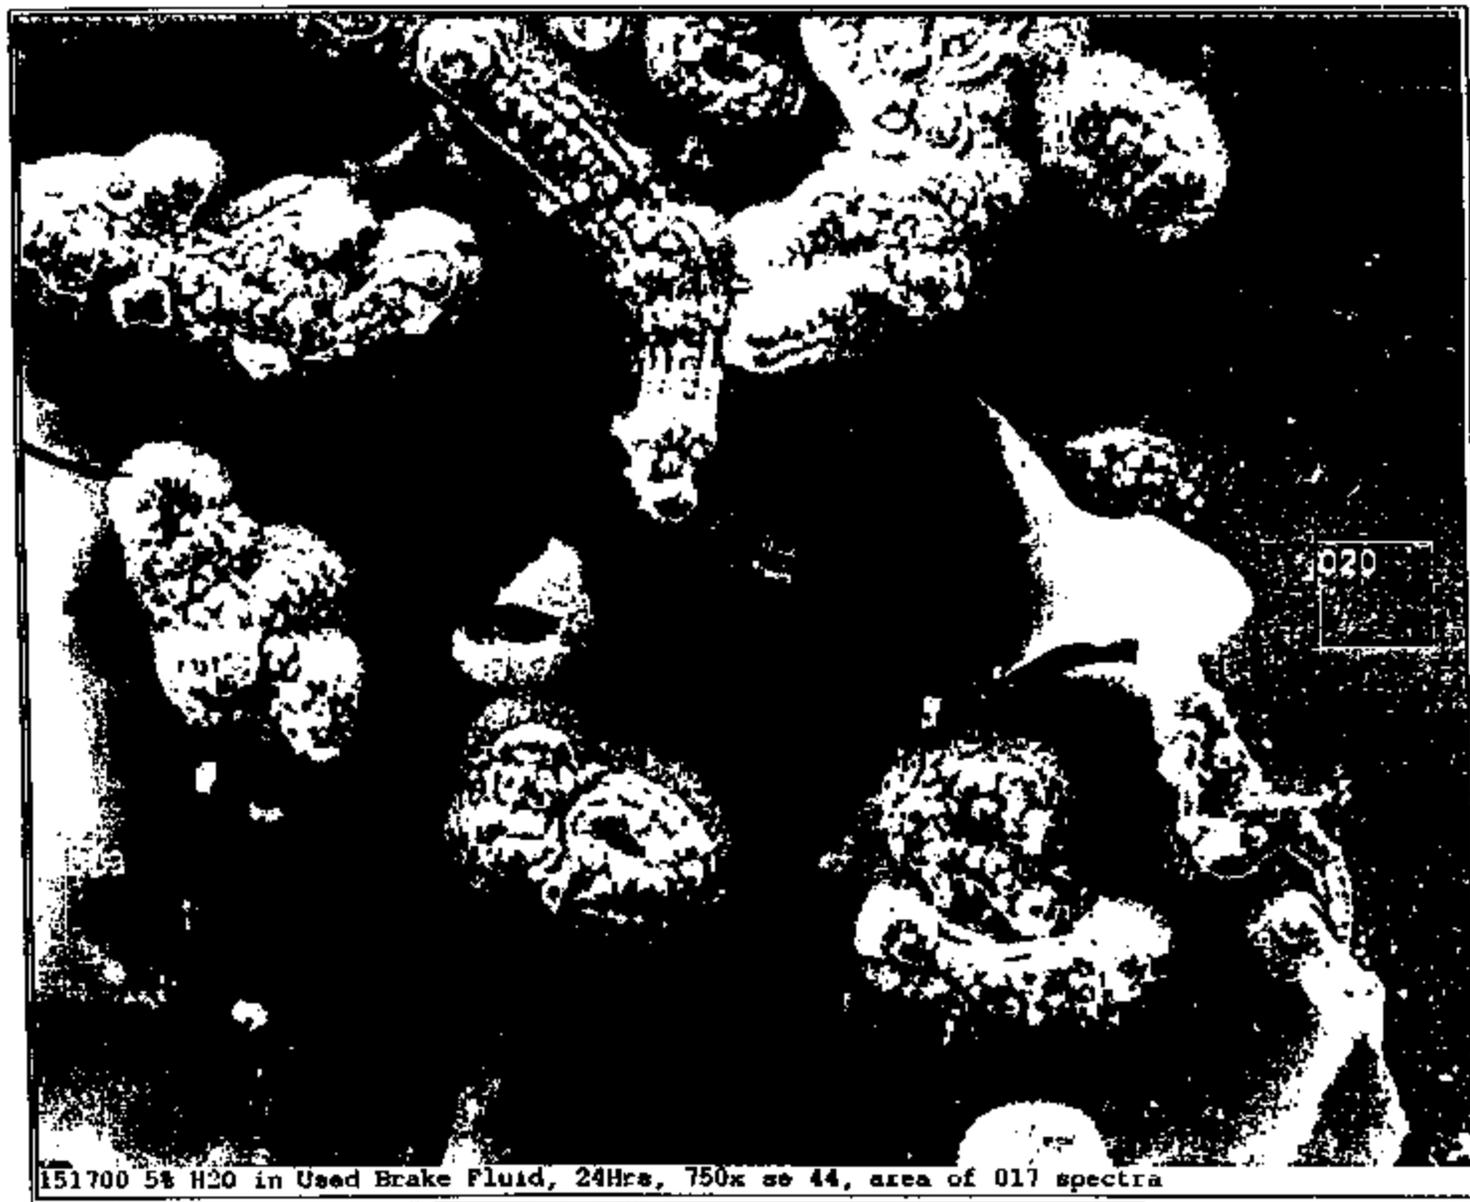
151700 5% H<sub>2</sub>O in Used Brake Fluid, 24Hrs, 750x se 44, area of 017 spectra
