**EA02-025**

**TEXAS INSTRUMENTS, INC.'S**

# Longtam\_BF\_tests.xls

## TECHNICAL SERVICE LABS

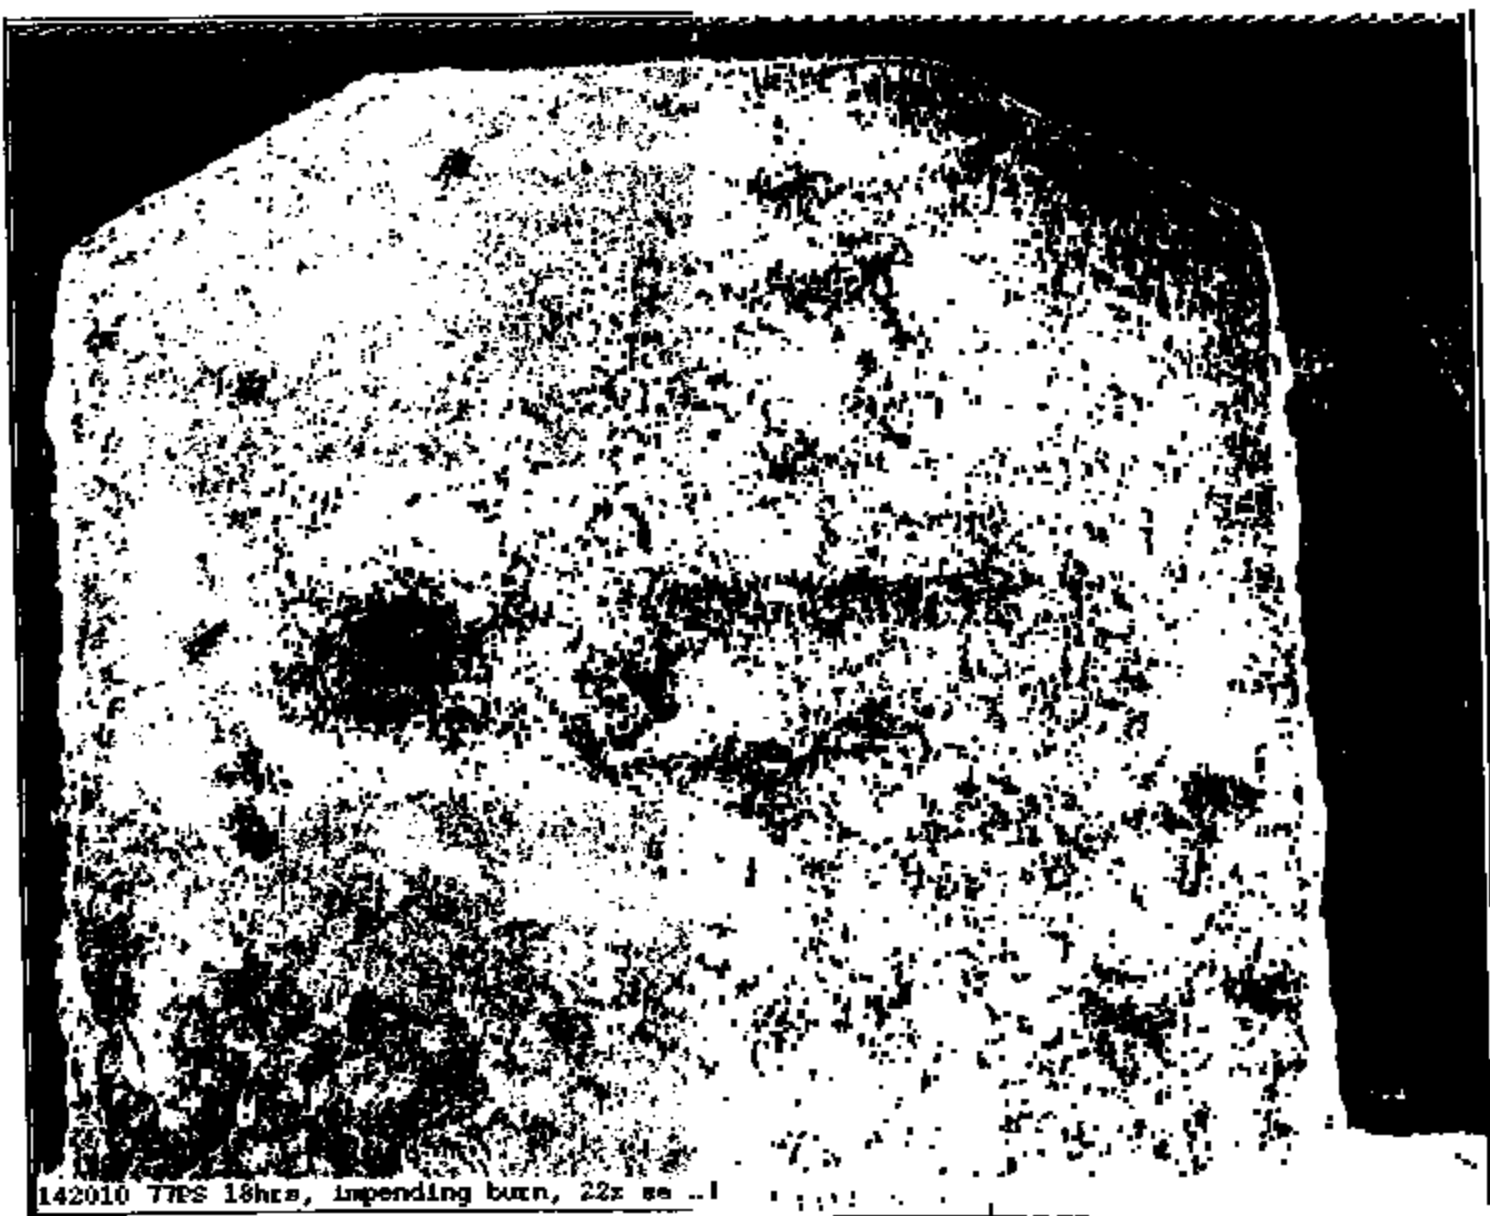
142010 77PS 18hrs, impending burn, 22x ss ...

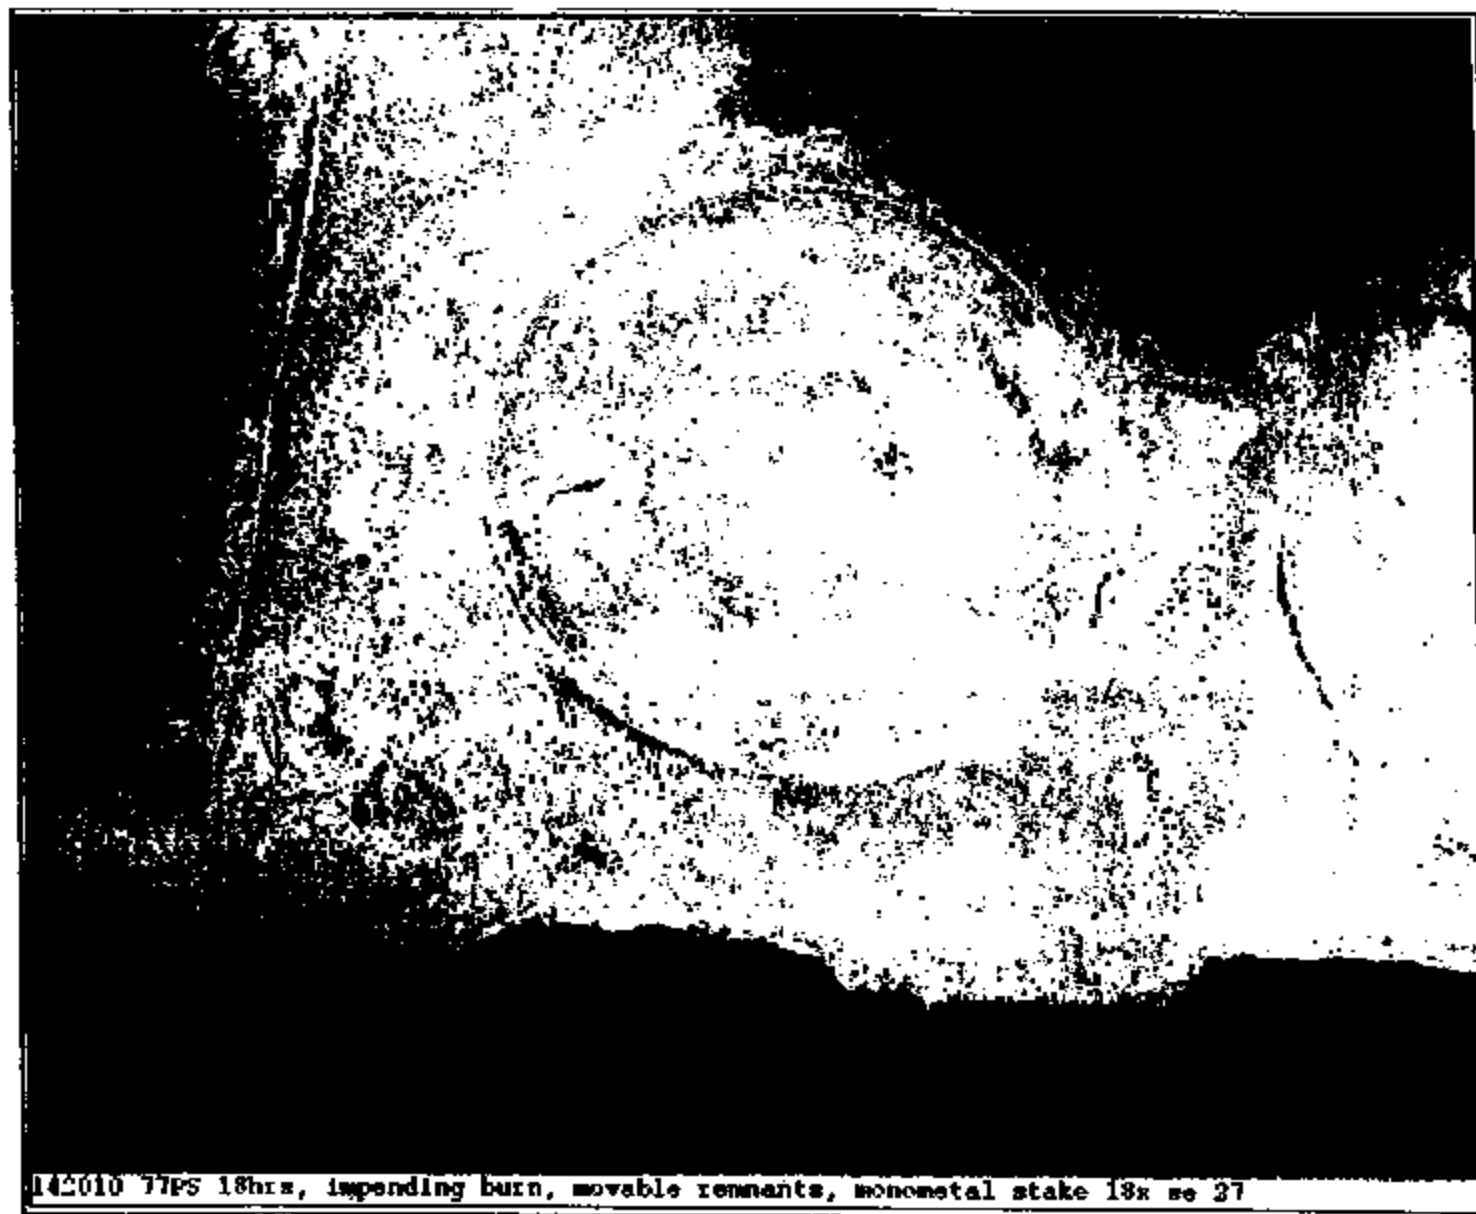
142010 77PS 18hrs, impending burn, movable remnants, monometal stake 18x se 27

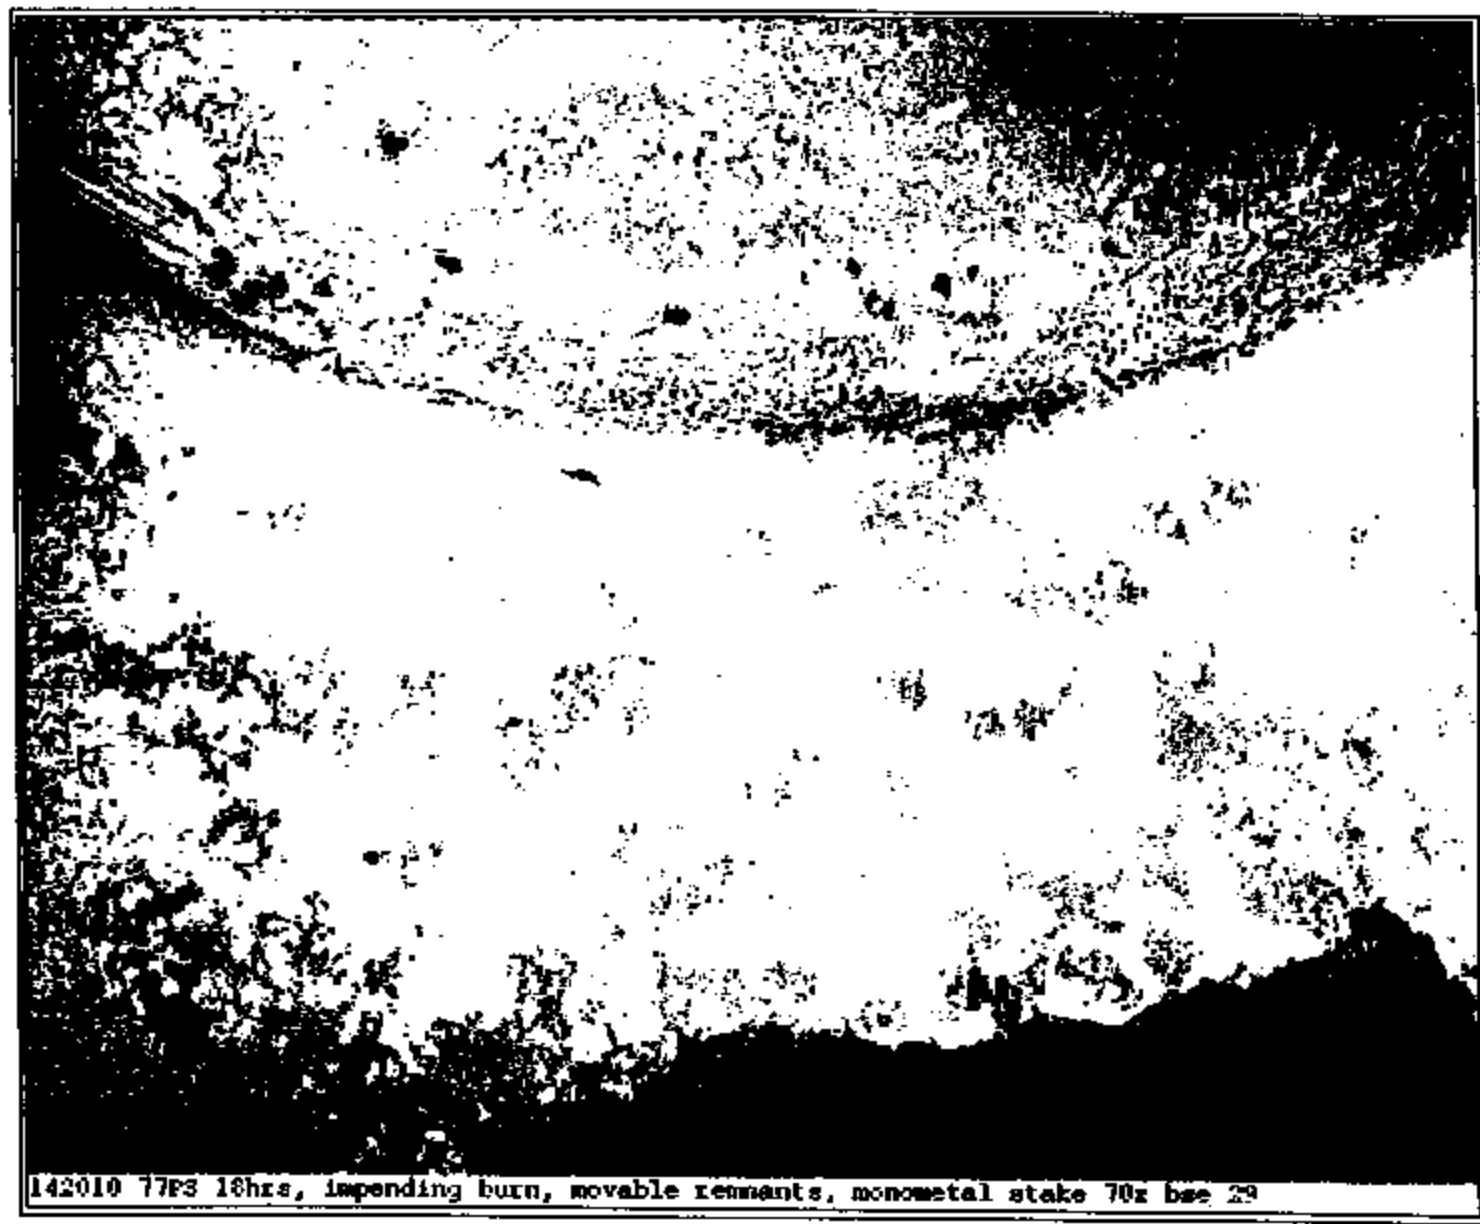
142010 77F3 18hrs, impending burn, movable remnants, monometal stake 70x base 29

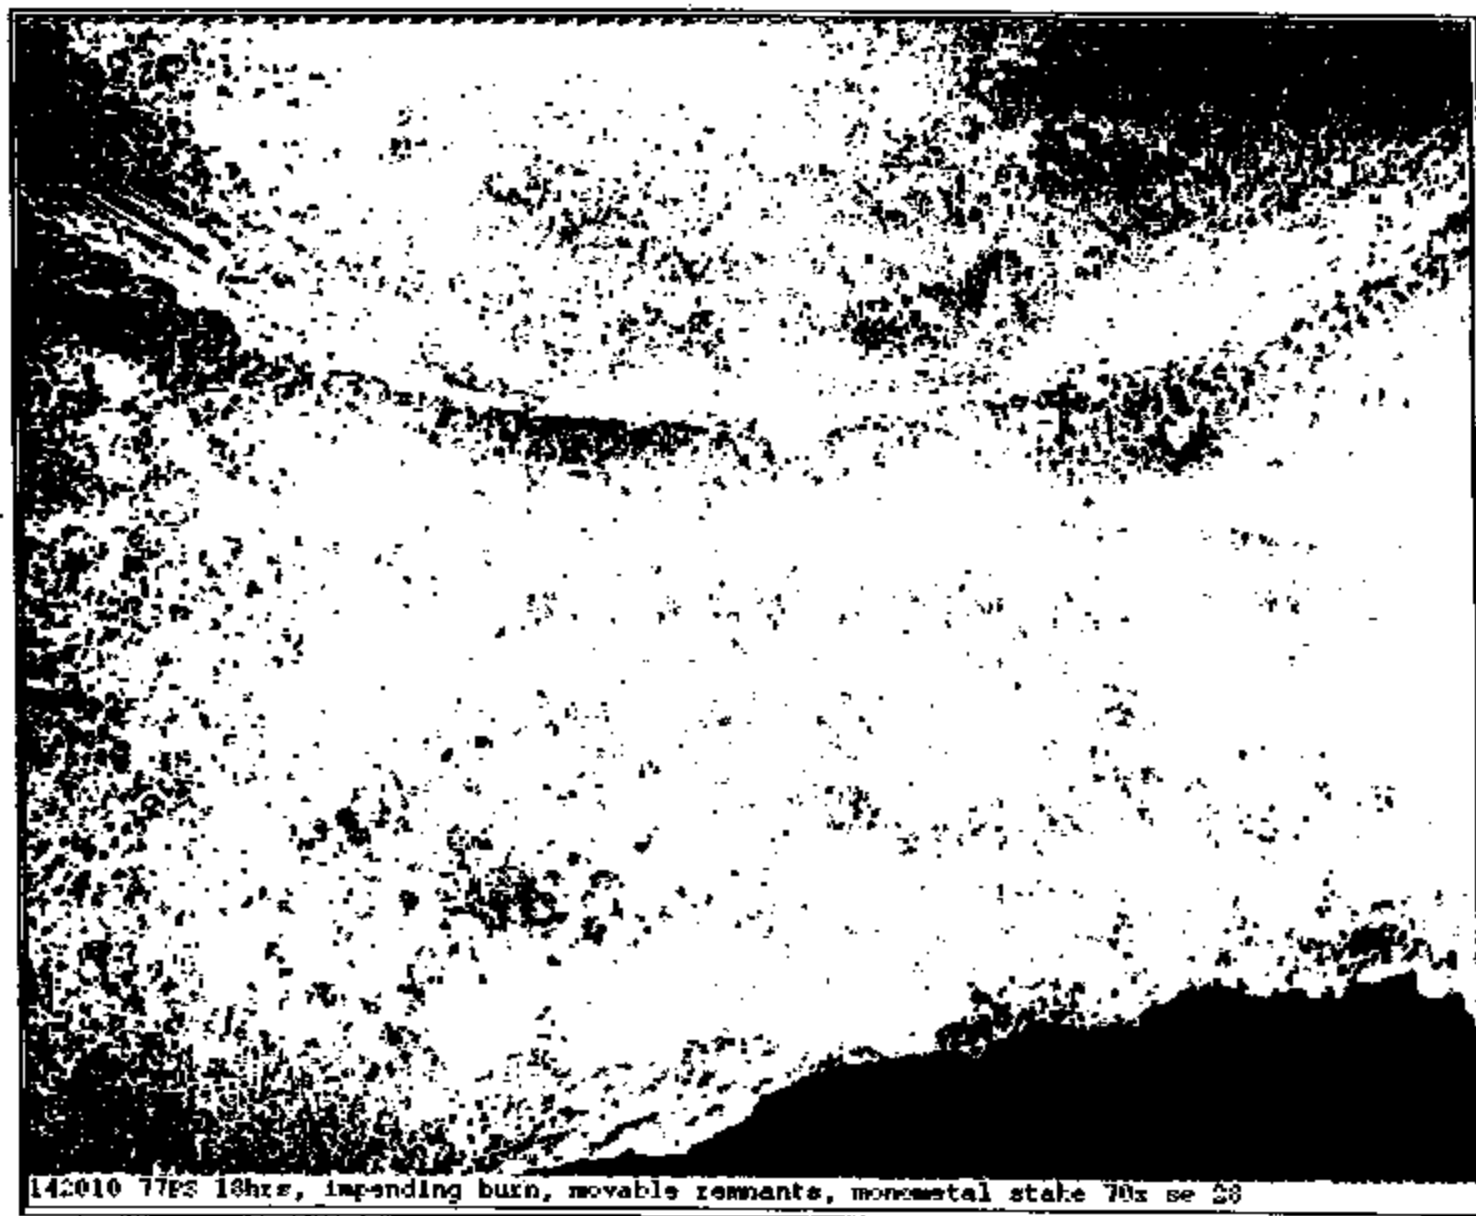
142010 77PS 13hrs, impending burn, movable remnants, monometal stake 70x se 50
