**TEXAS INSTRUMENTS, INC.'S**

Brake Pressure Switch Test Log, Updated 5/20/90

**Brake Pressure Switch  
Potential Thermal Event Theory Profile 5/20/99**

The purpose of this test was to investigate the possibility of switch ignition caused by excessive heat dissipation in the contact cavity of 77PS switches. The intention was to determine the conditions necessary to nucleate a switch ignition. A heater coil was installed in the contact cavity of (3) 77PS switches. The contact cavity of (1) switch was filled with a solution of brake fluid with 6 wt. % water, the contact cavities of the other (2) switches remained dry. Power was applied to each heater coil until the switch base began to melt. A spark was then generated inside the contact cavity of the switch. All (3) switches ignited during the test. In each ignition, contact cavity temperature exceeded 600°F when 5 Watts of power (approximate) was dissipated in the heater coil.

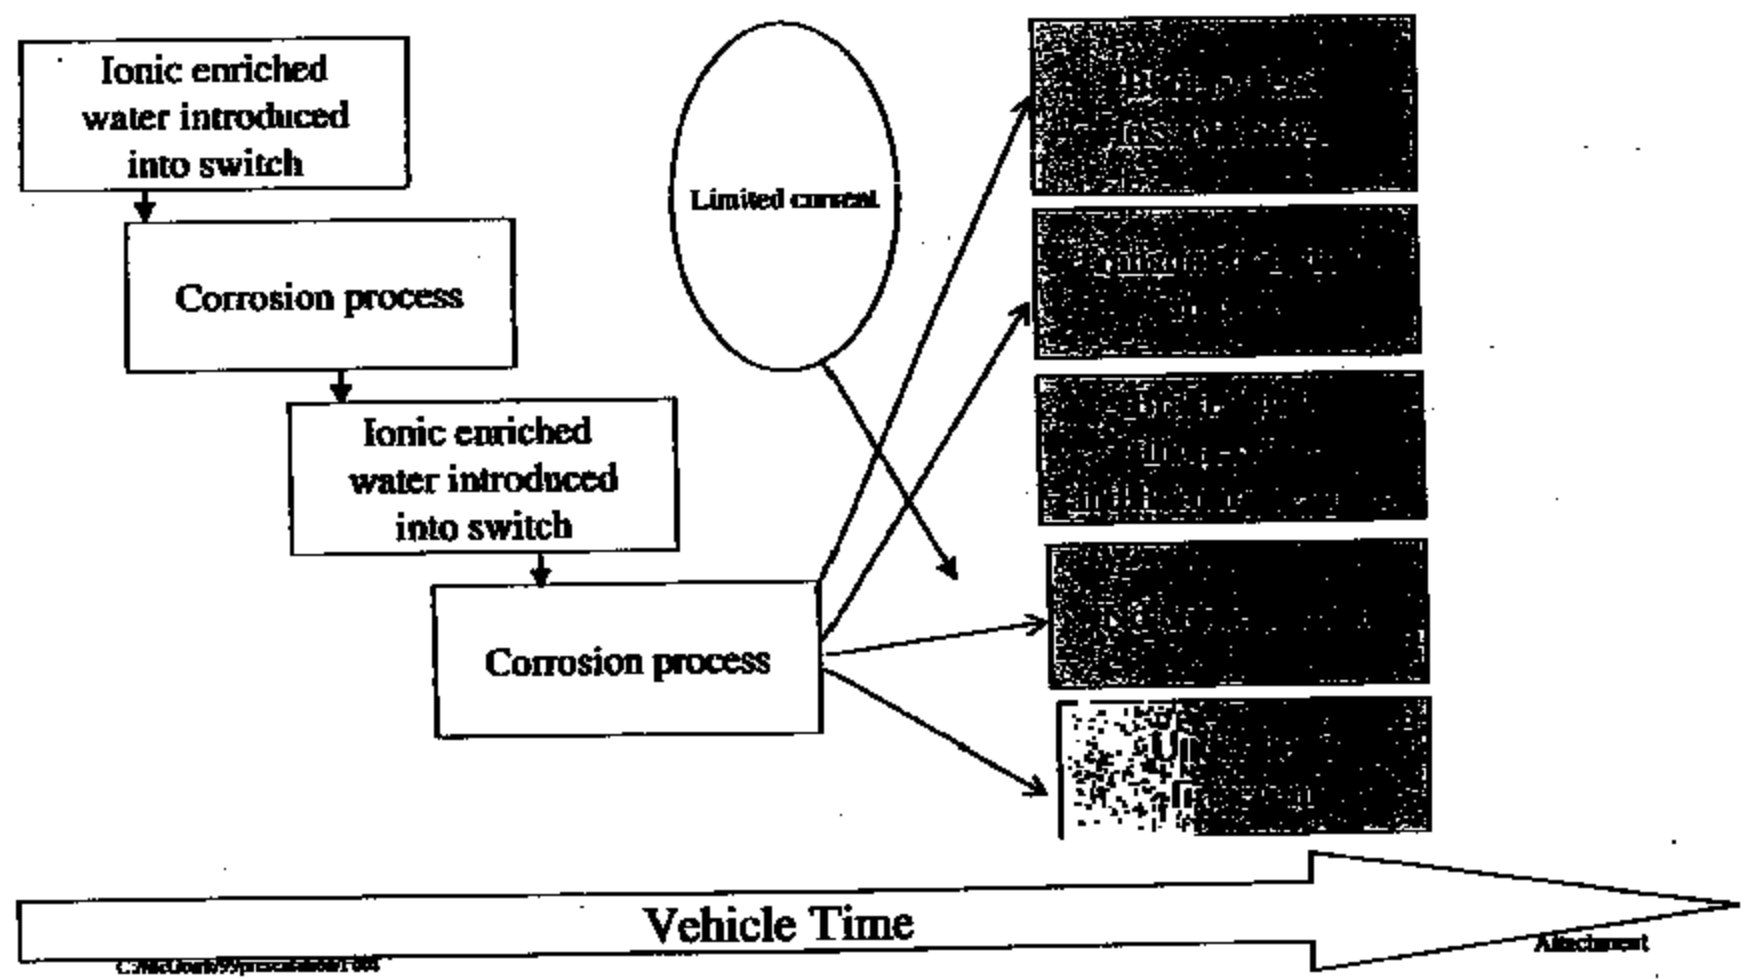
### "Corrosion" potential cause time line Theory Time Line

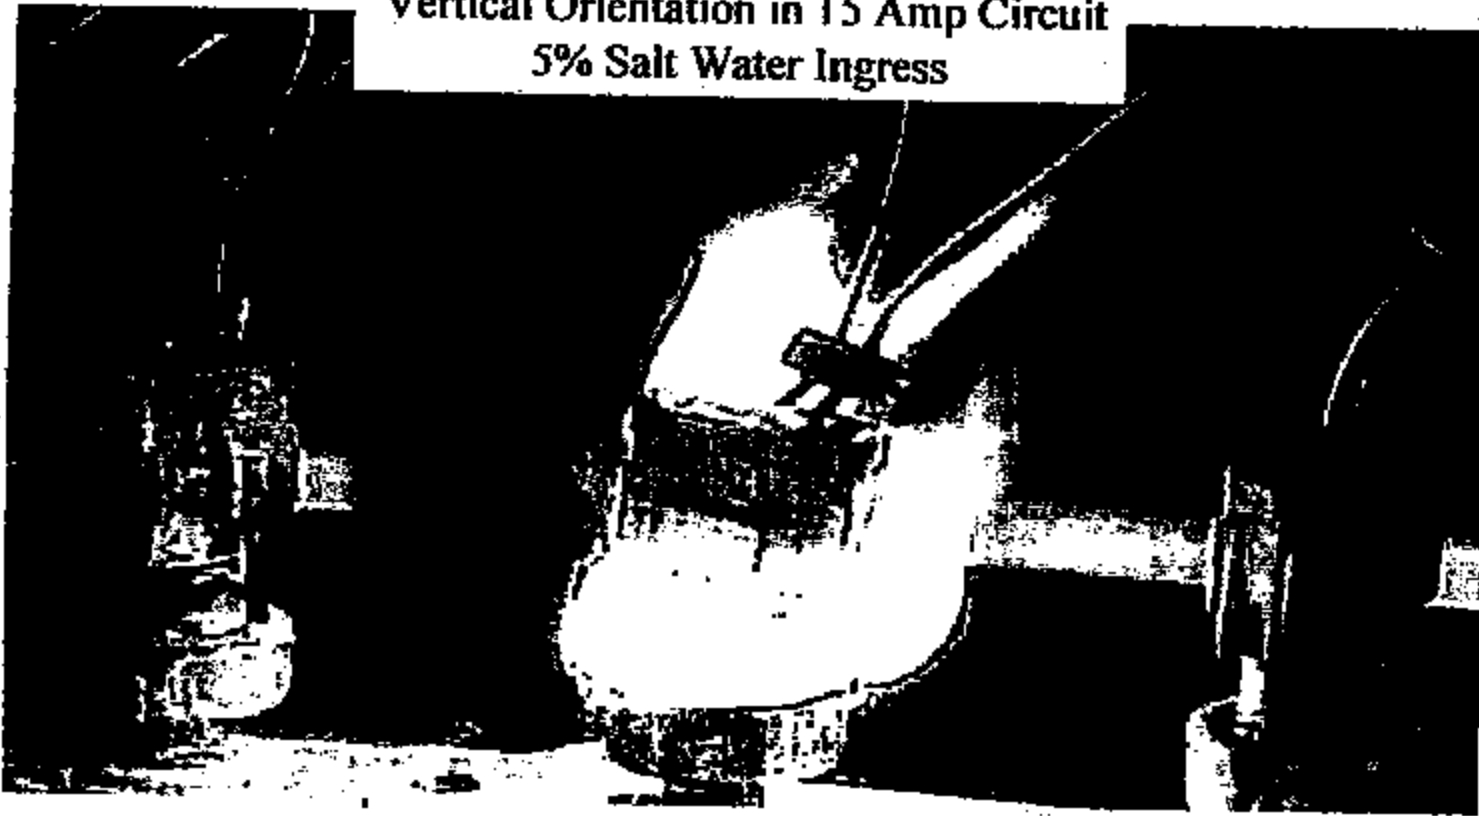
**77PS Cellanex 4300 Base**  
**Vertical Orientation in 15 Amp Circuit**  
**5% Salt Water Ingress**

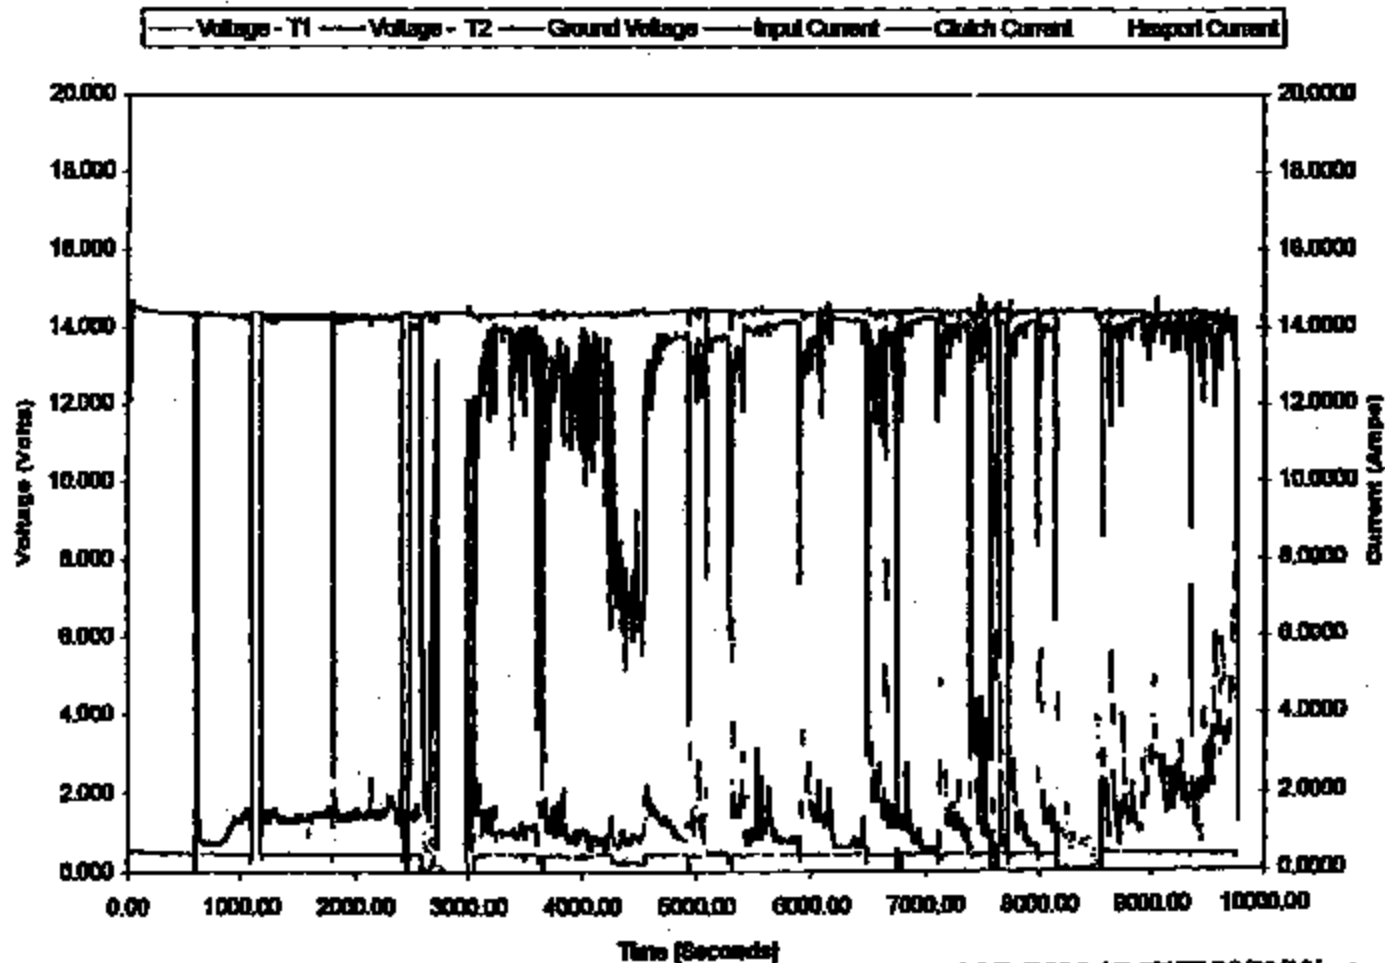
## 5% Salt Water Ingress Experiment

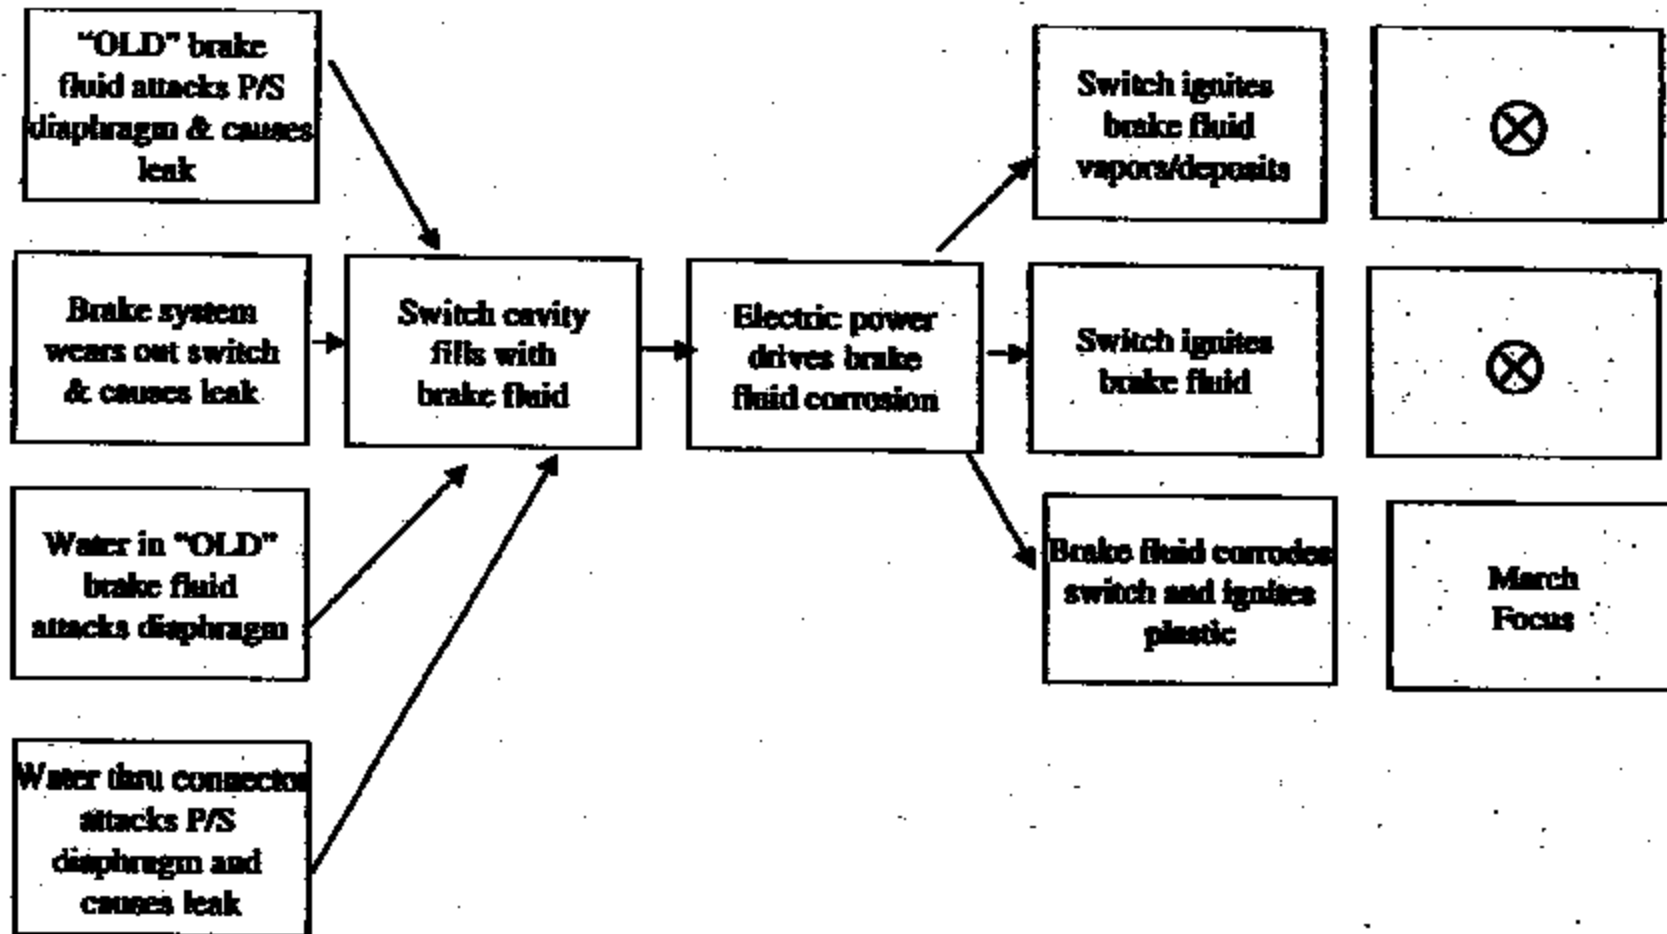
**REFINED BRAKE FLUID IGNITION THEORY  
POSSIBLE CAUSE THEORIES  
"FEB '99 FOCUS"**

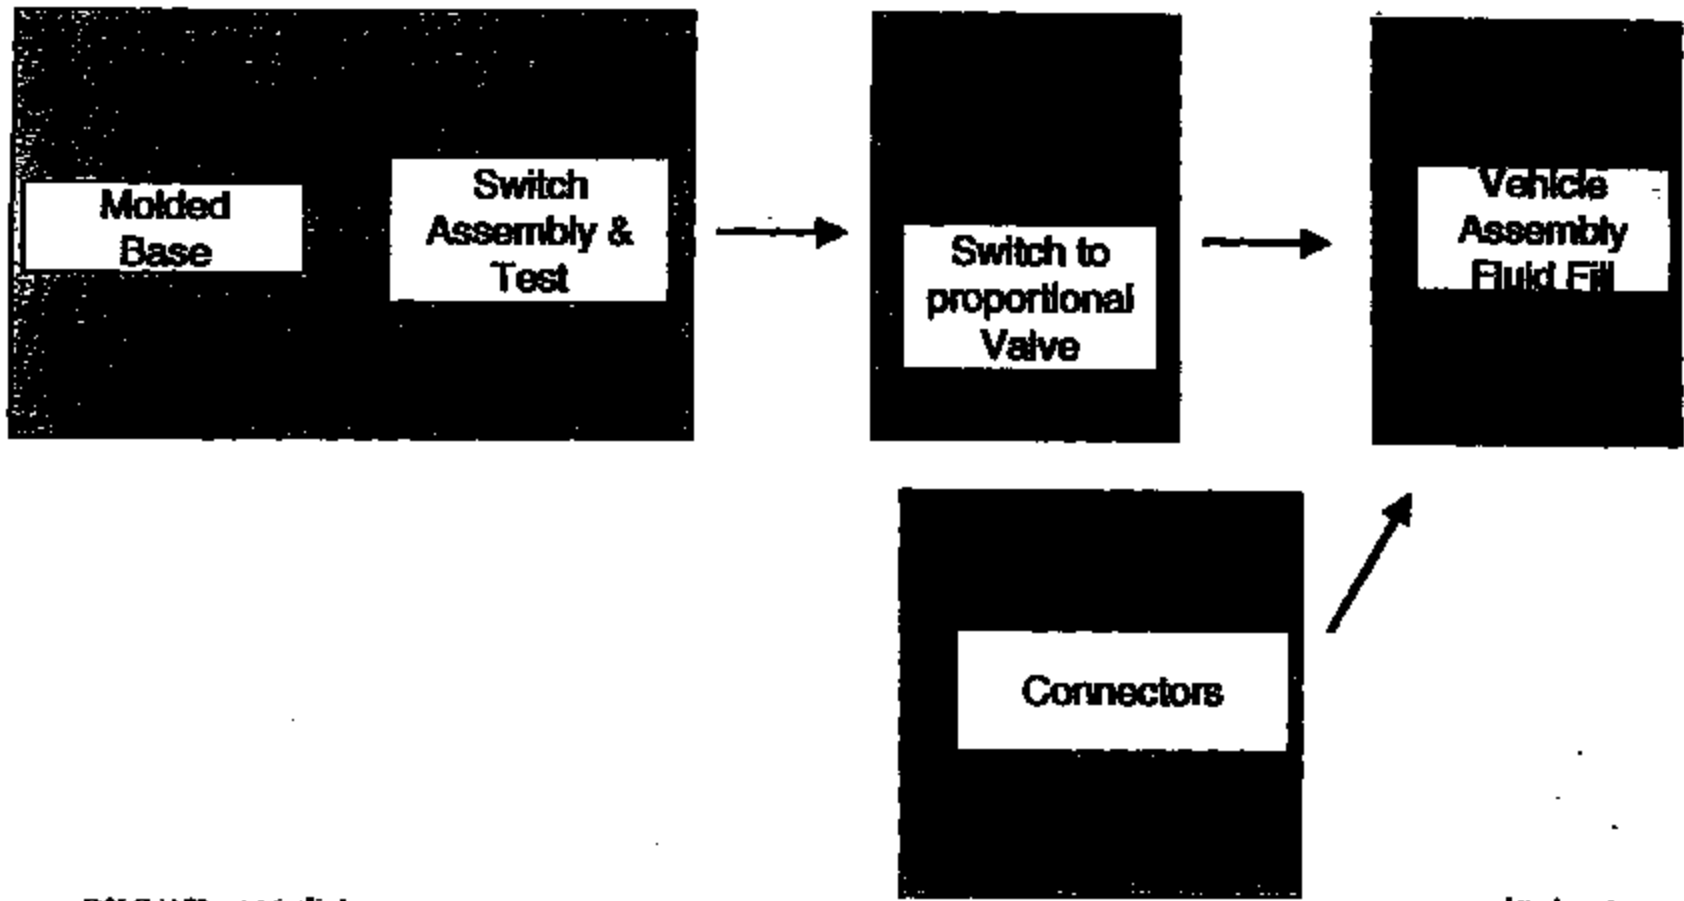
**PRESSURE SWITCH "FLOW DIAGRAM"**  
**('92, '93, TOWN CAR)**
