EA02-025

TEXAS INSTRUMENTS, INC.'S

77PS THERMAL EVENT THEORY

Brake Pressure Switch Potential Thermal Event Theory Profile 6/02/99

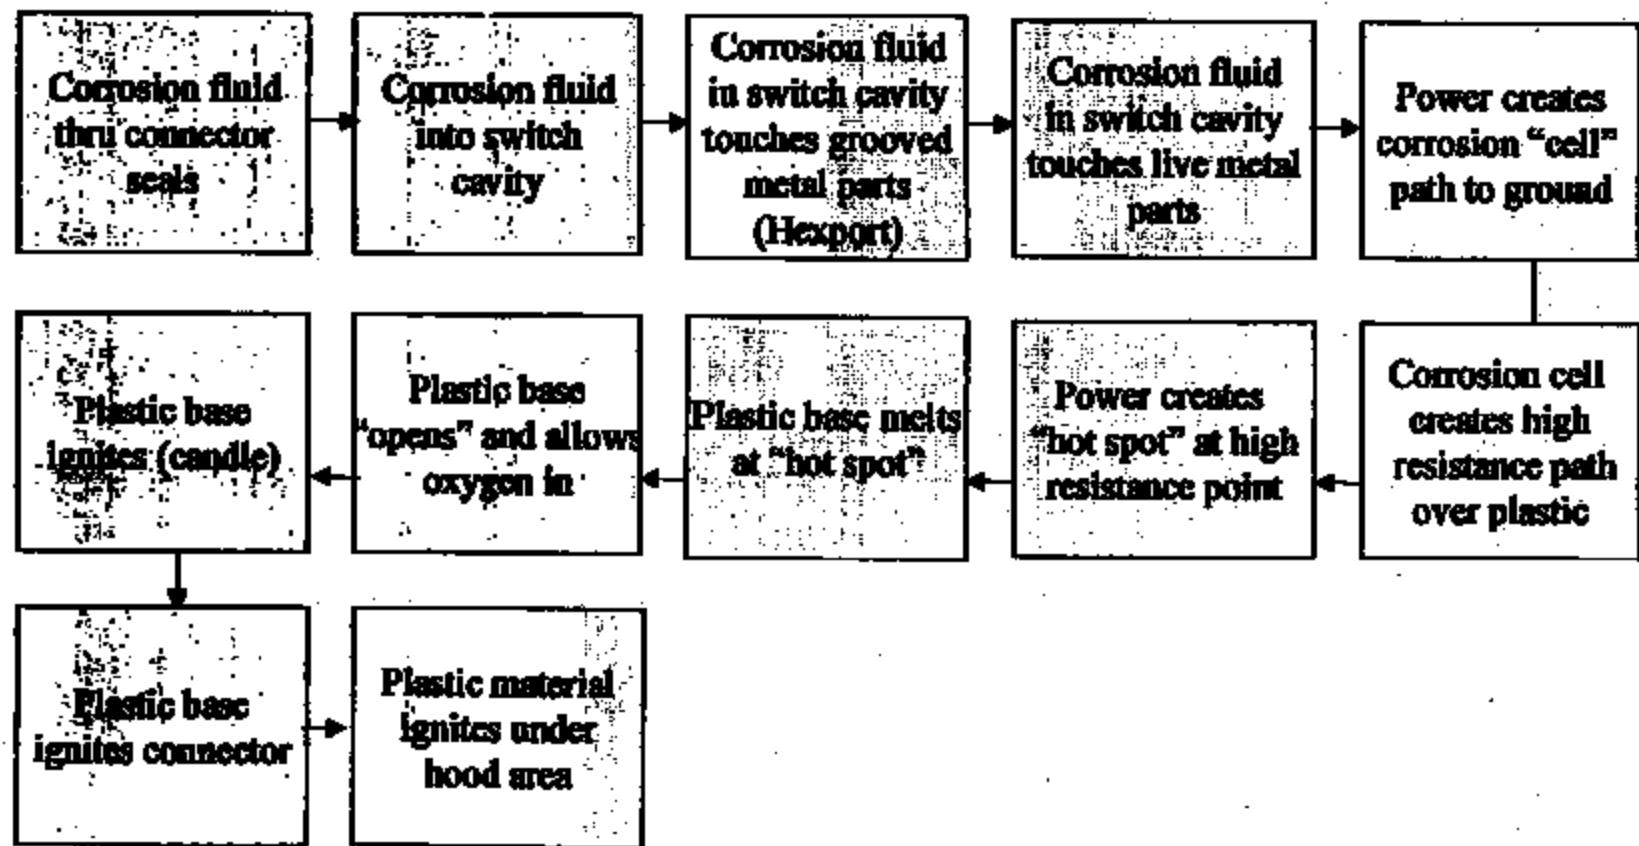
PROCESS FLOW DIAGRAM "CORROSION" POTENTIAL CAUSE FLOW ANALYSIS

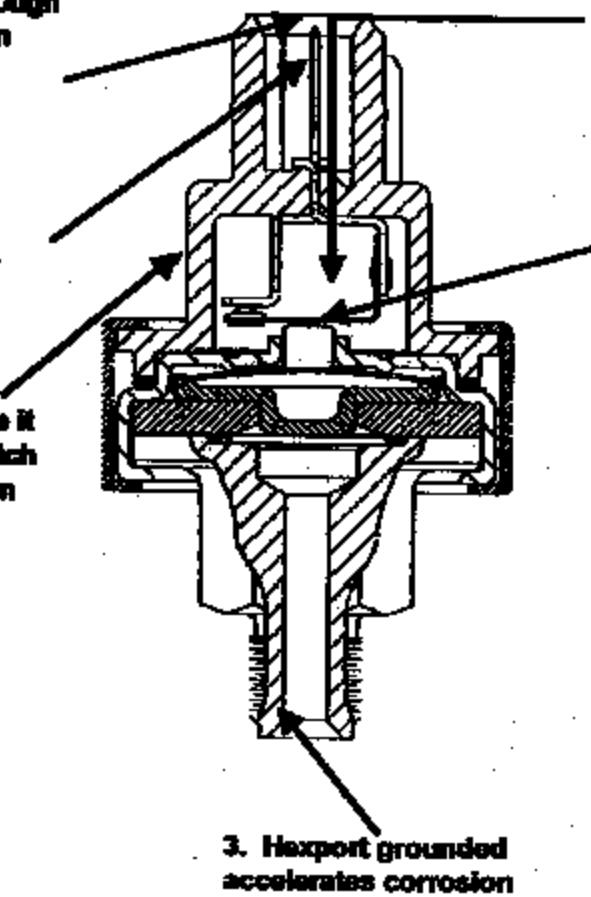
5. High current flow to case through water and ionic contamination

2. 12V Battery source to drive corrosion and provide energy

6. Plastic connector melts. Once it opens, oxygen enters the switch cavity. Ann terminal corrosion becomes "RED HOT" igniting the plastic

1. Water and "Ionic" contamination (e.g. NaCl or cleaner) enters the switch cavity

4. Contact arm& terminal corrosion increases resistance (acts like heater wire).

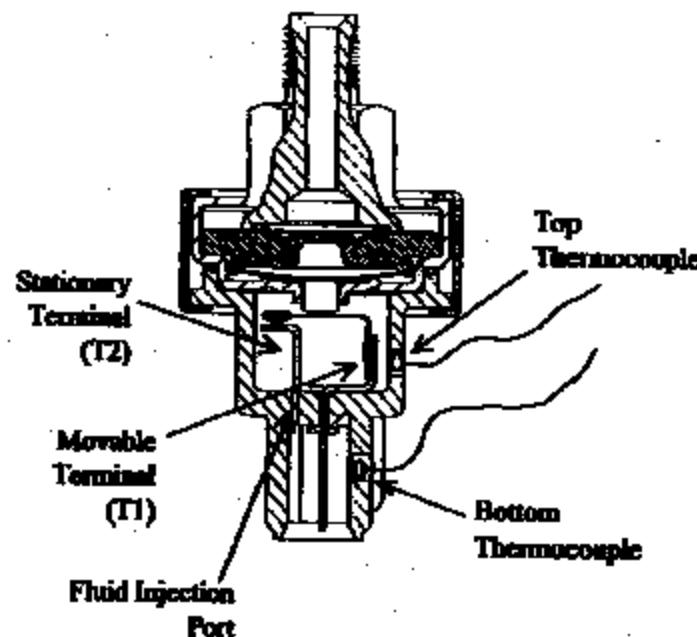
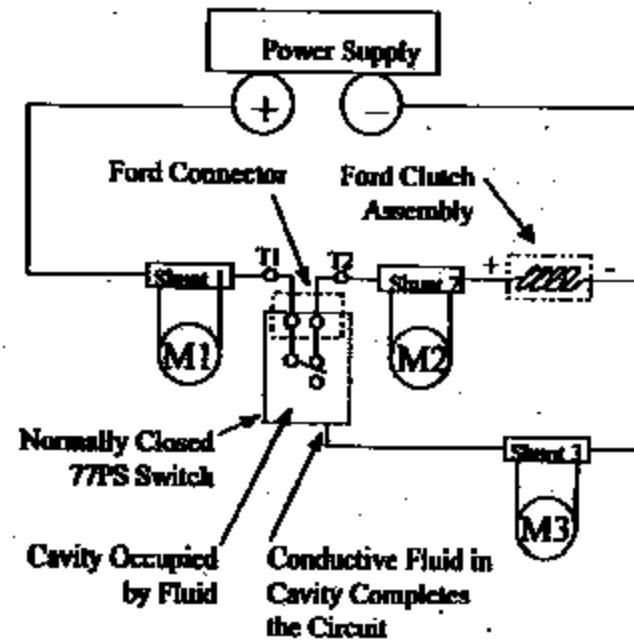
Test 1: Figure 1 and Figure 2.

**5% Salt Water Ingress Experiment
Test 1**

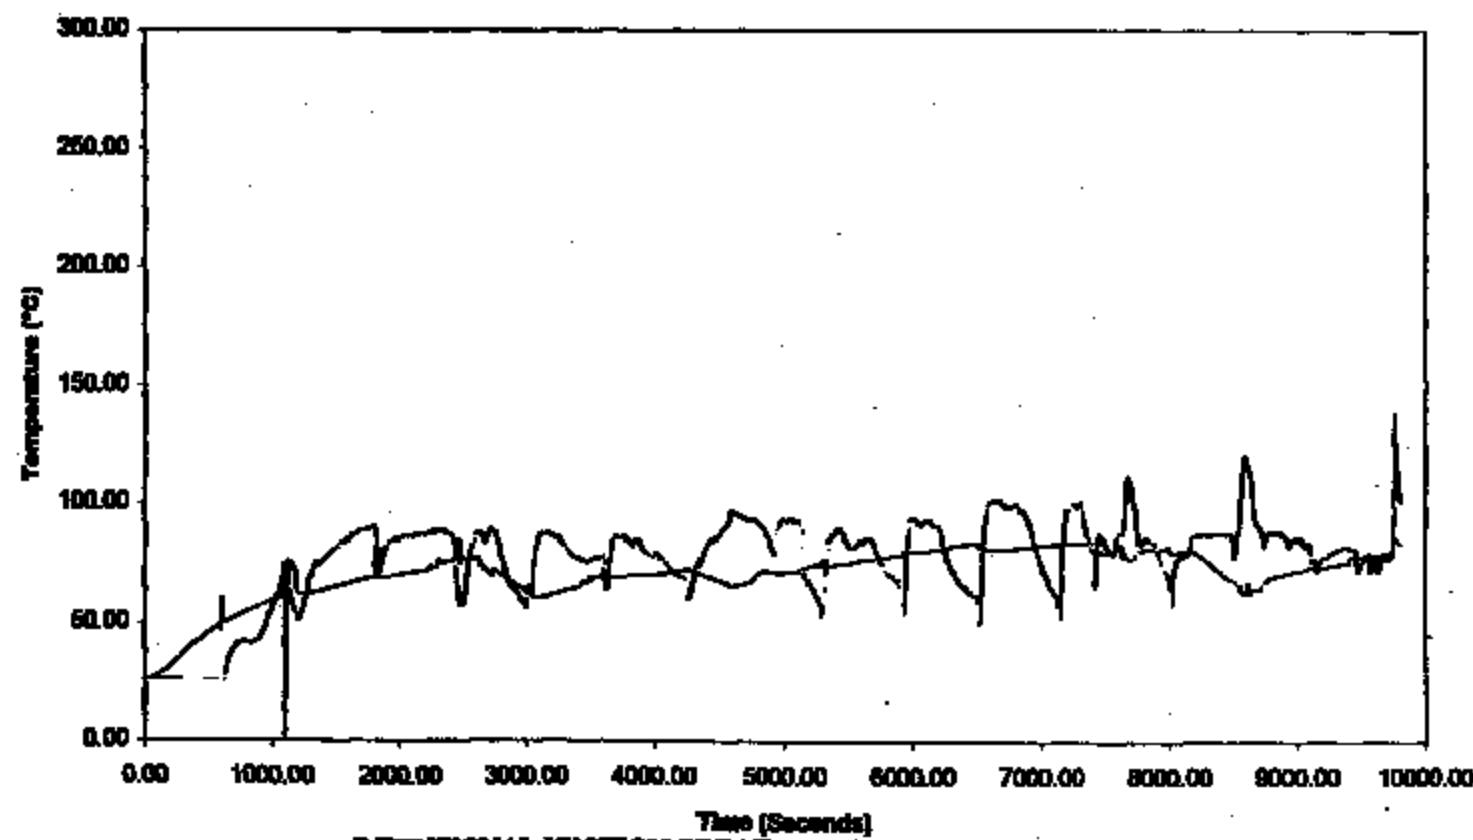
5% Salt Water Ingress Experiment
Temperature vs. Time

— Top Temp — Clutch Temp Bottom Temp

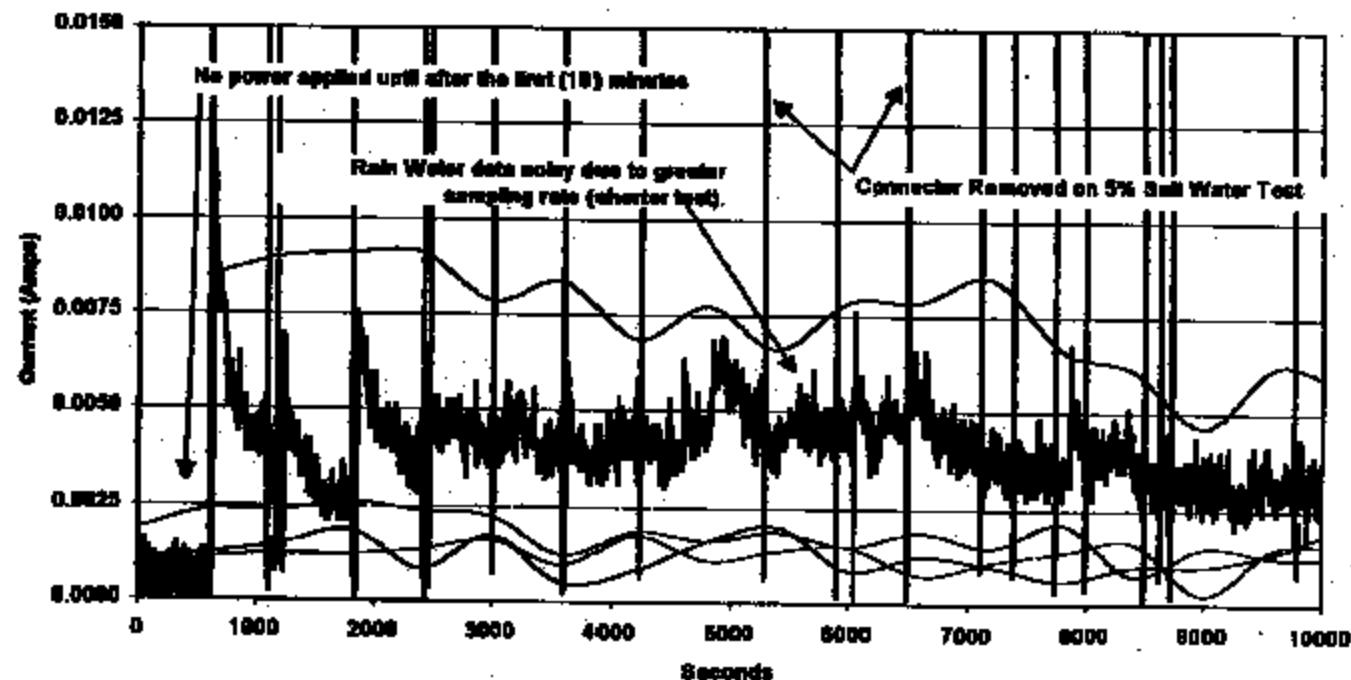
Hasport Current vs. Time
(3) Hour Fluid Ingress Experiment
(0.015 Amp Full Scale)

New Brake Fluid	New Brake Fluid w/ 5% water	Used Brake Fluid w/ 5% Water
Tap Water	Used Brake Fluid	Rain Water
5% Salt Water	100 per. Mov. Avg. (5% Salt Water)

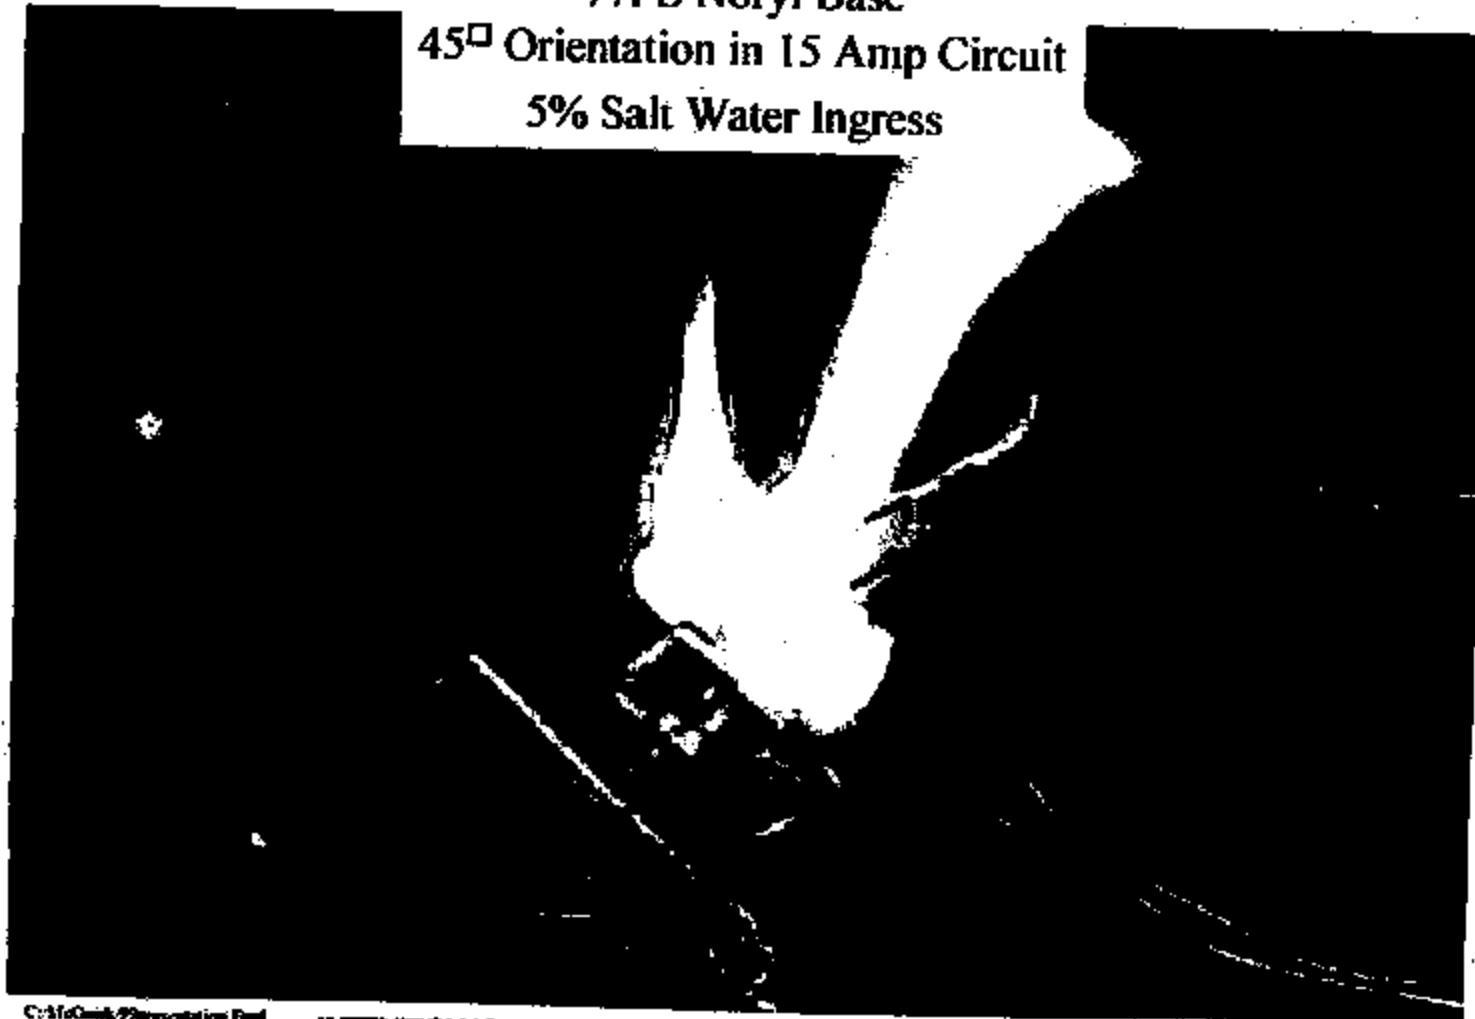
77PS Noryl Base

45° Orientation in 15 Amp Circuit

5% Salt Water Ingress

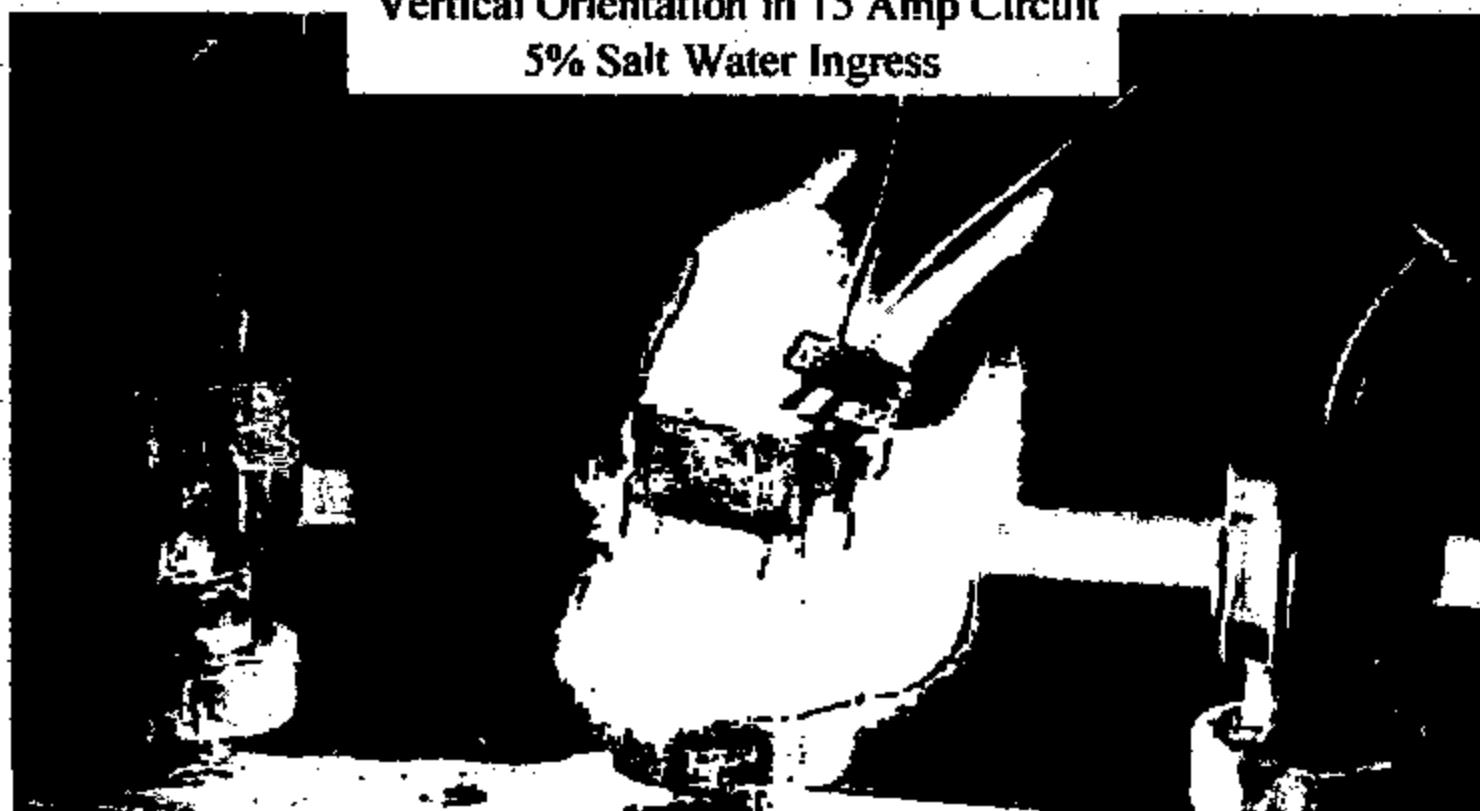
**77PS Cellanex 4300 Base
Vertical Orientation in 15 Amp Circuit
5% Salt Water Ingress**

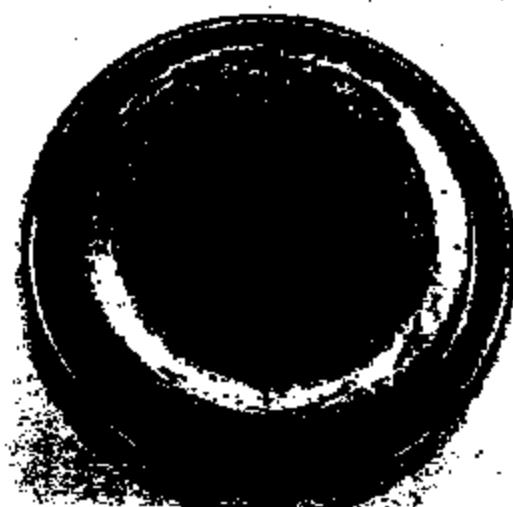
Lab Experiment-5% NaCl/H₂O and Continuous Power

- Contact arm (Cu) corrodes - chemical analysis shows presence of Na, Cl, Cu, and O on the cup surface

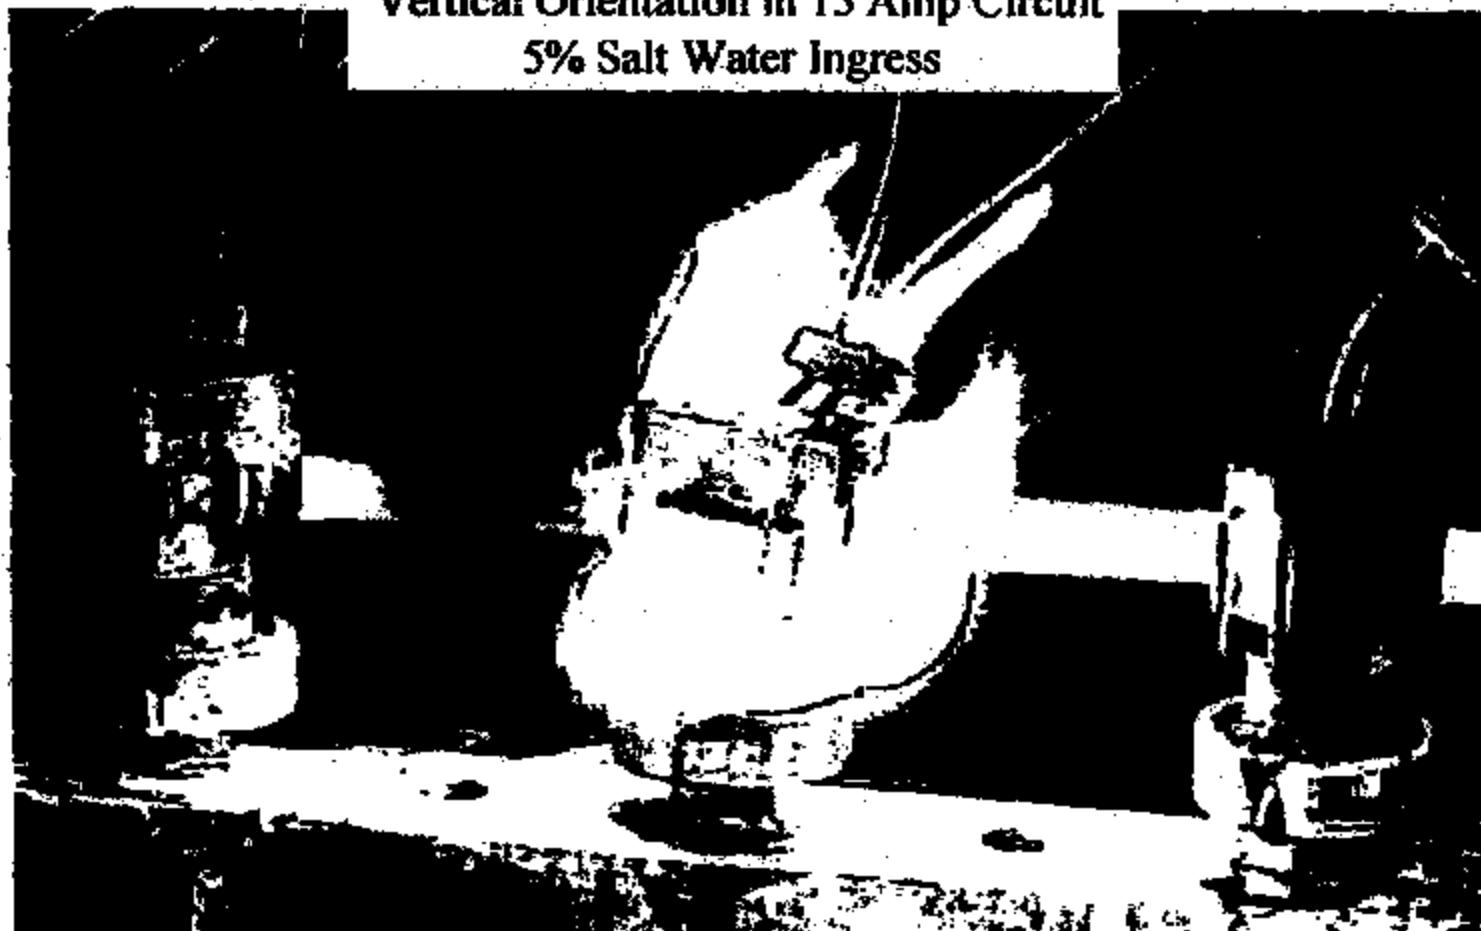
**77PS Cellanex 4300 Base
Vertical Orientation in 15 Amp Circuit
5% Salt Water Ingress**

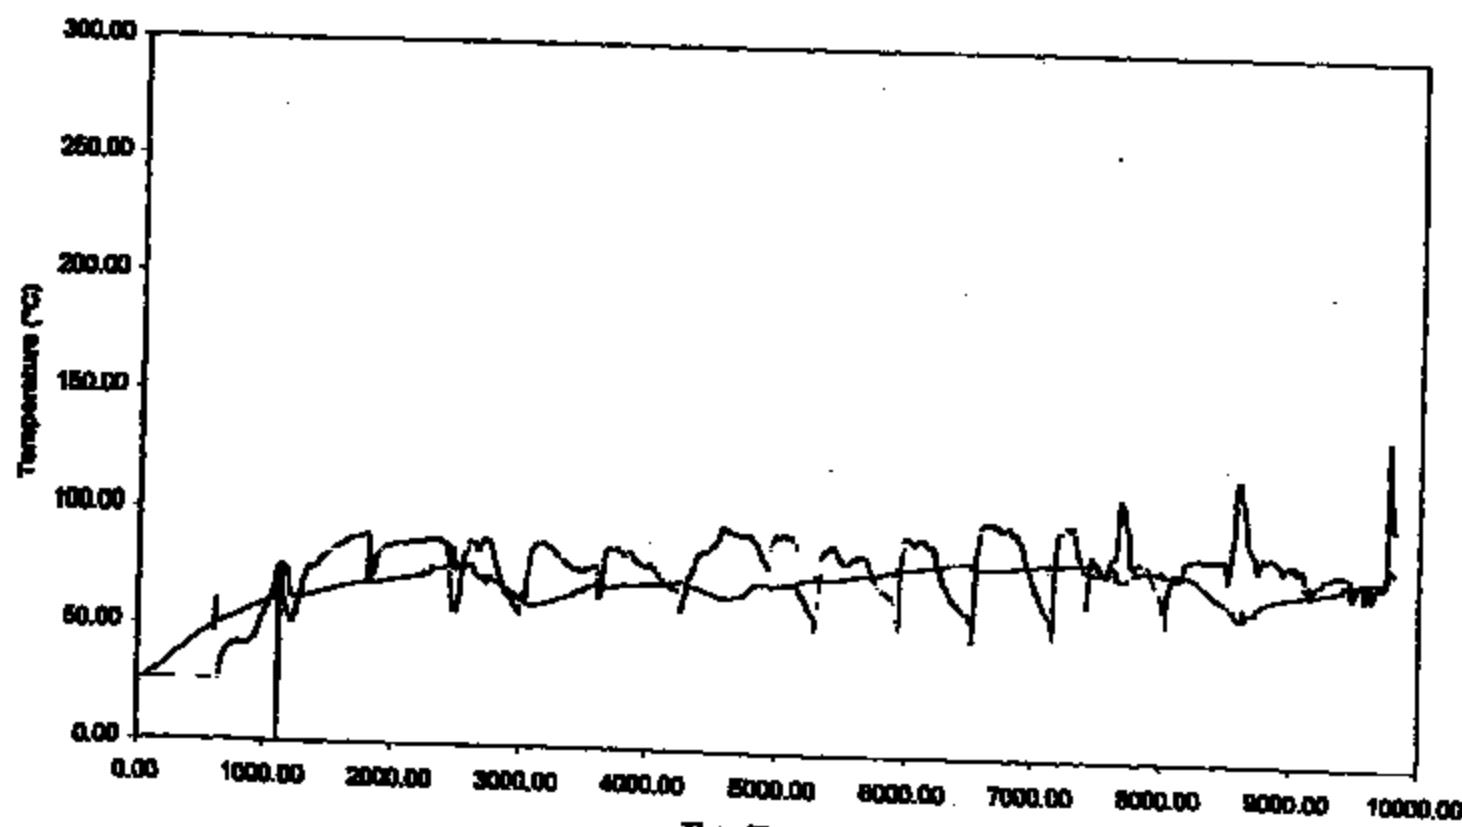
5% Salt Water Ingress Experiment
Temperature vs. Time

— Top Temp — CATCH TEMP Bottom Temp

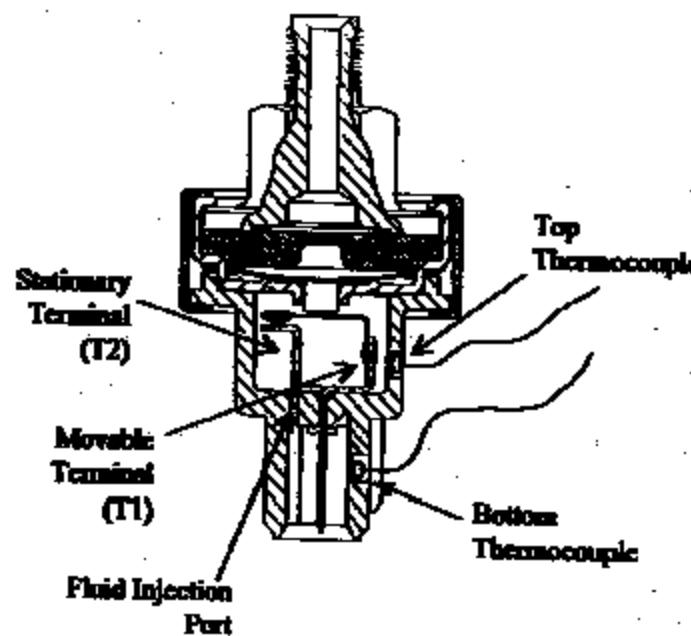
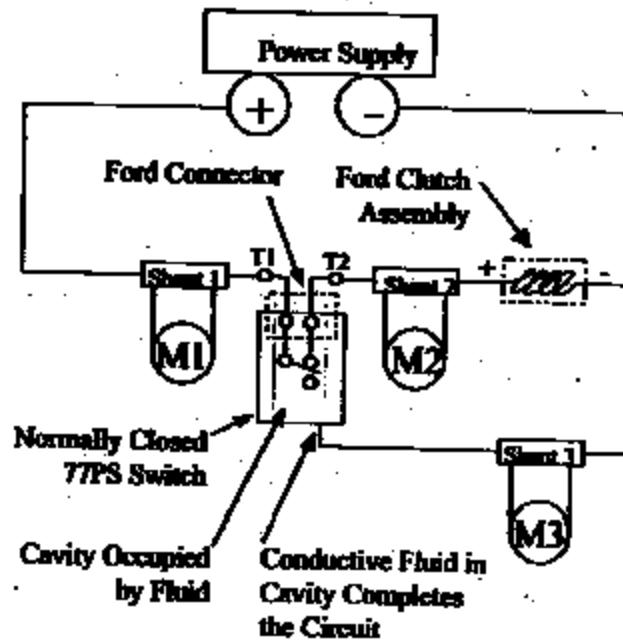
Test 1: Figure 1 and Figure 2.

**5% Salt Water Ingress Experiment
Test 1**

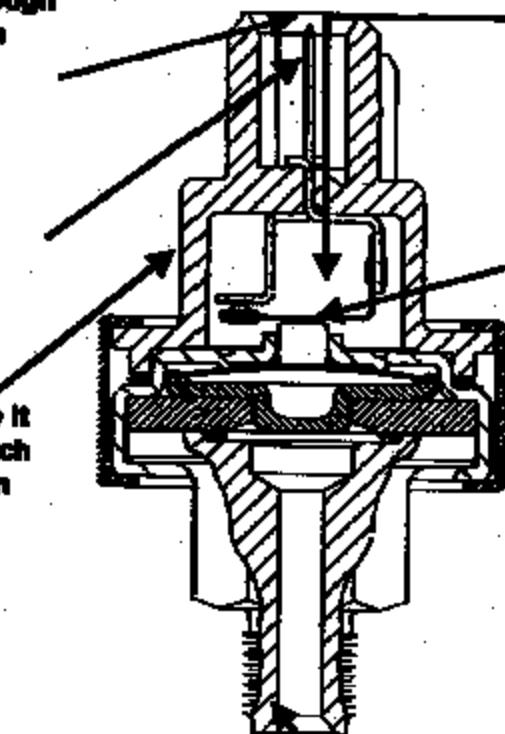
6. High current flow to case through water and ionic contamination

2. 12V Battery source to drive corrosion and provide energy

5. Plastic connector melts. Once it opens, oxygen enters the switch cavity. Anne terminal/corrosion becomes "RED HOT" igniting the plastic

1. Water and "Ionic" contamination (e.g. NaCl or cleaner) enters the switch cavity

4. Contact arm& terminal corrosion increases resistance (acts like heater wire).

3. Hexport grounded accelerates corrosion

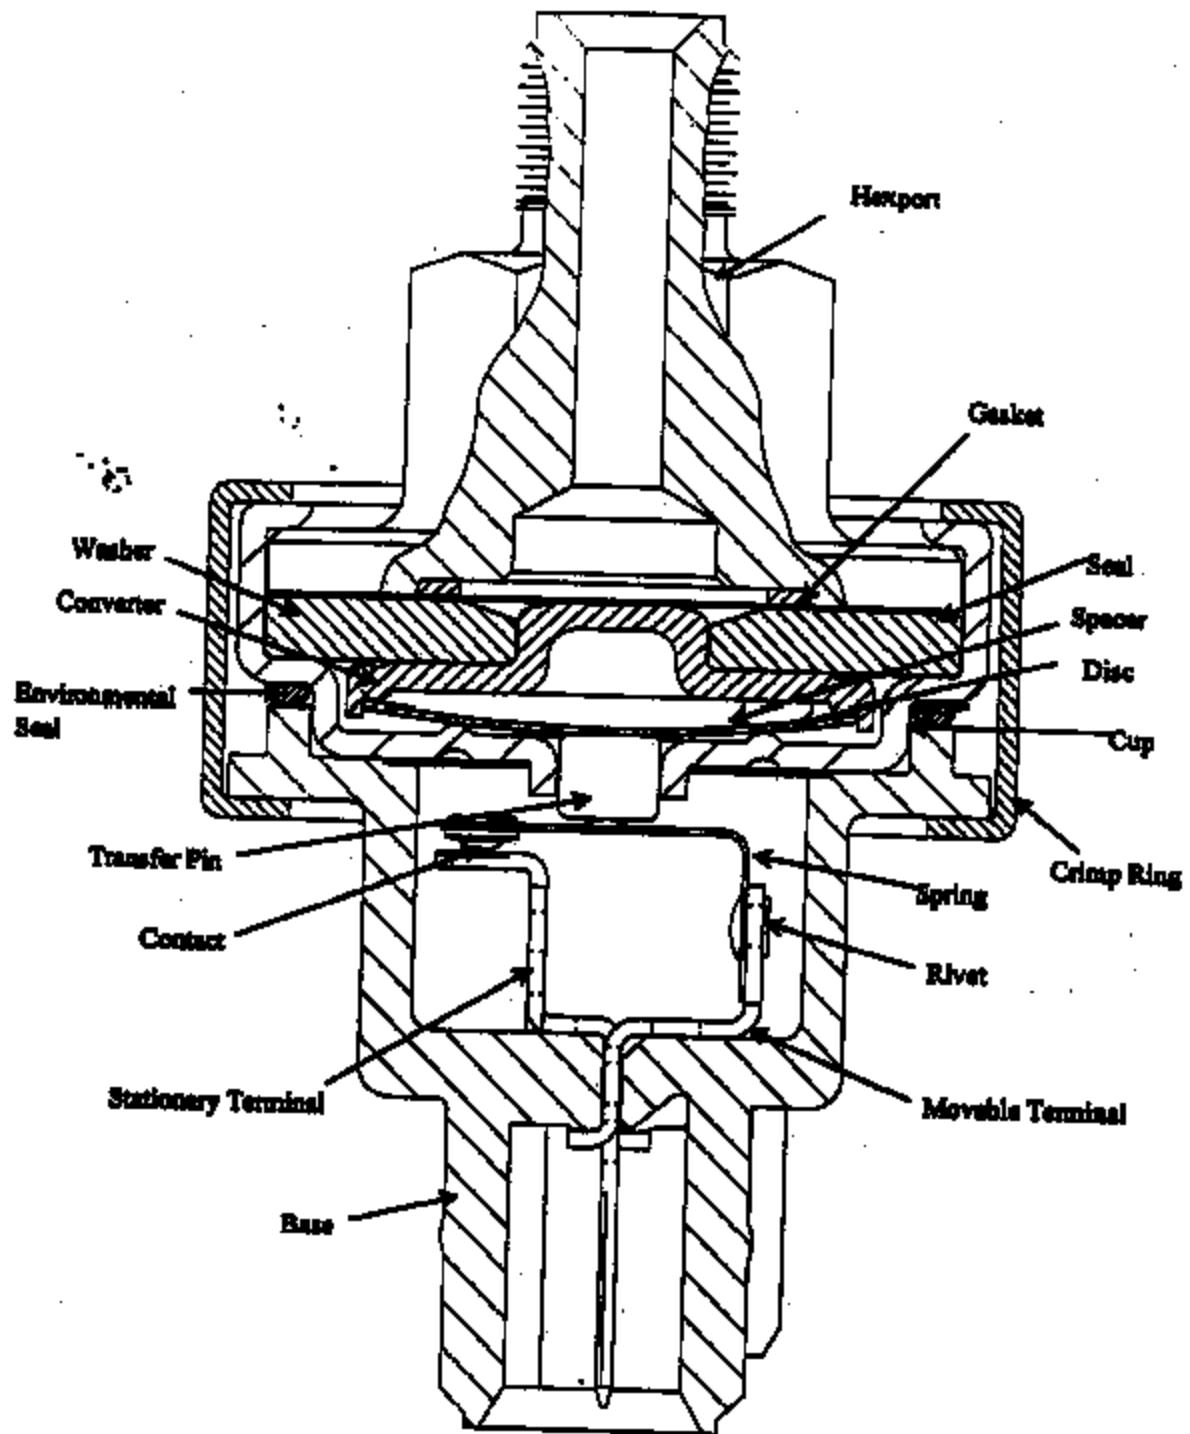
Hydraulic Pressure Switch Cross Section

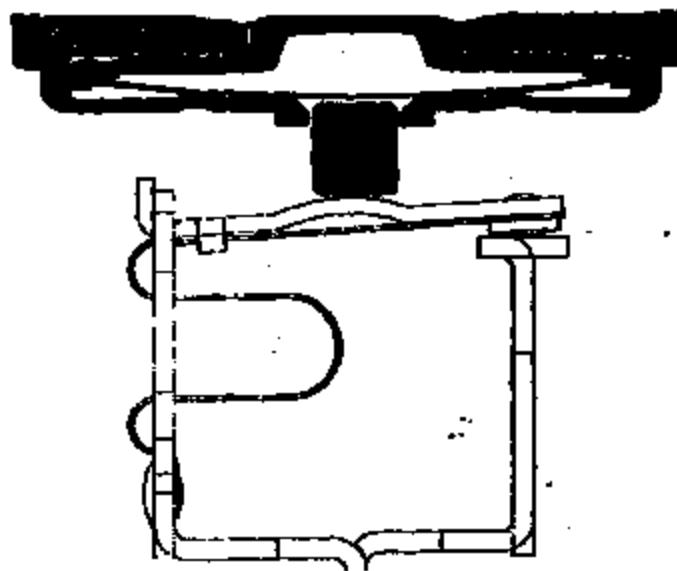
PRESSURE SWITCH LOGIC

NORMALLY CLOSED

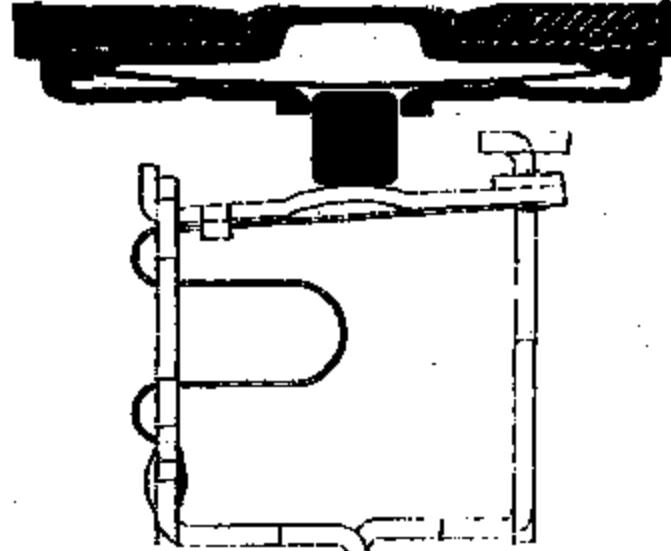
NORMALLY OPEN

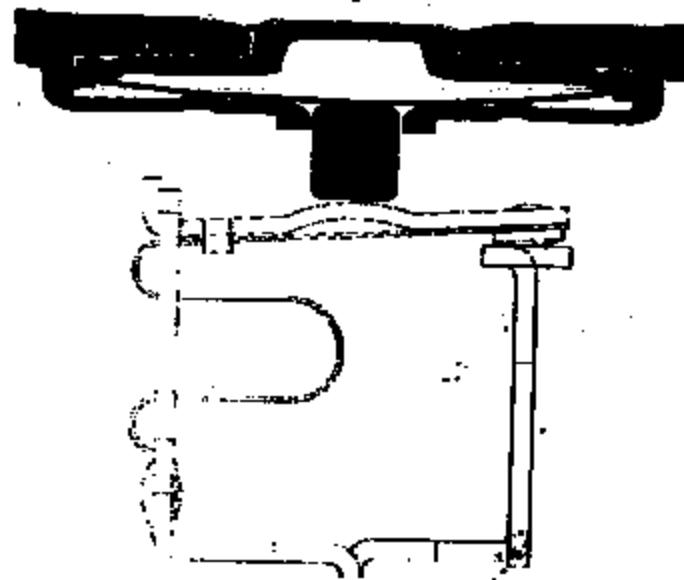
USING DISC MOTION TO MAKE / BREAK CONTACTS

BEFORE SNAP

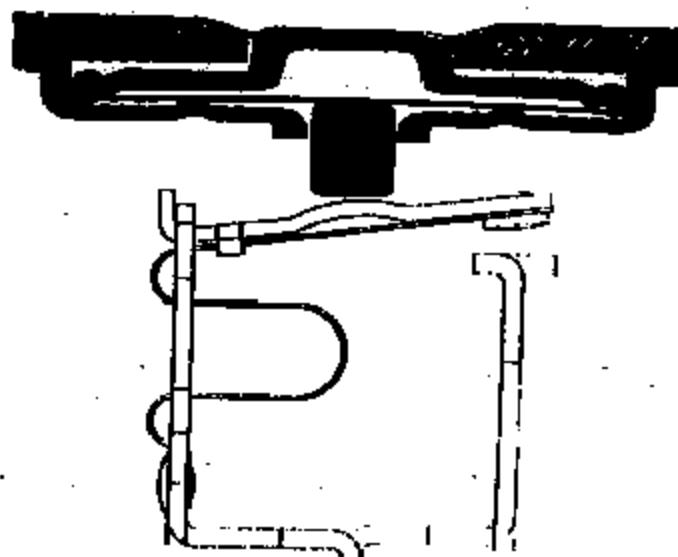
AFTER SNAP

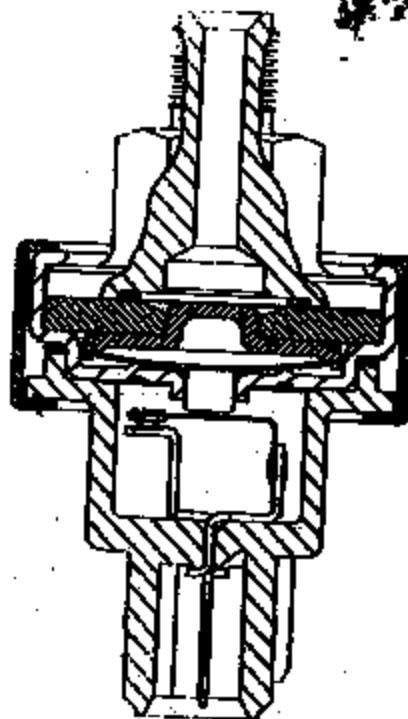
PRESSURE SWITCH ASSEMBLIES

L - SHAPED SPRING
NORMALLY CLOSED

S - SHAPED SPRING
NORMALLY CLOSED

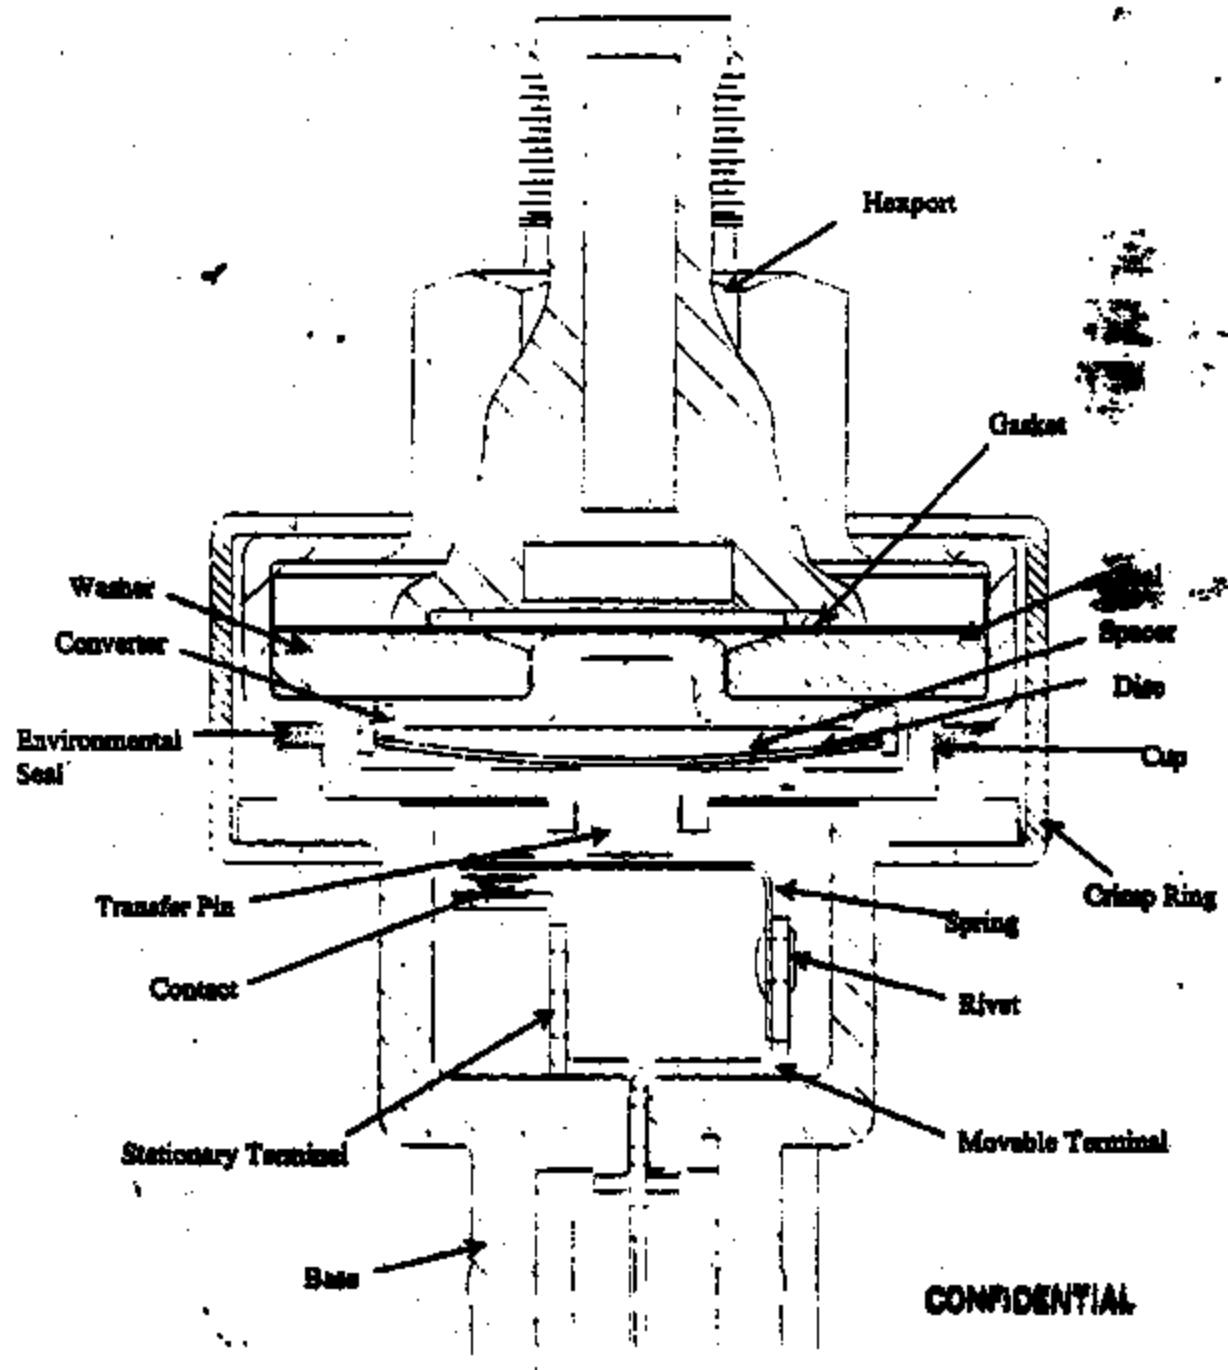
Hydraulic Pressure Switch Cross Section

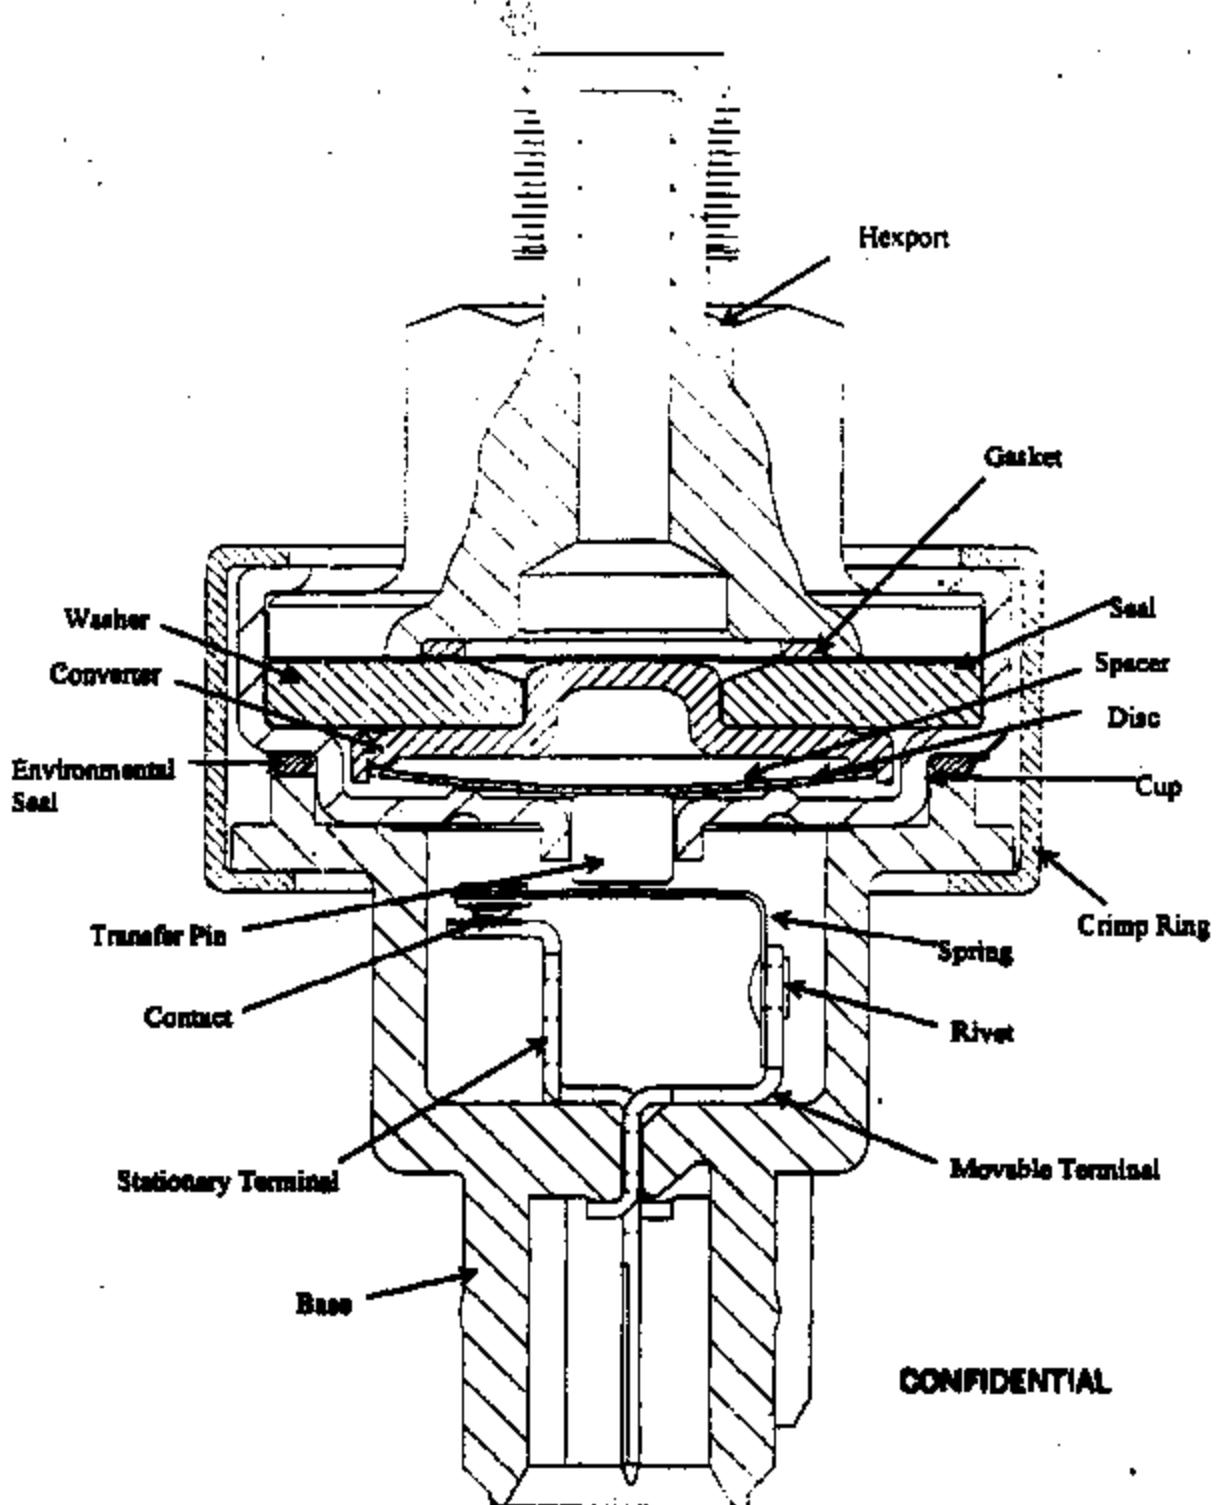
Hydraulic Pressure Switch Cross Section

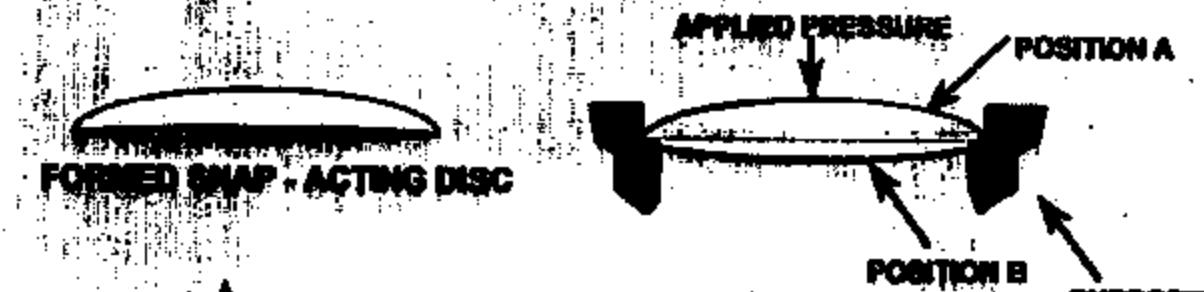
THE SNAP-ACTING DISC

FORMED SNAP-ACTING DISC

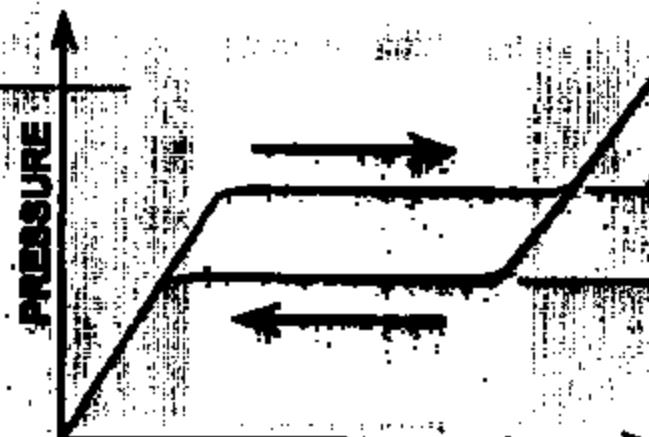
DISC CHARACTERISTIC CURVE

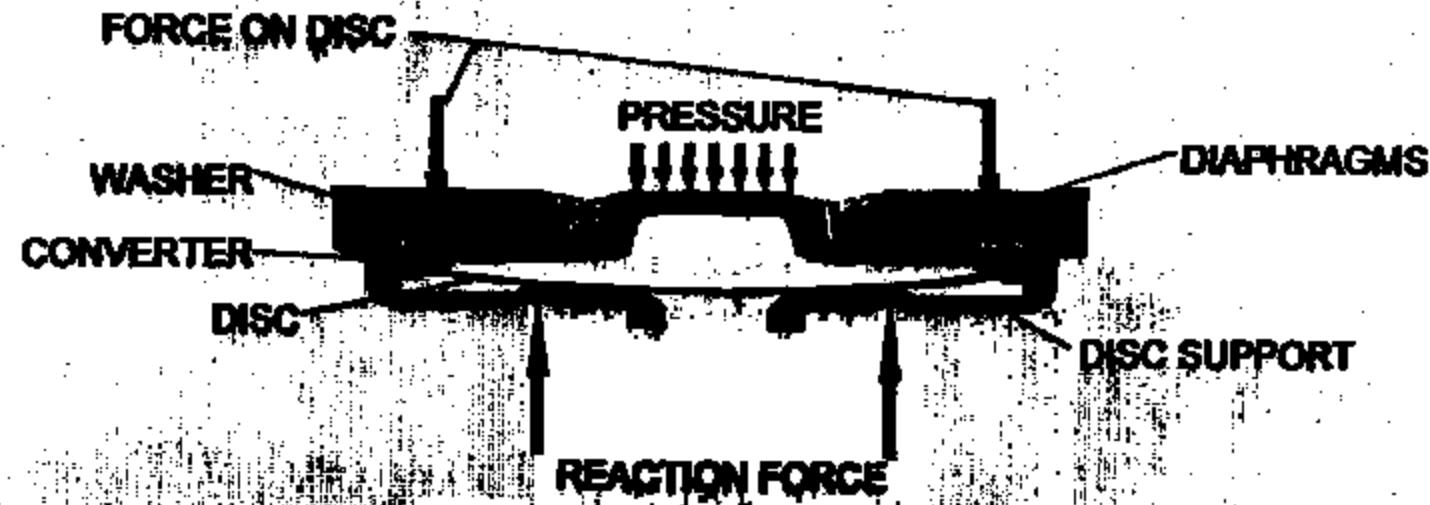
AMPLIFYING DISC PRESSURE USING A PRESSURE CONVERTER

$$\text{FORCE ON DISC} = \text{PRESSURE} \times \text{EFFECTIVE AREA}$$

**EFFECTIVE AREA IS INFLUENCED BY THE CONVERTER / WASHER DESIGN
AND THE WAY THE DIAPHRAGM CONFORMS TO THE CONVERTER**

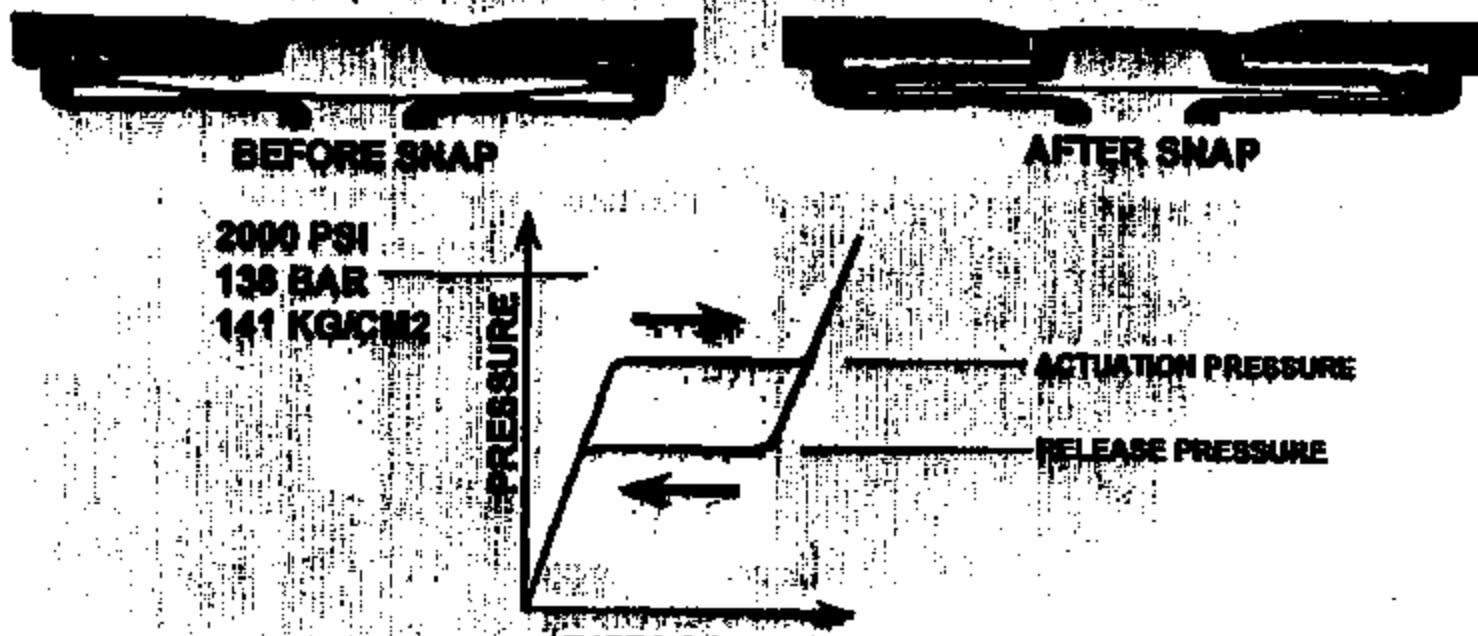
PRESSURE SENSOR OPERATION

SENSOR CHARACTERISTIC CURVE

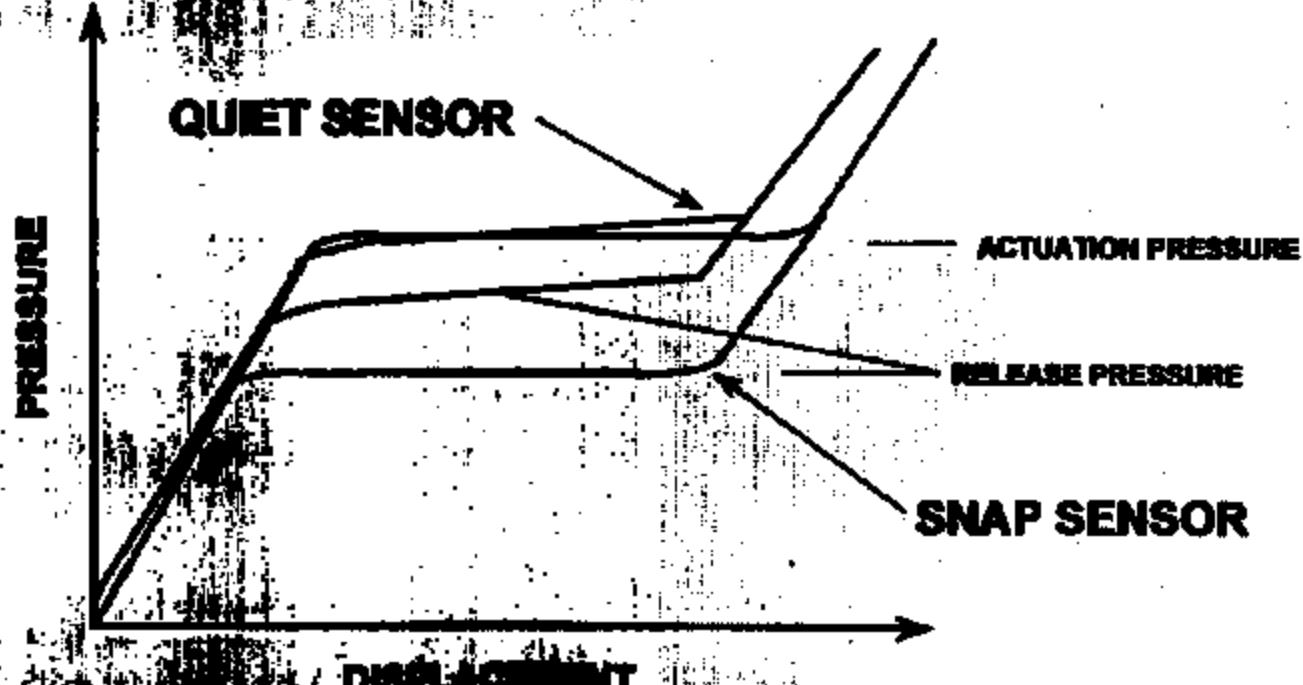
QUIET VS SNAP SENSORS

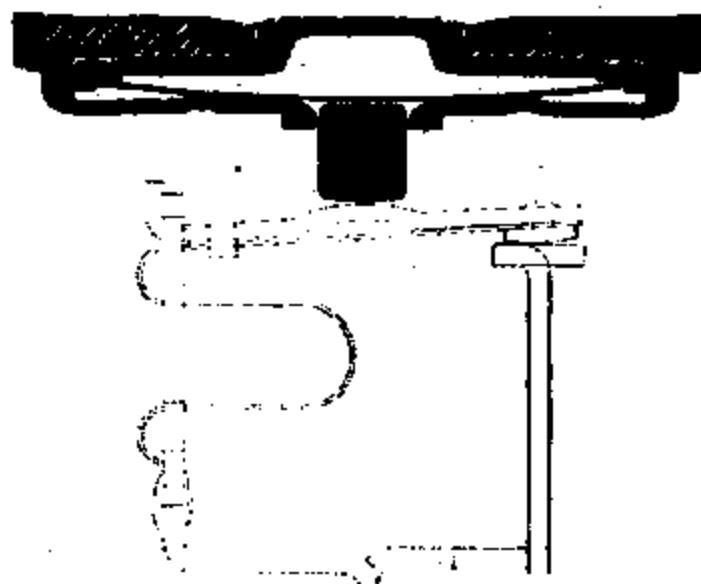
USING DISC MOTION TO MAKE / BREAK CONTACTS

BEFORE SNAP
