EA02-025

TEXAS INSTRUMENTS, INC.'S

77PS THERMAL EVENT THEORY

Brake Pressure Switch Potential Thermal Event Theory Profile 6/02/99

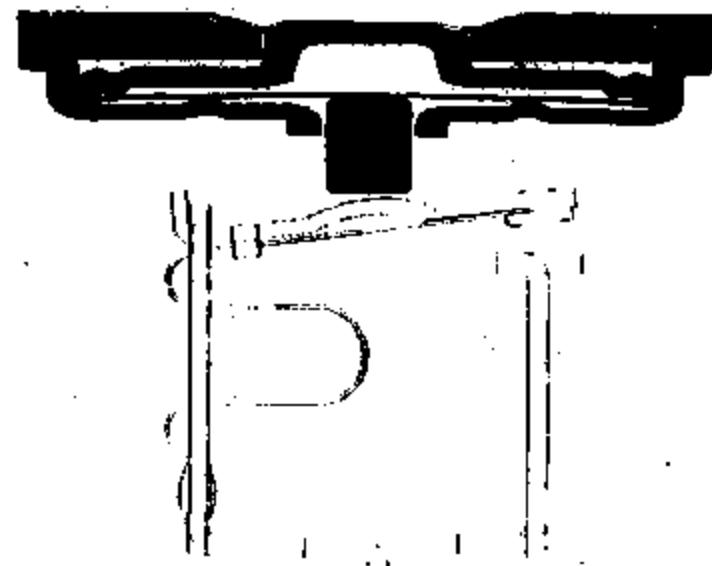
USING DISC MOTION TO MAKE / BREAK CONTACTS

AFTER SNAP

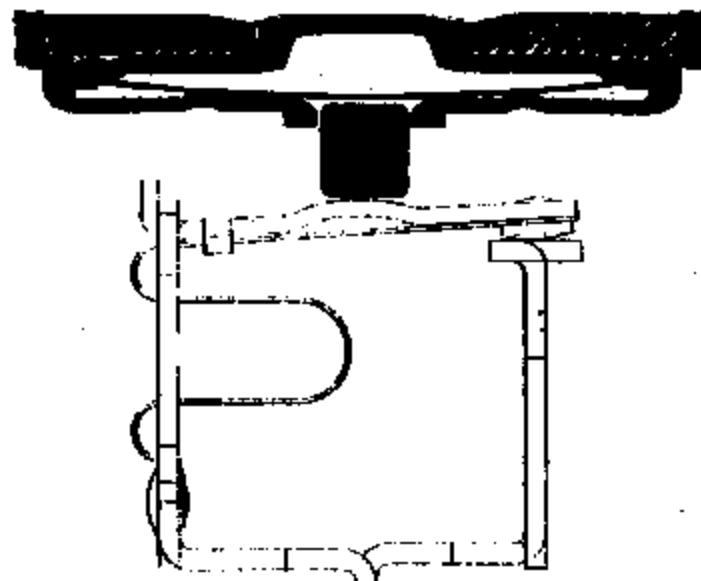
PRESSURE SWITCH LOGIC

NORMALLY CLOSED

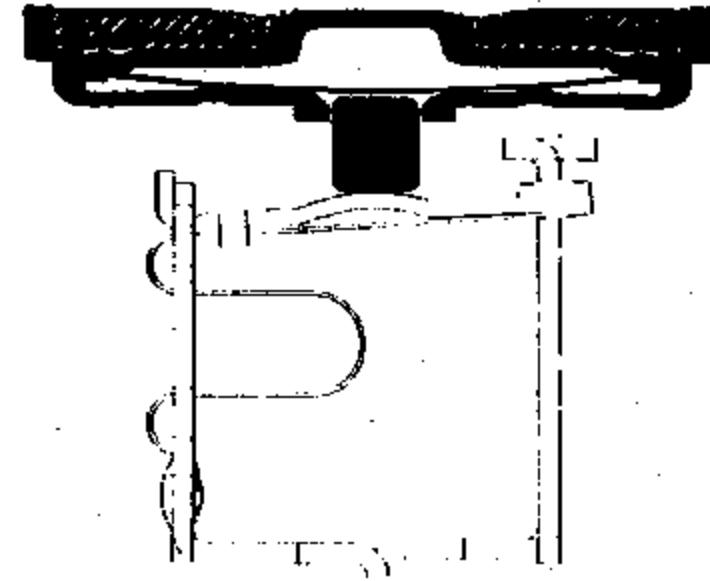
NORMALLY OPEN

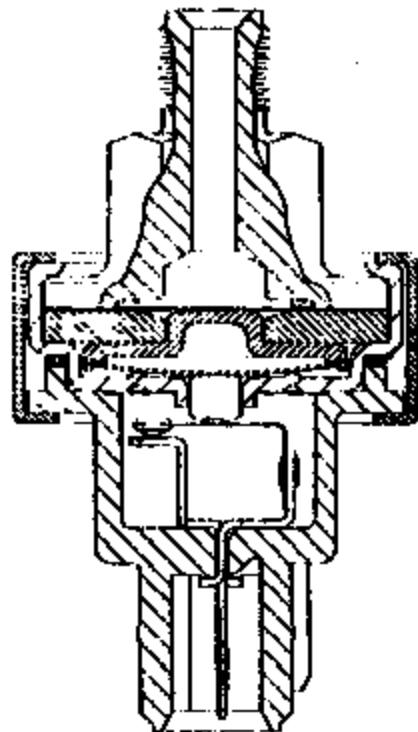
PRESSURE SWITCH ASSEMBLIES

L - SHAPED SPRING
NORMALLY CLOSED

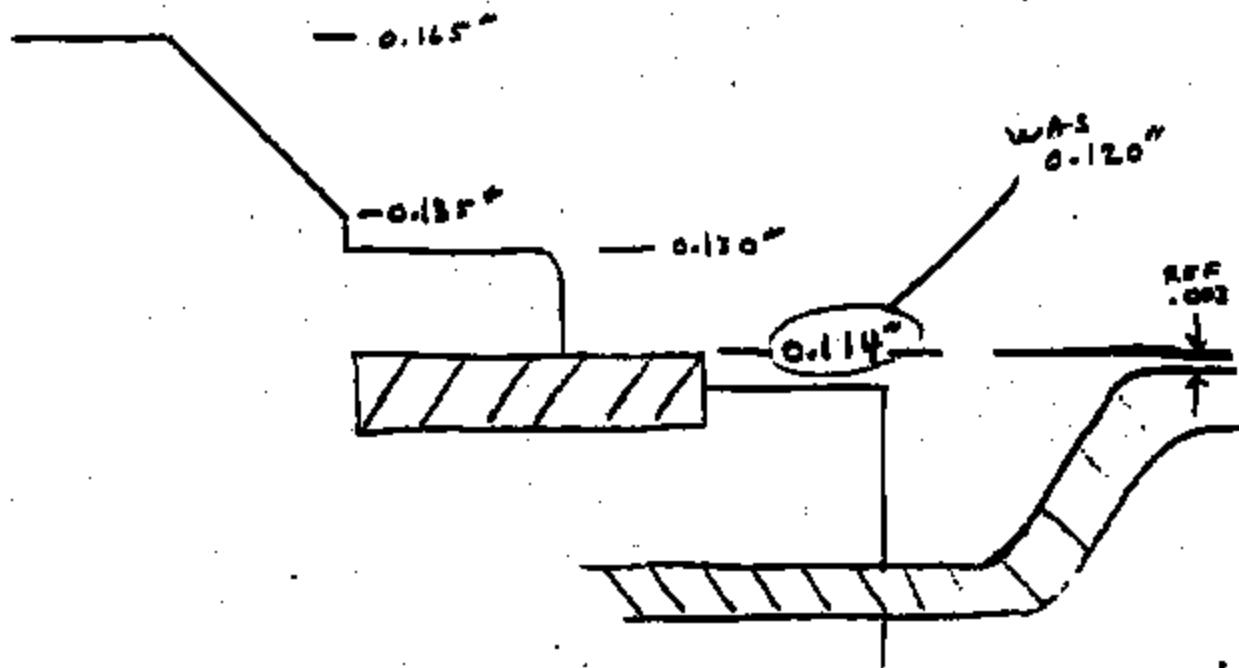
N/O switch, disc seat depth ADJUSTMENT

THE WALL THAT HOLDS THE DISC IN PLACE IS INCREASED
IN HEIGHT BY 0.006" TO HOLD THE DISC IN PLACE
BETTER. DONE BY DROPPING THE DISC 3/16" & COUNTING
AND ALL RELATED PARTS DOWN BY 0.006".
