EA02-025

TEXAS INSTRUMENTS, INC.'S

TI 77PS Test Synopsis

Brake Pressure Switch Potential Thermal Event Theory Profile 5/20/99

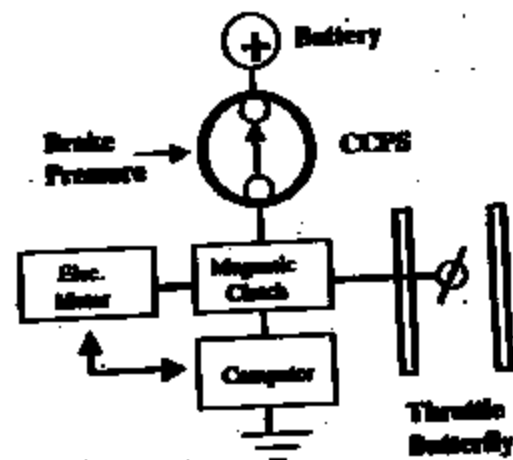
- The CCPS is a redundant safety device designed for use in a vacuum-less electronic cruise control system.
- Functionally, it replaces the present vacuum damp valve by de-energizing a clutch which connects the throttle to an electronic actuator.
- It is plumbed into the brake line. When the driver applies pressure to the brake pedal, the normally-closed switch opens, disconnecting the actuator from the throttle butterfly.

Actuation:	125 PSI +/- 35 250 PSI +/- 50
Release:	20 PSI min 40 PSI min
Burst:	7000 PSI
Proof:	3000 PSI 4000 PSI
Cycles:	500K, 0 - 1450 PSI, 2 Hz
Voltage:	Battery
Current:	0.75 AMP Inductive

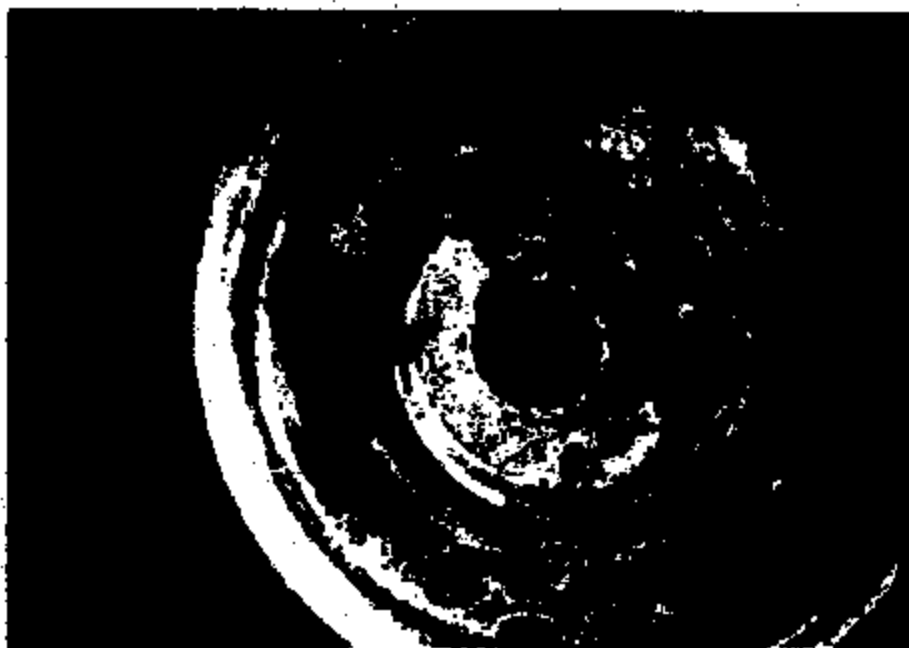
Memphis Switch Analysis

- **Chemical analysis reveals K, S, Cu, C, and O.**
