**Materials & Controls  
Automotive Sensors & Controls**

**OVERVIEW OF  
CONCERN TIME LINE**

**Ford recalls 279,000 cars because of risk of cruise-control fires**

**Brake Pressure Switch  
Potential Thermal Event Theory Profile 5/20/99**

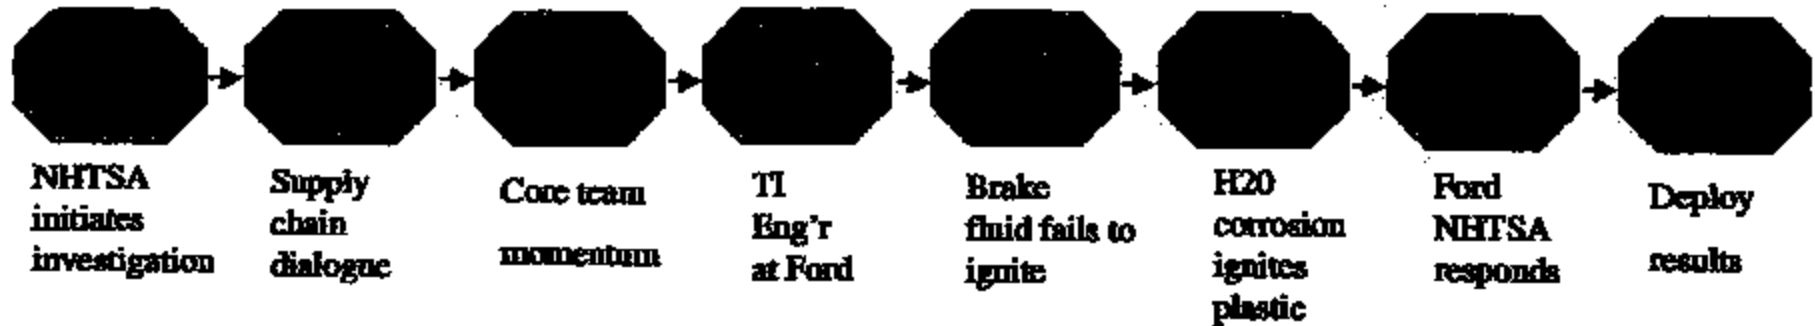
**OVERVIEW OF  
CONCERN TIME LINE**

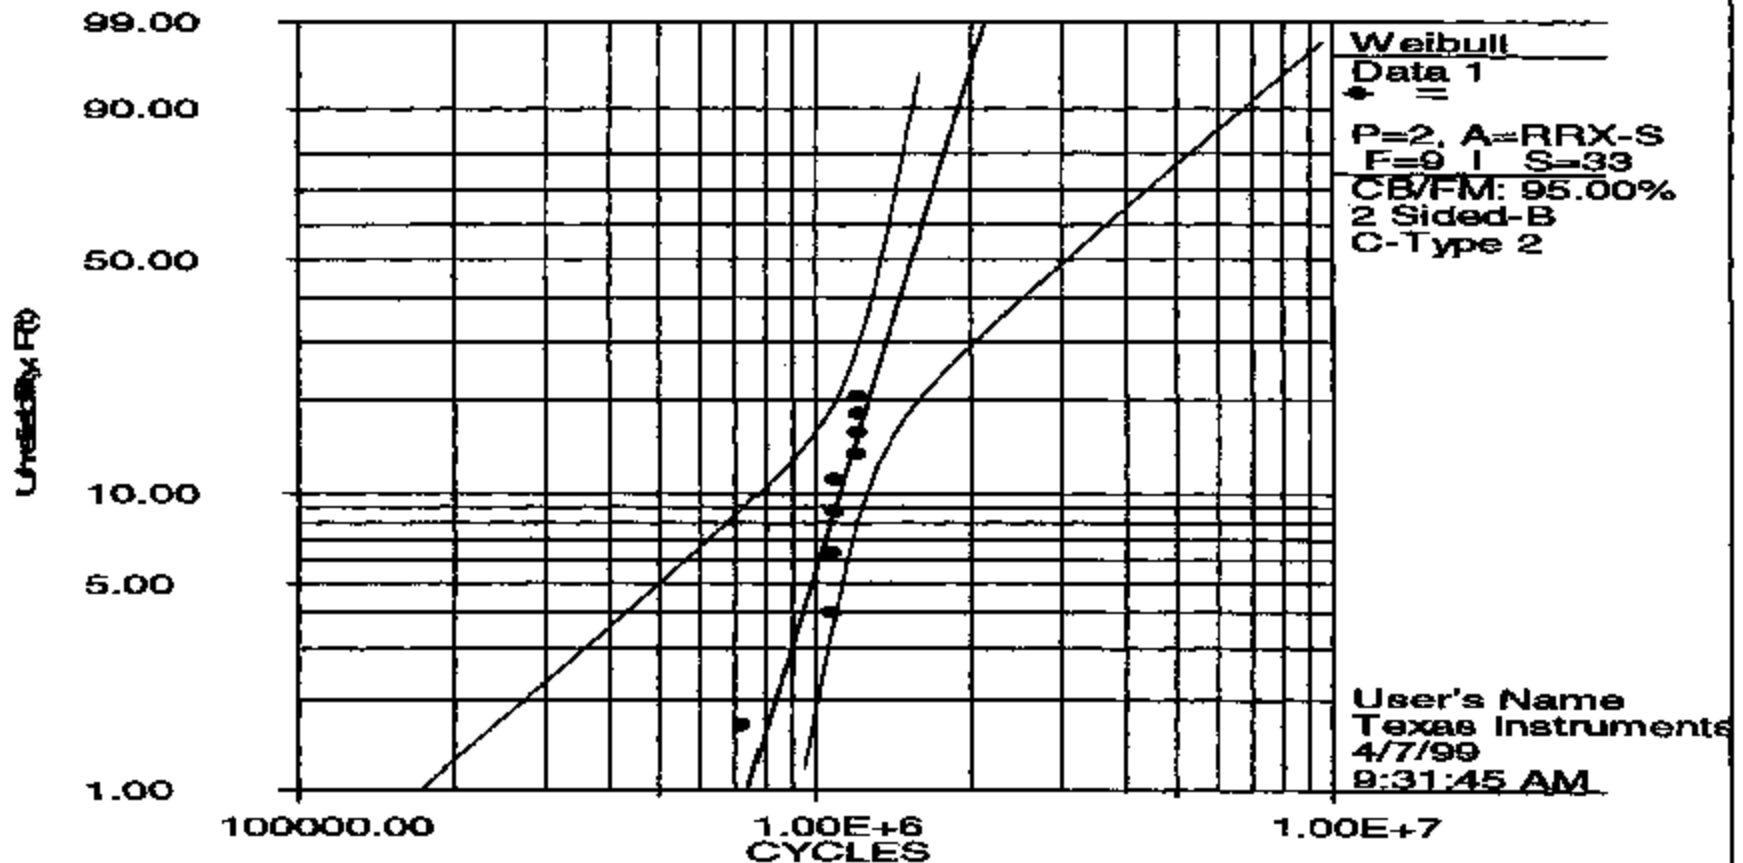
**77PSL2-1 COMBINED DATA**

$\beta=5.83, \eta=1.64E+6, \rho=0.91$

- "Town Car" switch meets accelerated/simulated life cycle specification shown by "success" and "end-of-life" testing

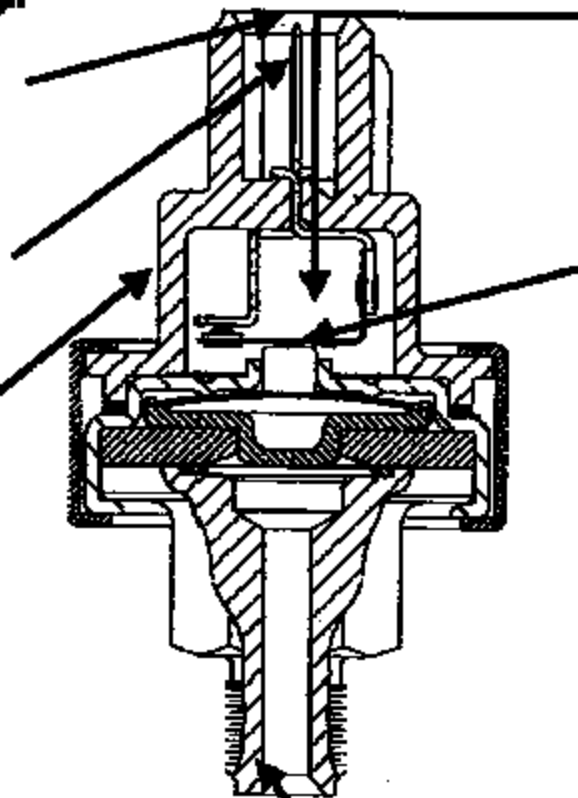
5. High current flow to case through water and ionic contamination

2. 12V Battery source to drive corrosion and provide energy

6. Plastic connector melts. Once it opens, oxygen enters the switch cavity. Arm terminal/corrosion becomes "RED HOT" igniting the plastic

1. Water and "Ionic" contamination (e.g. NaCl or cleaner) enters the switch cavity

4. Contact arm & terminal corrosion increases resistance (acts like heater wire).

3. Hexport grounded accelerates corrosion

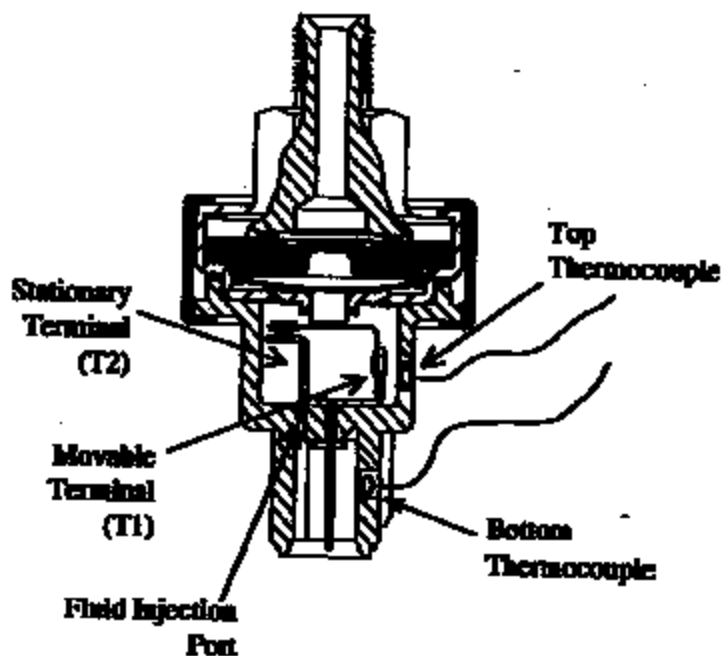
Test 1: Figure 1 and Figure 2.

**5% Salt Water Ingress Experiment  
Test 1**

TI Report PS/99/12  
03/15/99

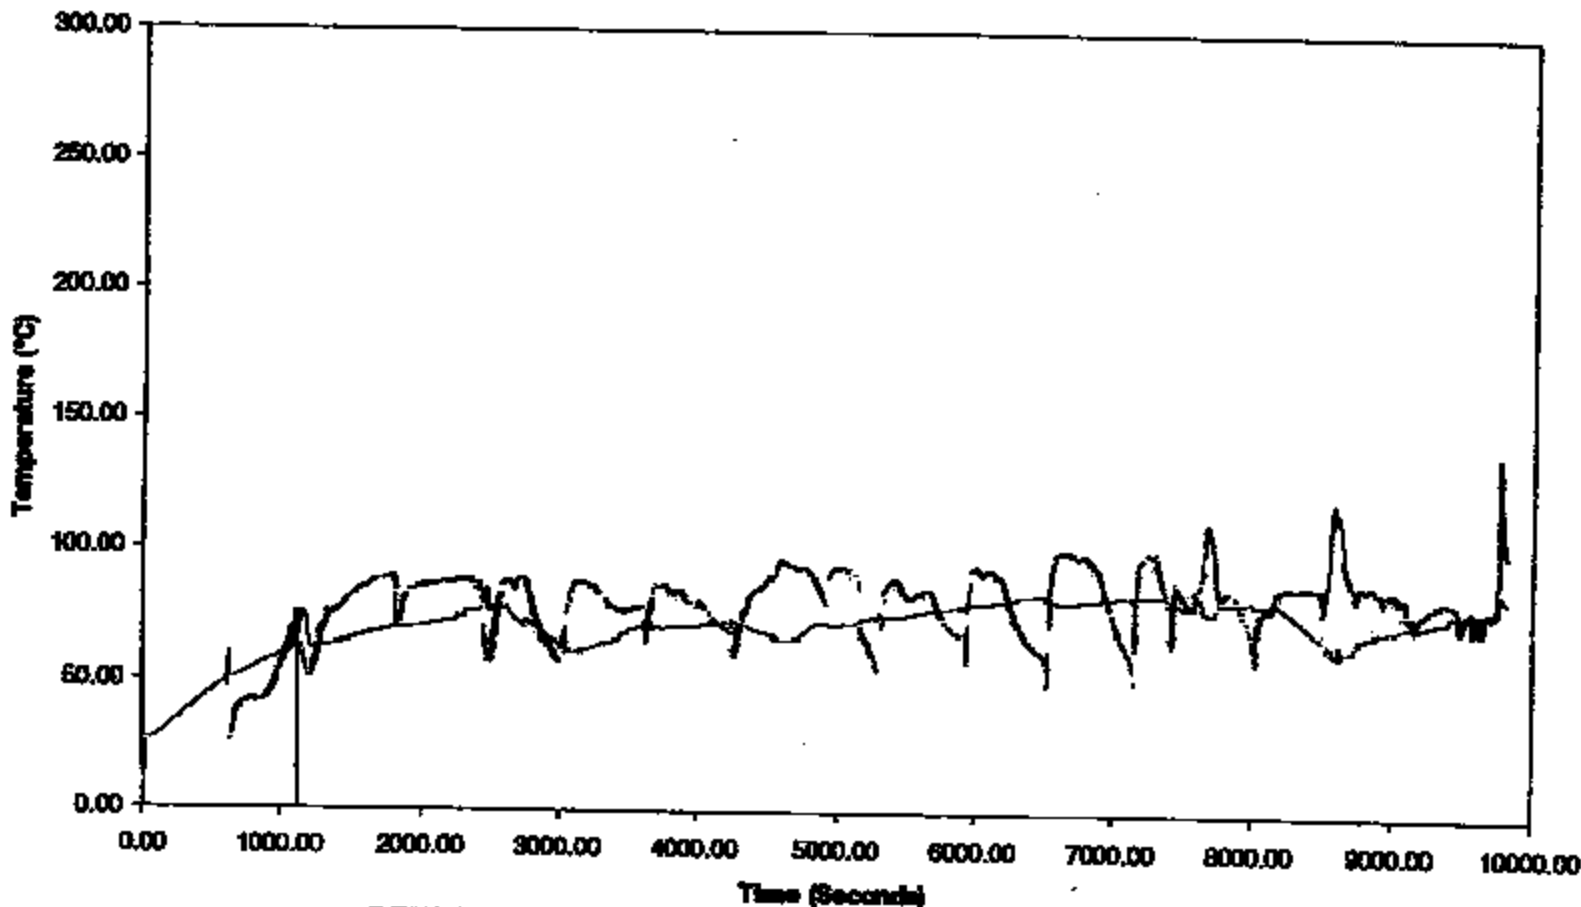
## 5% Salt Water Ingress Experiment Temperature vs. Time

— Top Temp — Clutch Temp — Bottom Temp

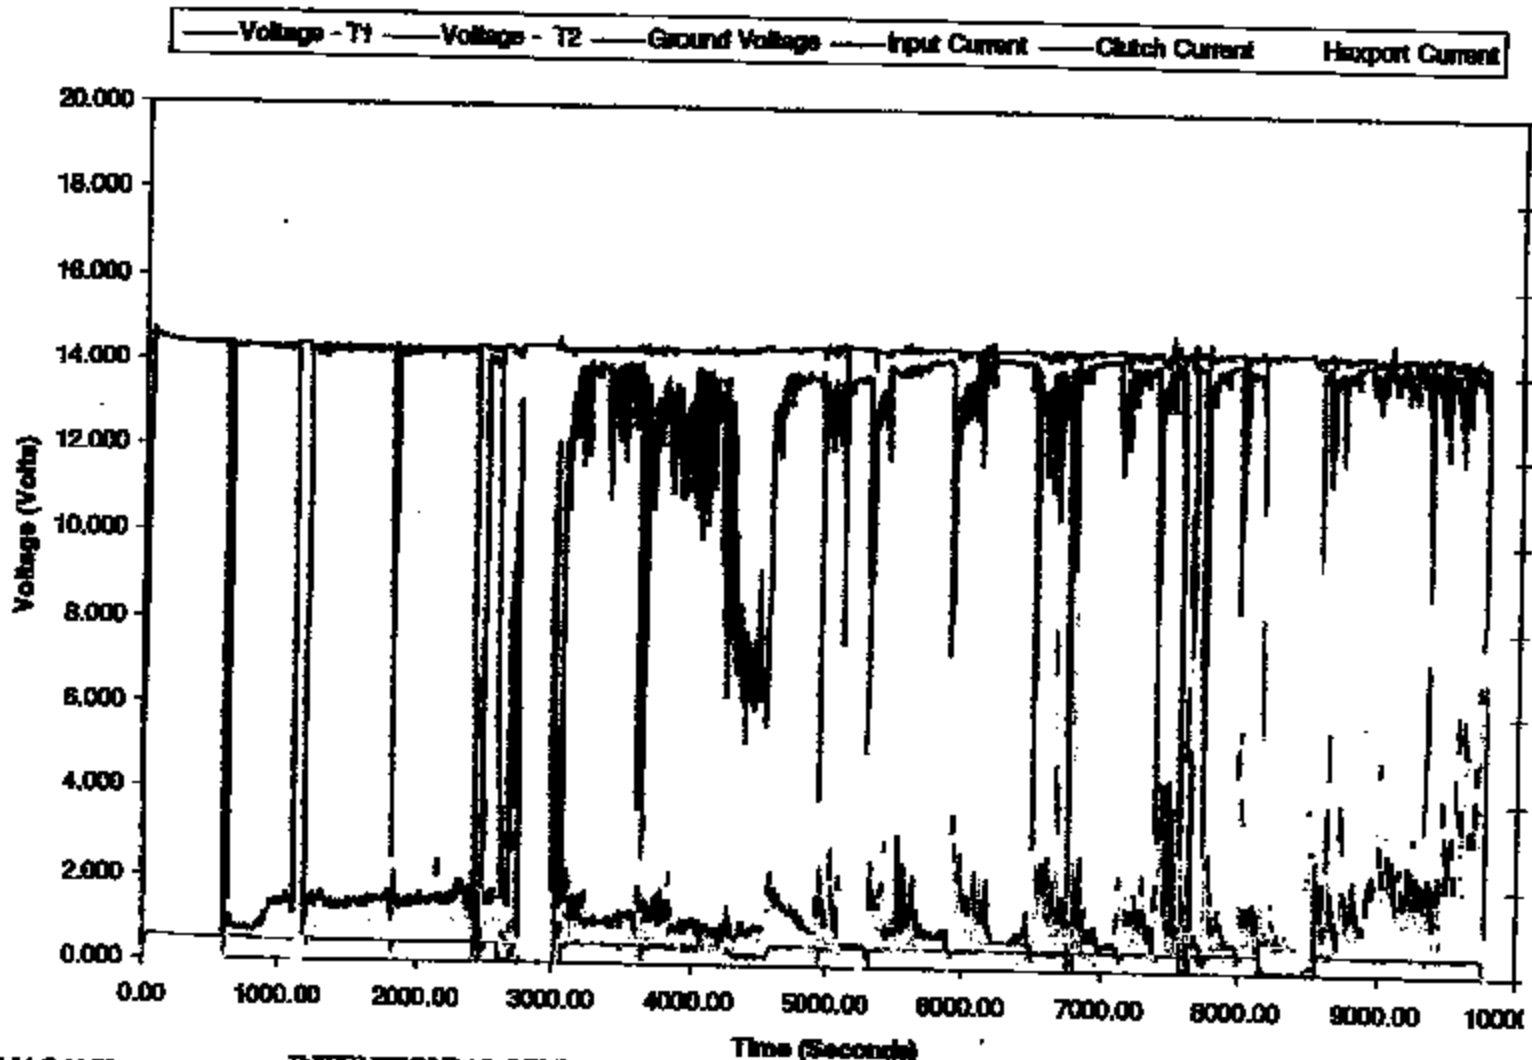
**5% Salt Water Ingress Experiment**

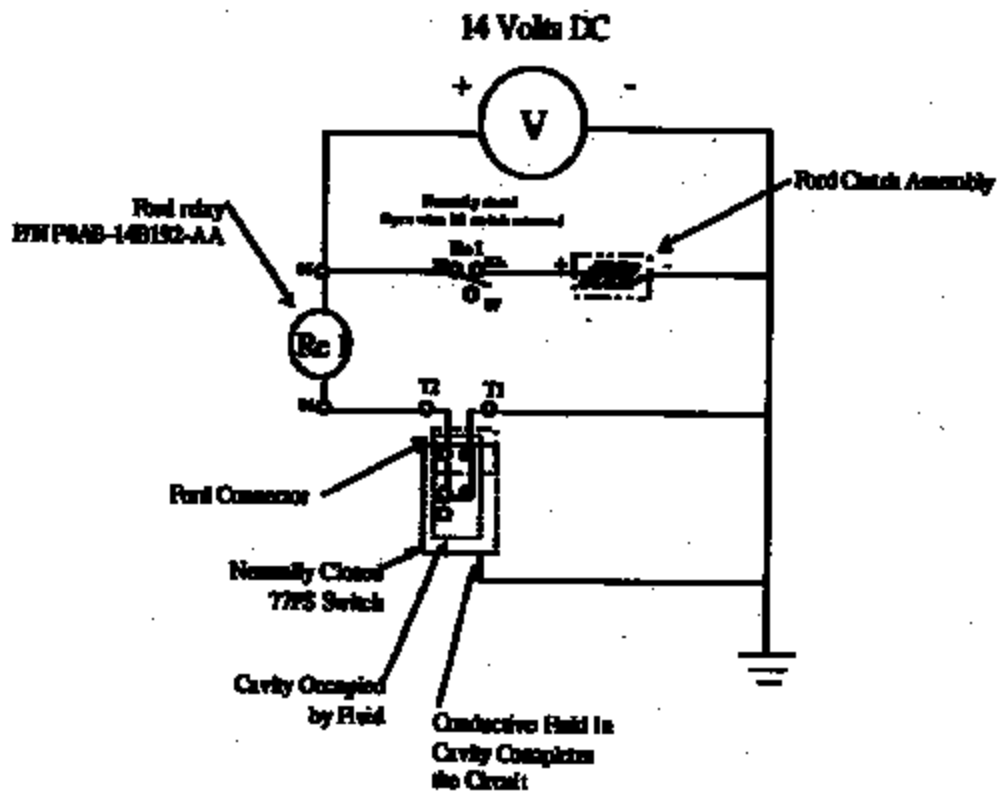
**77FS Proposed Wiring Schematic**

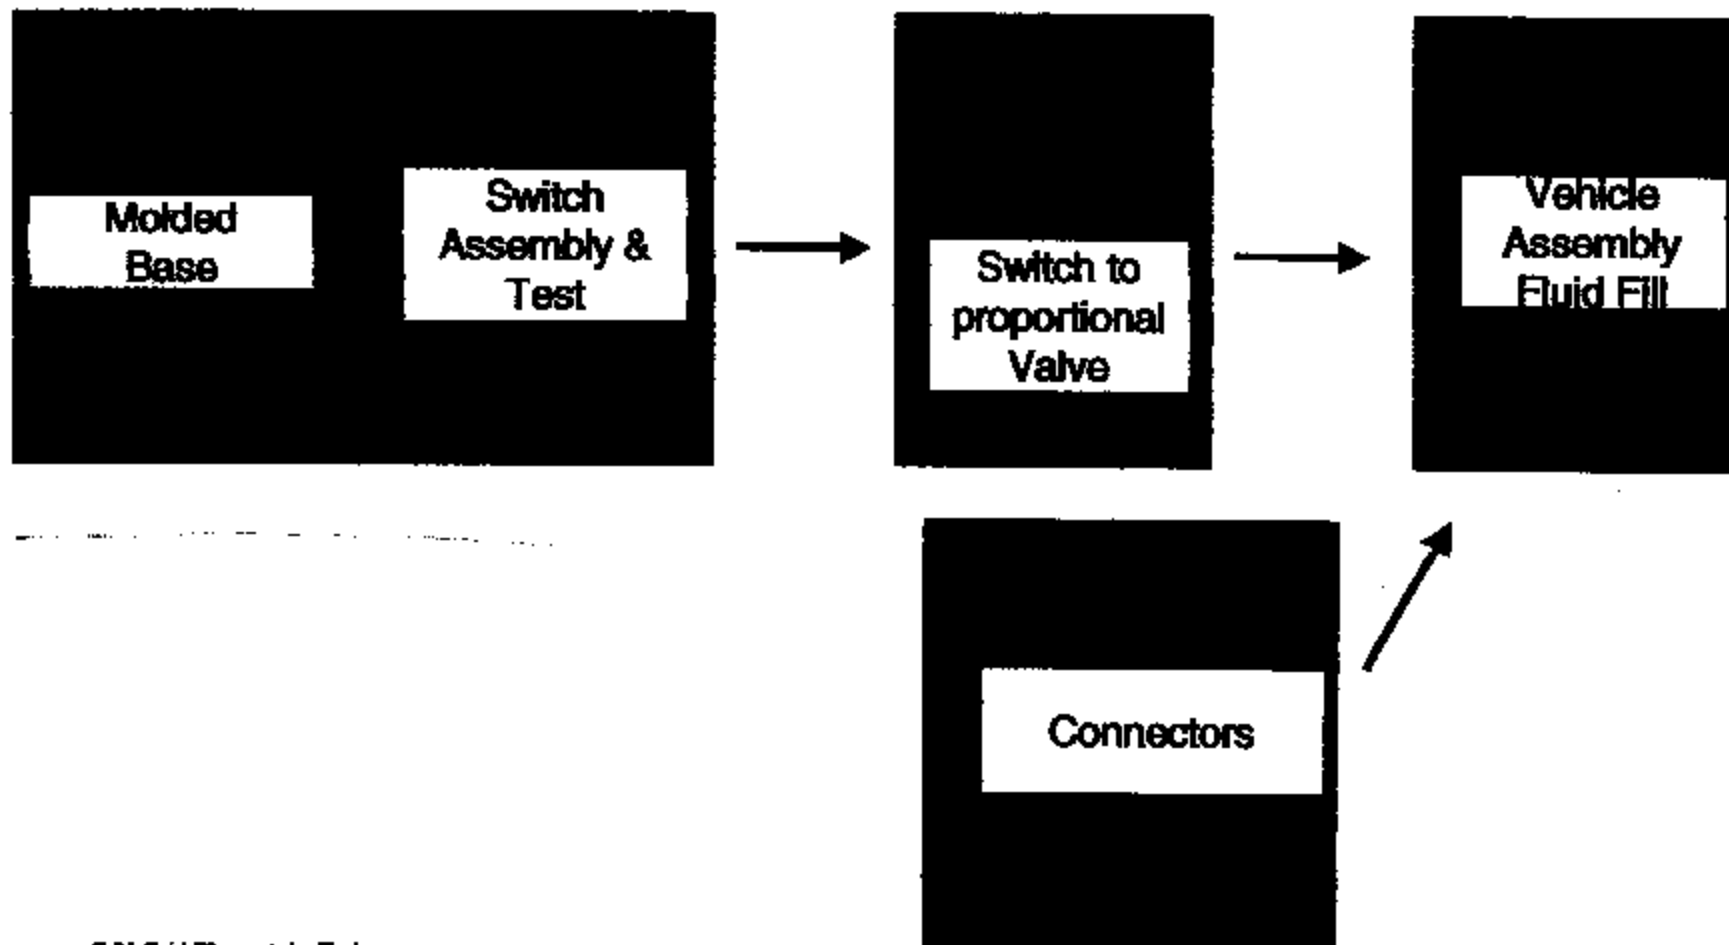
**PRESSURE SWITCH "FLOW DIAGRAM"**  
**('92, '93, TOWN CAR)**

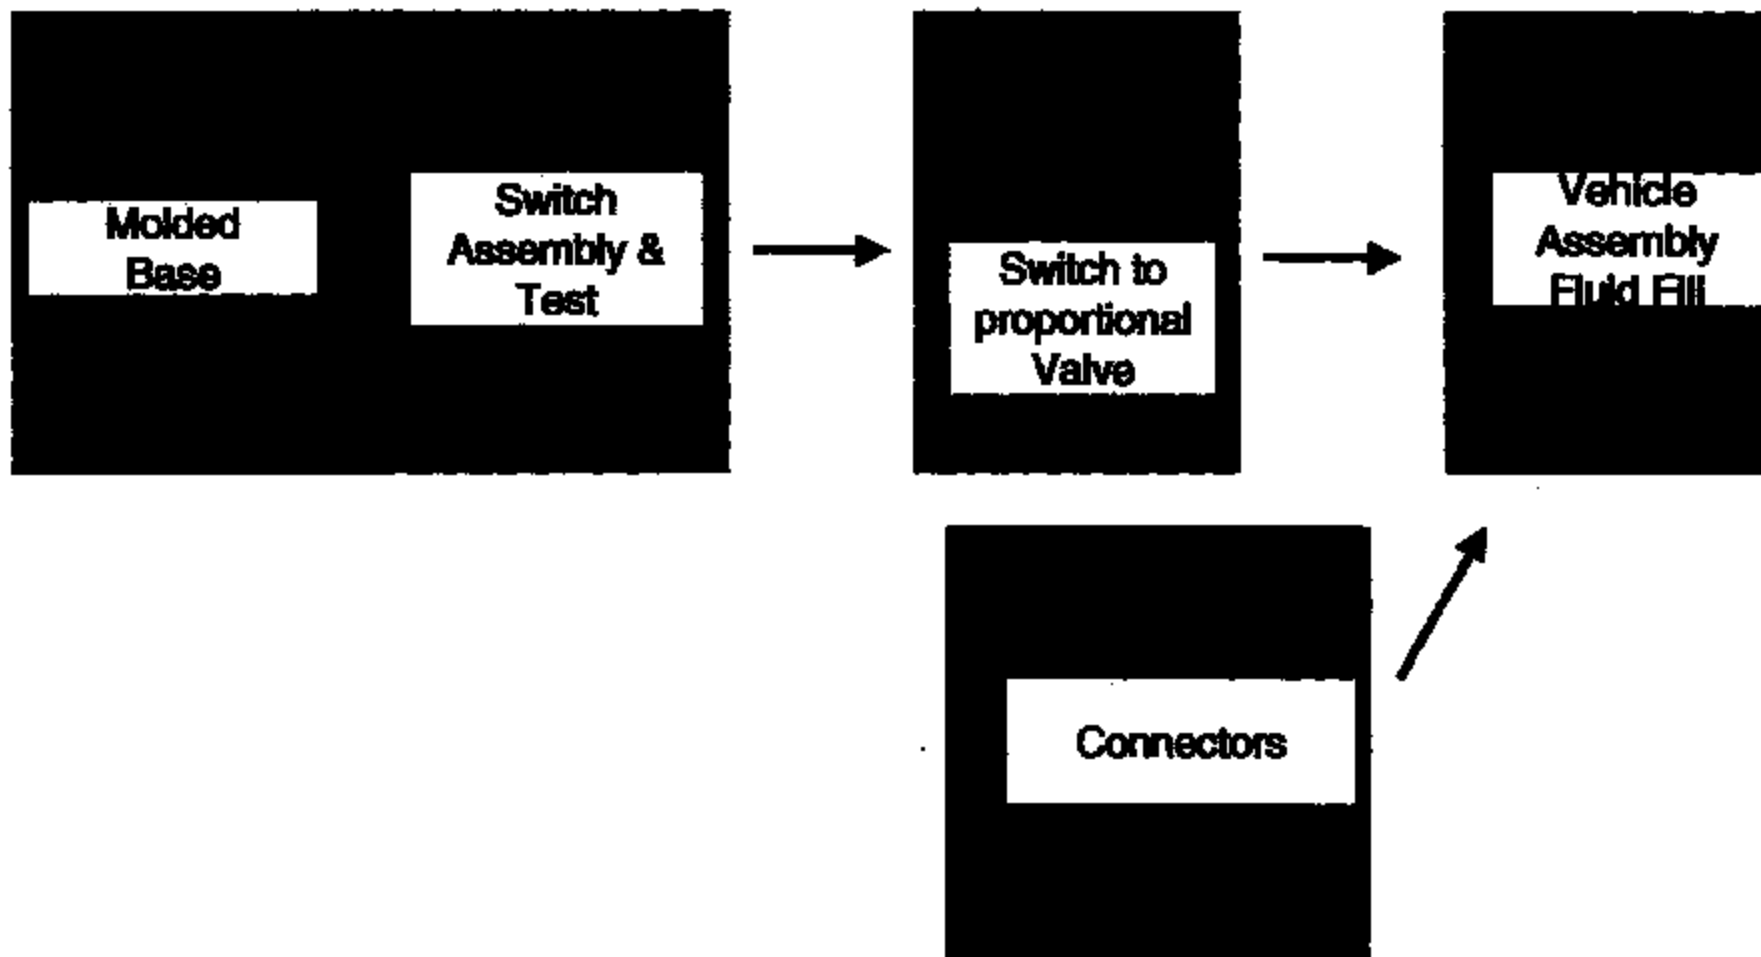
**PRESSURE SWITCH "FLOW DIAGRAM"  
('92, '93, TOWN CAR)**

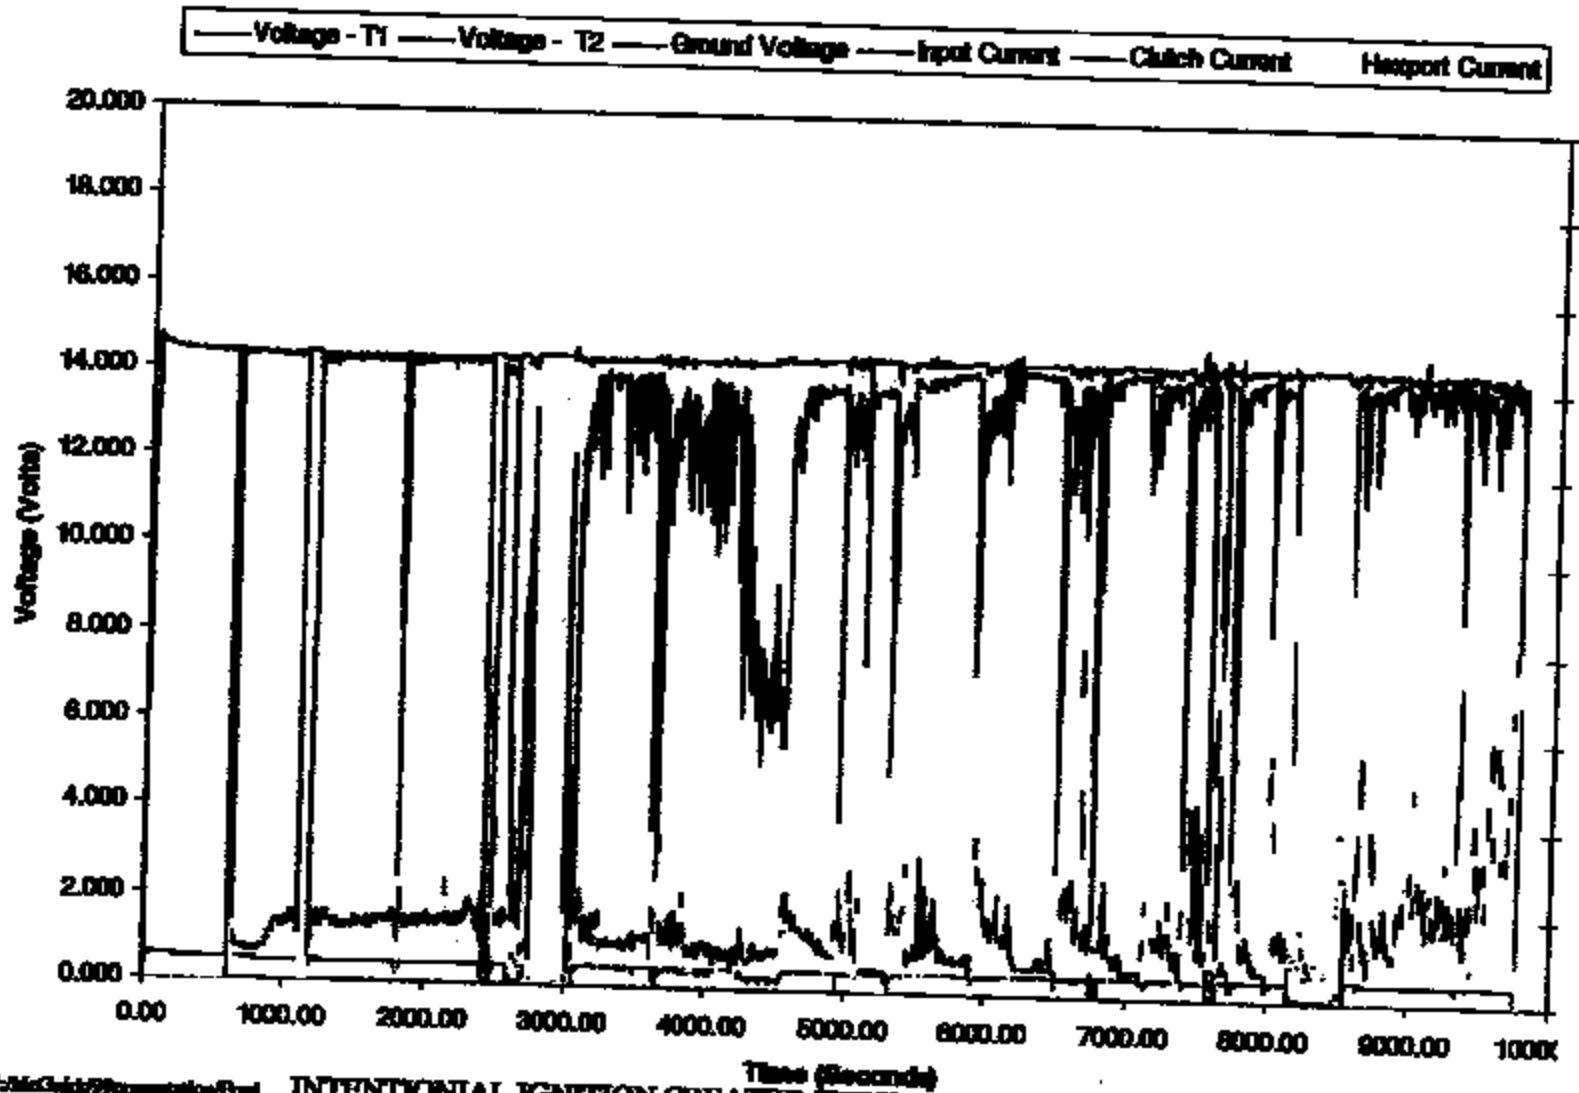
## 5% Salt Water Ingress Experiment

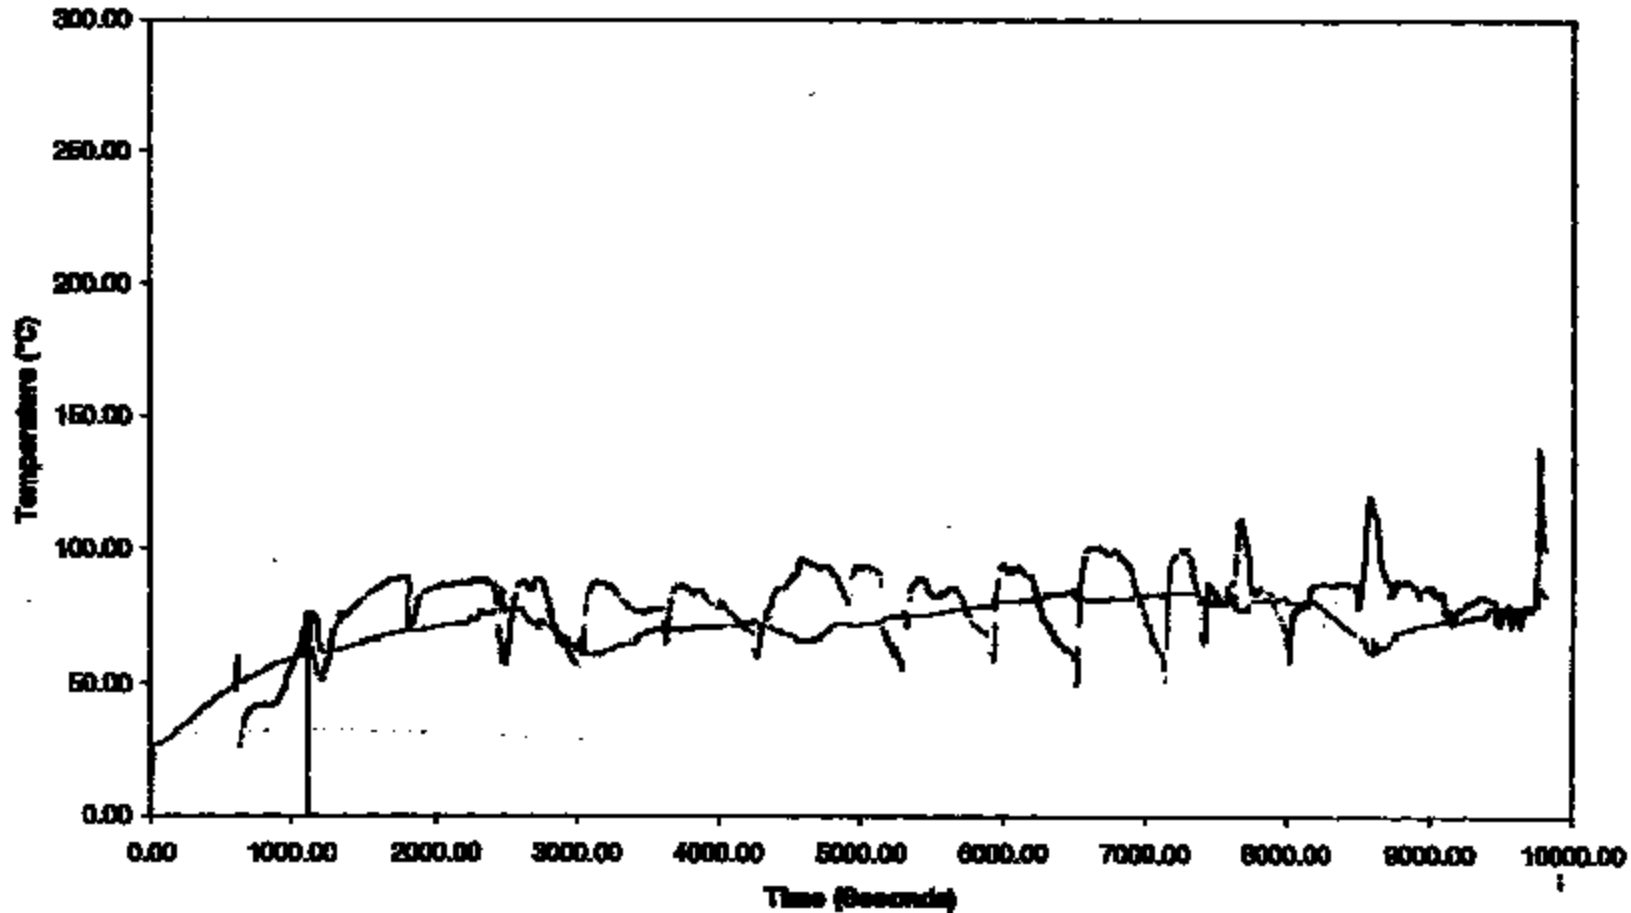
**8% Salt Water Ingress Experiment**  
**Temperature vs. Time**

— Top Temp — Clutch Temp — Bottom Temp

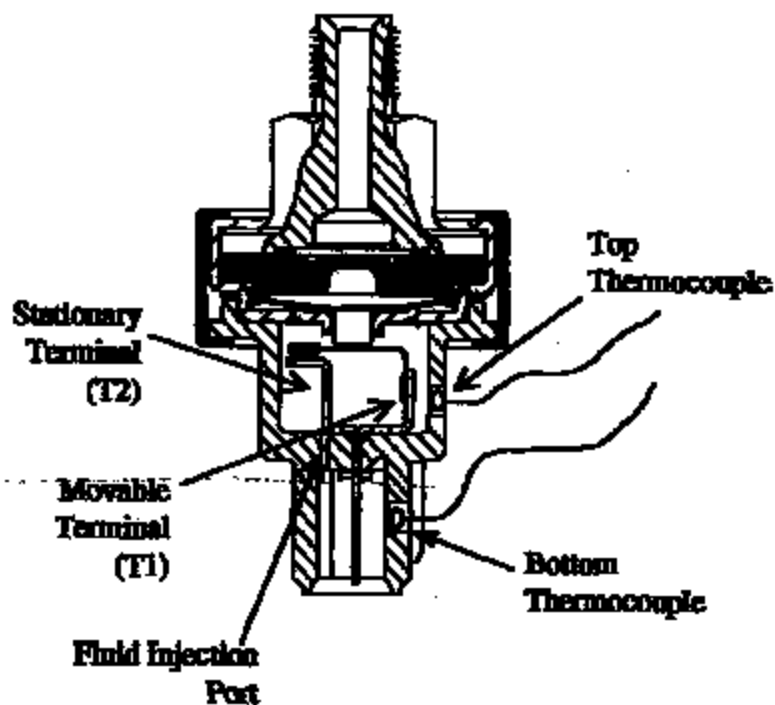
Test 1: Figure 1 and Figure 2.

**5% Salt Water Ingress Experiment**  
**Test 1**

TI Report PS/99/12  
03/15/99

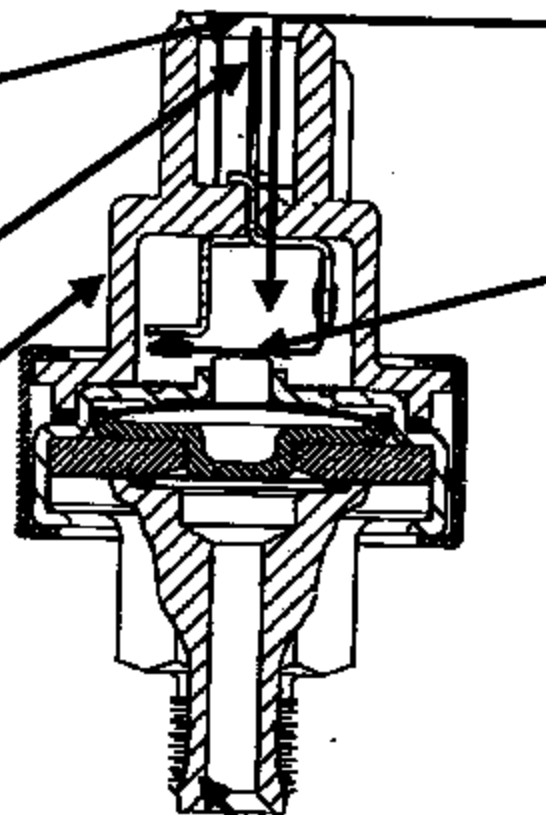
5. High current flow to case through water and ionic contamination

2. 12V Battery source to drive corrosion and provide energy

6. Plastic connector melts. Once it opens, oxygen enters the switch cavity. Arm terminal/corrosion becomes "RED HOT" igniting the plastic

1. Water and "ionic" contamination (e.g. NaCl or cleaner) enters the switch cavity

4. Contact arm & terminal corrosion increases resistance (acts like heater wire).

3. Hazard grounded accelerates corrosion

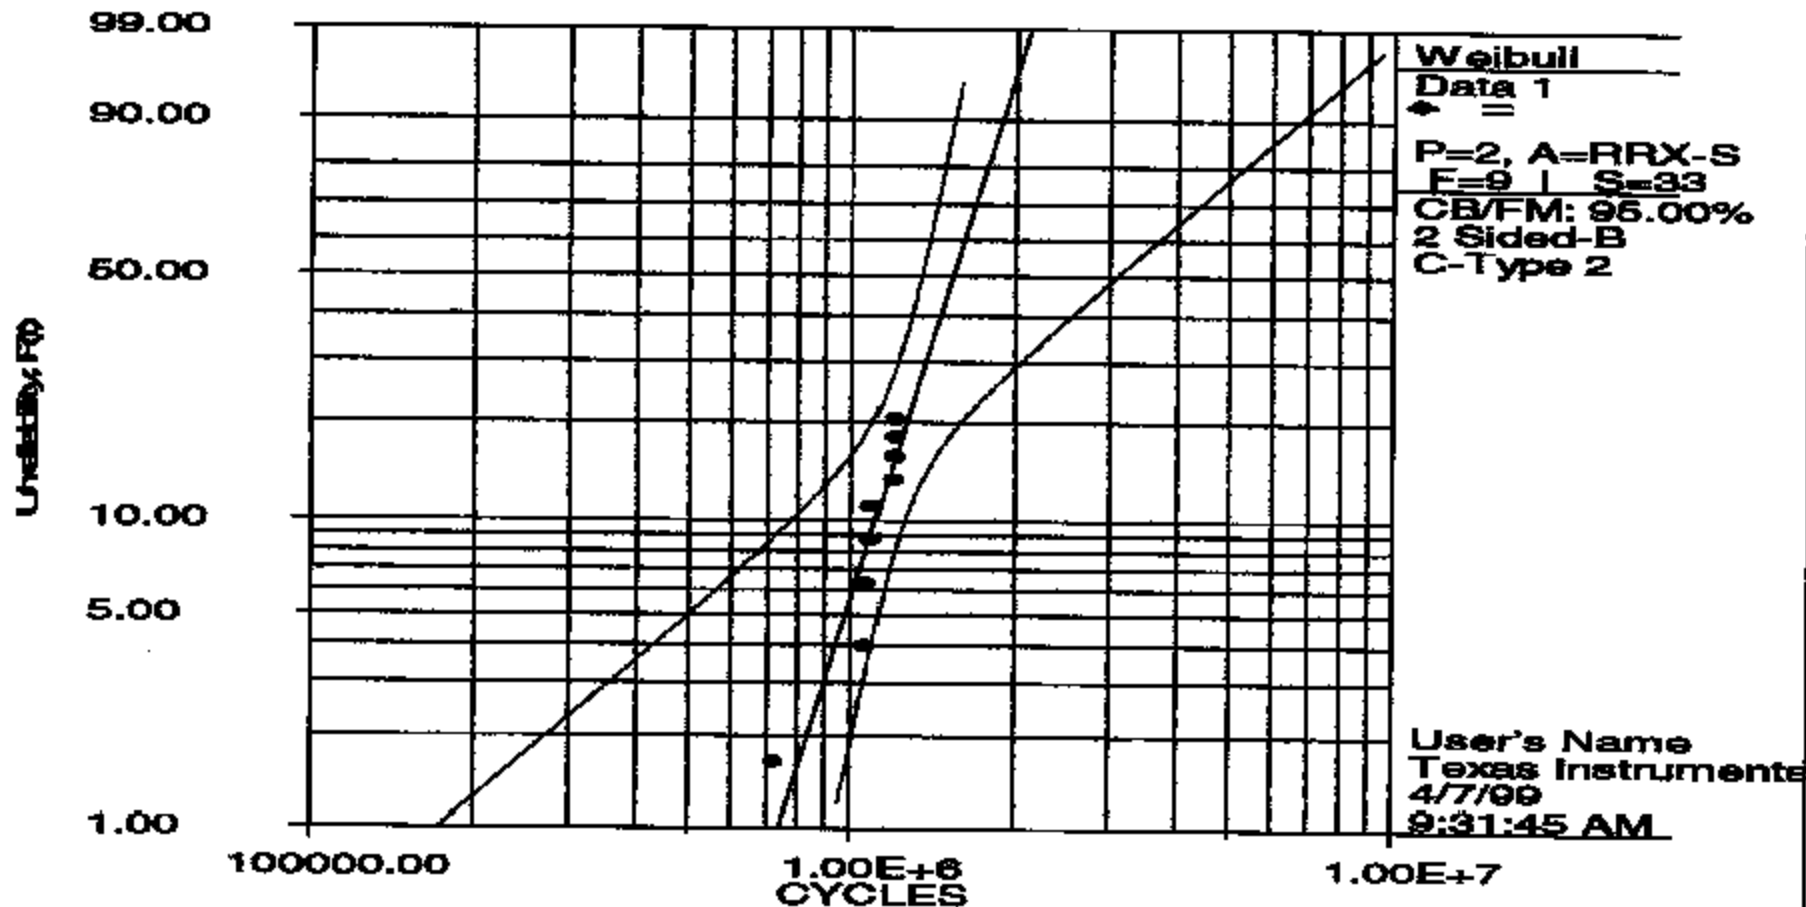
- "Town Car" switch meets accelerated/simulated life cycle specification shown by "success" and "end-of-life" testing

**77PSL2-1 COMBINED DATA**

$\beta=5.83, \eta=1.64E+6, \rho=0.91$

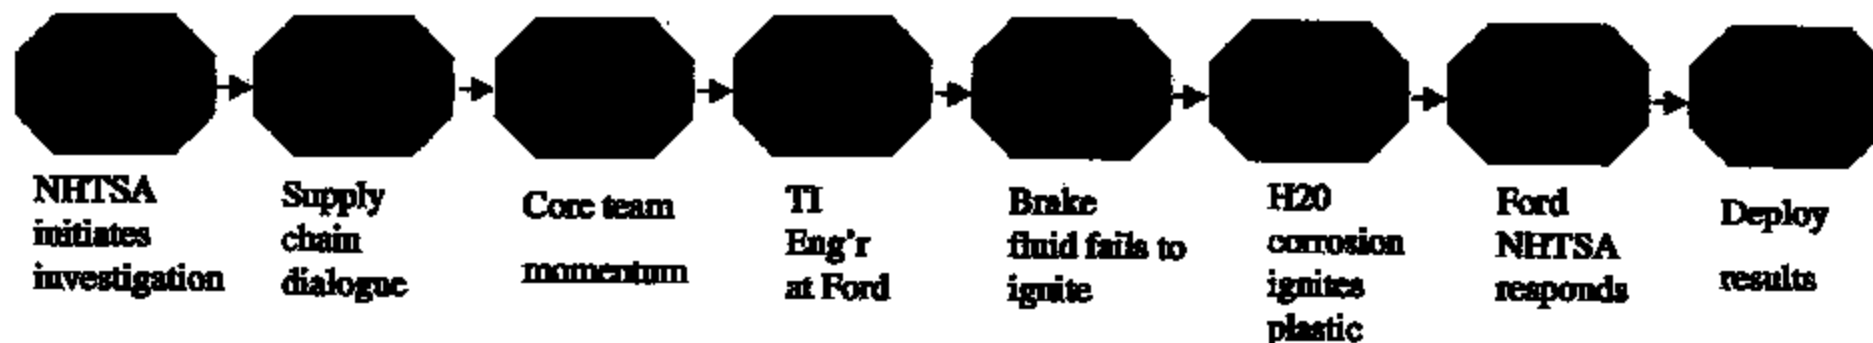
**OVERVIEW OF  
CONCERN TIME LINE**
