EA02-025

TEXAS INSTRUMENTS, INC.'S

77PS Life Cycle Test to Leakage

TI 77PS Test Synopsis Draft 7/22/99

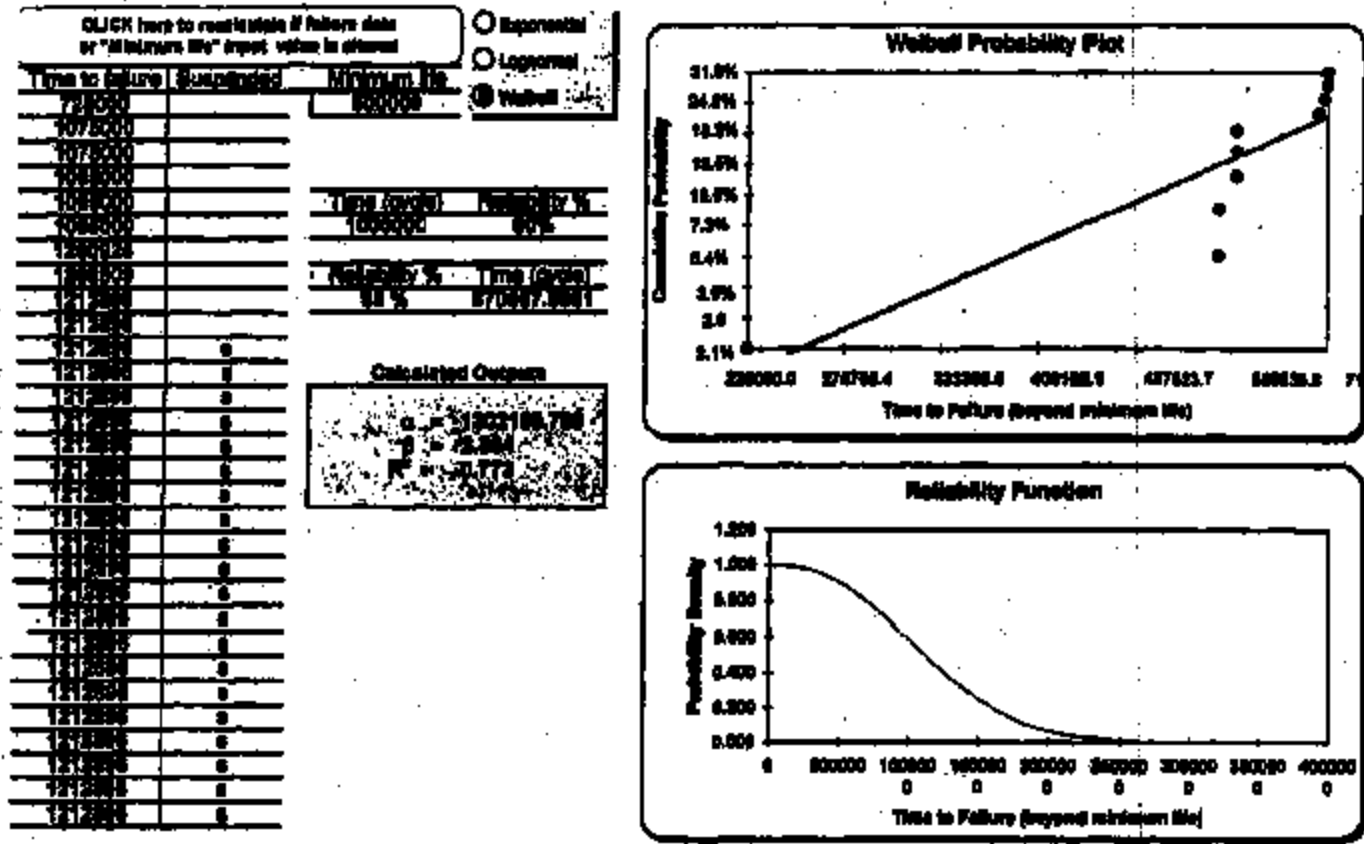
Figure 1.

2 and 3 parameter WEIBULL FAILURE ANALYSIS

NOTES: 77P8 - 725K cycle data point included in analysis

OVCA = 135°C

For each set of data entered into a Weibull Analysis, the set of parameters α , β and R^2 are determined. Values for the data used in this test may be seen in Figure 1 and Figure 2.

For example, Figure 1 shows a calculated $\alpha = 1,302,169$ while Figure 2 shows a value of 841,858. In Figure 1, the 728K point is included in the analysis and causes a greater spread of the distribution than that of Figure 2, where the 728K point is not included in the analysis.

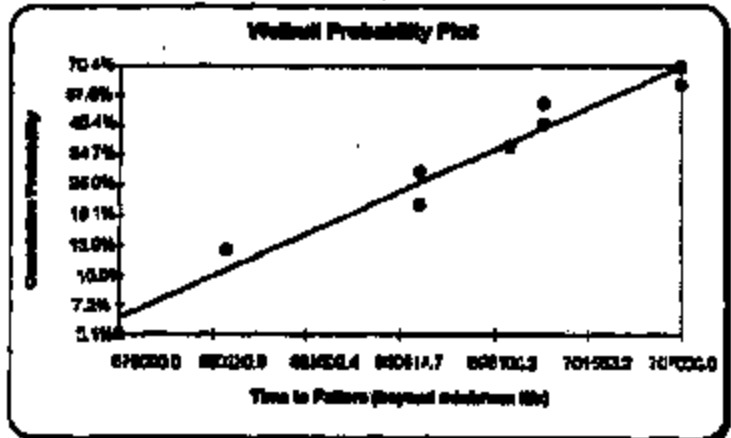
2 and 3 parameter WEIBULL FAILURE ANALYSIS

NOTE: DOE 1 Group 2: 77PBL4-1 (no snap) w/ 0% water in brake fluid.

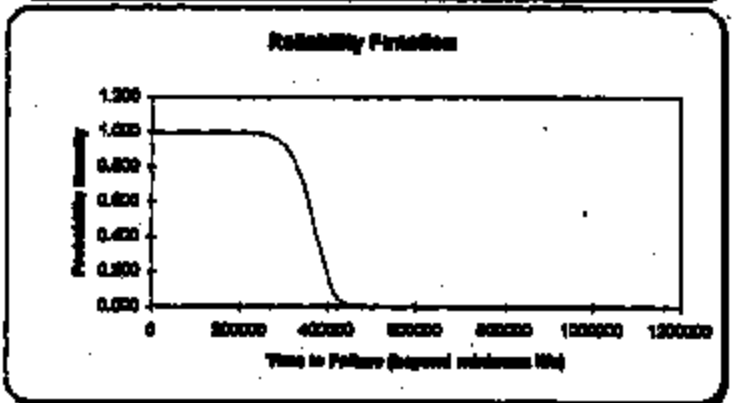
Figure 2.

2 and 3 parameter WEIBULL FAILURE ANALYSIS

NOTES: DOE 1 Group 4: 77PBLA-1 (no snap) w/ 6% water in brake fluid.

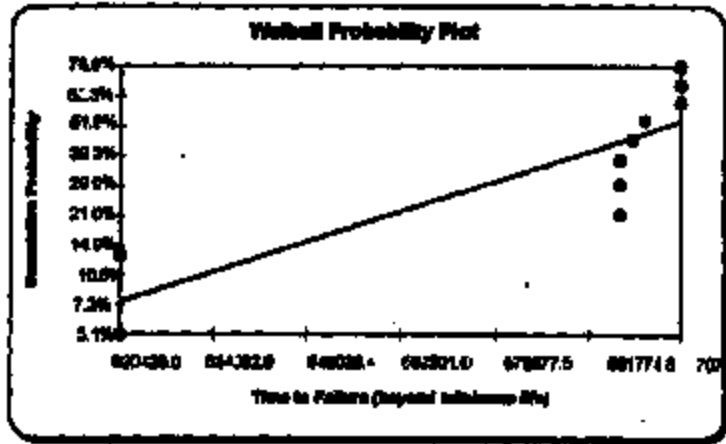
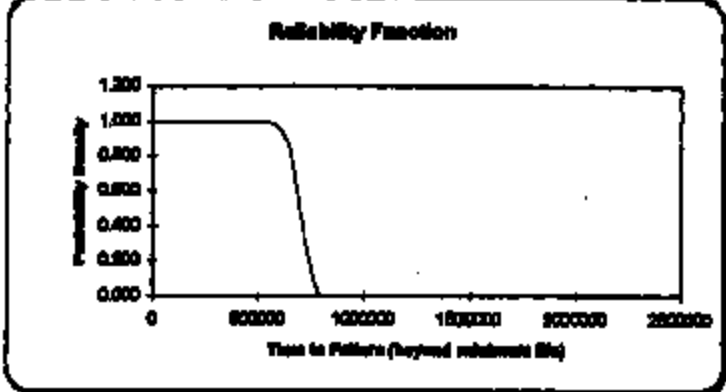
Figure 2.

2 and 3 parameter WEIBULL FAILURE ANALYSIS

NOTE: DOE + Group 3: 77P8L2-1 (w/ wrap) w/ 0% water in brake fluid.
