EA02-025

TEXAS INSTRUMENTS, INC.'S

Brake Pressure Switch Test Log, Updated 7/22/98

The purpose of this experiment was to corrode contact terminals of 77PS switches in an attempt to cause ignition when power is applied to the switch

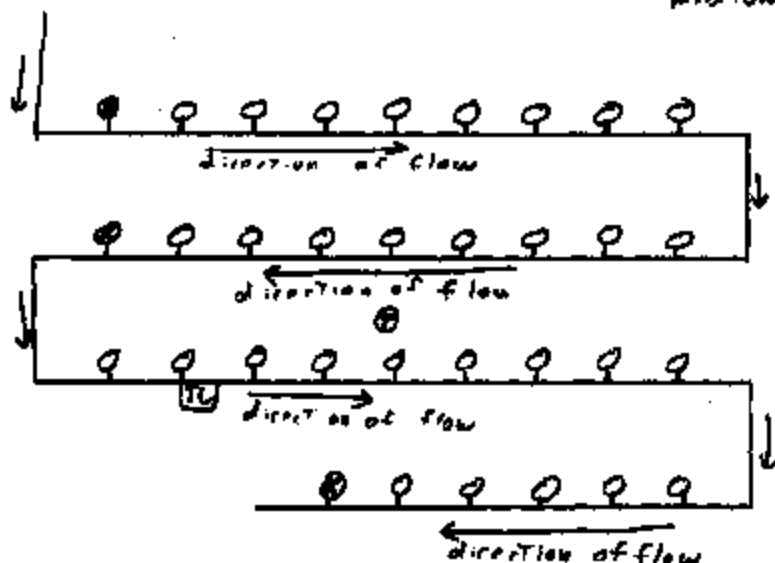
P_{min}: 0-50psi P_{max}: 1450±50psi

medium: New brake fluid.

- = 77PS devices
- ⊙ = APT 3CP2-1 device
- = Surface mounted thermocouple
- ⊗ = Suspended (Ambient) Thermocouple

- 10 connectors w/counters randomly placed on devices.

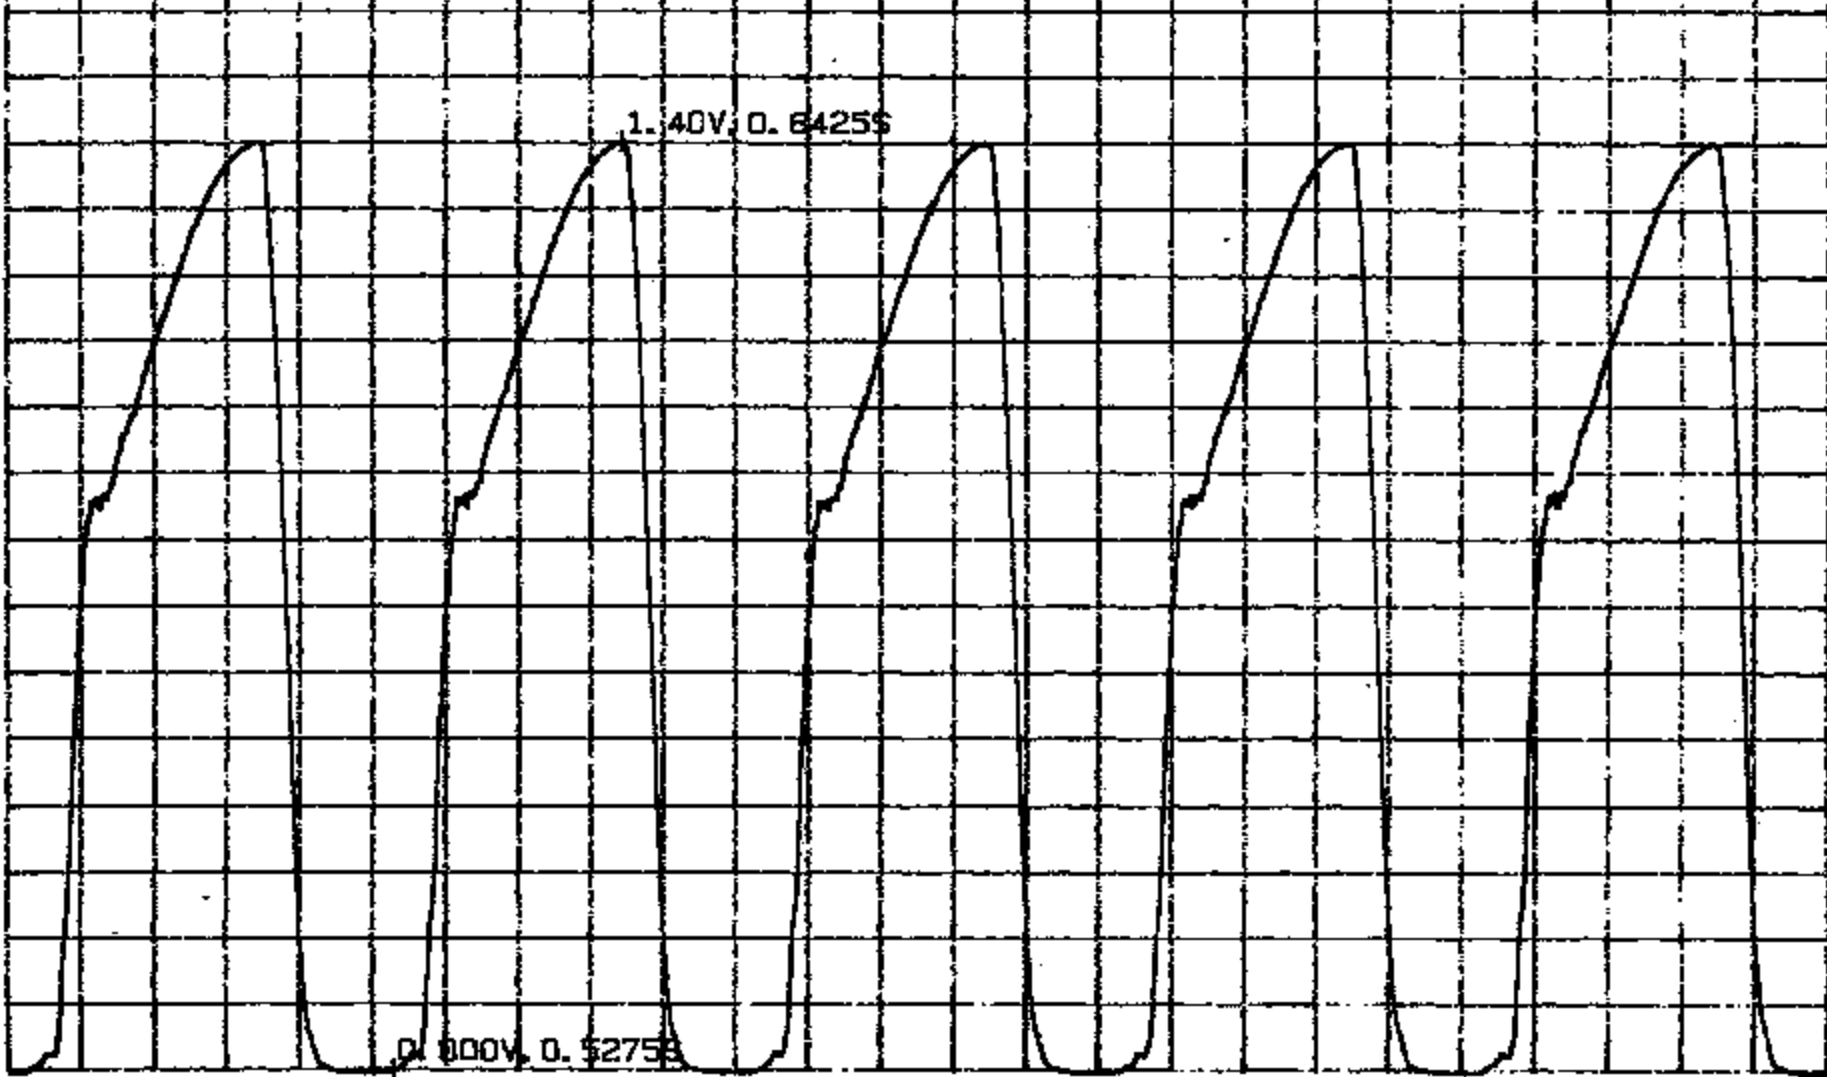
x = 1 grid = 0.1 sec

y = 1 div = 1psi 1 grid = 100 psi
