EA02-025

TEXAS INSTRUMENTS, INC.'S

FORD NEXT GENERATION SPEED CONTROL

Ford - Electronic Speed Control Deactivation Pressure Switch TI P/N 77PSL Series

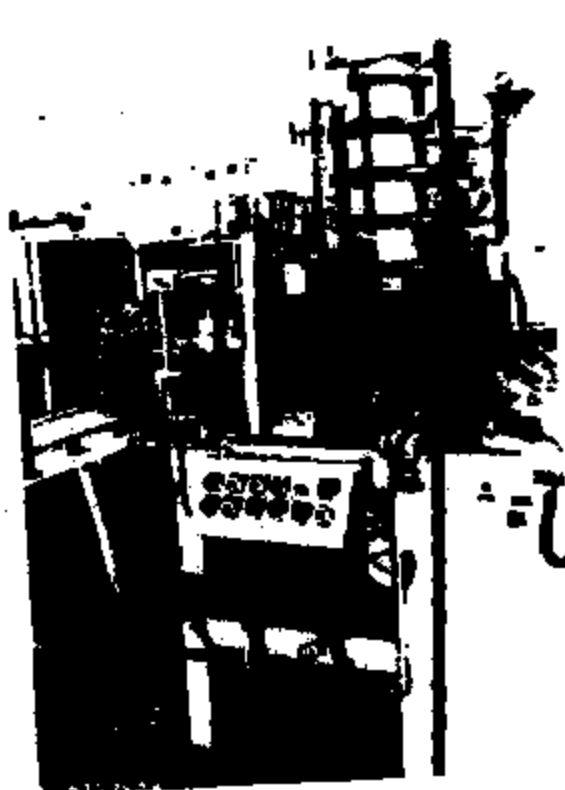
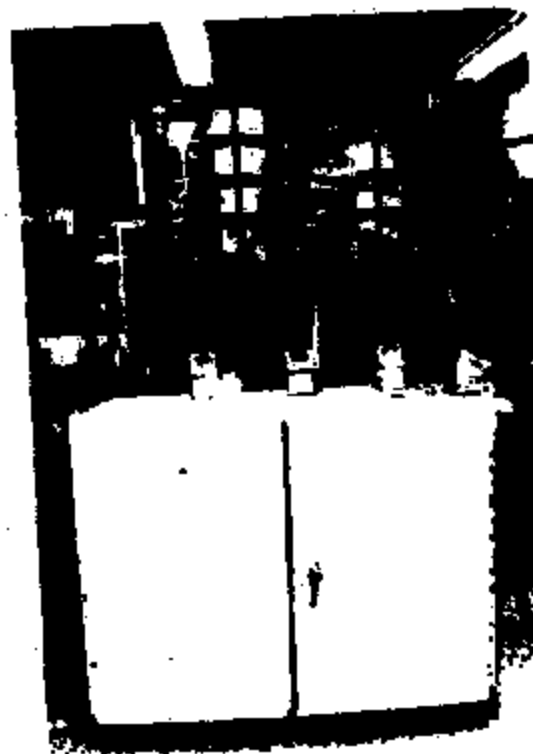
Automated Crimp Equipment

45° Station

90° Station

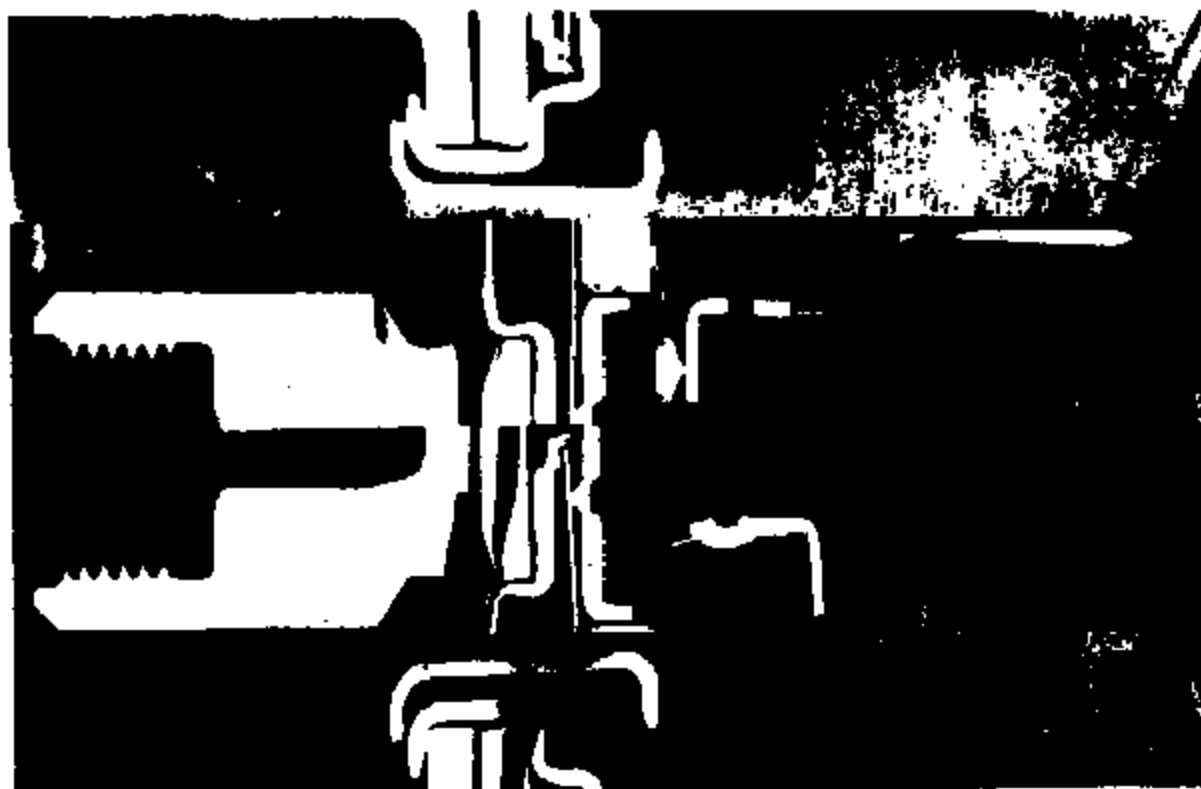
Switch X-Section

TI's pressure switches provide low cost, on/off controls for many automotive systems. The snap action disc reacts to changing pressure by reversing its curvature and activating electrical switch contacts.
