**TEXAS INSTRUMENTS,
INC.'S 9/10/03
ATTACHMENT**

77PS Ignition Re-creation

77FS Brake Fluid Intrusion
2/3/99

TEXAS INSTRUMENTS Brake Pressure Switch Potential Thermal Event Theory Profile 4/26/99

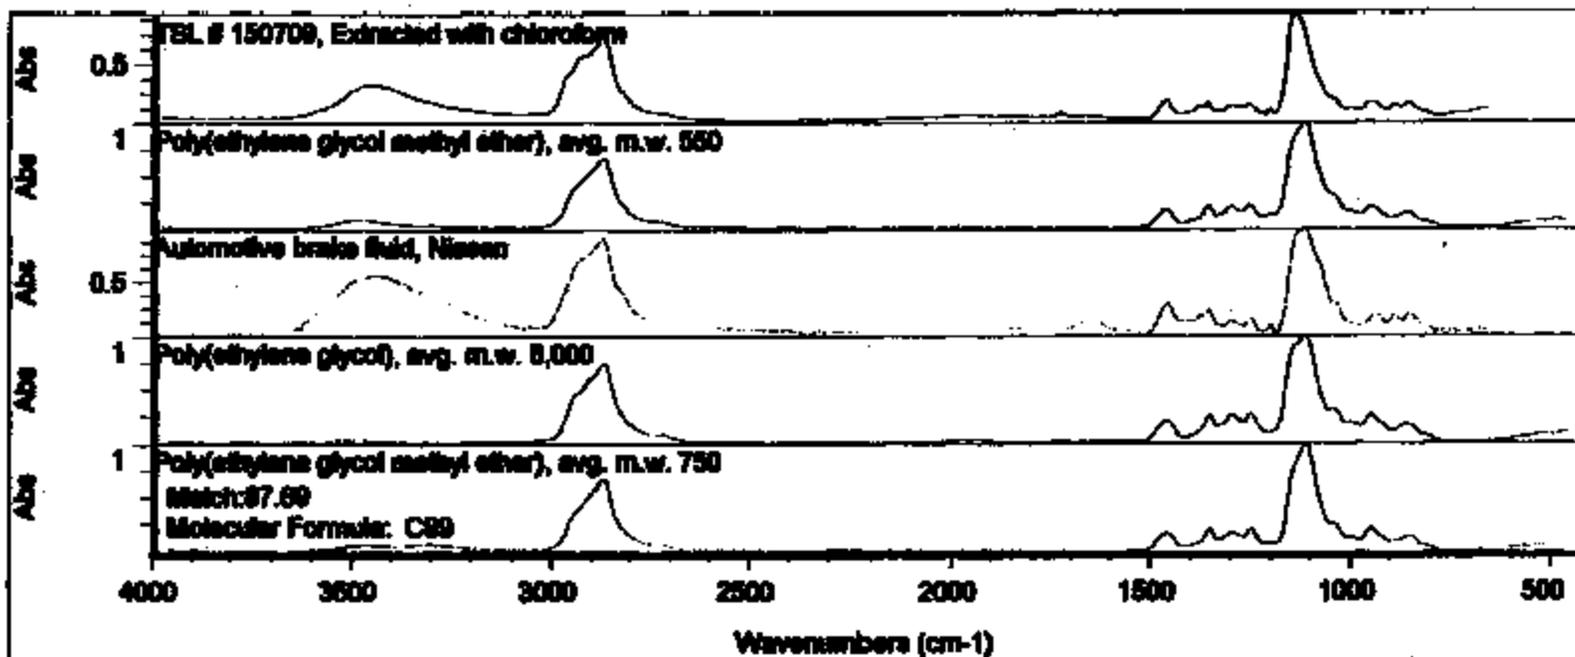
Spectrum: TSL # 150709, Extracted with chloroform

Index	Match	Compound name	Library
10394	98.09	Poly(ethylene glycol methyl ether), avg.	Aldrich Condensed Phase
90	89.55	Automotive brake fluid, Nissan	TSL
10392	87.98	Poly(ethylene glycol), avg. m.w. 8,000	Aldrich Condensed Phase
10395	87.69	Poly(ethylene glycol methyl ether), avg.	Aldrich Condensed Phase
9548	87.10	Etj 99; Polyoxyethylene(20) methyl ether	Aldrich Condensed Phase
9613	86.38	Etj 35; Polyoxyethylene(23) lauryl ether	Aldrich Condensed Phase
9539	84.80	Etj 78; Polyoxyethylene(20) stearyl ether	Aldrich Condensed Phase
10393	83.30	Poly(ethylene glycol methyl ether), avg.	Aldrich Condensed Phase
9535	83.05	Tetraethylene glycol dimethyl ether, 98%	Aldrich Condensed Phase
10388	82.99	Poly(ethylene glycol), avg. m.w. 600	Aldrich Condensed Phase

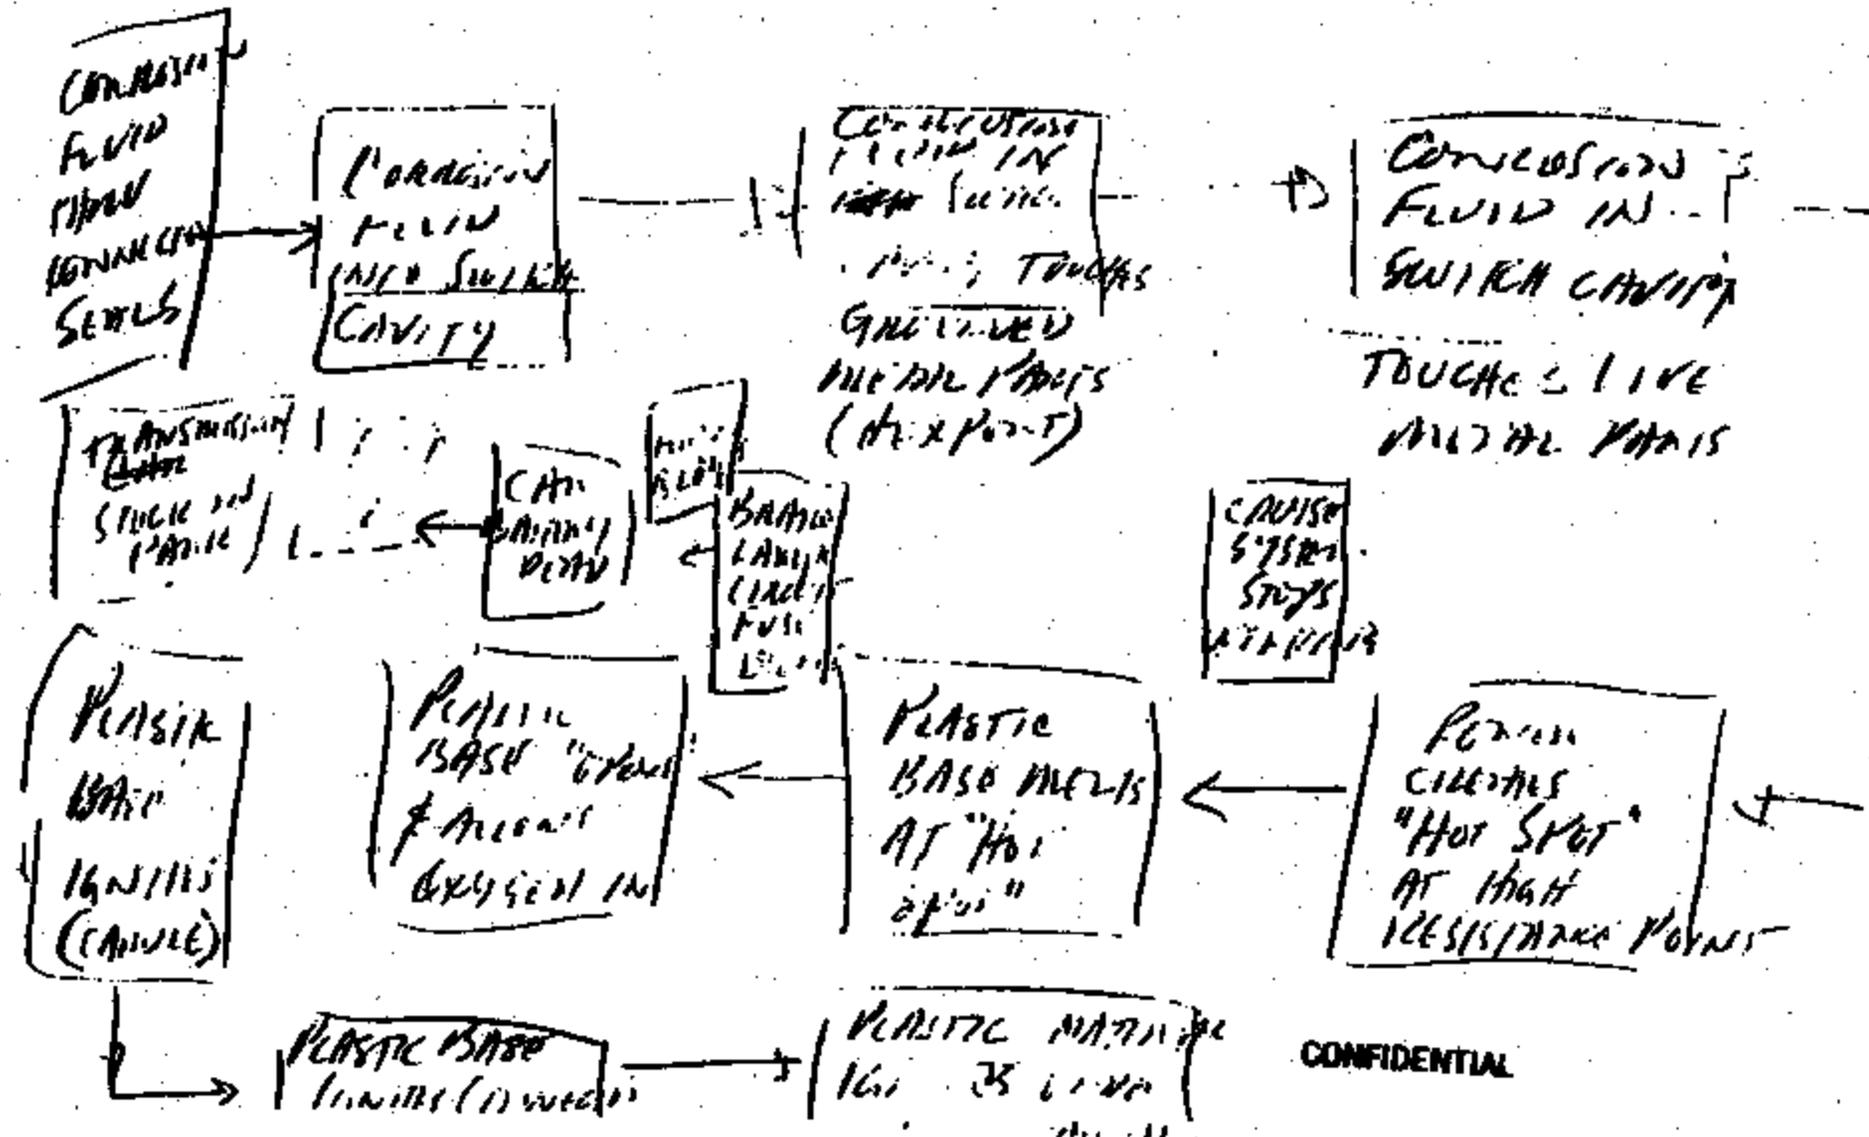
"Condensation" POTENTIAL CAUSE FLOW ANALYSIS

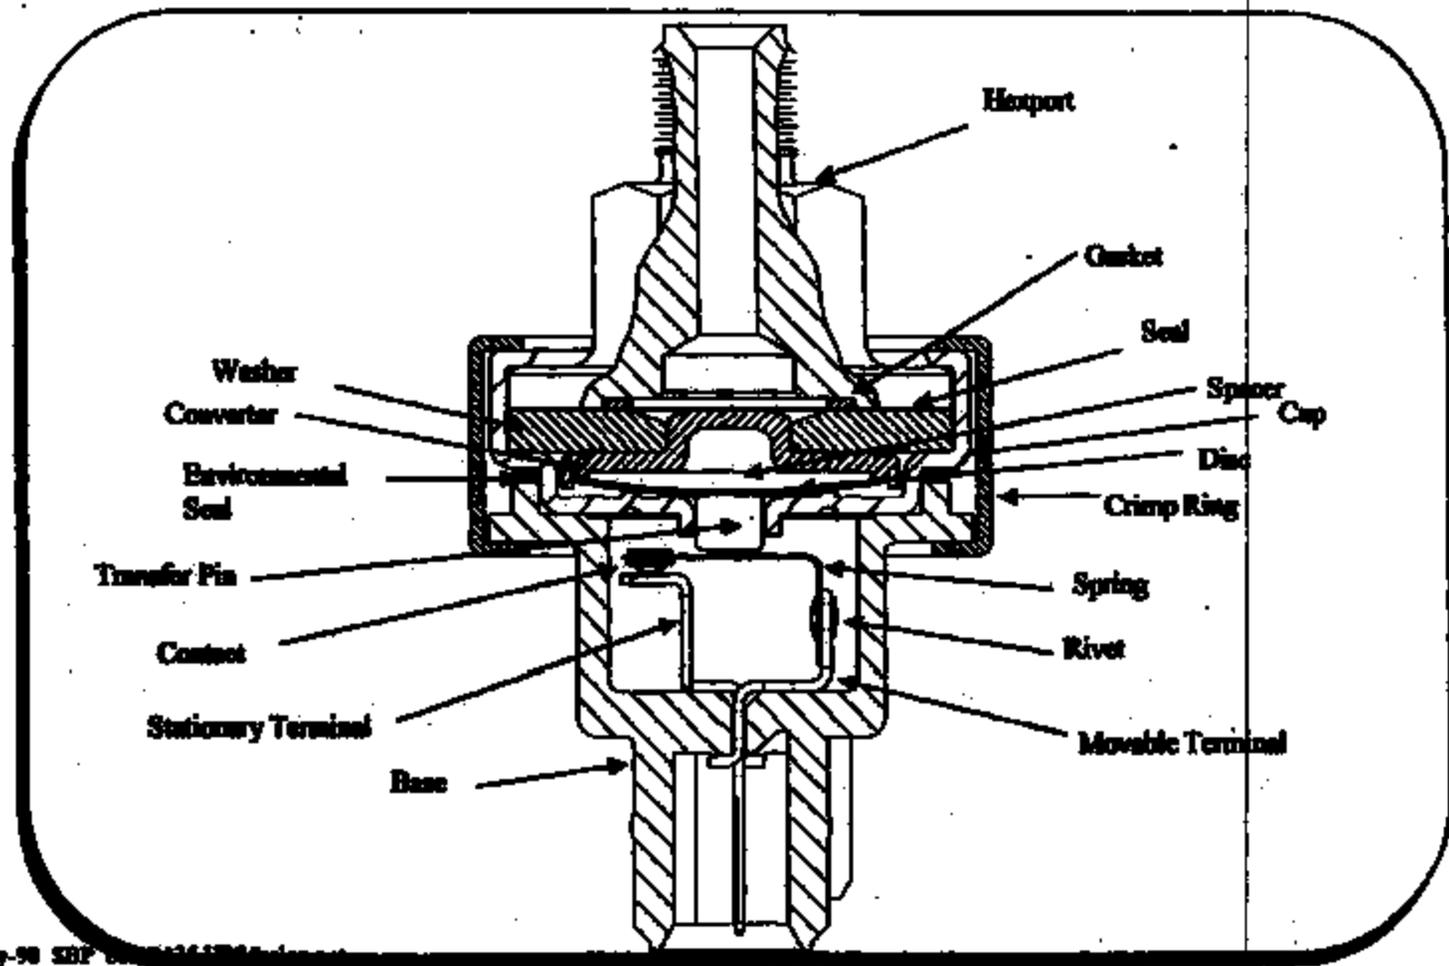
Pressure Switch Cross Section

Two known ways that brake fluid may enter the contact cavity of TI's brake switches from the pressure cavity are i. brake fluid could leak past an impaired gasket seal, or ii. brake fluid could leak through a damaged or 'worn out' Kapton™ diaphragm.

Basically, a single piece of Kapton™ in this design consists of a 0.003-inch thick polyimide film laminated on both sides with a 0.001-inch thick FEP Teflon film. The polyimide film has the ability to stretch without breaking (strains on the order of 70% before rupture), and the Teflon film is compatible with a wide range of chemicals. As a result of this layered construction, Kapton™ was selected for its mechanical and chemical properties. Moreover, TI has been using this material in pressure switch applications since 1981. In this application three stacked Kapton™ layers were used as the diaphragm seal.

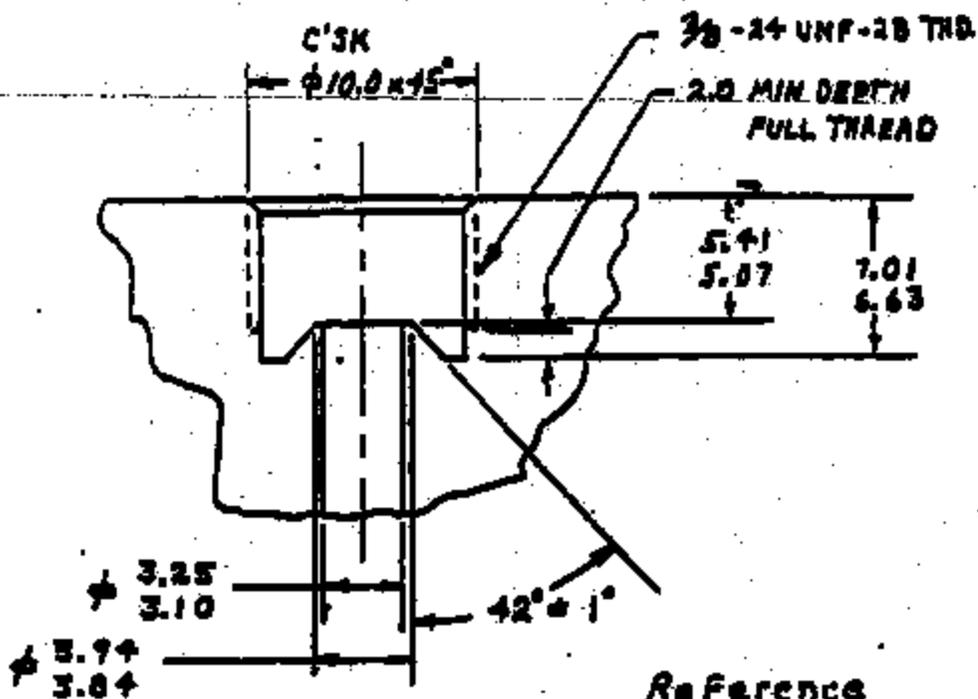
TEST FIXTURE PORT CONFIGURATION

Reference
 SAE J512 OCT 80
 Figure 5A

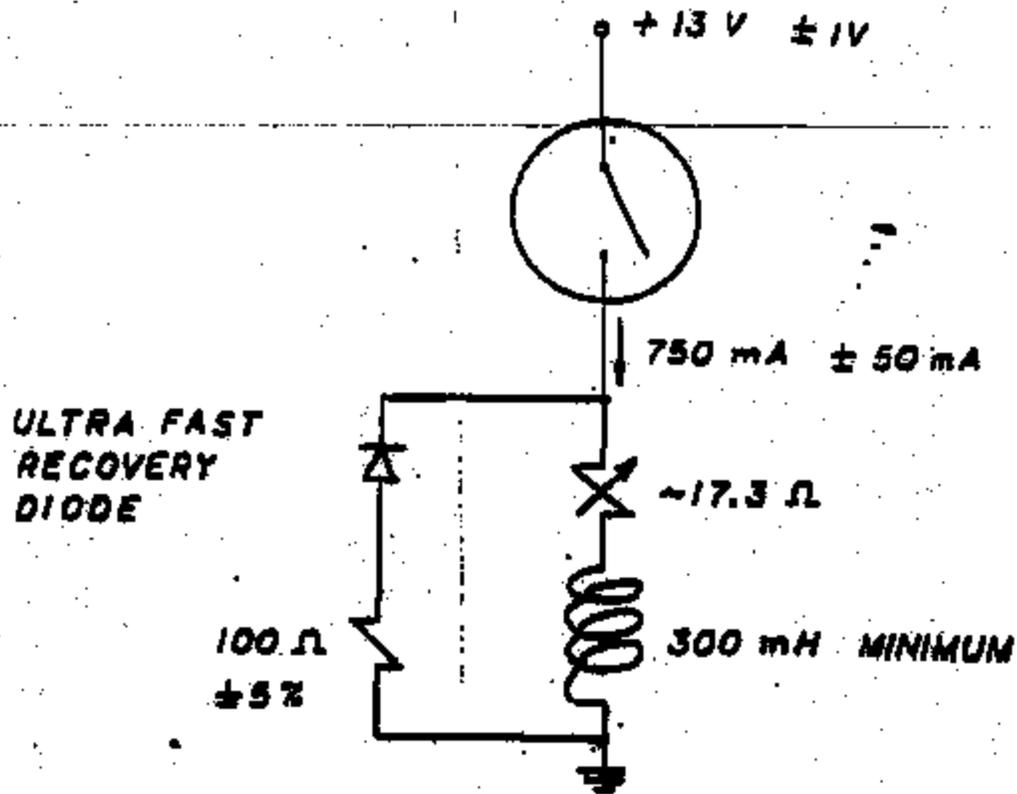
FIGURE 4

DEACTIVATE SWITCH
TEST SET UP
