**EA02-025**

**TEXAS INSTRUMENTS,  
INC.'S 9/10/03  
ATTACHMENT**

Tests Currently in Progress  
Last updated: 2/15/99

## Brake Pressure Switch Potential Thermal Event Theory - 2/24/99

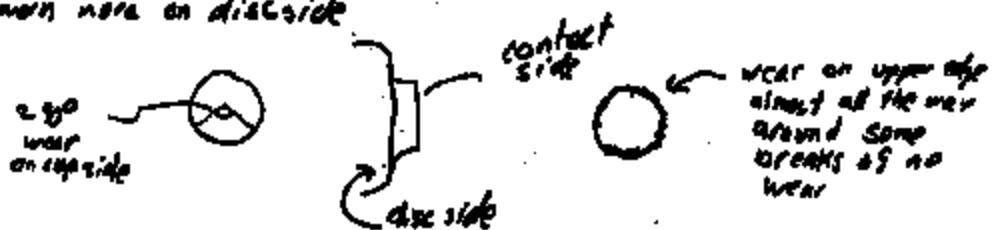
YOOK Device #1 observations

- Cup wear more on disc side

SOOK Device #1 observations

- There is almost a continuous ring of wear on both cup side and contact side outer edges
- There is also wear on inside surface

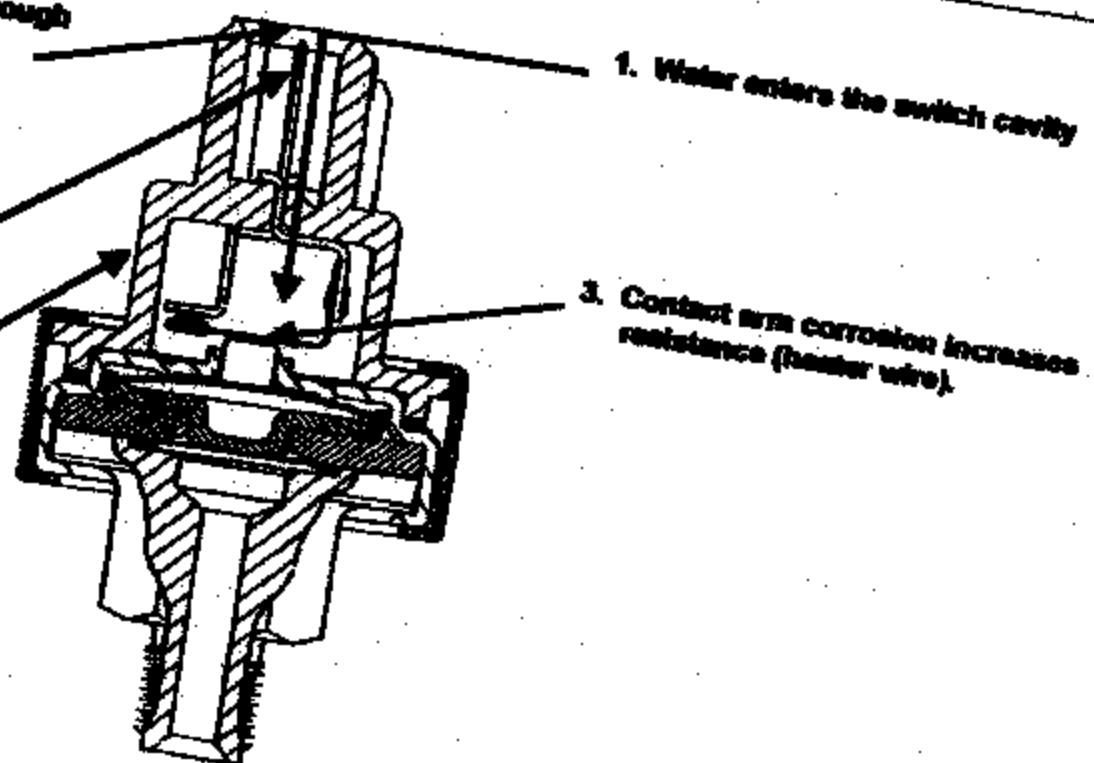
4. Down stream short to ground causes high current to pass through the switch
2. 12V Battery source to drive corrosion and provide energy
5. Plastic connector melts. Once it opens, oxygen enters the switch cavity. If any erosion is present a fire can start, burning the plastic.

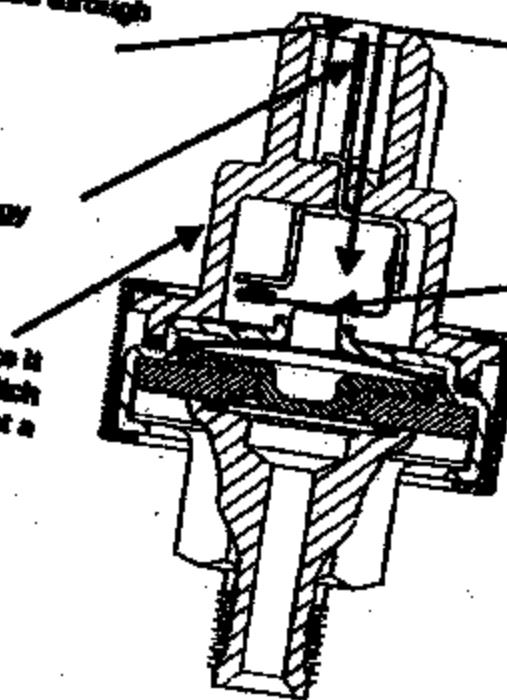
## Brake Pressure Switch Potential Thermal Event Theory - 2/24/99

4. Down stream short to ground causes high current to pass through the switch
2. 12V Battery source to drive corrosion and provide energy
1. Water enters the switch cavity
3. Contact arm corrosion increases resistance (heater wire).

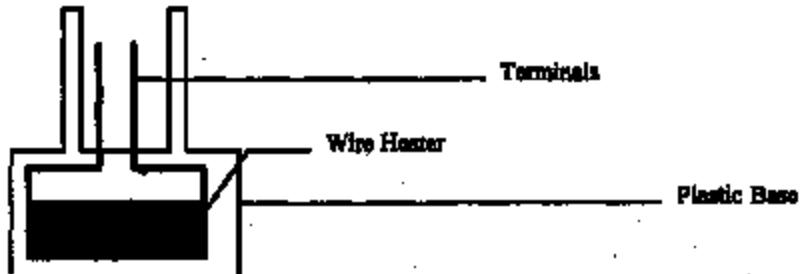
#### Terminal / Heater Attachment

Devices will not ignite with heat alone , not allowing it to be a self sustaining thermal event . There must be smoke present from the plastics and a spark for the ignition of the device to be realized . The device must be open to atmosphere for the introduction of Oxygen to sustain ignition .

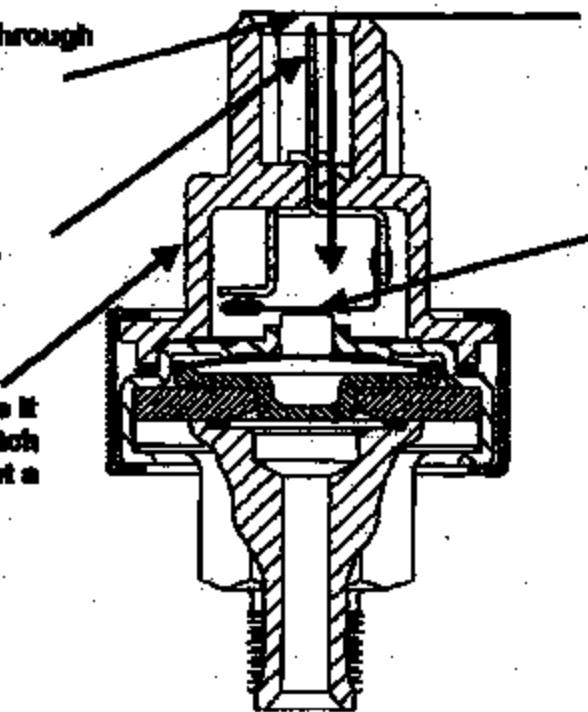
1. Water enters the switch cavity

3. Contact arm corrosion increases resistance (heater wire).

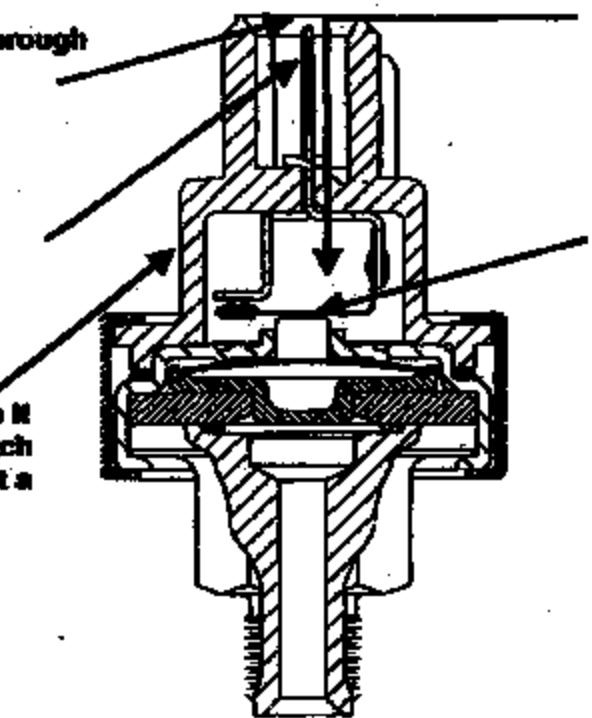
## Brake Pressure Switch Potential Thermal Event Theory - 2/24/99

4. Down stream short to ground causes high current to pass through the switch
1. Water enters the switch cavity
2. 12V Battery source to drive corrosion and provide energy
3. Contact arm corrosion increases resistance (heater wire).
5. Plastic connector melts. Once it opens, oxygen enters the switch cavity. If any arcing is present a fire can start, burning the plastic.

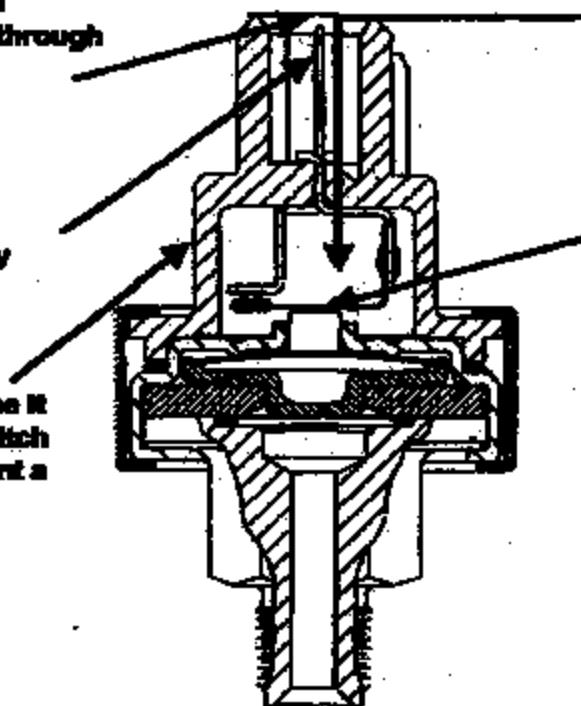
## Brake Pressure Switch Potential Thermal Event Theory - 2/24/99

4. Down stream short to ground causes high current to pass through the switch

1. Water enters the switch cavity

2. 12V Battery source to drive corrosion and provide energy
3. Contact arm corrosion increases resistance (heater wire).

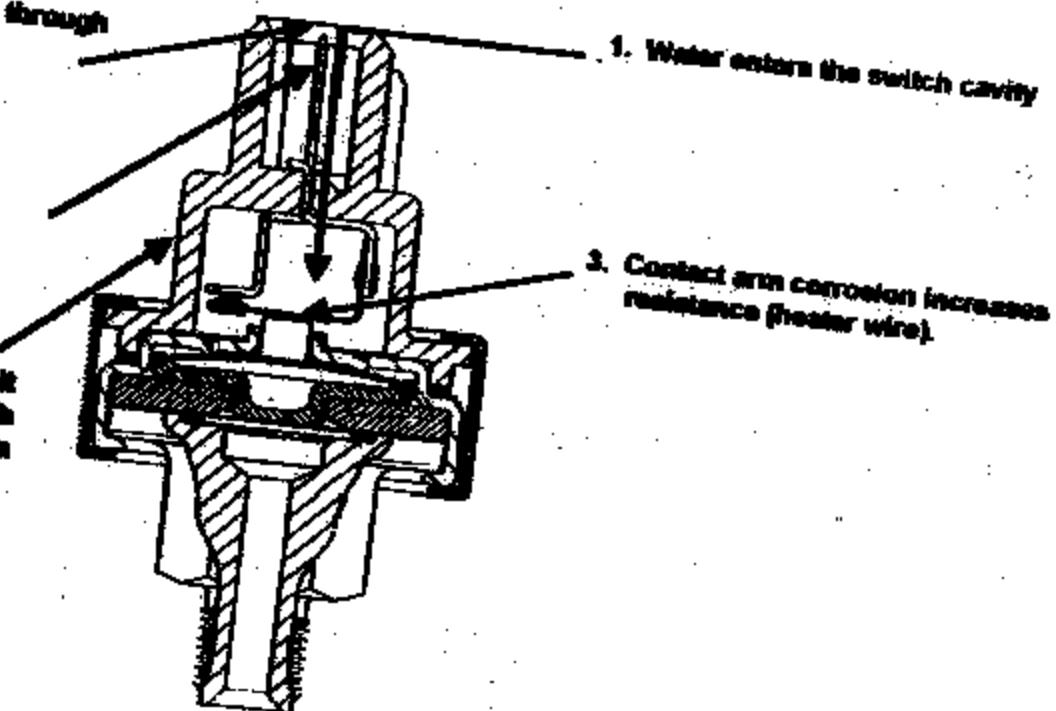
Potential Thermal Event Theory - 2/24/99

4. Down stream short to ground causes high current to pass through the switch
2. 12V Battery source to drive corrosion and provide energy
5. Plastic connector melts. Once it opens, oxygen enters the switch cavity. If any scaling is present a fire can start, burning the plastic.

1. Water enters the switch cavity

3. Contact arm corrosion increases resistance (heater wire).

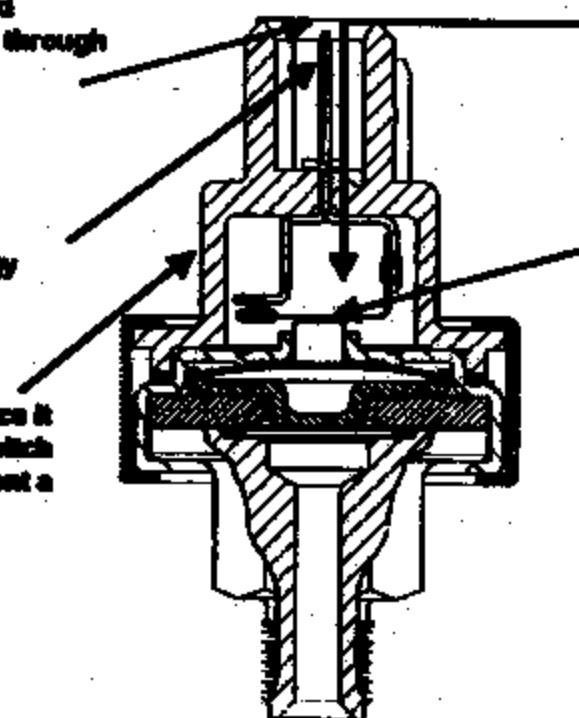
1. Water enters the switch cavity

2. Contact arm corrosion increases resistance (heater wire).

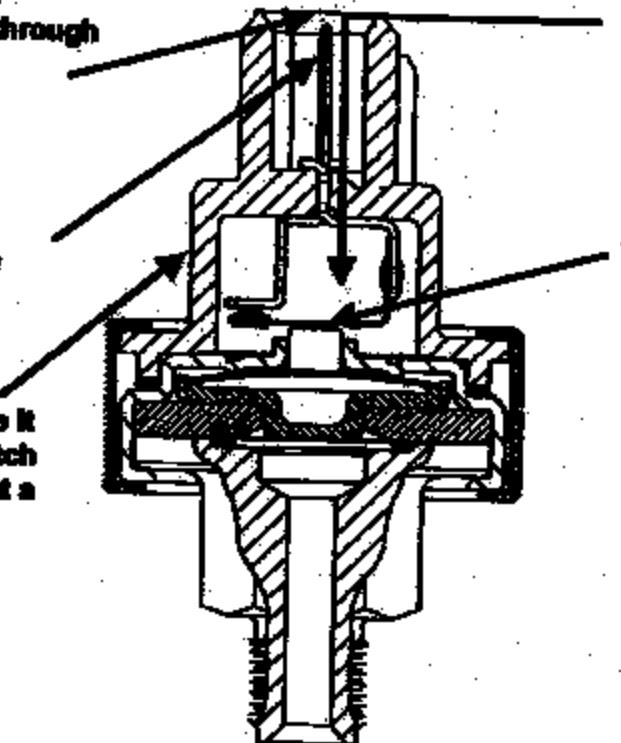
## Brake Pressure Switch Potential Thermal Event Theory - 2/24/99

1. Water enters the switch cavity

3. Contact arm corrosion increases resistance (heater wire).

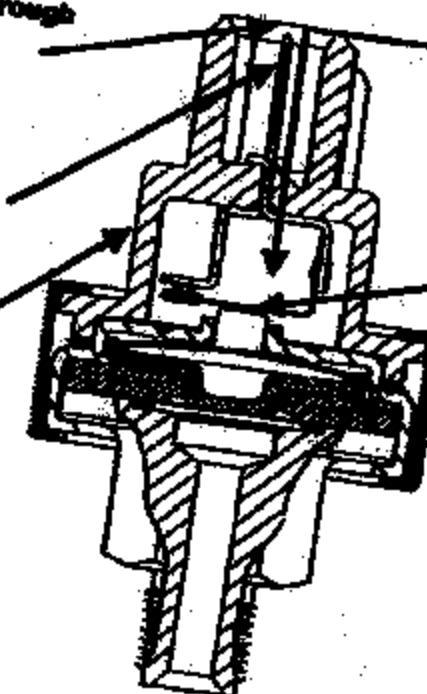
## Brake Pressure Switch Potential Thermal Event Theory - 2/24/99

4. Down stream short to ground causes high current to pass through the switch
2. 12V Battery source to drive corrosion and provide energy
5. Plastic connector melts. Once it opens, oxygen enters the switch cavity. If any arcing is present a fire can start, burning the plastic.

1. Water enters the switch cavity

2. Contact and corrosion increases resistance (faster melt).

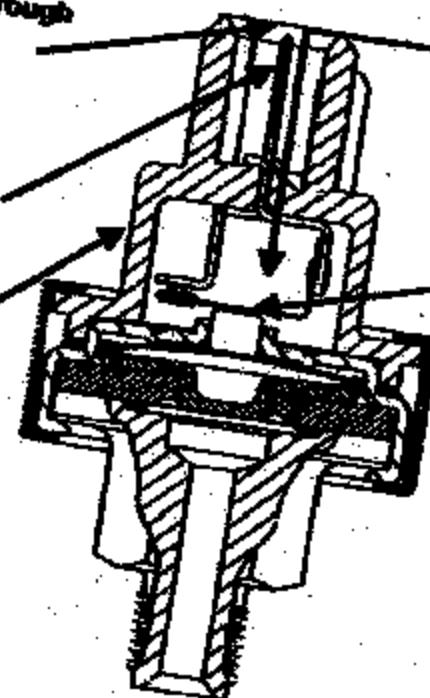
## Brake Pressure Switch Potential Thermal Event Theory - 2/24/99

1. Water enters the switch cavity
2. 12V Battery source to drive corrosion and provide energy
3. Contact arm corrosion increases resistance (heater wire).
4. Down stream short to ground causes high current to pass through the switch
5. Plastic connector melts. Once it opens, oxygen enters the switch cavity. If any smoke is present a fire can start, burning the plastic.

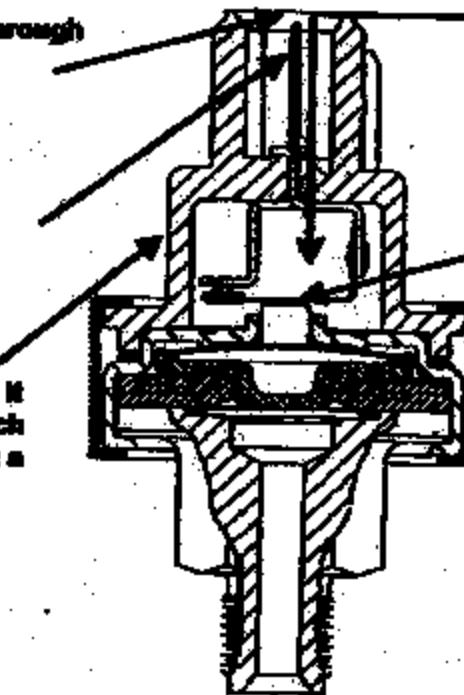
4. Down stream short to ground causes high current to pass through the switch
2. 12V Battery source to drive corrosion and provide energy
5. Plastic connector melts. Once it opens, oxygen enters the switch cavity. If any arcing is present a fire can start, burning the plastic.

1. Water enters the switch cavity
3. Contact arm corrosion increases resistance (heater wire).

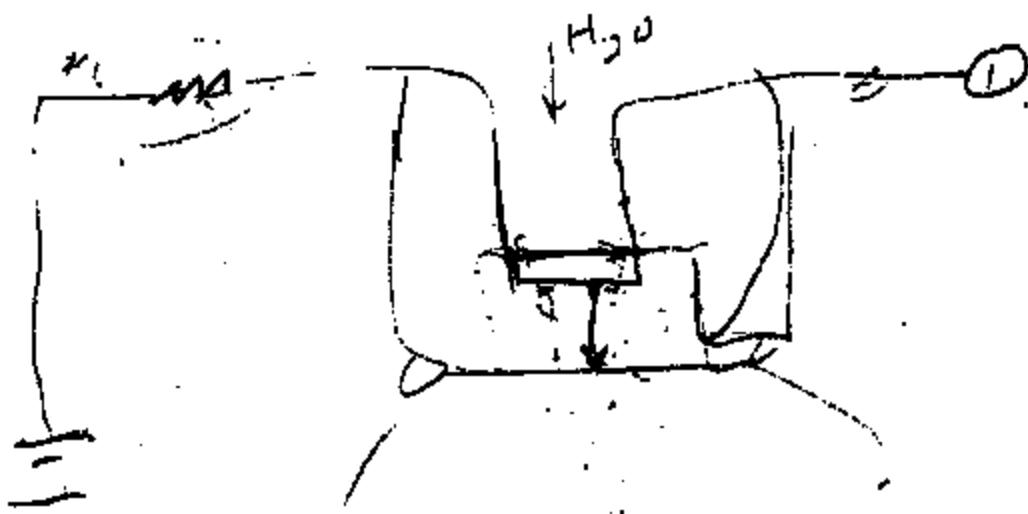
Corrosion - Internal terminals to case ground

Q - could it happen w/o case ground  
 Q - could it happen w/o brake fluid (old & dirty)

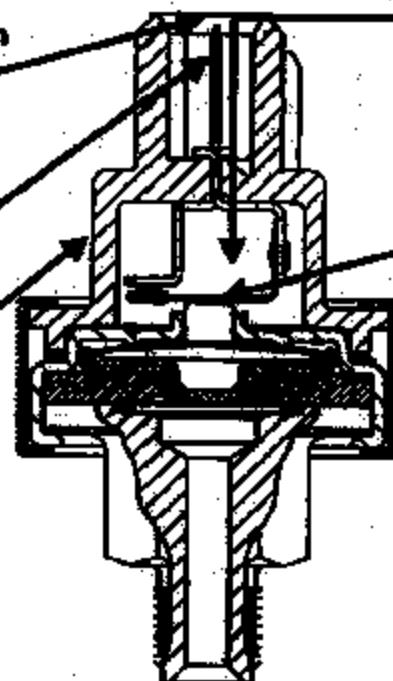
4. Down stream short to ground causes high current to pass through the switch
2. 12V Battery source to drive connection and provide energy
5. Plastic connector melts. Once it opens, oxygen enters the switch cavity. If any arcing is present a fire can start, burning the plastic.
1. Water enters the switch cavity.
3. Contact arm corrosion increases resistance (heater wire).

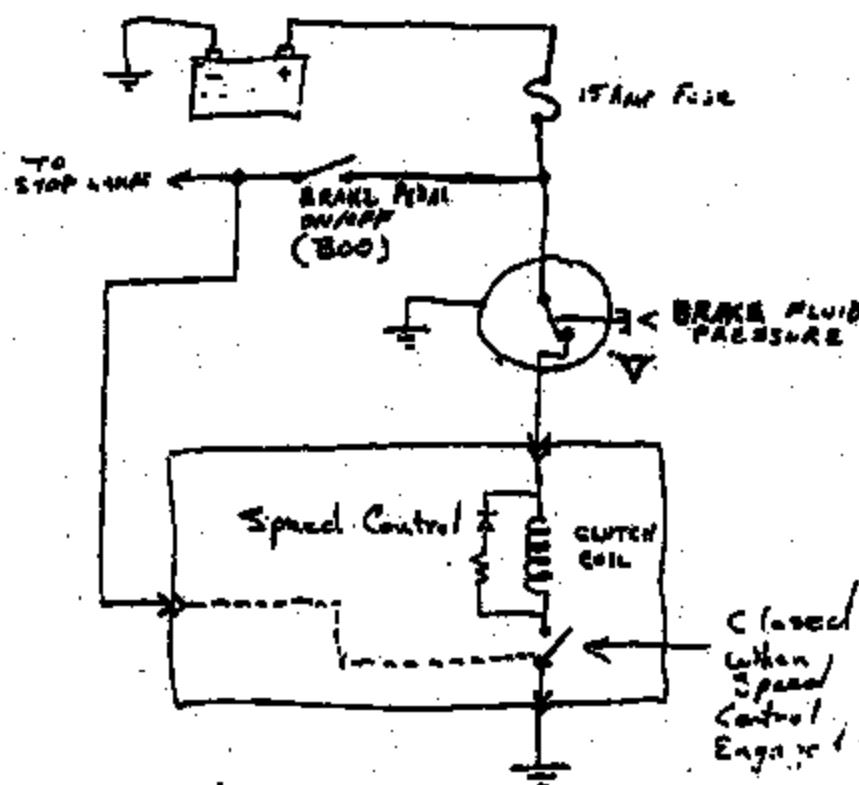
## **Brake Pressure Switch Function-**

- Provide power to Speed Control Clutch circuit.  
Clutch engages servo-motor to pull throttle cable.
- Provide redundant sensing of brake application independent of the primary system deactivation mode by disconnecting power to clutch circuit causing servo-motor to release throttle cable.
  - Under Hard Braking only
  - Stop lamp signal to primary (normal braking)
