**TEXAS INSTRUMENTS,
INC.'S 9/10/03
ATTACHMENT**

Background Testing
Speed Control Deactivation Switch
Ford Part #XF1Z-9F924-AA

**Brake Pressure Switch
Potential Factors - 3/3/99**

77PS Life Cycle DOE Test to Leakage

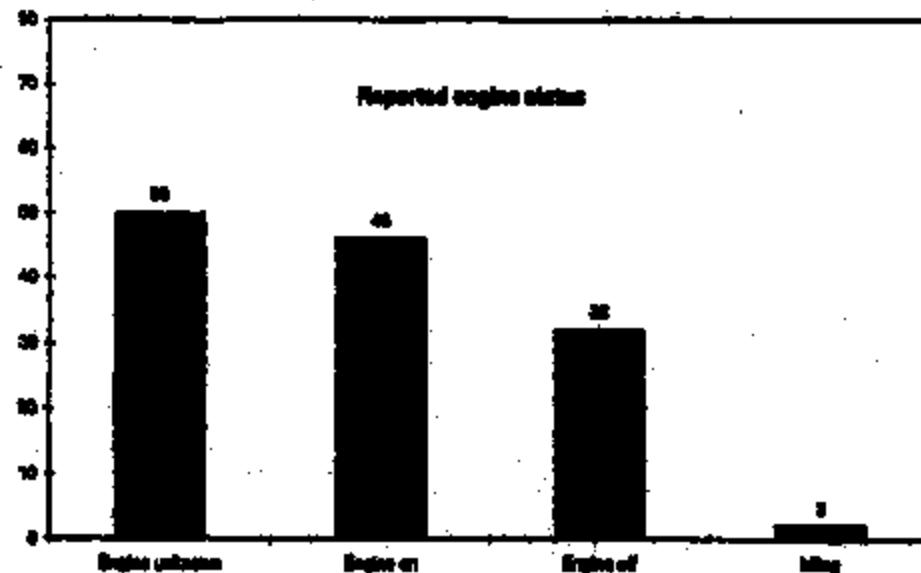
92MY Town Car CCRS Pareto Analysis

Note:

* Of the reported probable causes with the cause(s):

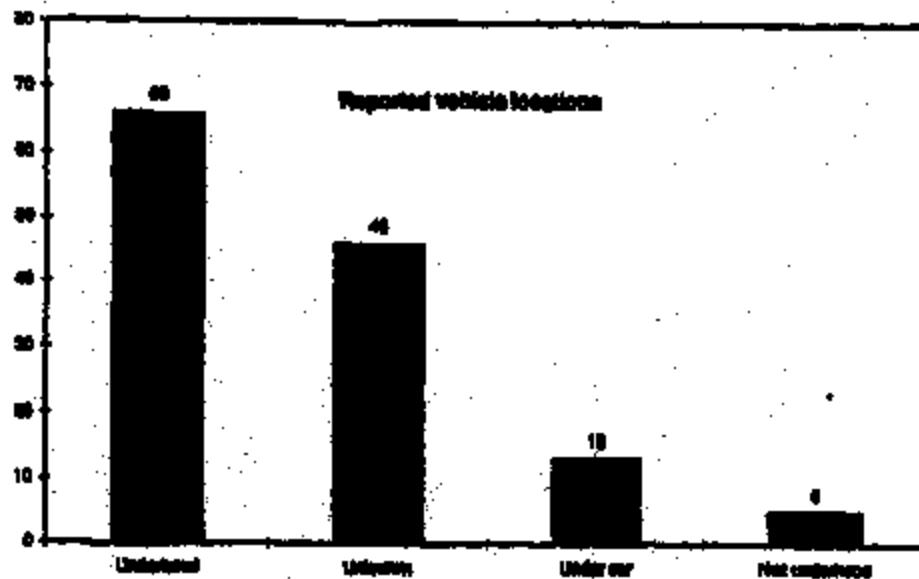
92MY Town Car CQIB Pareto Analysis.

* Underhood location is broken down into the following subparts as probable causes:

(1) Underhood unknown	19	Out of a total of 66
(2) Brake related	12	Out of a total of 66
(3) Electrical related	12	Out of a total of 66
(4) Lost front of vehicle	7	
(5) Engineenville Oil leak	3	
(6) Gas line	1	
(7) Battery on top of hood	1	
(8) Catalytic converter	1	
(9) A/C comp. (overhead)	1	
(10) Spark plug wires	1	
(11) Right rear side	1

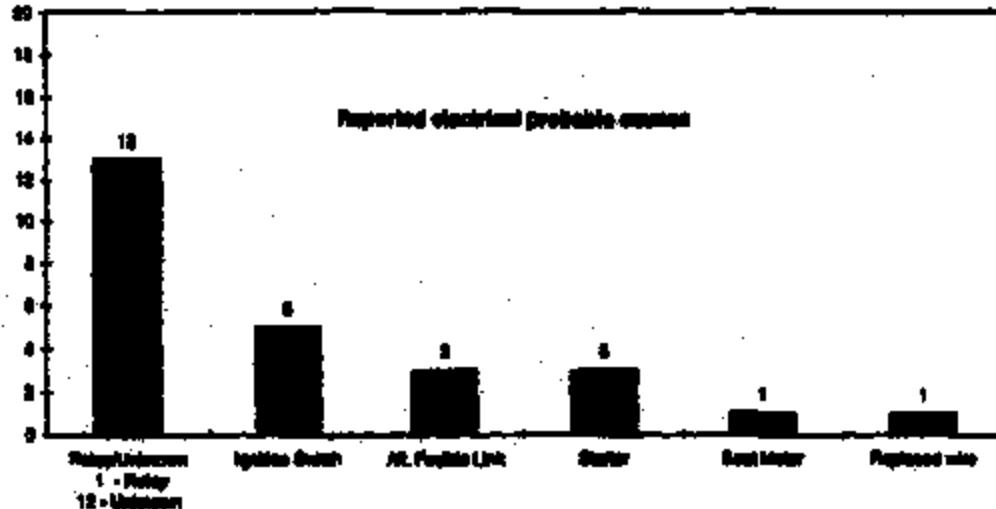
SEMY Town Car COIS Pareto Analysis

(1) Of the 13 probable electrical issues on the first bar, 12 are stated as an electrical issue without any other conclusion.

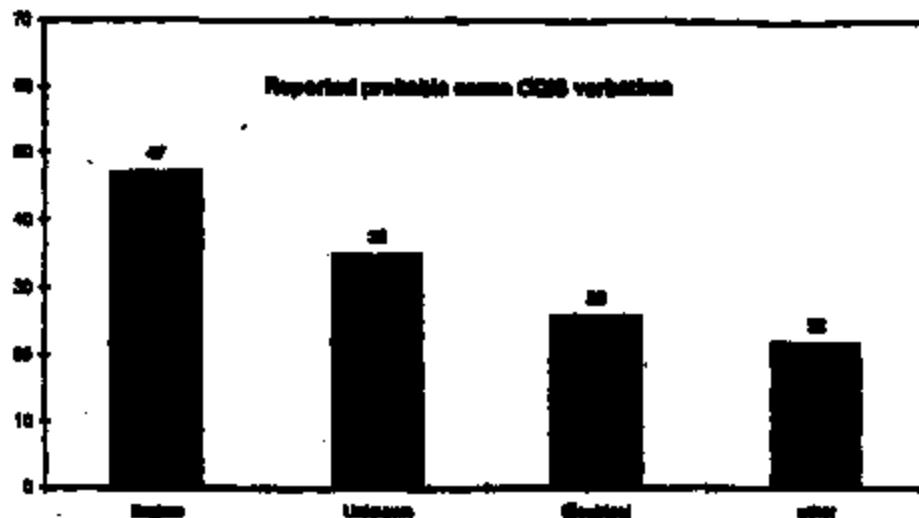
92MY Town Car CDS Pareto Analysis

- (1) Brakes account for 47 out of 130 92MY Town Car CDS verifications.
* Categories include these types of comments: Brake pressure switch, Brake lock-up, brake booster hinge-up, brake lines, frozen caliper, power brake unit, plastic piston caliper melts, brakes caught fire, undercar rotors, other master parts.

- (2) Unknowns account for 35 out of 130 92MY Town Car CDS verifications.
* No probable root cause identified.
- (3) Electrical accounts for 25 out of 130 92MY Town Car CDS verifications.

* Categories include these types of comments: 18 are reportedly an electrical issue with comments such as car started, possible electrical wire malfunction, electrical problem, electrical short, the department stated electrical issue.
other include suspension relay, replaced a wire, ignition switch, meter, alternator trouble first, Gear motor.

- 1.0 There are 4 main categories that the 130 CGM vehicles can be broken to:
 - (A). 38% or 47 out of 130 are reportedly brake related.
 - (B). 27% or 35 out of 130 are reportedly unknown.

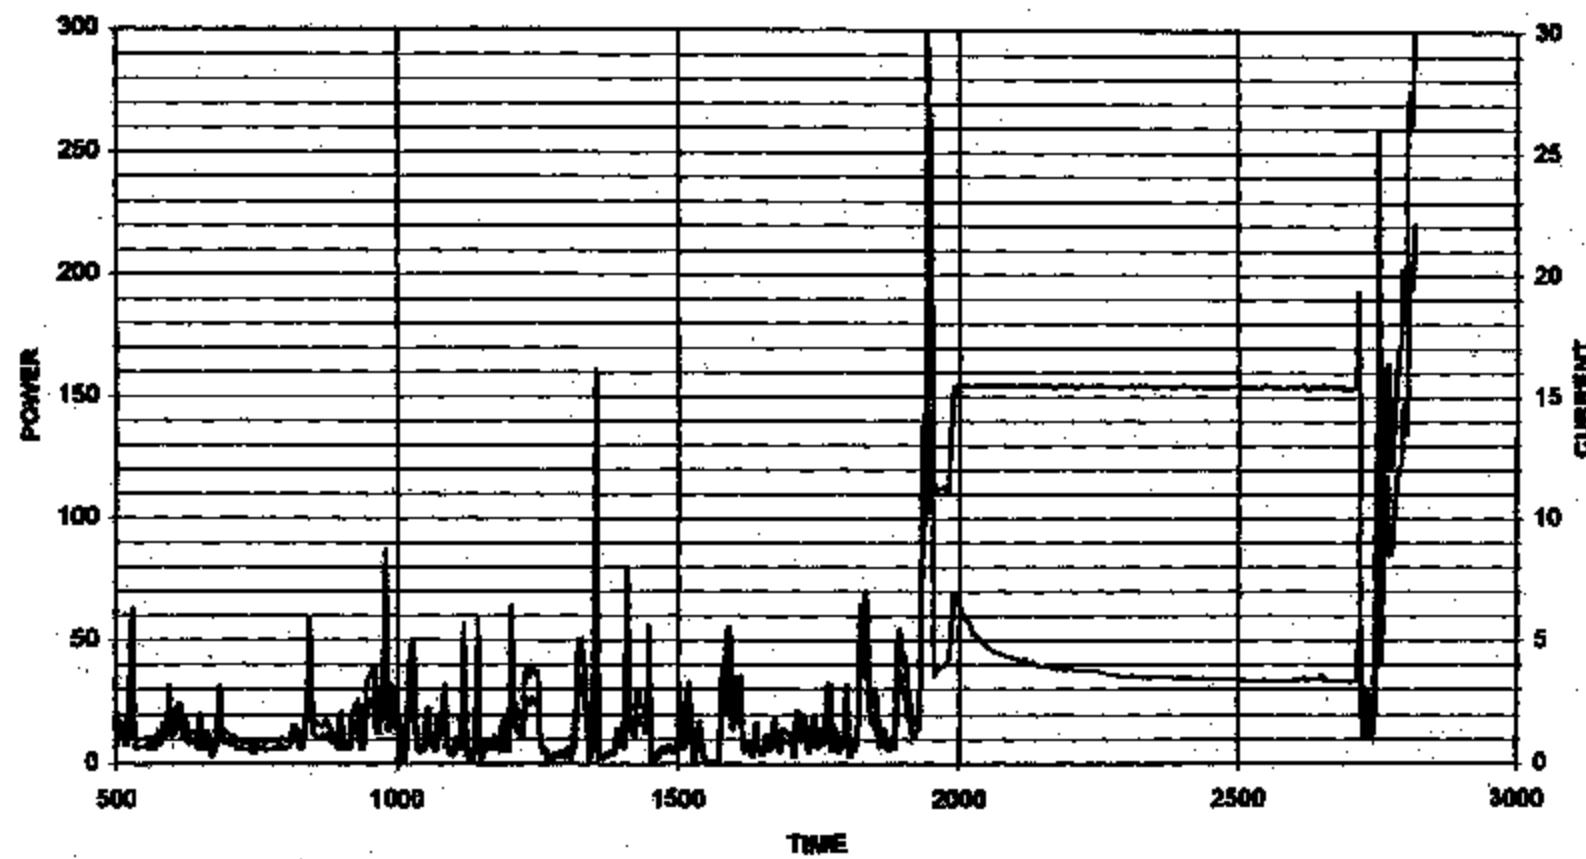
ZYTEL BASE
5% SALT WATER INGRESS
VERTICAL ORIENTATION

— POWER — CURRENT

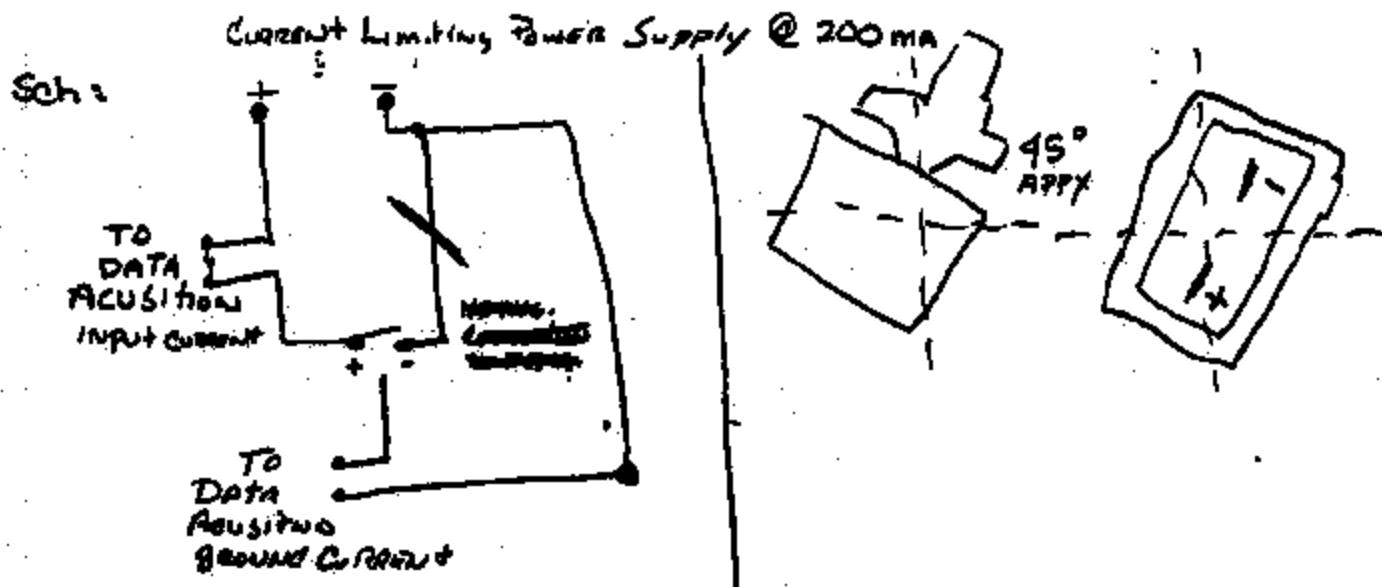
Current Limited Burn testing

DEVICE will Be connected to Positive Terminal only with CURRENT IN AND CURRENT GROUND DATA Logged. A solution of 5% SALT will Be injected into Device at 10 min intervals or as Needed

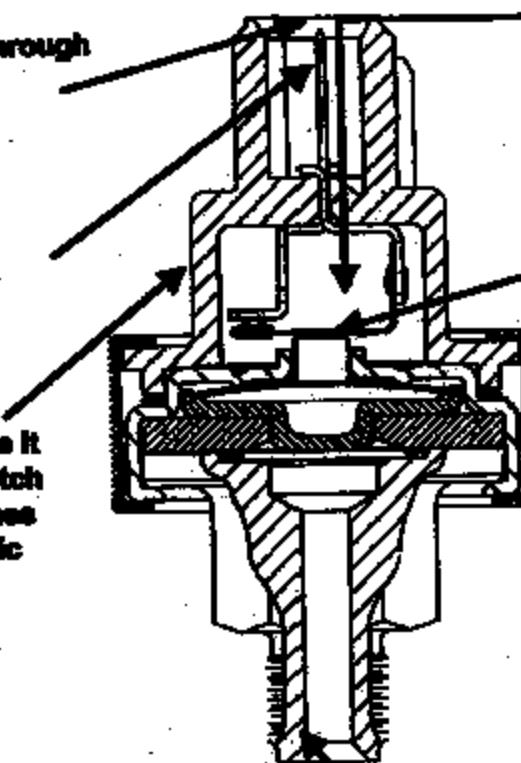
5. Down stream short to ground causes high current to pass through the switch

2. 12V Battery source to drive corrosion and provide energy

6. Plastic connector melts. Once it opens, oxygen enters the switch cavity. Arm corrosion becomes "RED HOT" igniting the plastic

4. Contact arm corrosion increases resistance (acts like heater wire).

3. Hexport grounded accelerates corrosion

4. Root Cause: See attachment 1 (Theory of 3/9/99) - Water enters pressure switch thru connector - Continuous power drives corrosion - Corrosion creates high resistance - Resistance creates local heating - Several exposures over time (T) - Local heating ignites pressure switch and connector plastic		% Contribution: Unknown

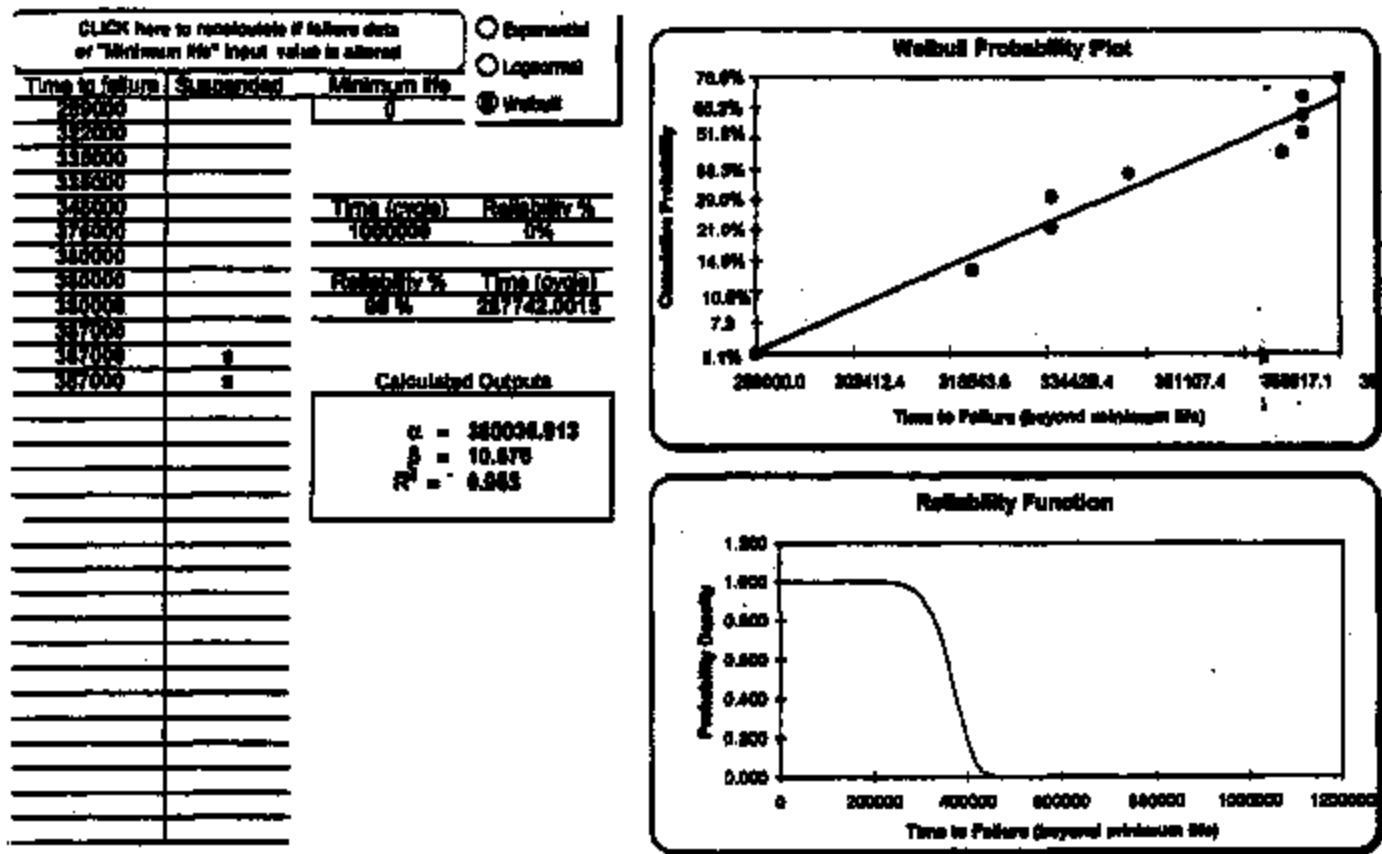
Figure 1.

2 and 3 parameter WEIBULL FAILURE ANALYSIS

NOTES: Group 4: 77PBL4-1 w/ 8% water in brake fluid

(10) 77PSL4-1 switches leaked before 400,000 cycles when tested with a brake fluid/ 5% water mix. It is suspected that these switches may have a less than optimum converter to spacer height that puts an excessive strain on the diaphragm. Measurements have been made that tend to support this theory. Analysis of these switches and 77PSL2-1 switches (see Table 2 above) has shown that the converter on 77PSL2-1 switches protrudes above the spacer roughly 1/1000 to 1.5/1000 of an inch more than on 77PSL4-1 switches. This difference may be enough to cause premature leaks. There seems to be no significant difference between 77PSL4-1 switches that have been life tested and those that are pulled from the production line.

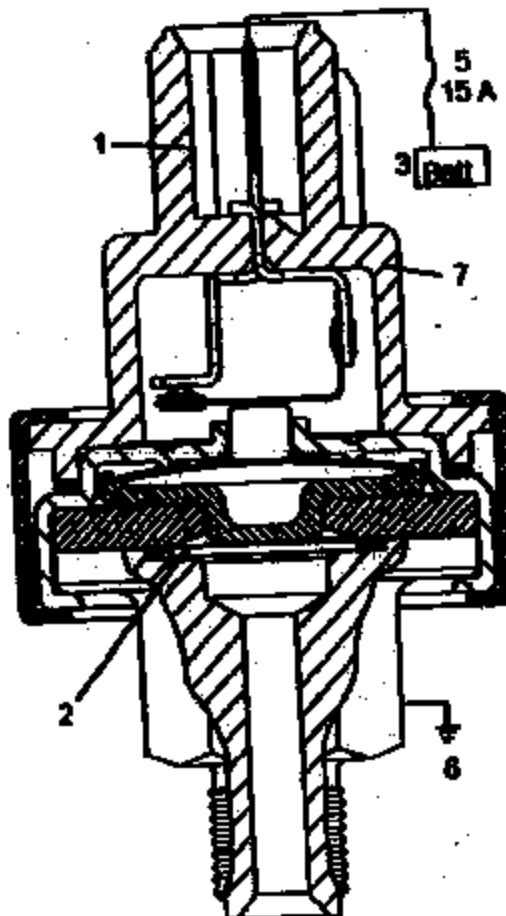
Contributing Factors

1. Connector Seal
2. Kapton Life
3. Continuous Power
4. Switch Orientation
5. Current Capability
6. Grounded Hex-Port
7. Plastic Parameters

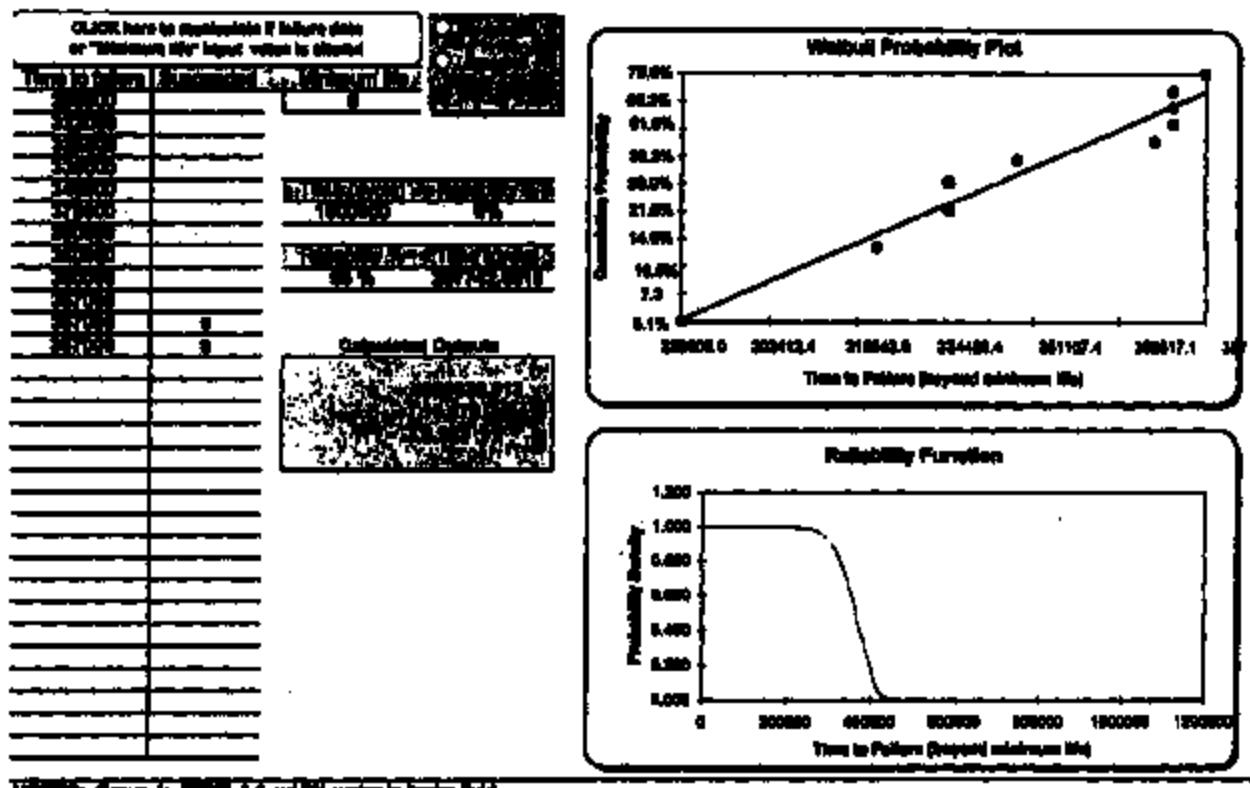
Figure 1.

2 and 3 parameter WEIBULL FAILURE ANALYSIS

NOTICE: Group 4: 77984-1 w/ 5% water in brake fluid

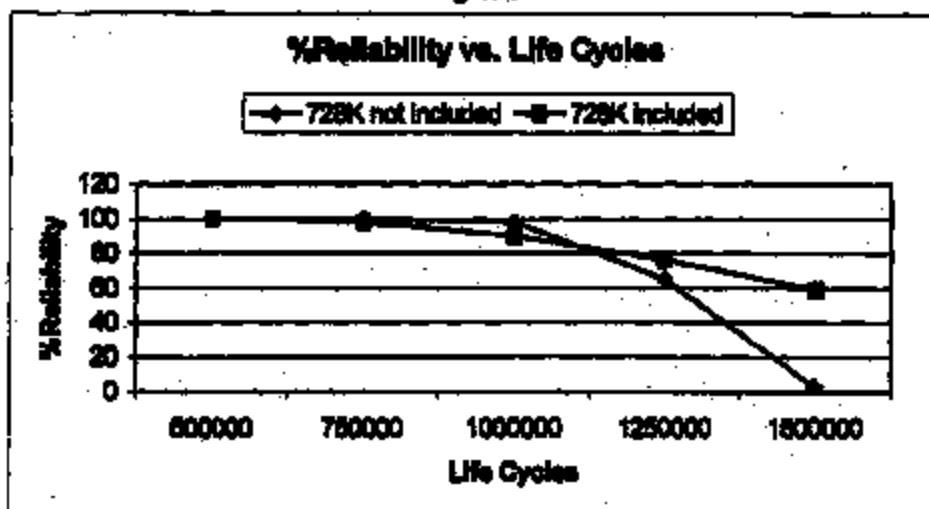
Figure 3.

728K point included in analysis		% Reliability vs. Life Cycles		728K point not included in analysis	
Life Cycles	% Reliability	Life Cycles	% Reliability	Life Cycles	% Reliability
500000	100			500000	100
750000	98			750000	100
1000000	90			1000000	98
1250000	76			1250000	65
1500000	59			1500000	3

For each set of data entered into a Weibull Analysis, the set of parameters α , β and R^2 are determined. Values for the data used in this test may be seen in Figure 1 and Figure 2.

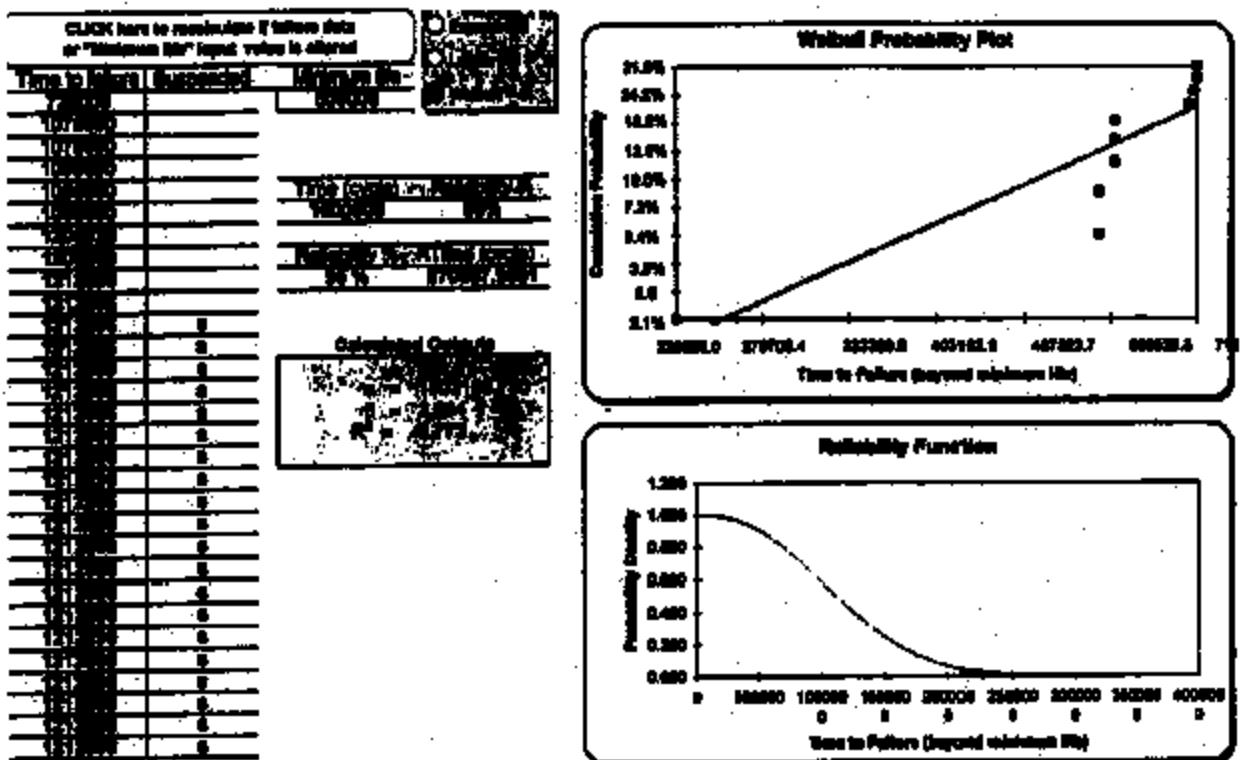
Figure 1.

2 and 3 parameter WEIBULL FAILURE ANALYSIS

NOTICE: 7743 - 720K cycle data point included in analysis

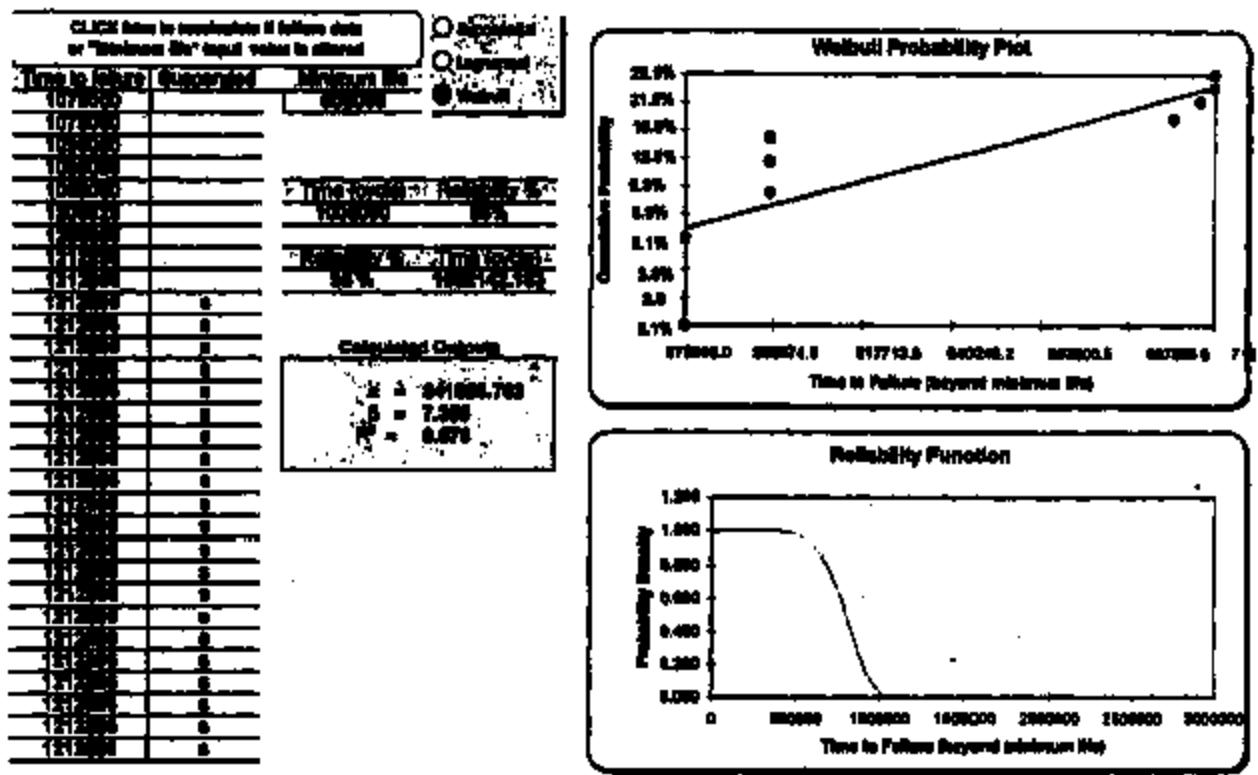
Figure 2-

2 and 3 parameter WEIBULL FAILURE ANALYSIS

NOTE: 77K - 720K cycle data point not included in analysis

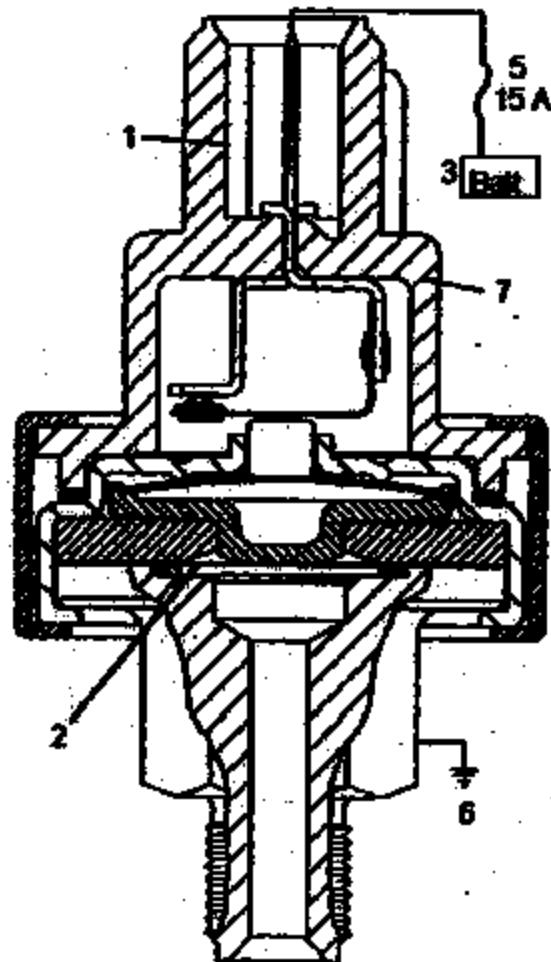
Contributing Factors

1. Connector Seal
2. Kapton Life
3. Continuous Power
4. Switch Orientation
5. Current Capability
6. Grounded Hex-Port
7. Plastic Parameters
