EA02-025

SUBJECT: 99-181: TSL # 151700: PRELIMINARY FINDINGS ON LINCOLN
SIMULATION SAMPLES

Determine if there are similarities between the original sample that Ford had hand-carried in (TSL # 150709) and the simulation samples.

99-243: TSL #'S 151700 & 142010: TTB SIMULATION SAMPLES: ROUGH DRAFT
ONLY

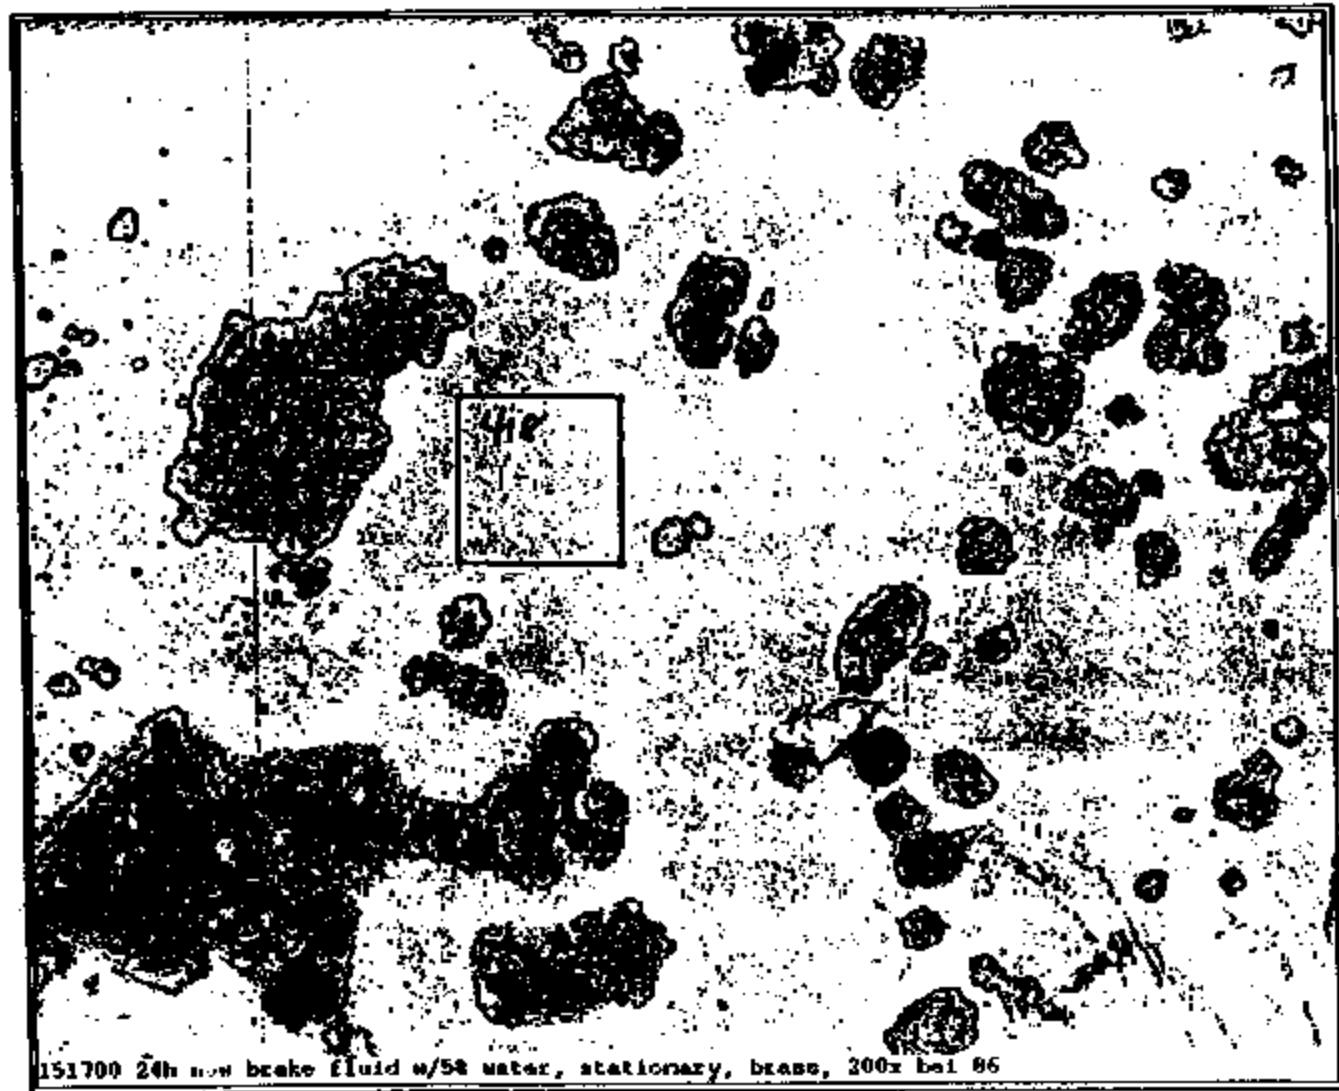
151700 24h new brake fluid w/5% water, stationary, brass, 25x mai 84

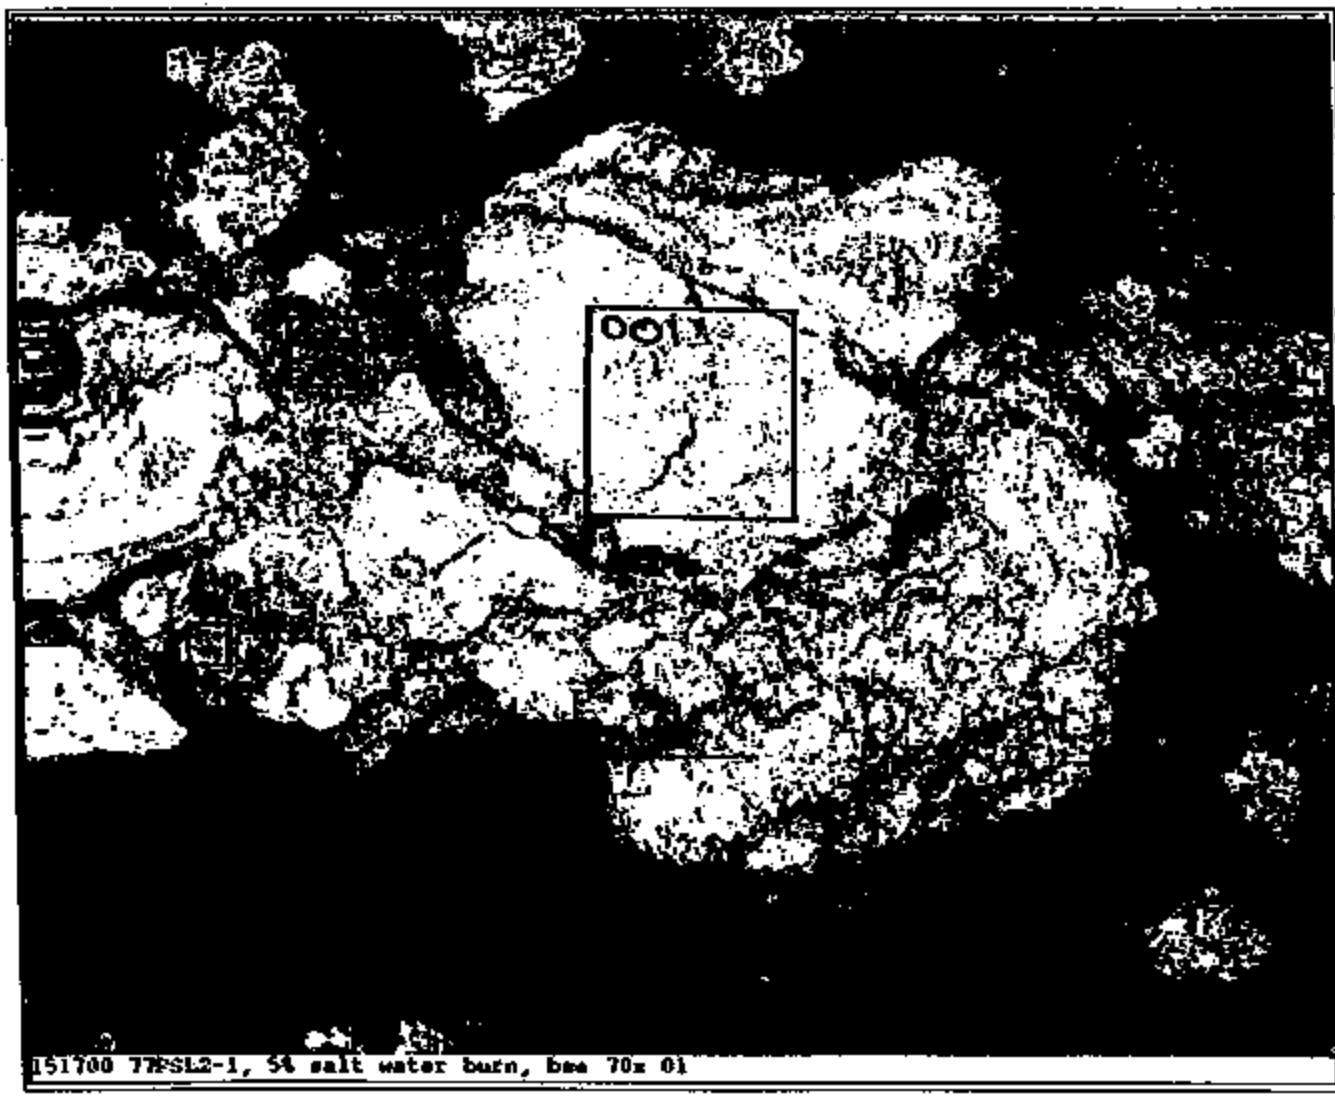
151700 77 SEL2-1, 54 salt water burn, bae 70x 01

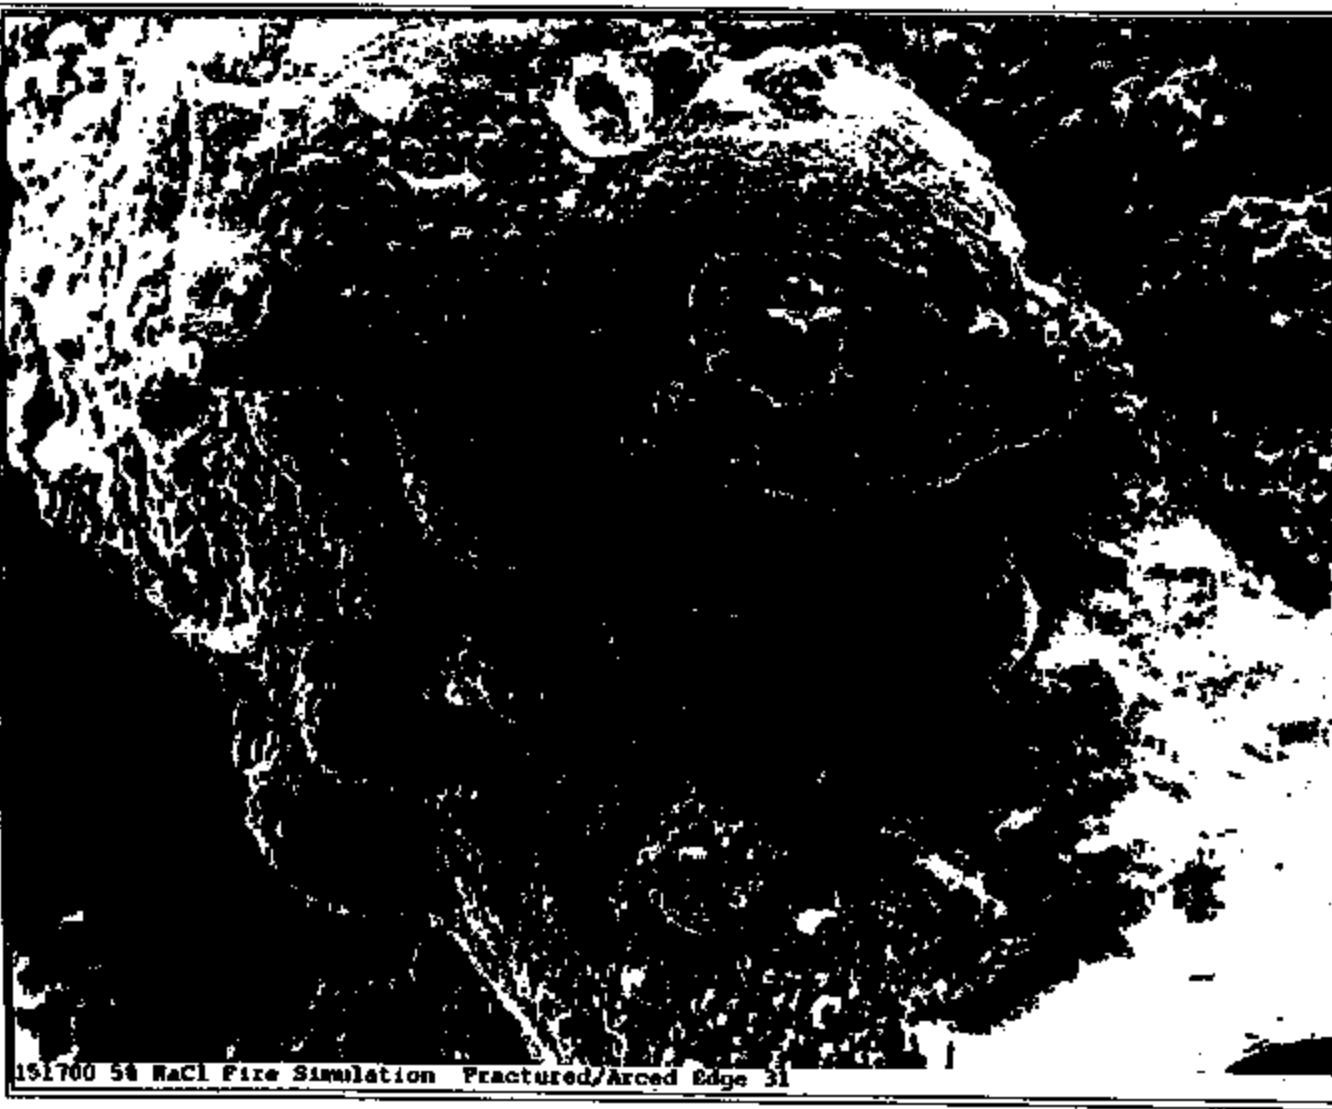
151700 54 NaCl Fire Simulation Fractured/Arced Edge 31

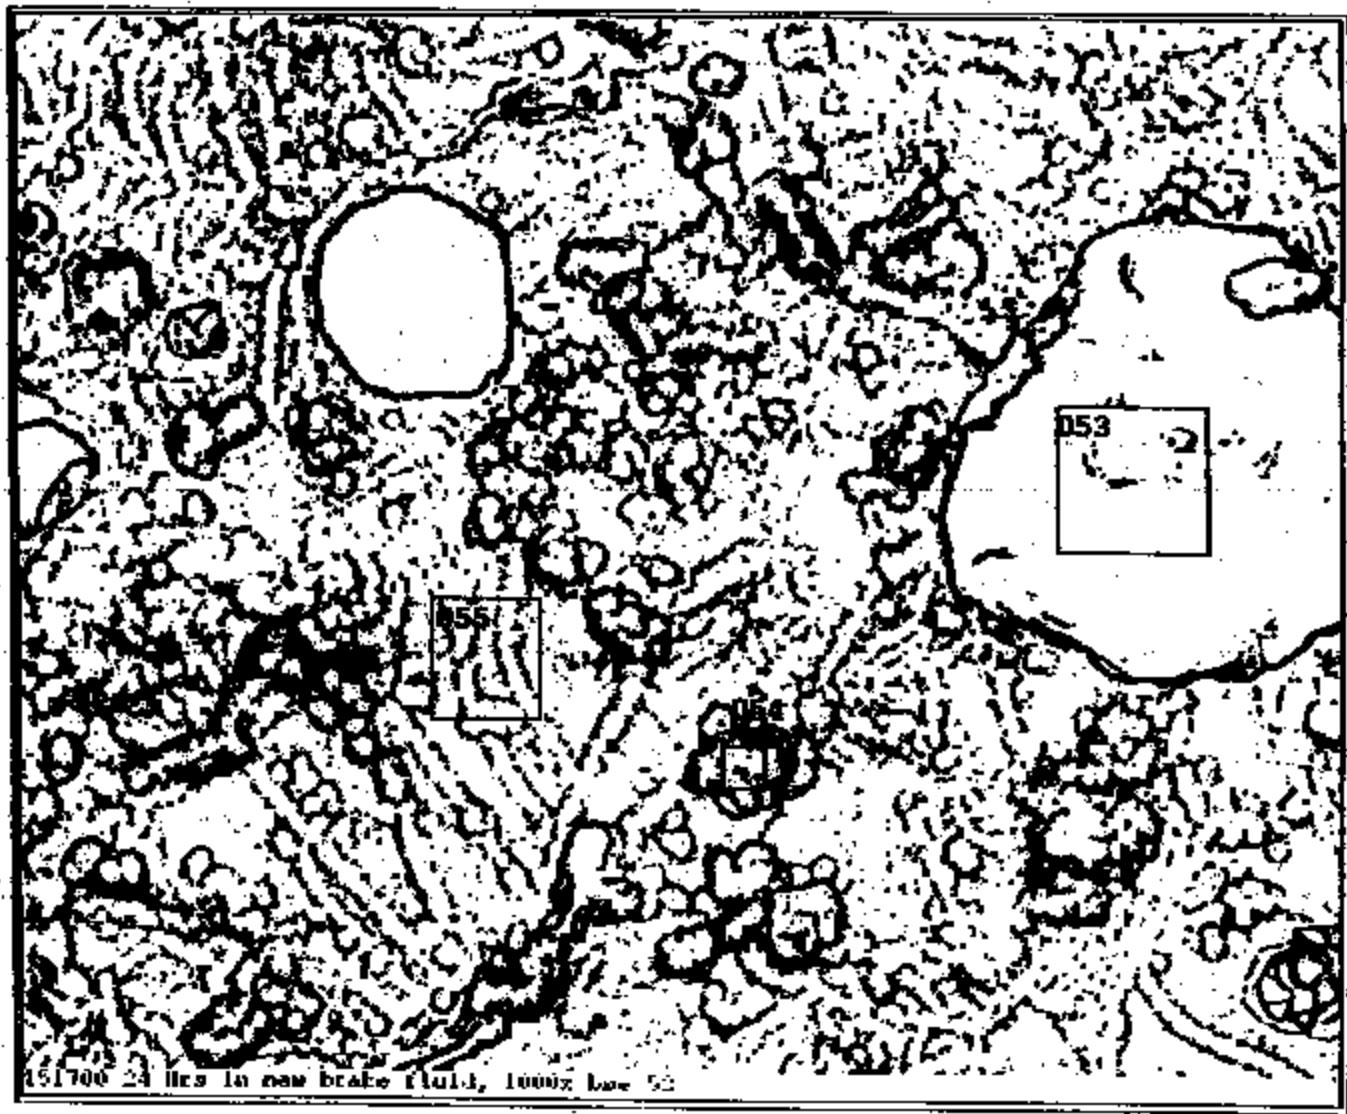
151700 24 hrs in new brake fluid, 1000x low 52

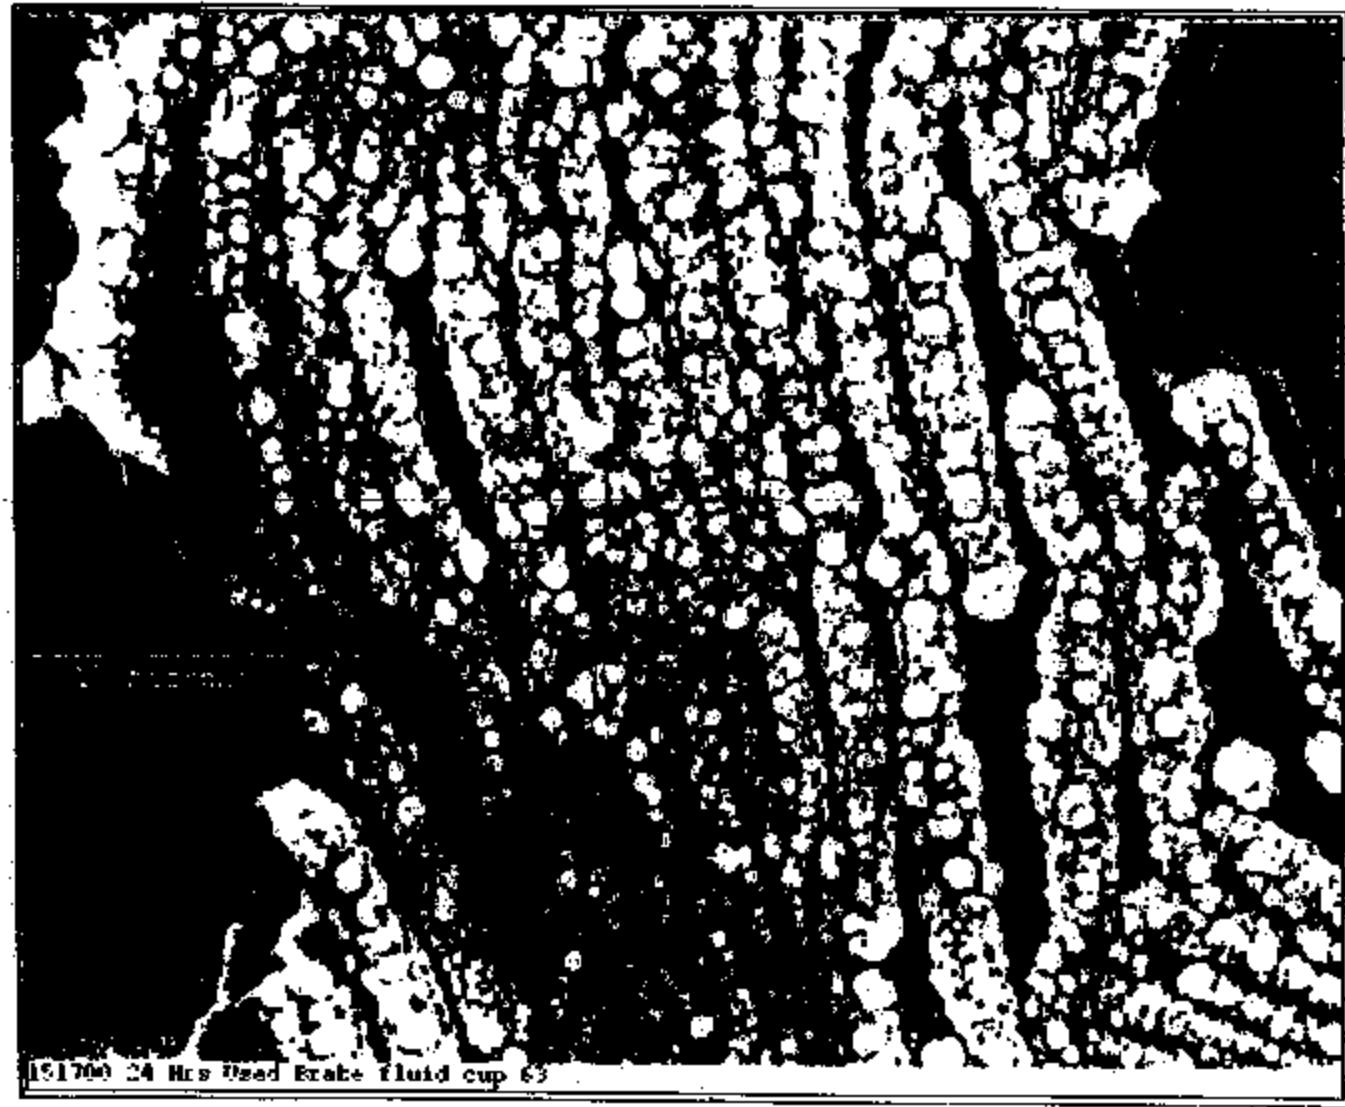
191700 24 Hrs Used Brake Fluid cup 63

CUP ANALYSIS: The chromate layer is missing in many areas; generally we find relatively uncorroded zinc metal underneath; these areas appear shiny under optical examination. In areas where the chromate isn't missing, we find that substantial amounts of copper have been deposited on top of the chromate surface. A zone showing both types of these areas is shown at various magnifications in Photos 61-64. Elemental distribution maps are also shown in Photos 60 and 69. They show the nodular nature of this copper deposit. This is also documented in Spectra 500-520.

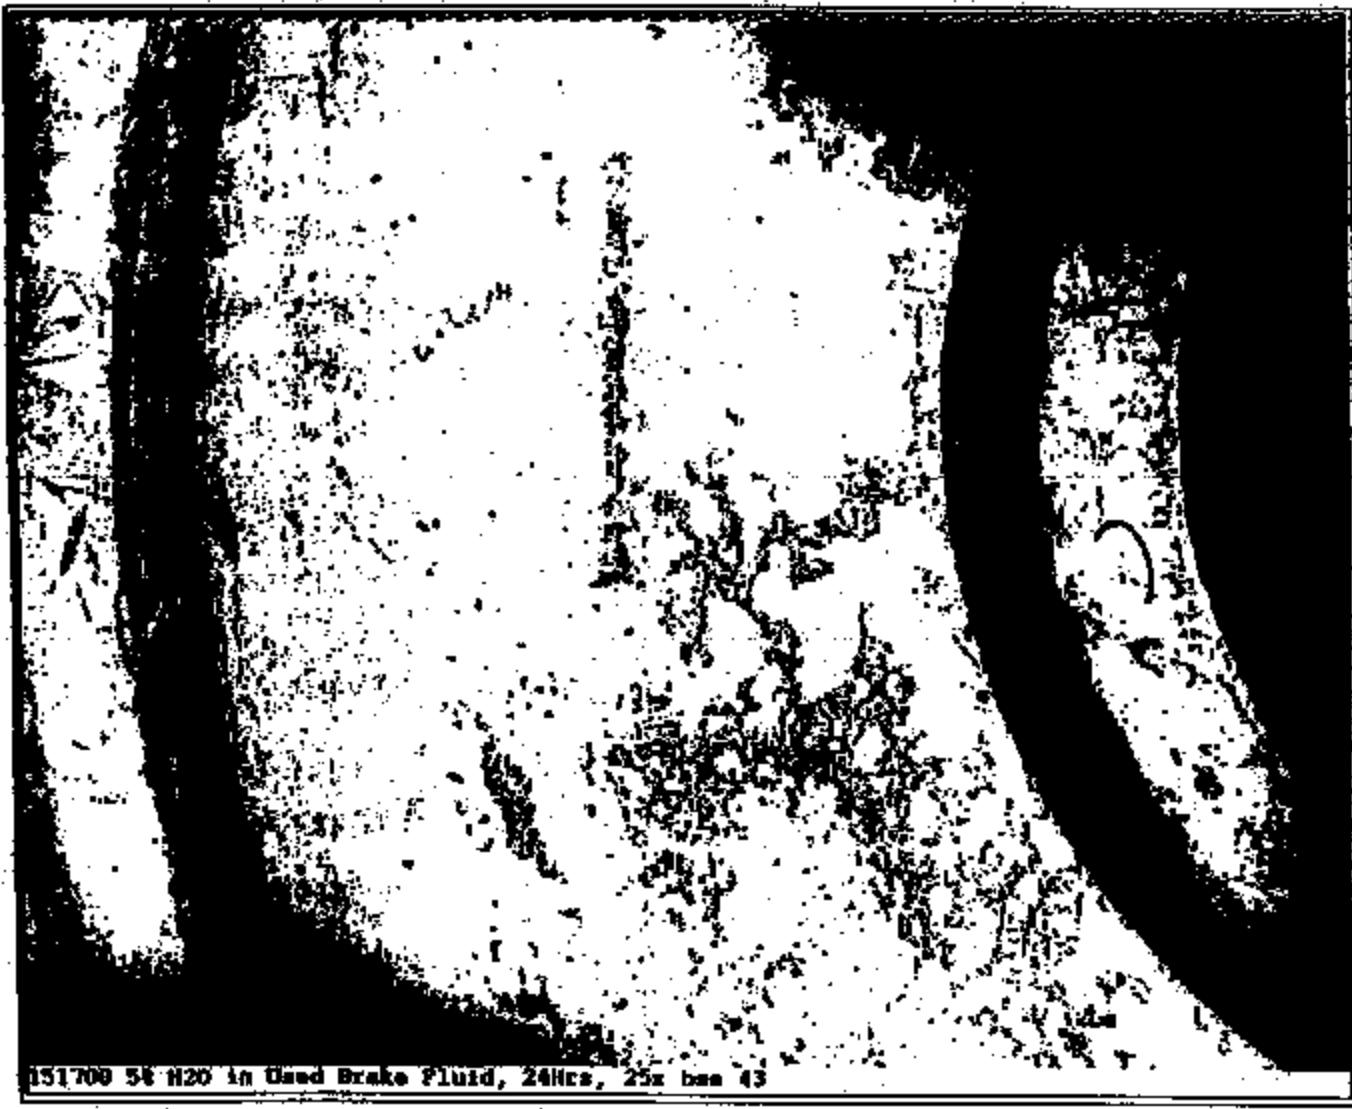
131700 56 H2O in Used Brake Fluid, 24Hrs., 25x bin 43

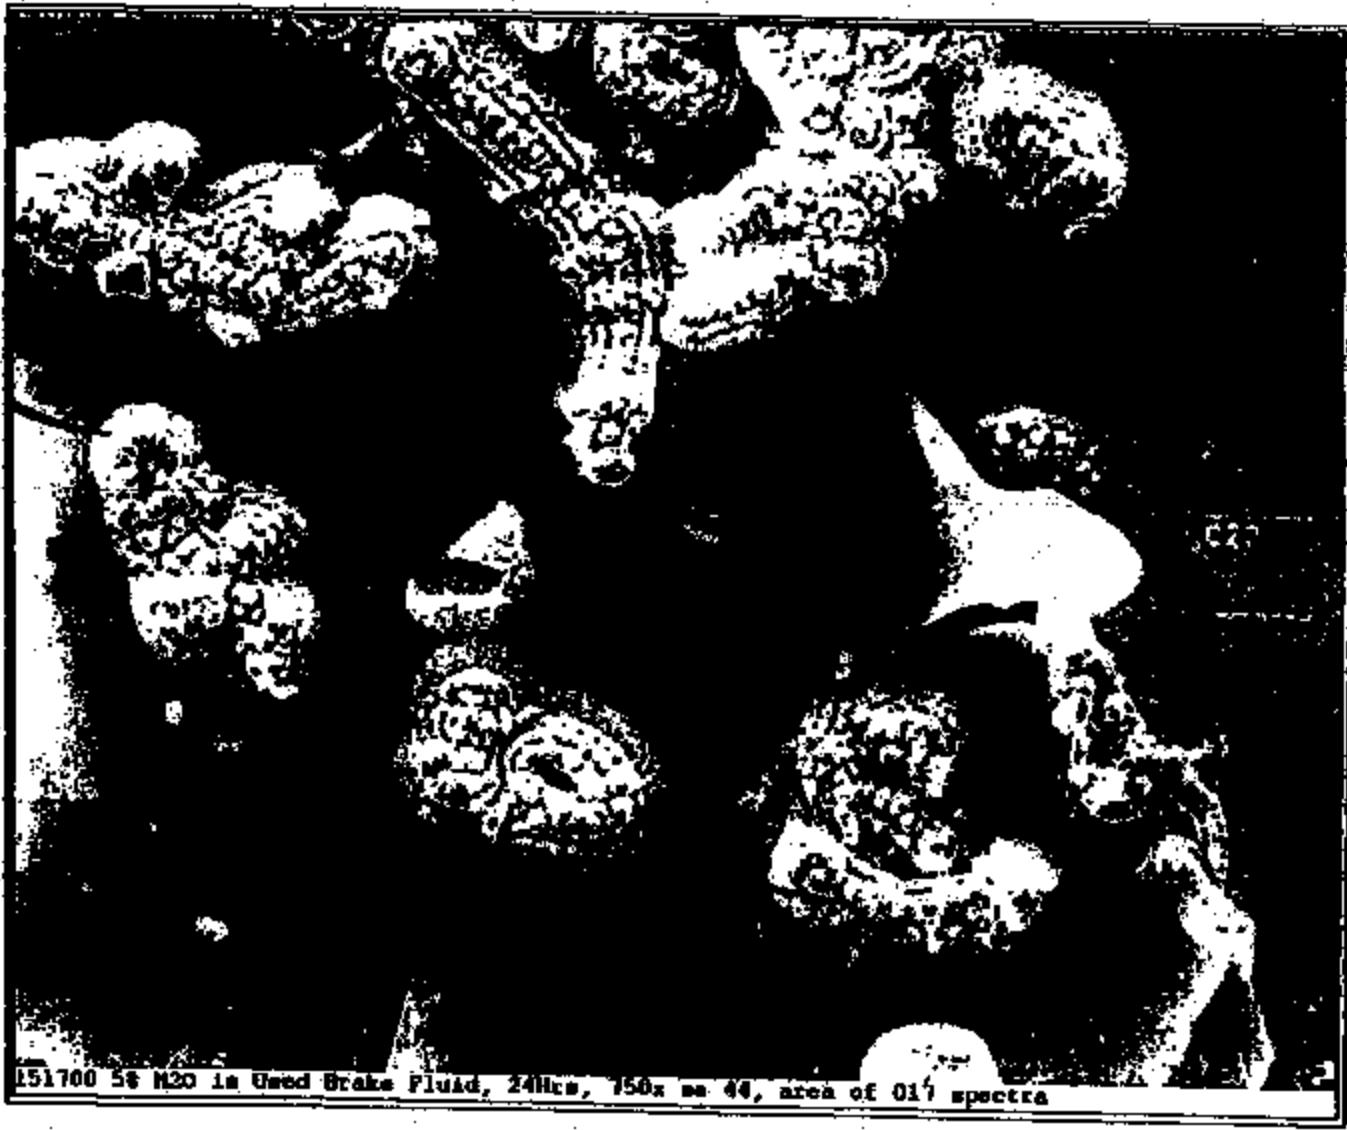
151700 58 M20 in Used Brake Fluid, 24hrs, 750x no 44, area of O17 spectra

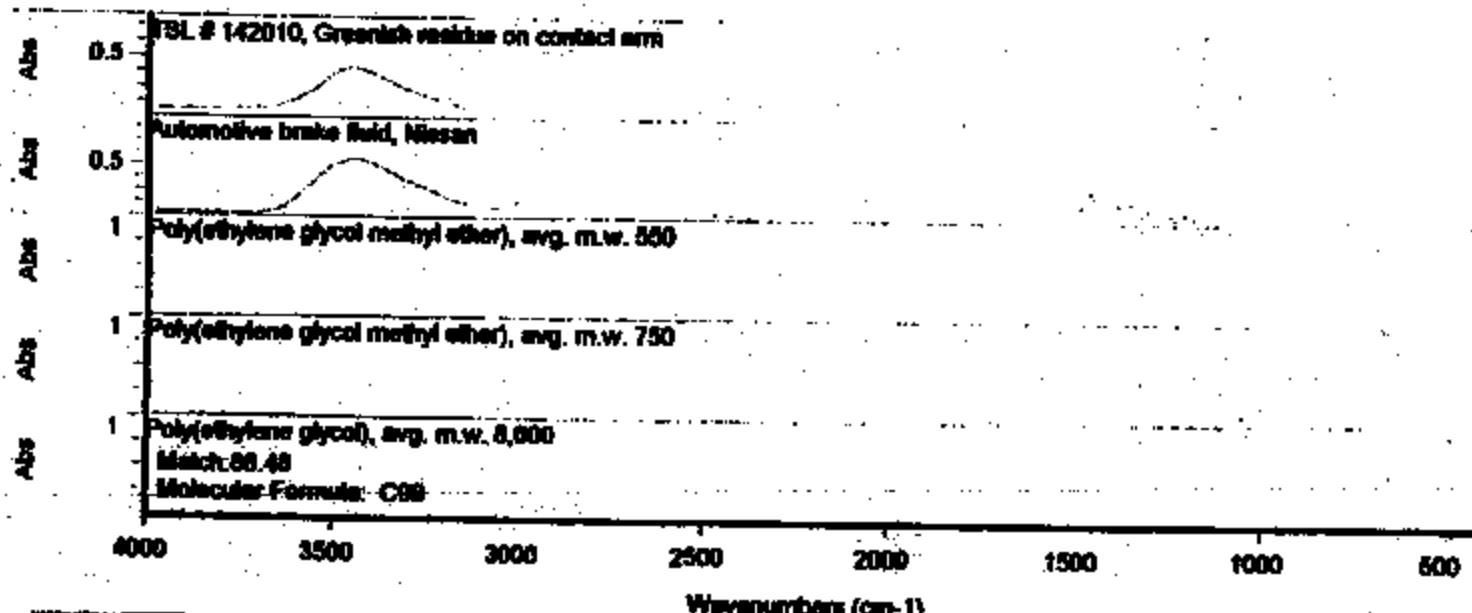
Spectrum: TSL # 142010, Greenish residue on contact arm

Index.	Match	Compound name	Library
98	93.66	Automotive brake fluid, Nissan	TSL
10394	98.12	Poly(ethylene glycol methyl ether), avg.	Aldrich Condensed Phase
10395	87.49	Poly(ethylene glycol methyl ether), avg.	Aldrich Condensed Phase
10392	86.48	Poly(ethylene glycol), avg. m.w. 8,000	Aldrich Condensed Phase
9340	86.40	Brij 95: Polyoxyethylene(37) methyl ether	Aldrich Condensed Phase
9613	86.37	Brij 35: Polyoxyethylene(23) methyl ether	Aldrich Condensed Phase
10398	85.42	Poly(ethylene glycol), avg. m.w. 600	Aldrich Condensed Phase
10393	83.37	Poly(ethylene glycol methyl ether), avg.	Aldrich Condensed Phase
9996	83.36	2-(2-Ethoxyethoxy)ethanol, 99-%	Aldrich Condensed Phase
10396	84.70	Trityl/caproyl isopropenyl ether	Thermal Polymer and Additives

Both the cup and the switch cavity had large amounts of blackish deposit on them. The deposits on the contact arm are being analyzed in the Chem Lab by FT/IR spectroscopy. The deposits on the cup were mainly removed by gentle washing in isopropyl alcohol. Before and after optical photos were taken to document the effect of cleaning. We can't analyze grossly oily samples in the SEM since that would contaminate the equipment.
