**TEXAS INSTRUMENTS,  
INC.'S 9/10/03  
ATTACHMENT**

# Brake Pressure Switch Potential Thermal Event Theory Profile 3/24/99

## 77PS Ionic Rich Fluid Ingress Experiment

## **Ford Circuit Robustness to 77PS Ion Rich Fluid Ingress Experiment**

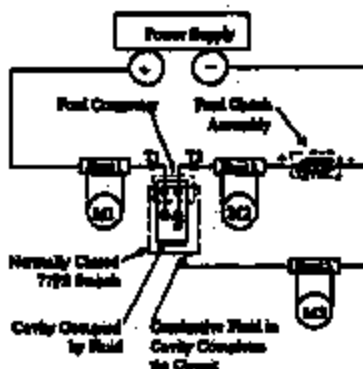
Figure 2.

Figure 2 below, shows a wiring schematic of the test setup.

Shunt 1 was connected between the power supply positive terminal and the pressure switch movable terminal through the Ford connector.

Shunt 2 was connected between the positive terminal of the Ford clutch assembly and the pressure switch stationary terminal via the Ford connector.

Shunt 3 was wired from the switch test block to the negative terminal of the power supply (also referred to as the Ground Voltage).

A Ford clutch assembly was connected in series with the pressure switch, represented as an inductive load in Figure 2, above.

Input current (= total current from power supply (M1 of Figure 2)).

Clutch current (= current through Ford Clutch Assembly (M3 of Figure 2)).

Hexport current (= current through fluid to grounded hexport (M2 of Figure 2)).

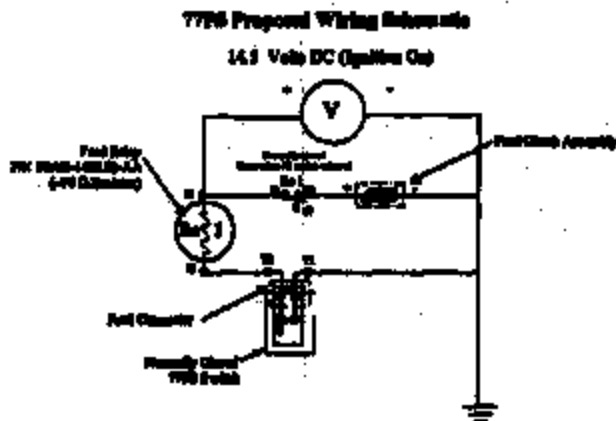
Figure 1

The proposed current limiting circuit design will replace the existing design used in specific Ford applications. Previous experiments have shown that electrolytic corrosion in 77Ps switches and high current draw in the existing circuit, are the principle factors leading to switch ignitions (see TI report PS/99/13). In previous experiments, 77PS switches were connected to the existing Ford circuit and subjected to ion rich fluid ingress. Electrolytic corrosion of components and the buildup of deposits bridged an electric path from hot switch terminals to the switch harness ground. Current to the harness ground slowly increased, causing a temperature rise in internal switch components which glowed red hot. Harness current exceeded 2 Amps (average), critical conditions were reached and ignition resulted. A schematic of the proposed current limiting circuit is shown in Figure 1, below.

- 1) Limit current at the switch to 200 mAmps.
- 2) Limit power at the switch to 0.75 Watts.
- 3) Minimize the possibility of electrolytic corrosion through:
  - A) Drastic reduction in time the switch is at a voltage potential above ground.
  - B) Reduction in switch surface area exposed to a voltage potential above ground.

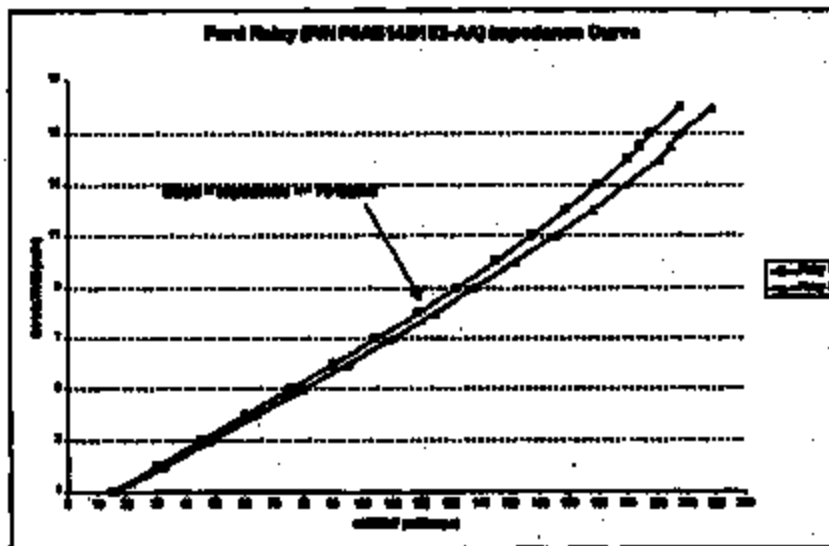
Figure 7.

In order to determine the maximum power possible in the proposed circuit, (2) Ford relays (P/N FCAB-14B192-AA) were characterized. The results are shown in Figure 7, below, which shows voltage versus current. The figure shows that the relay functions as a 70  $\Omega$  resistor over the operating range of interest.
