**TEXAS INSTRUMENTS,  
INC.'S 9/10/03  
ATTACHMENT**

**PROCESS FLOW DIAGRAM**  
**"CORROSION" POTENTIAL CAUSE FLOW ANALYSIS**

# Brake Pressure Switch Potential Thermal Event Theory Profile 3/24/99

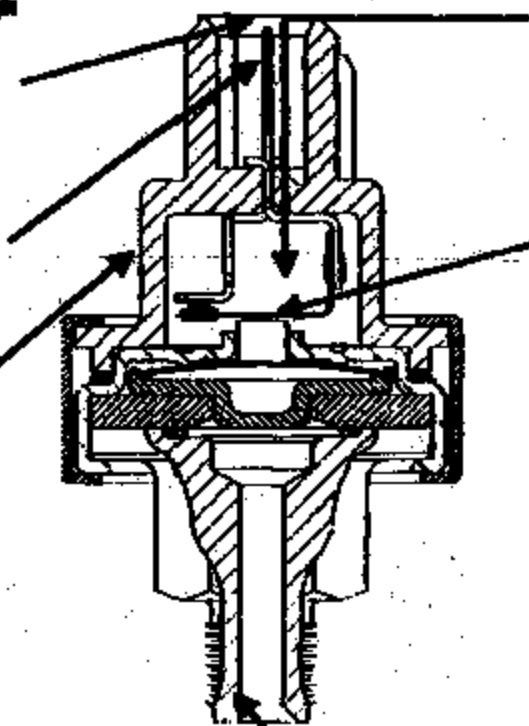
5. High current flow to case through water and ionic contamination

2. 12V Battery source to drive corrosion and provide energy

6. Plastic connector melts. Once it opens, oxygen enters the switch cavity. Arc terminal/corrosion becomes "RED HOT" igniting the plastic

1. Water and "ionic" contamination (e.g. NaCl or cleaner) enters the switch cavity

4. Contact arm & terminal corrosion increases resistance (acts like heater wire).

3. Hexport grounded accelerates corrosion

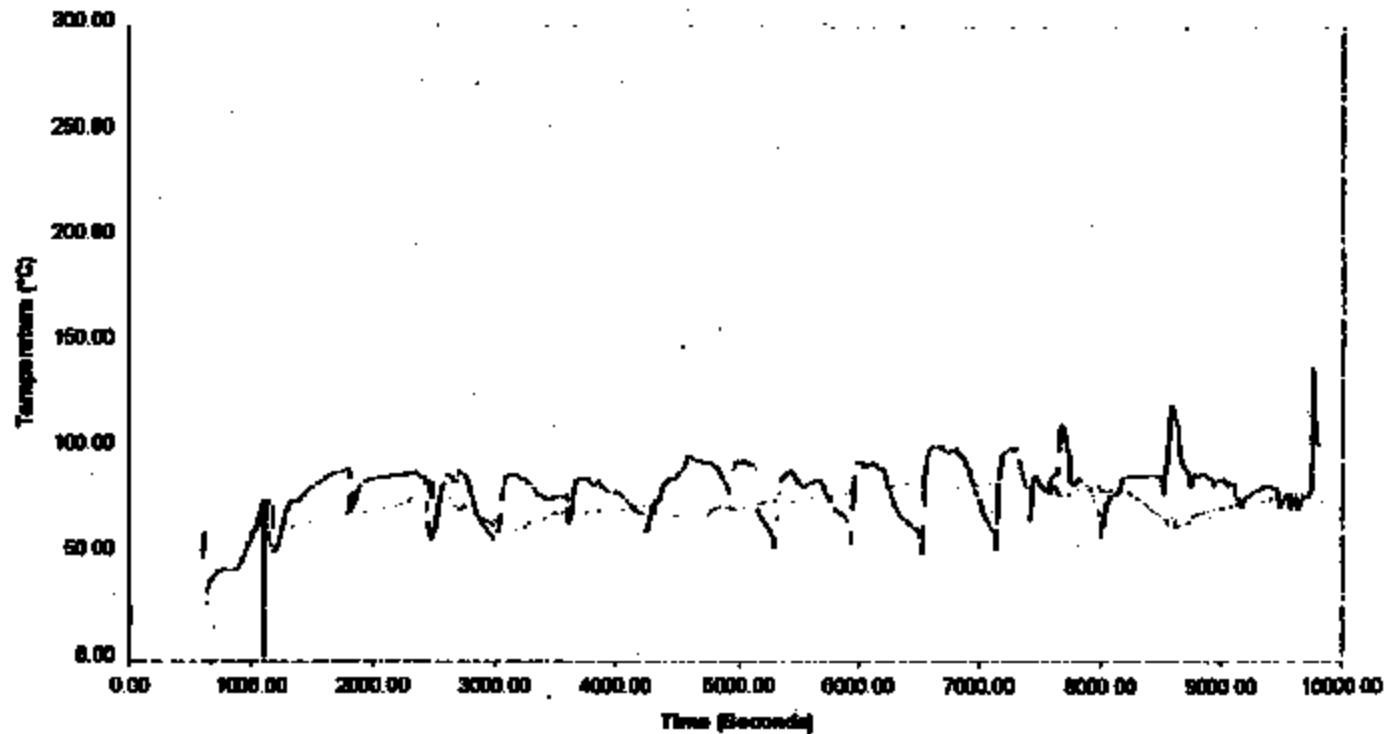
5% Salt Water Ingress Experiment  
Temperature vs. Time

— Top Temp    - - - Check Temp    | Bottom Temp |

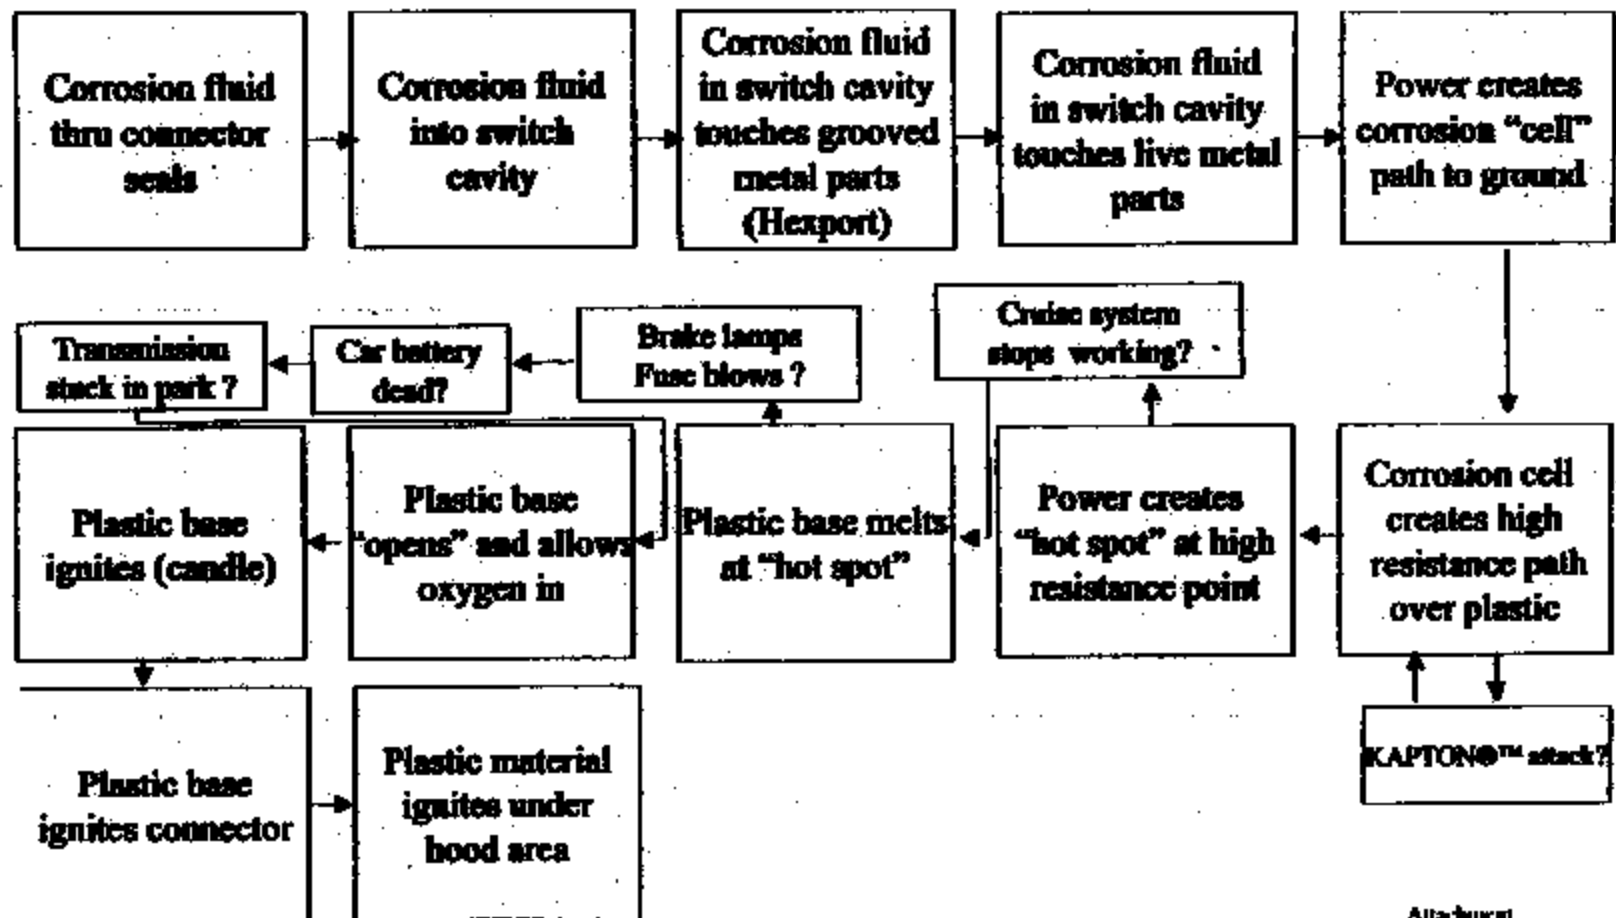
**PROCESS FLOW DIAGRAM  
"CORROSION" POTENTIAL CAUSE FLOW ANALYSIS**

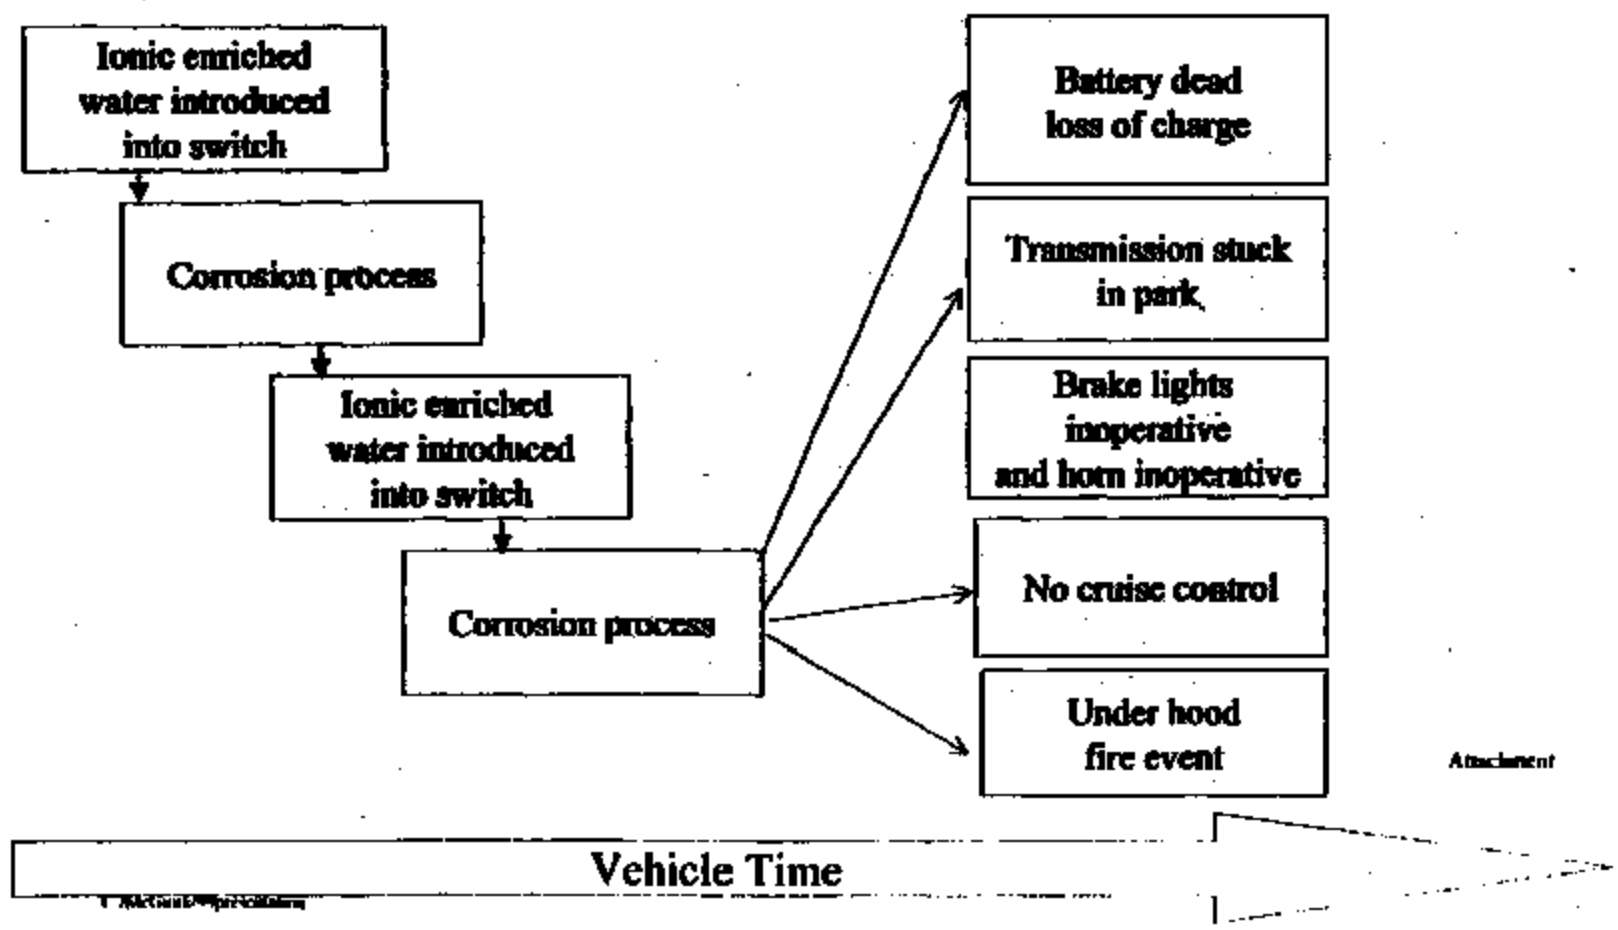
**“Corrosion” potential cause time line**  
**Theory Time Line**

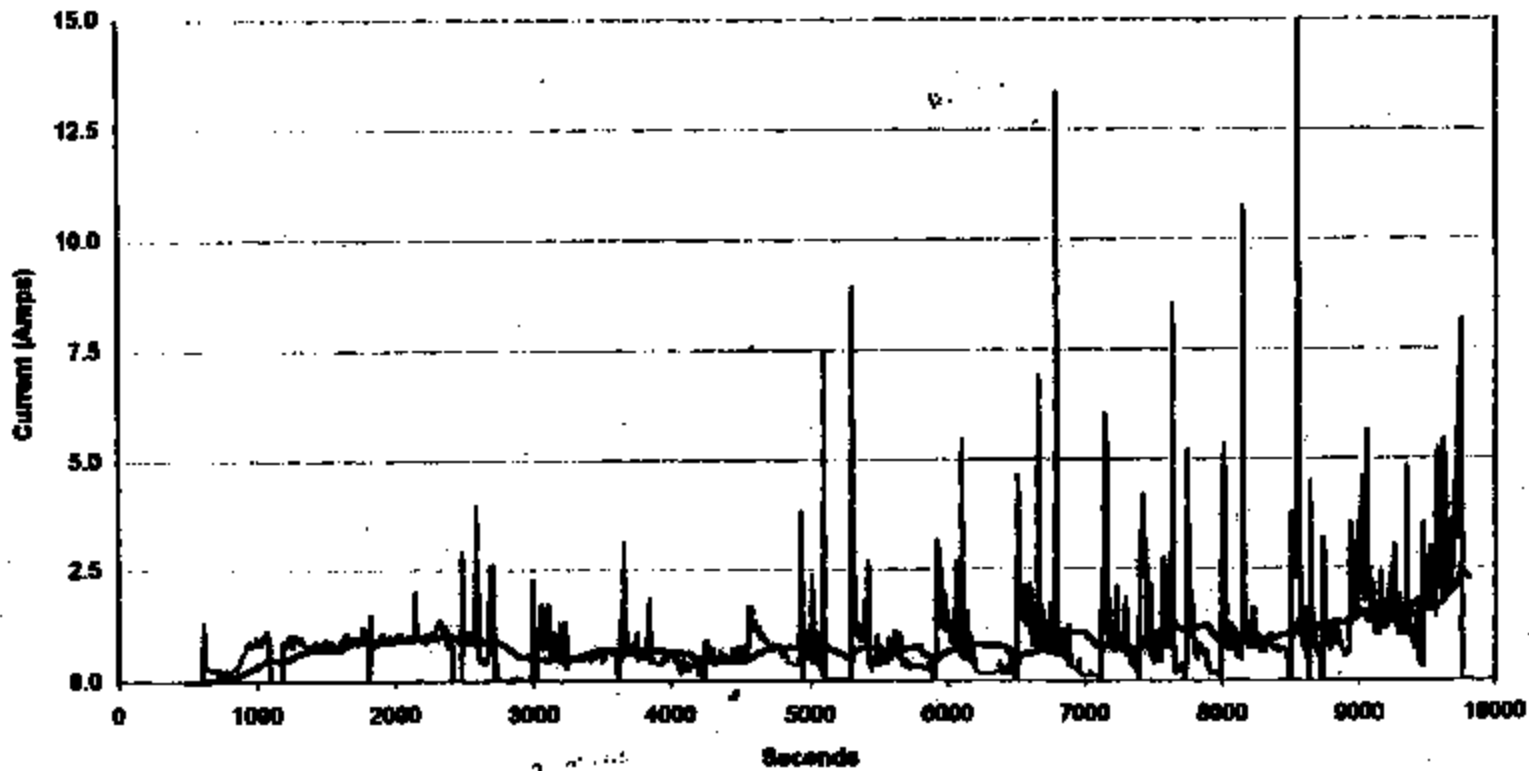
**Hexport Current vs. Time  
Field Ingress Experiment**

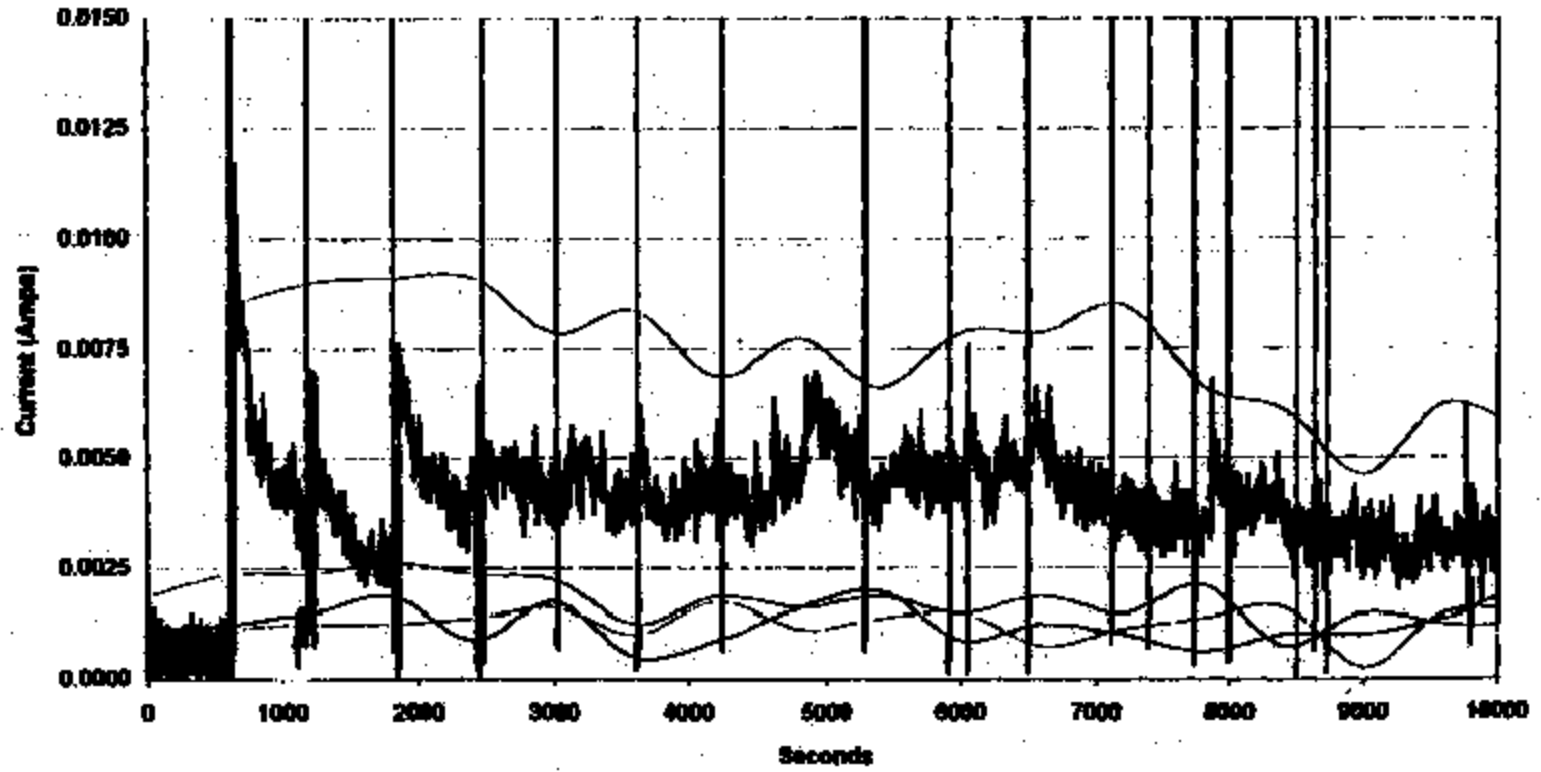
### Hezport Current vs. Time Fluid Ingress Experiment

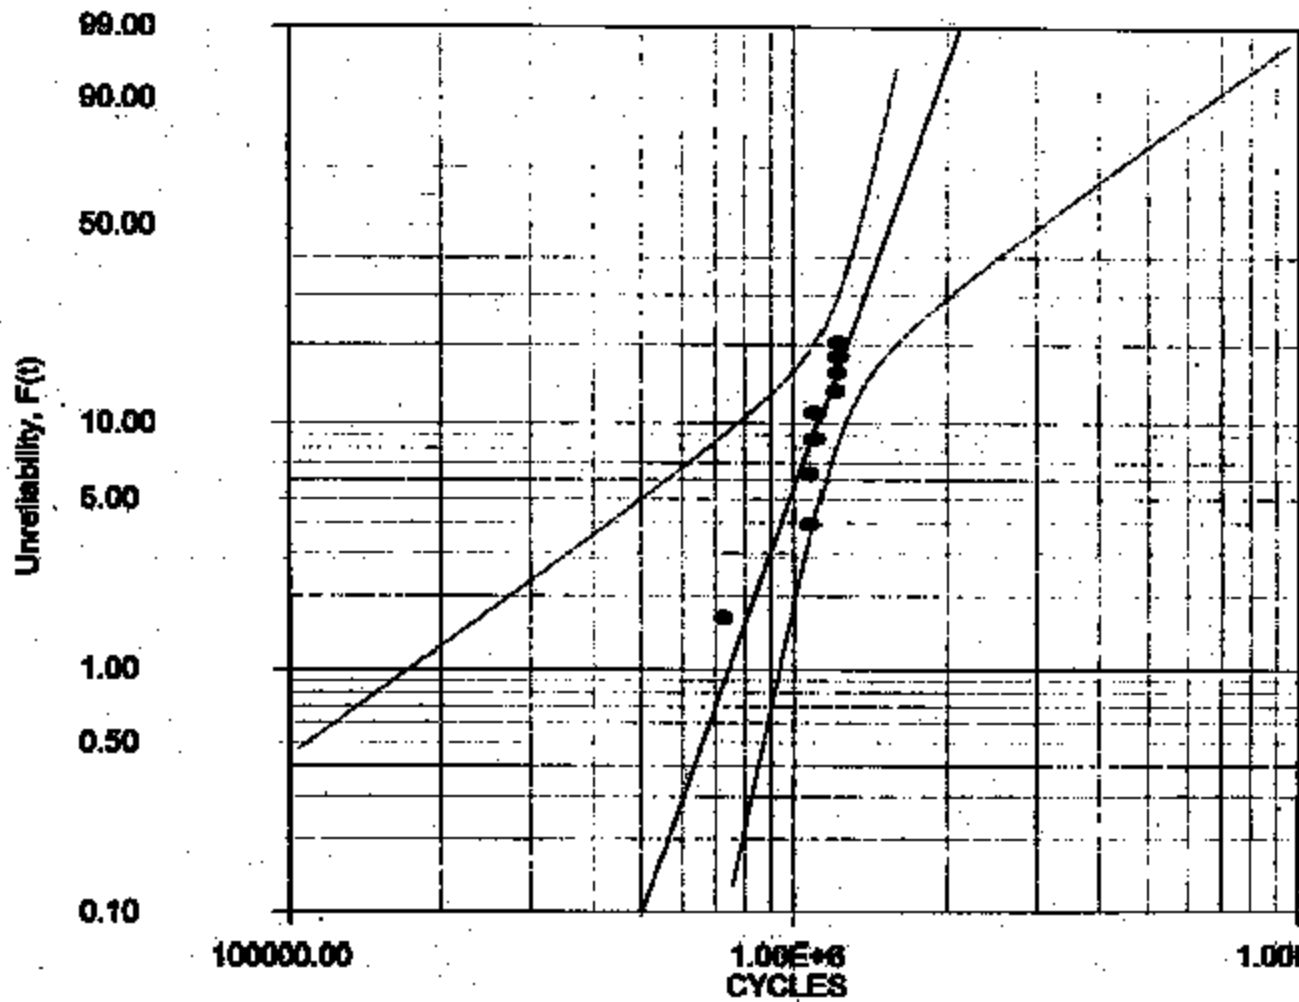
77PSL2-1 COMBINED TEST

**Weibull**  
**Data 1**  
 P=2, A=RRX-S  
 F=9 | S=33  
 CB/FM: 95.00%  
 2 Sided-B  
 C-Type 2

$\beta=5.83, \eta=1.64E+6, \rho=0.91$

I did a Weibull analysis on (4) separate sets of 2-1 data. (Note there were no failures on DOE test)

- Page 5: Test set 1; 95% Confidence = 99.9% Reliability with a lower confidence limit at 95%
- Page 6: Test set 2; 99% Confidence = 100% Reliability with a lower confidence limit at 99.9%
- Page 7: Test set 4; 95% Confidence = 100% Reliability with a lower confidence limit at 99.9%

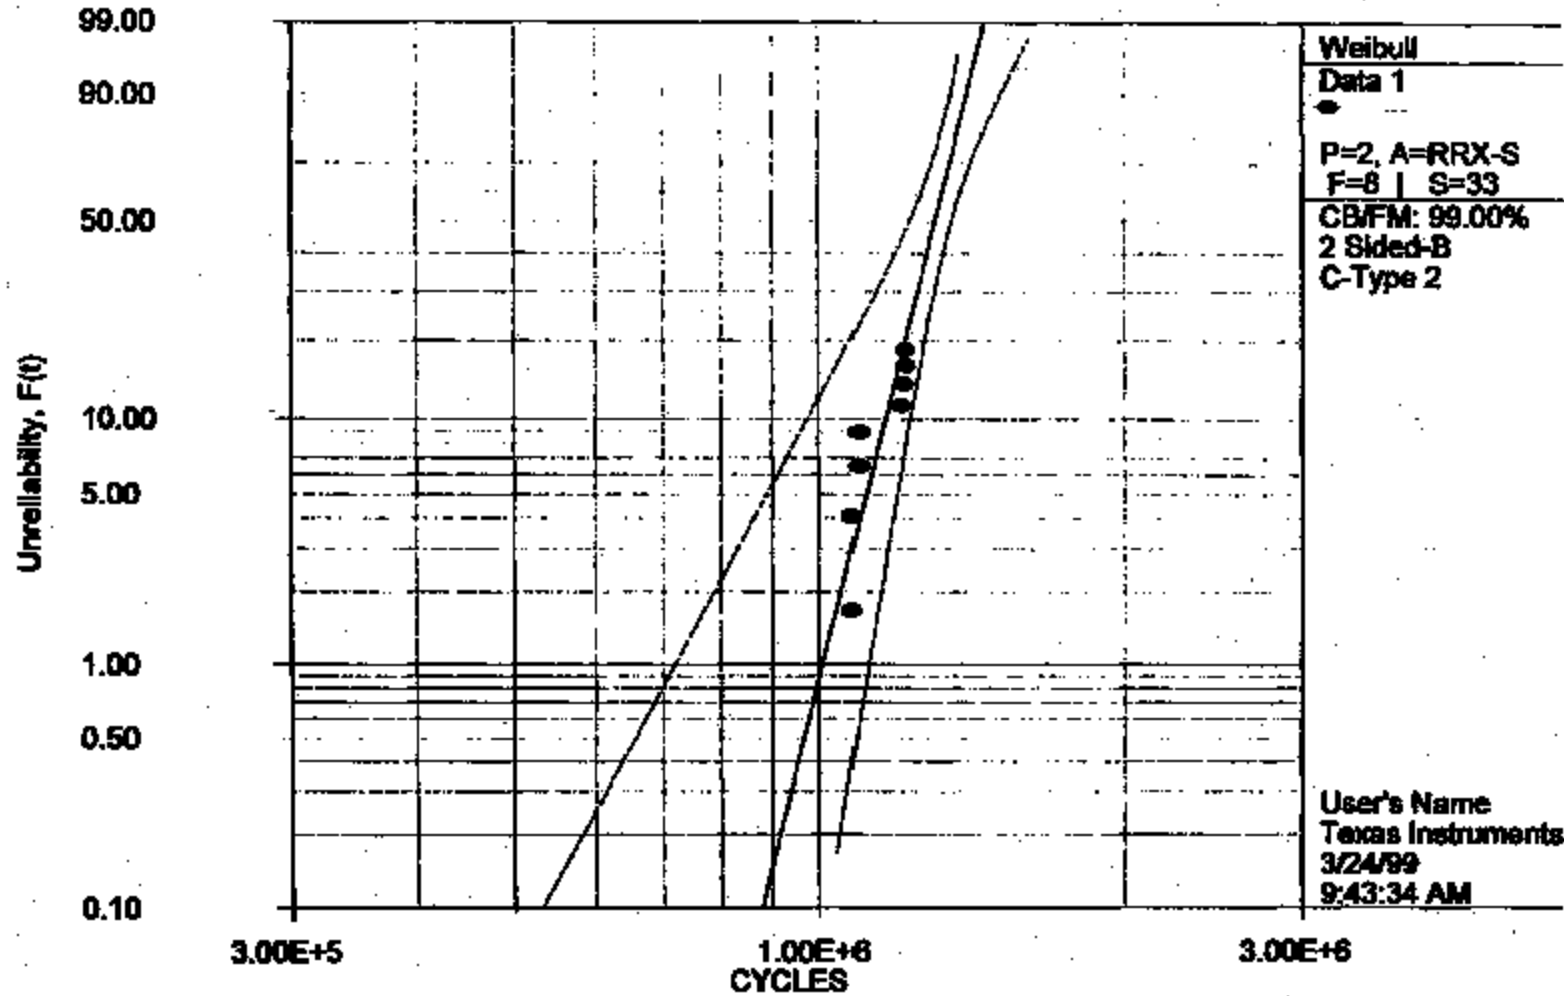
77PSL2-1 COMBINED TEST

$\beta=16.80, \eta=1.33E+6, \rho=0.86$

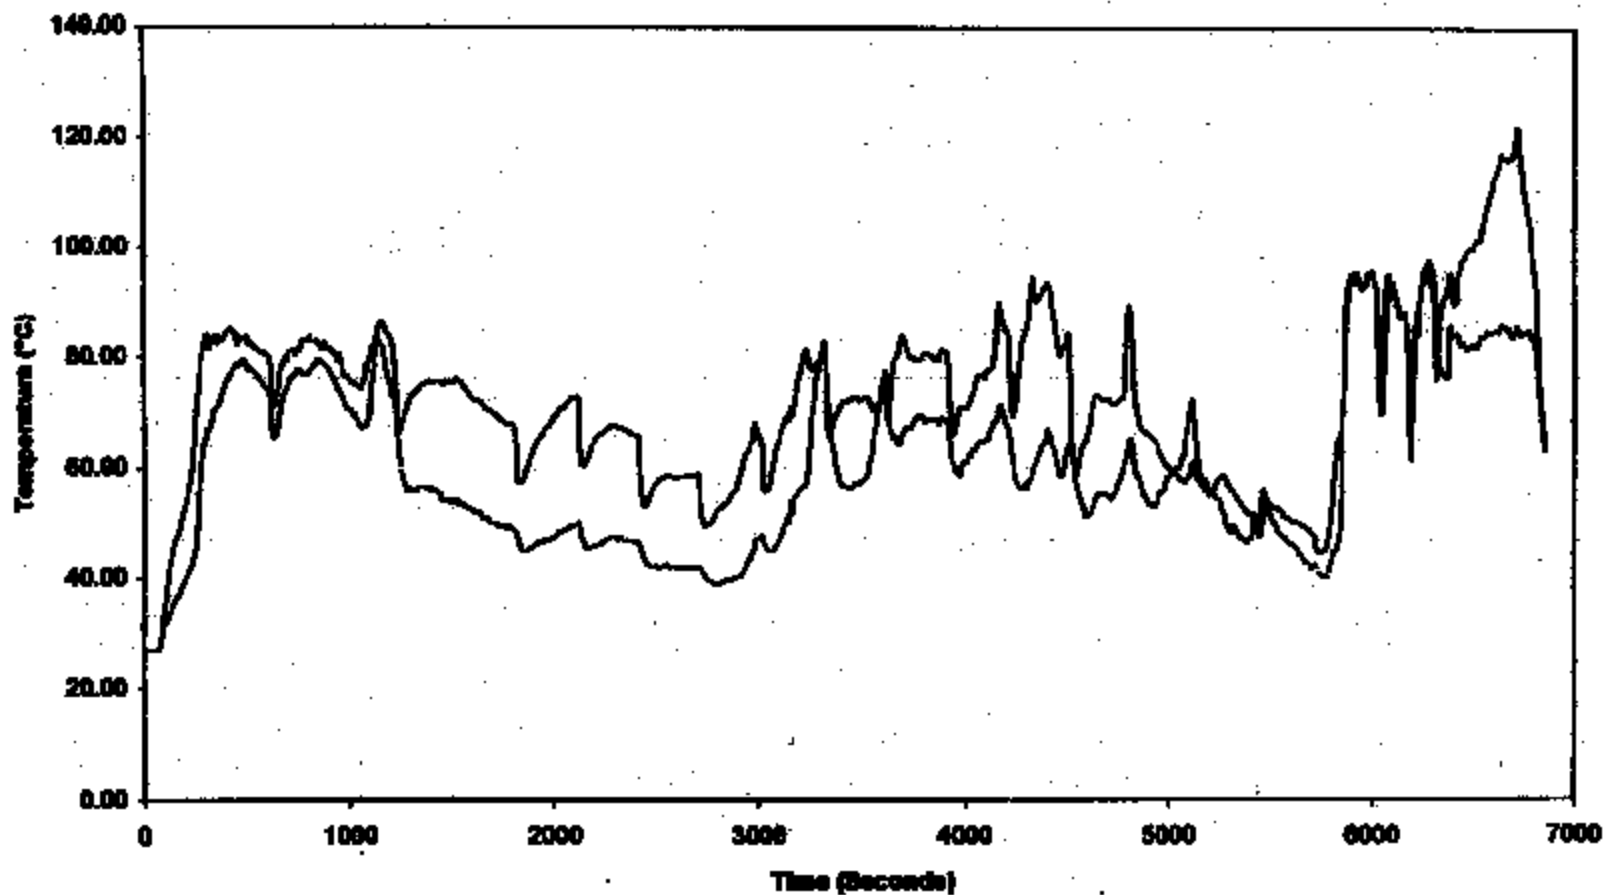
FR base\_2 5% Salt Water Ingress Experiment  
Temperature vs. Time

— Top Temp — Bottom Temp — Catch Temp

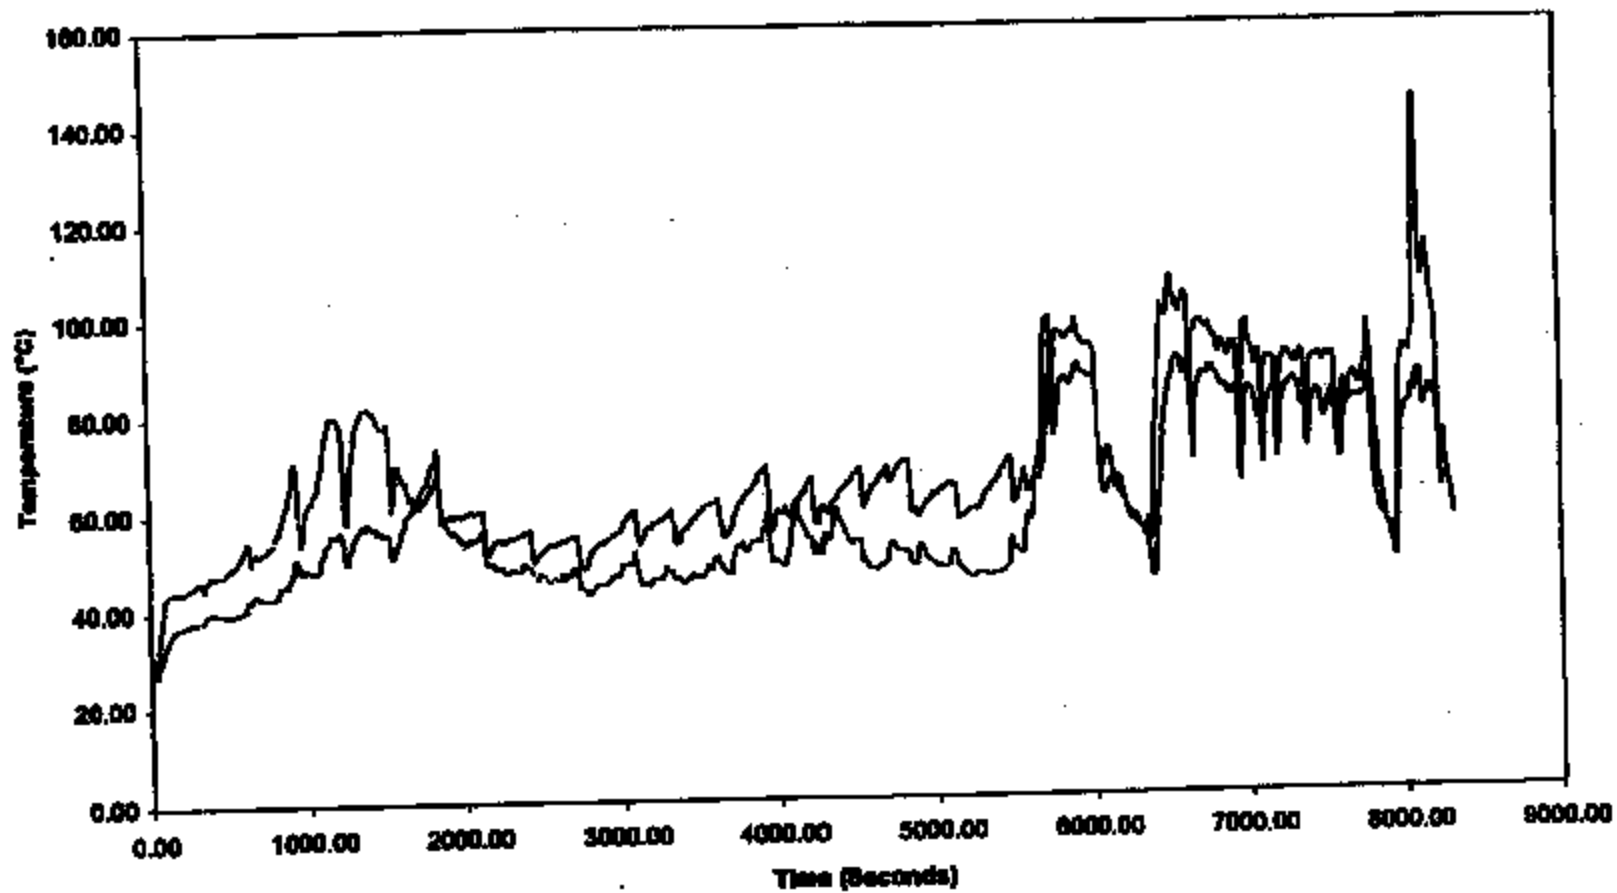
FR base 5% Salt Water Ingress Experiment  
Temperature vs. Time

— Top Temp — Bottom Temp — Clutch Temp

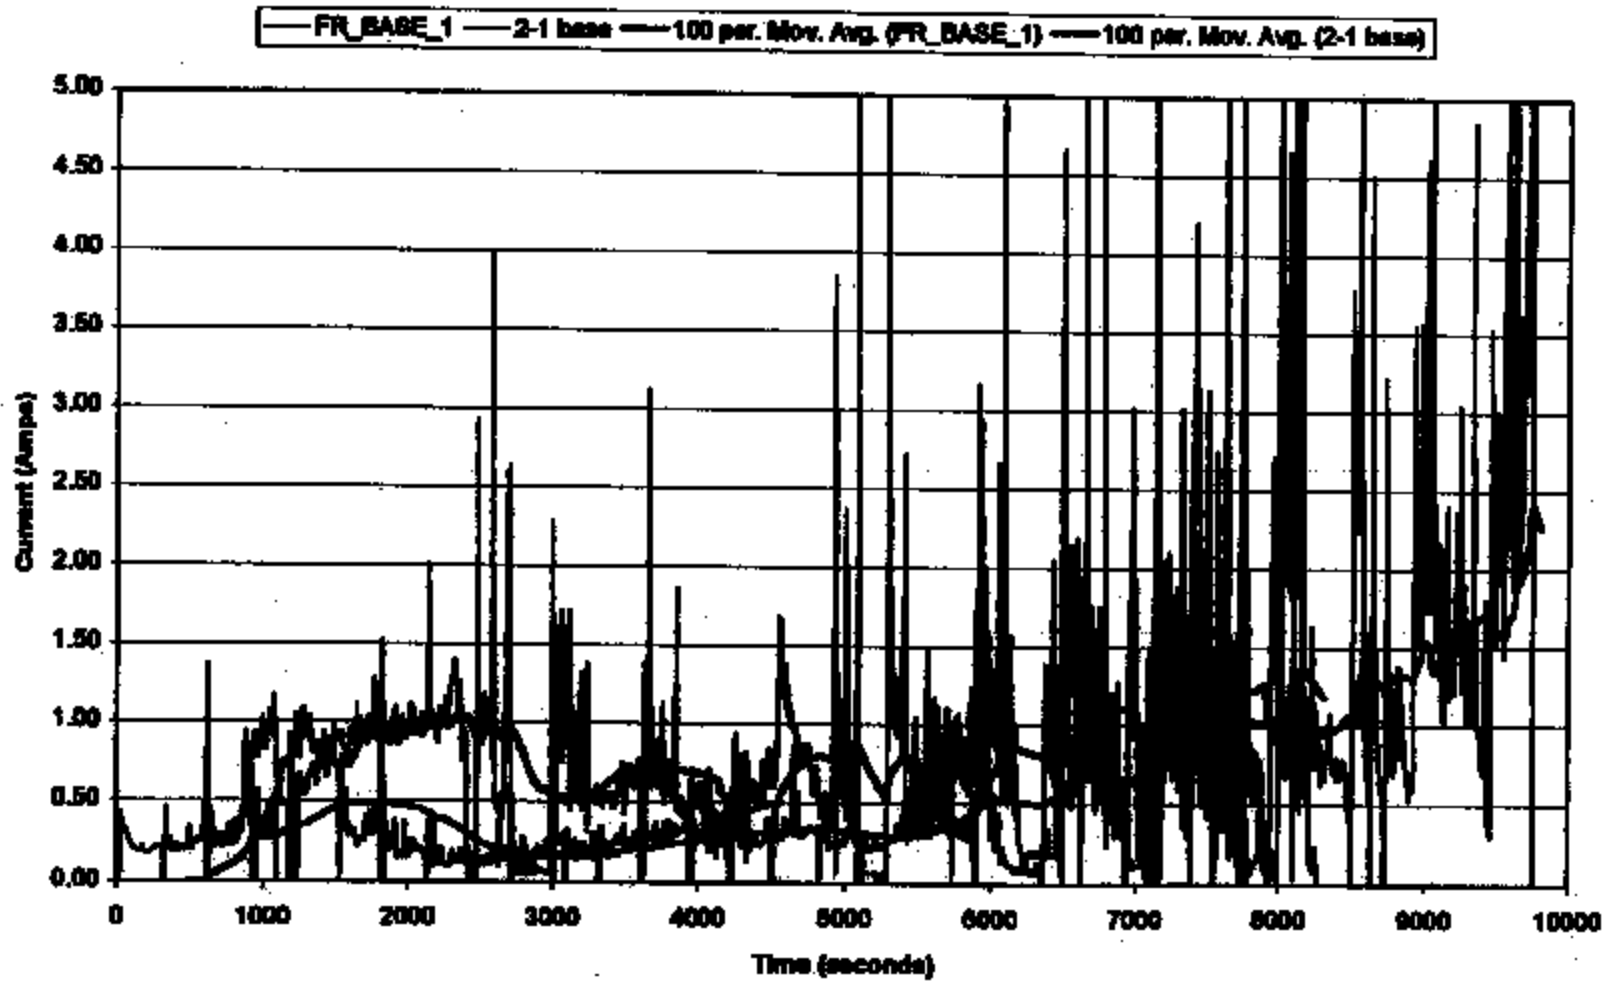
5% SALT WATER INGRESS EXPERIMENT  
EXPORT CURRENT vs. Time

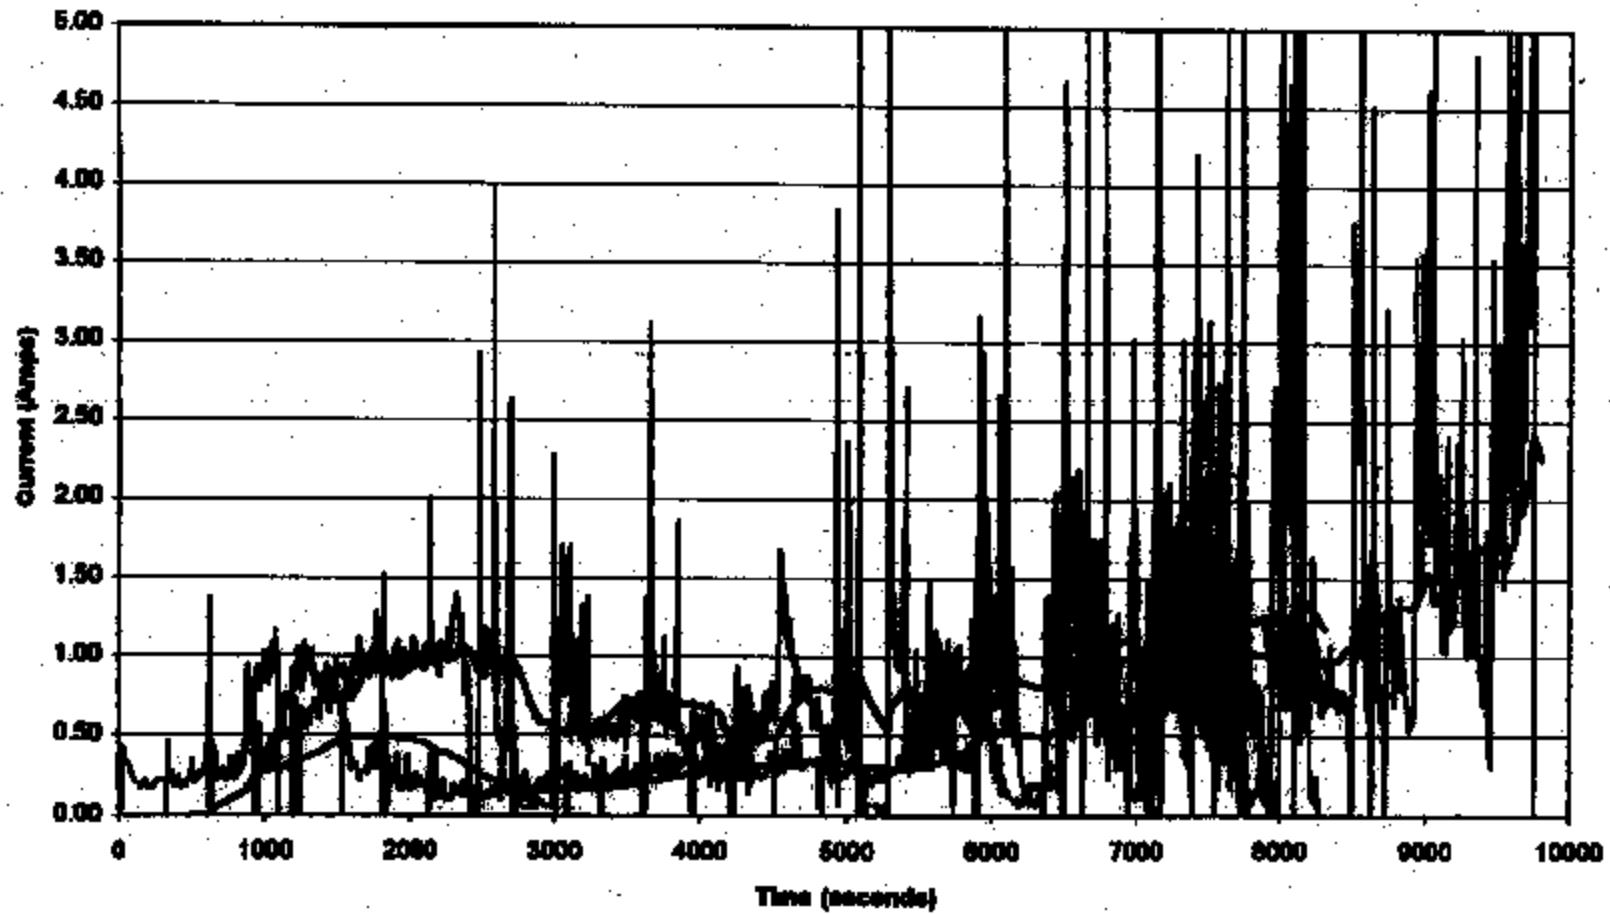
5% SALT WATER INGRESS EXPERIMENT  
EXPORT CURRENT vs. Time

FR\_BASE\_1 2-1 base 100 per. Mov. Avg. (FR\_BASE\_1) 100 per. Mov. Avg. (2-1 base)

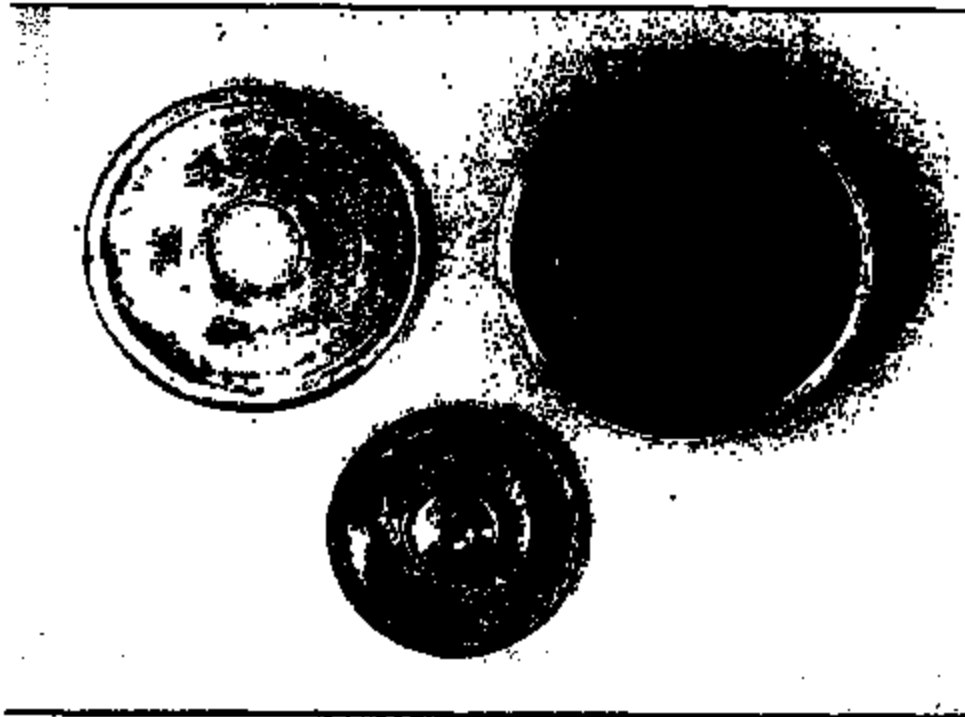
Figure 20: FX163920, cup, washer, converter, disc.

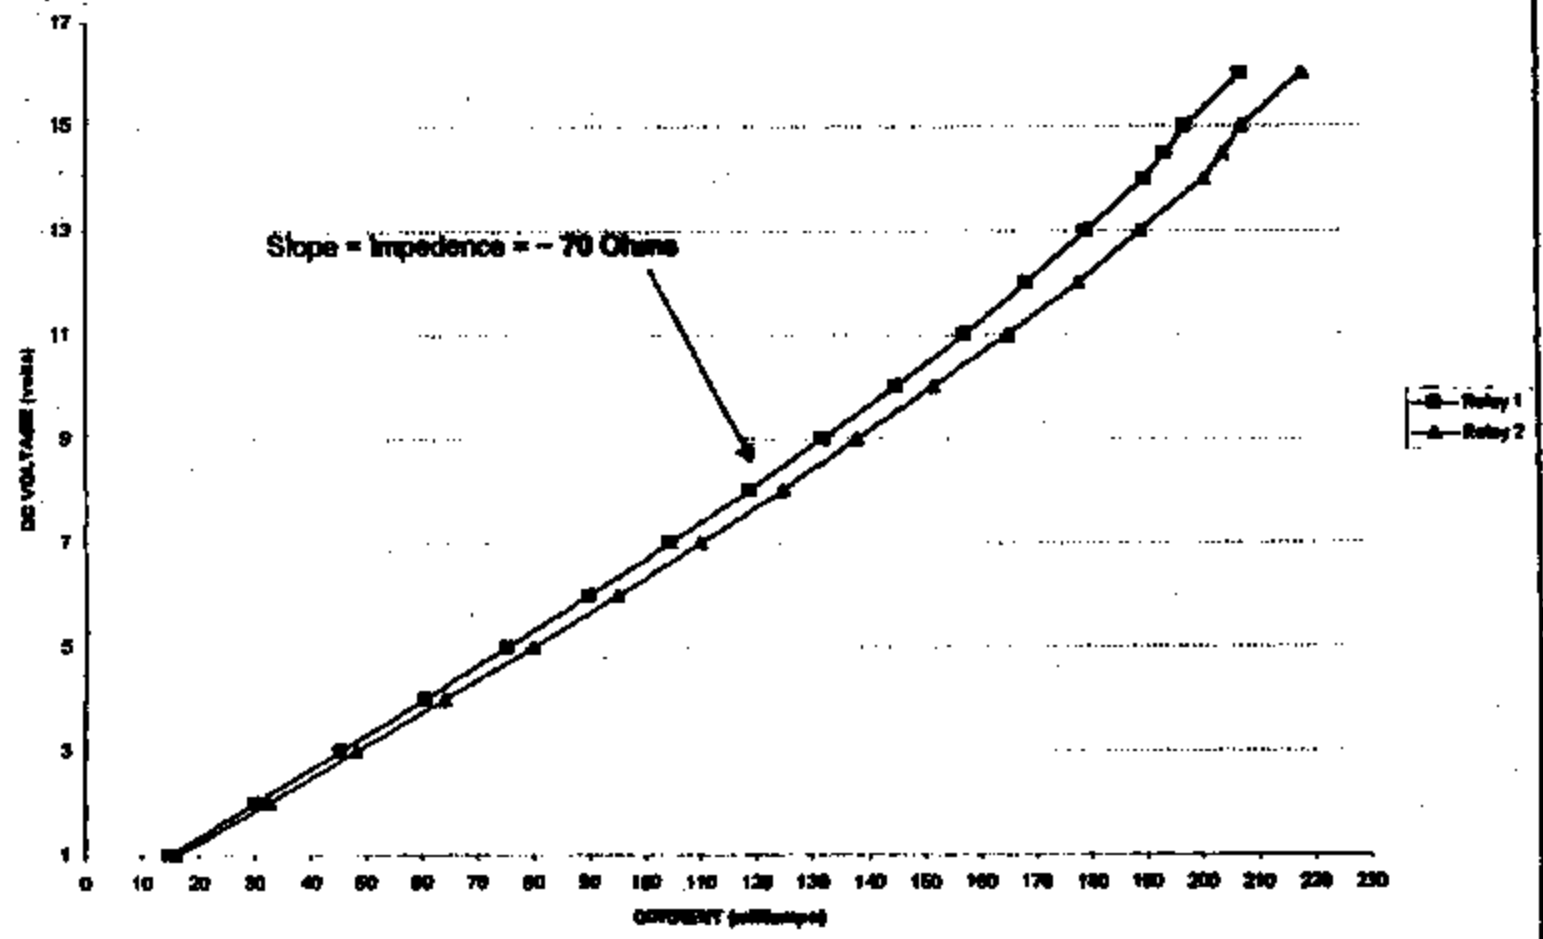
### Ford Relay (P/N F0AB14B192-AA) Impedance Curve

<u>Voltage (V)</u>	<u>Current</u>
1.0	14.86 mA
2.0	29.98 mA
3.0	45.20 mA
4.0	60.40 mA
5.0	75.30 mA
6.0	90.20 mA
7.0	104.8 mA
8.0	118.90 mA
9.0	132.10 mA
10.0	145.0 mA
11.0	157.4 mA
12.0	168.70 mA
13.0	179.40 mA
14.0	190.0 mA
14.5	194.0 mA
15.0	197.6 mA
16.0	207.5 mA
