**TEXAS INSTRUMENTS,
INC.'S 9/10/03
ATTACHMENT**

Thermal Cycle Fluid Ingress Test

8D Report

Concern Title: 77 PS Thermal Events		Open Date: 3/9/99	
T.I. CAR Report Number: CAR 99-26		Updated: 3/15/99 <i>4/14/99</i>	
Status Date:	Vehicle: Lincoln	Part Name:	Electric Speed Control Deactivation Pressure Sw
	Model: Town Car	Part No:	77PS 12-1
	Plant: Various

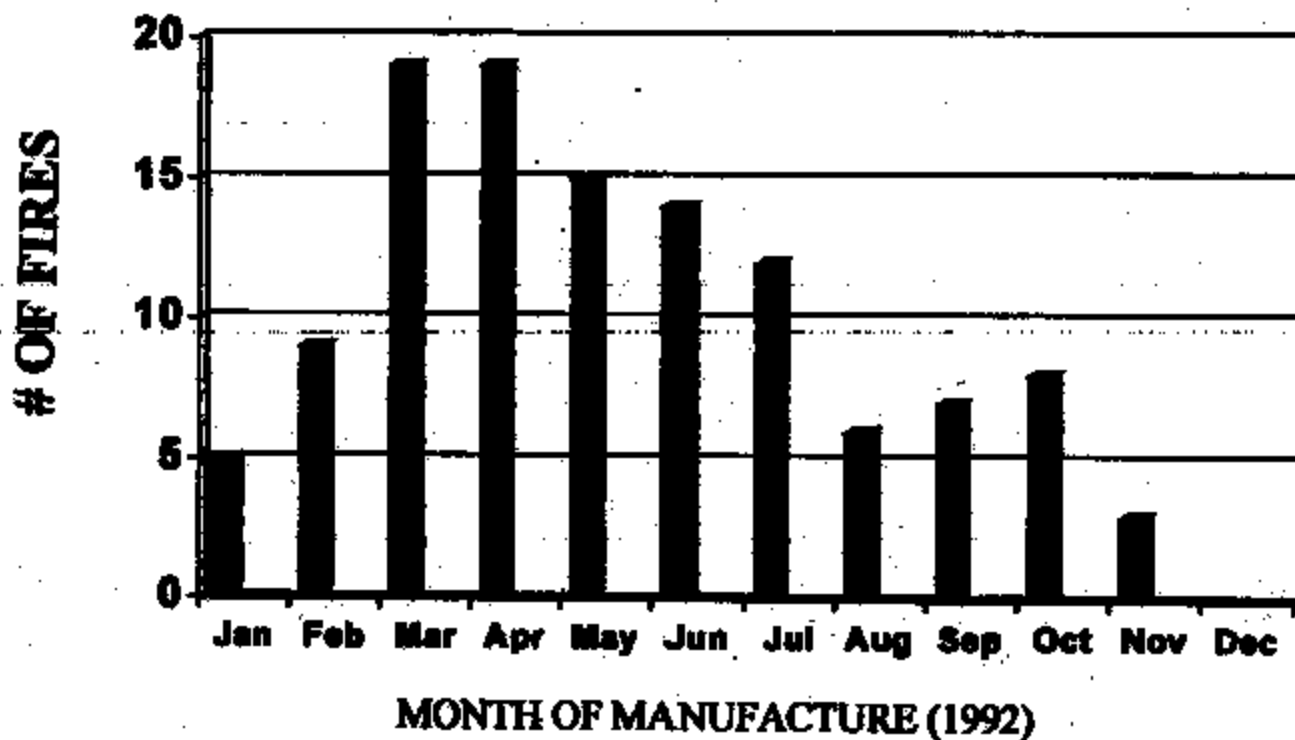
FORD TOWN CAR ISSUES

NOTES: Ford data as of 4/14/99

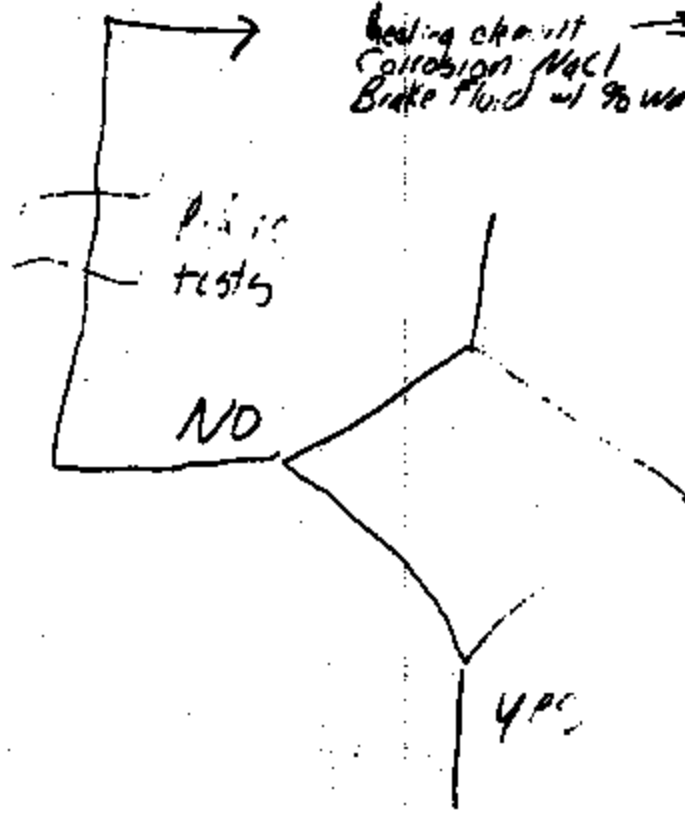
Objective → Can we recreate the Ignition

feeding circuit → short to ground
Corrosion NaCl
Brake fluid w/ 90 water

22-141 24 MONTHS
22-142 180 MONTHS
22-144 360 MONTHS
22-141 24 MONTHS
22-142 180 MONTHS
22-144 360 MONTHS
