EA02-025

LETTER TO ODI

On October 9, 2001 Ward & Whitmore Universal Fire Consultants, Inc. was retained by Liberty Mutual Insurance Company for the purpose of conducting an investigation to determine the origin and cause of a fire, which damaged a residential structure owned by [REDACTED] located at [REDACTED] in Spring, Texas. On October 10, 2001, I conducted my investigation of this loss. This report will provide you with a synopsis of that investigation.

INVESTIGATION PHOTOGRAPHS

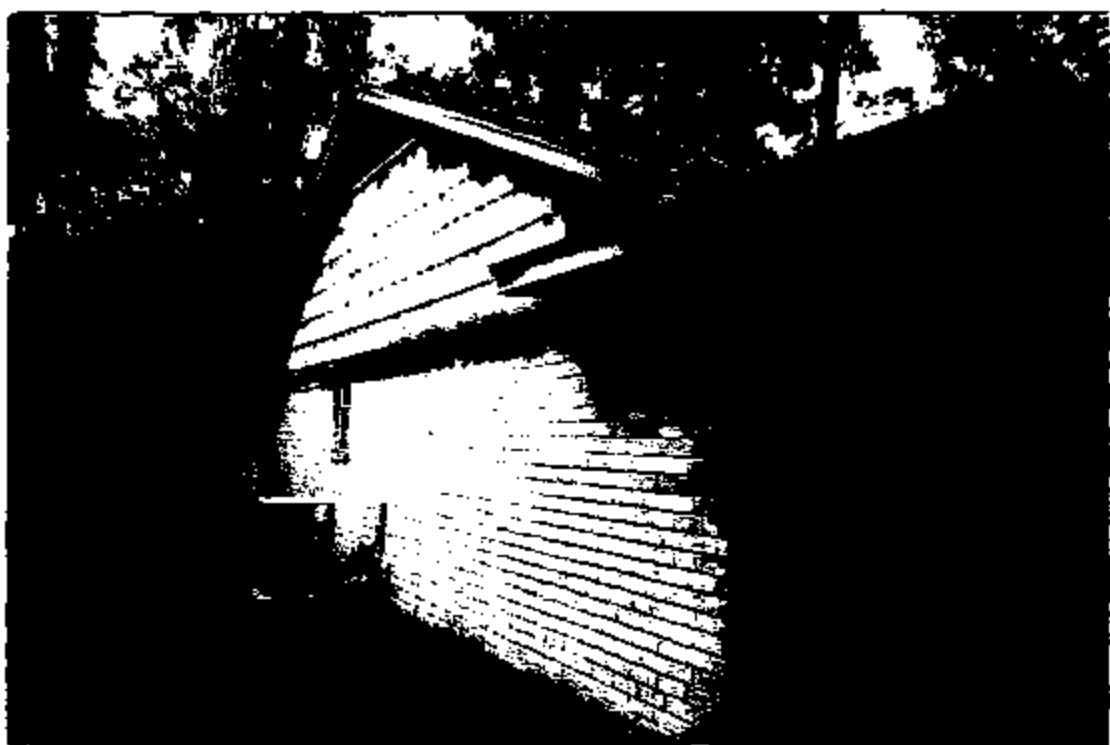
This series of photographs depict external views of the [REDACTED] residence located in Spring, Texas. Photograph #6 documents the vehicle and items removed from the garage by fire personnel.

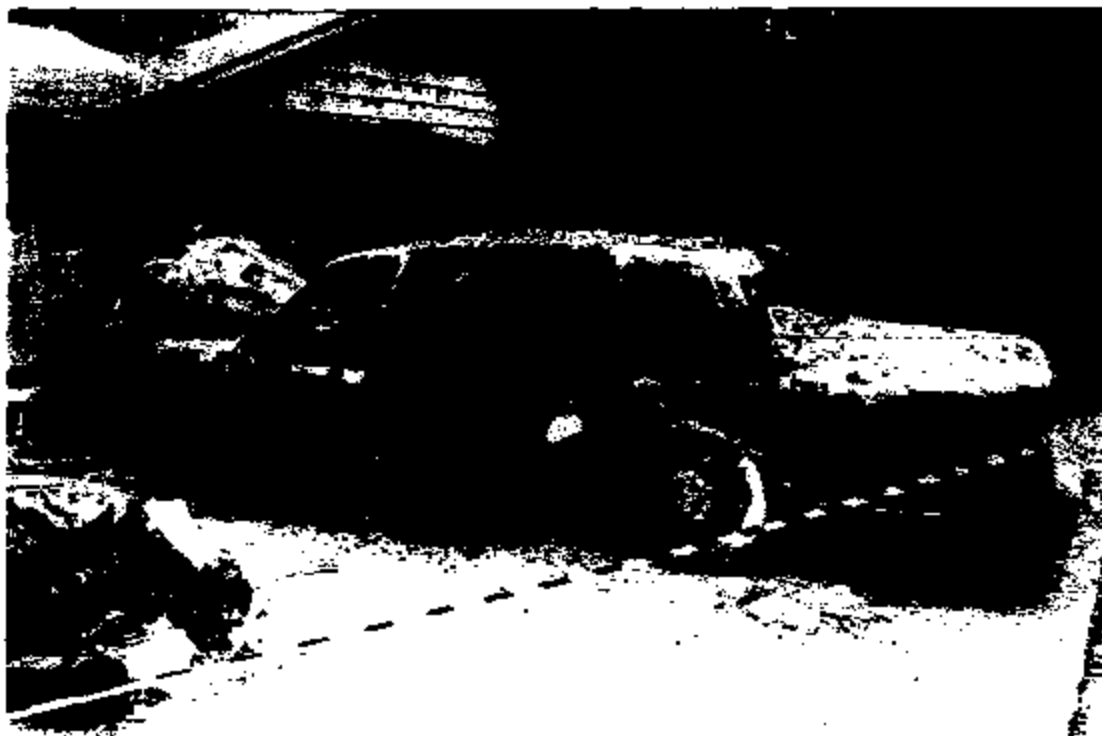
26-30

This series of photographs depict exterior views of the 1994 Lincoln Town car which was parked inside the garage. The vehicle exhibits extensive damage with the greatest amount of damage located in the engine compartment.

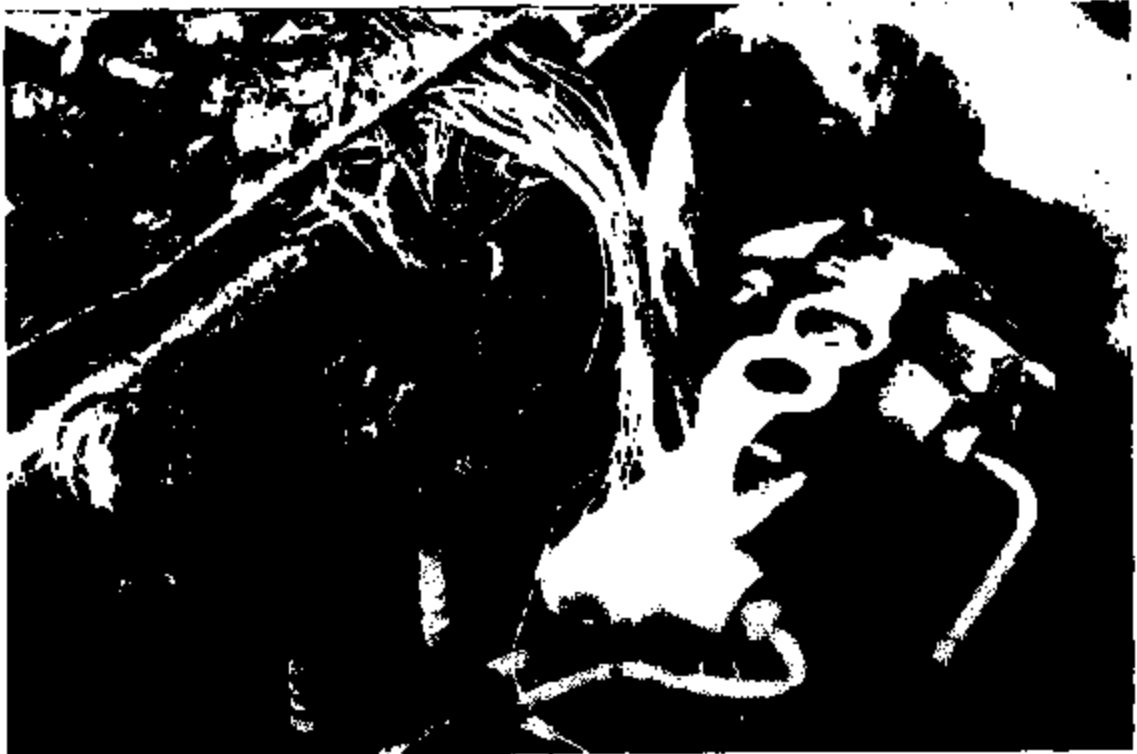
54-59

This series of photographs depict detailed views of the driver's side engine compartment. Note the deterioration of the fiberglass valve cover. This damage indicates fire exposure from below, the area where the fire originated.
