**EA02-025**

**APPENDIX M**

At your request, I traveled to the Michigan Auto Salvage Pool in Taylor, Michigan, on December 22, 1994 to examine a 1994 Mercury Grand Marquis belonging to [REDACTED]. This vehicle had been involved in a fire loss on February 3, 1994. It was requested that I attempt to determine the origin and cause of this loss.

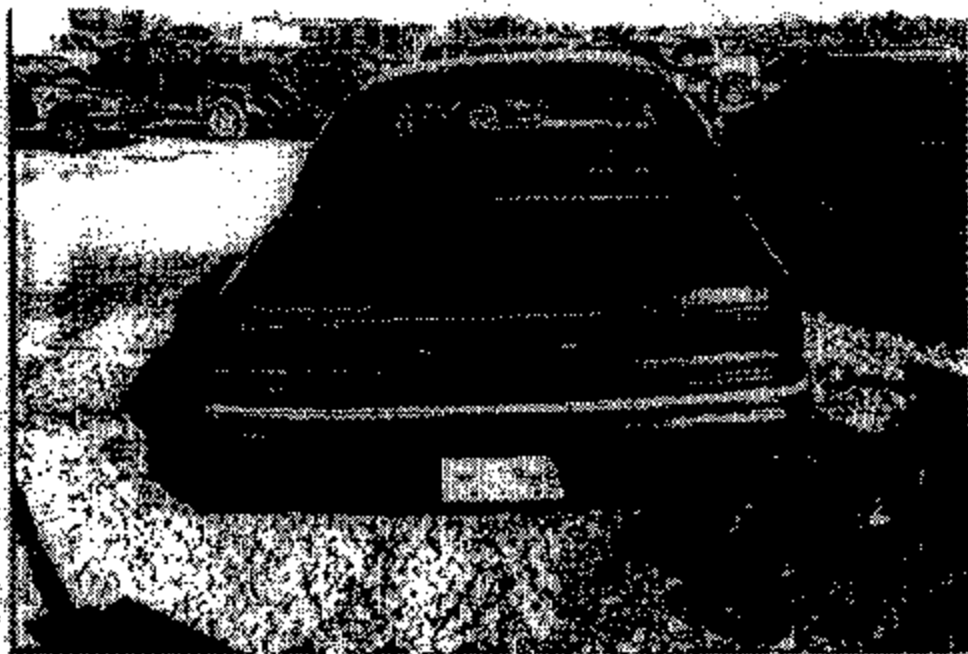
Figure 1  
Left side of vehicle

The vehicle was a 1994 Mercury Grand Marquis. It was identified as VIN 2MEHM75W5RX631976. An initial examination of the vehicle found fire damage to the front grille and bumper area of the vehicle, as shown in Figures 1 through 4. All four (4) tires were present and fully intact. No fire damage was observed in the passenger compartment, as shown in Figure 5. An examination of the vehicle's odometer showed 344 miles at the time of my examination (see Figure 6).

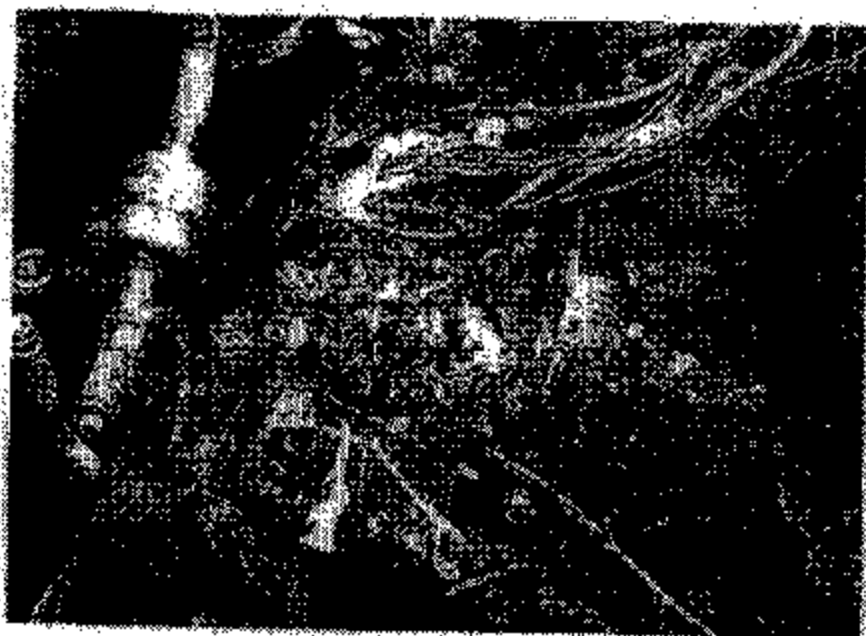
15. A view of the right front valve cover being heavily damaged by the fire, burning a hole through it.

At this time, Operative observed that the high current fuse box/power distribution box was heavily damaged as a result of the fire, that the plastic inner fender well on the right fender had been consumed during the fire, and that the right turn signal lens had also been consumed. Operative further noted that the air conditioning lines had melted during the course of the fire and that the valve cover on the right side of the engine had also suffered heavy fire damage, resulting in a hole burning through the front portion of the valve cover.

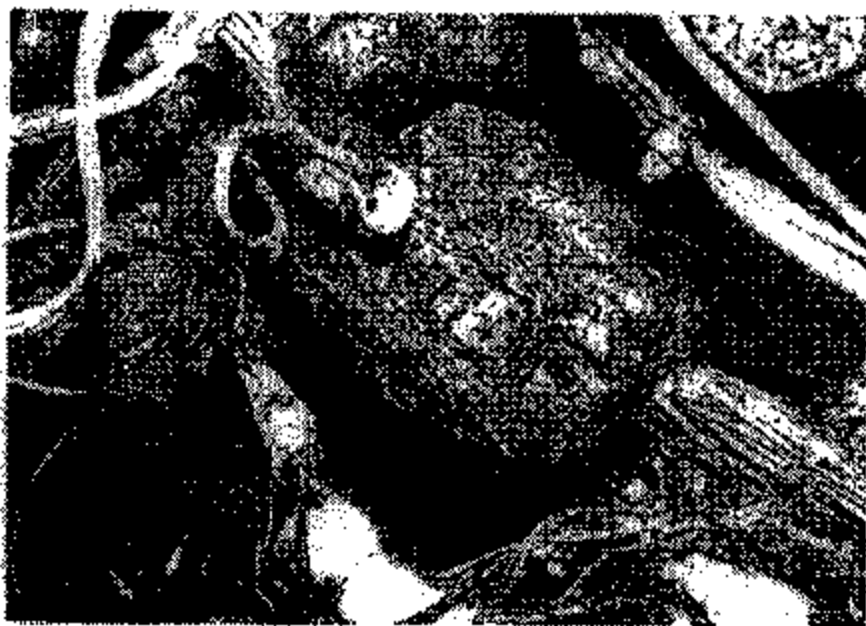
19. Another view of the high current fuse box power distribution box.

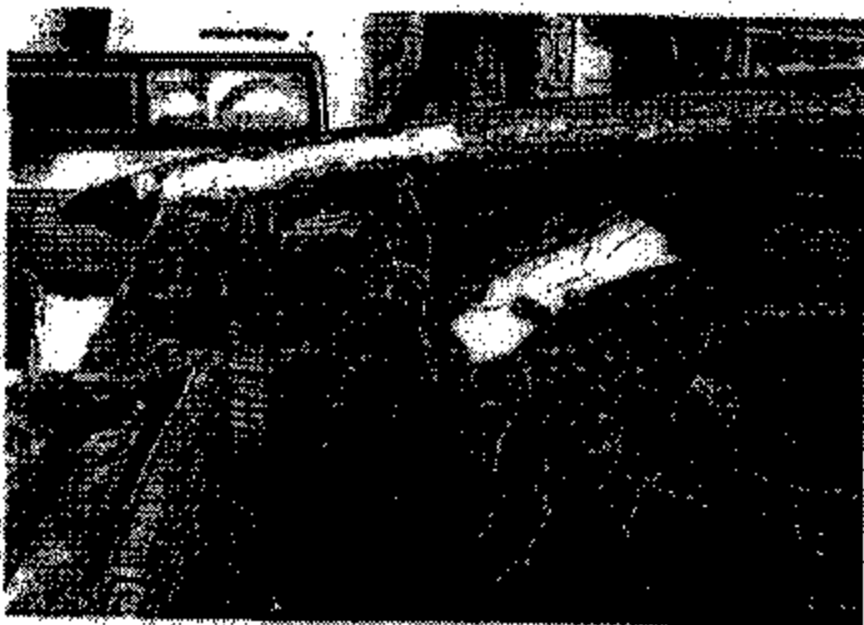
20. A view of the wiring harness running from the alternator to the high current fuse box/power distribution box.

Additionally, Operative observed that the insulation of all of the wiring that connected to the high current fuse box/power distribution box was consumed during the course of the fire. Operative also observed that there was a length of wire which connected to the positive battery cable and then was connected to the high current fuse box/power distribution box with a studded type terminal block. Operative further observed that there was a second length of wire connected to this terminal block that led to the alternator.

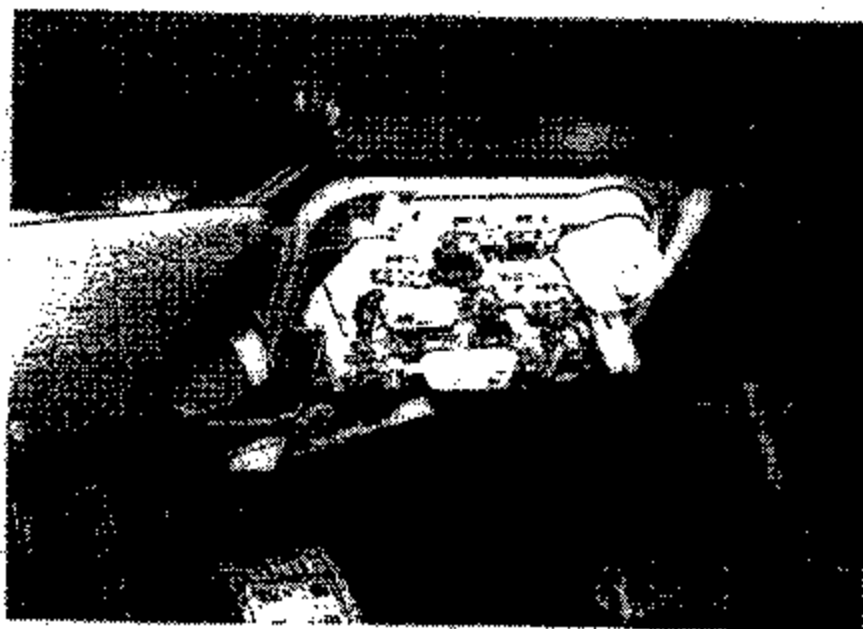
29. A view of the instrument panel fuse panel cover removed and a fuse puller attached to the number nine fuse.

Operative then gained entry to the passenger compartment and performed an inspection of the instrument panel fuse panel. Operative found that one of the fuses in the panel was blown. This fuse was located in the number nine slot of the fuse panel. This was a blue 15 amp fuse. The fuse description was "autolamps (park), instrument panel illumination, keyless entry module, license plate lamp, parking lamps, tail lamps."
