EA02-025

RE: Our Claim #: 38-J962-070
Our Insured: [REDACTED]
Date of Loss: June 18, 2002
Year, Make, and Model of Product: 1994 Mercury Grand Marquis
VIN: 2MELM75WXRX807088

*Forensic Mechanical Evaluation
Origin and Cause of Vehicle Fires*

The purpose of this examination was to determine the origin and cause of the vehicle fire, which occurred on June 18, 2002.

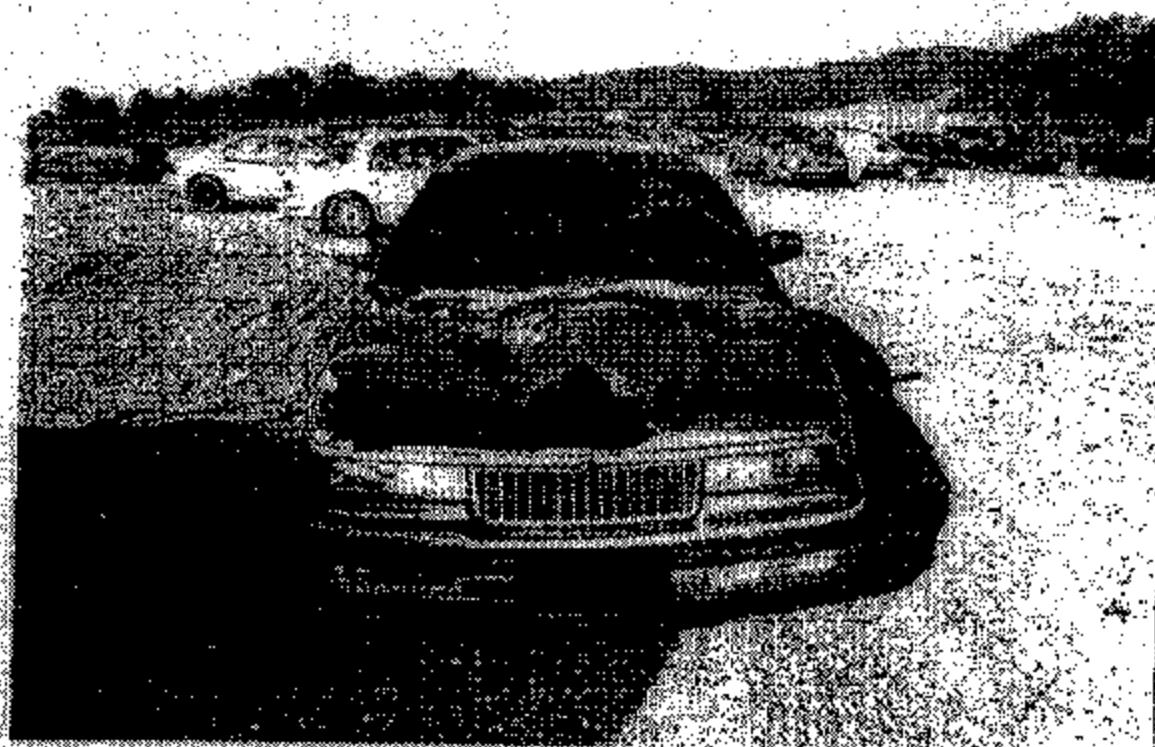
Photograph I

This photograph is of the front of the subject vehicle. Extensive and concentrated fire damage is apparent at the passenger side, rear of the engine compartment.

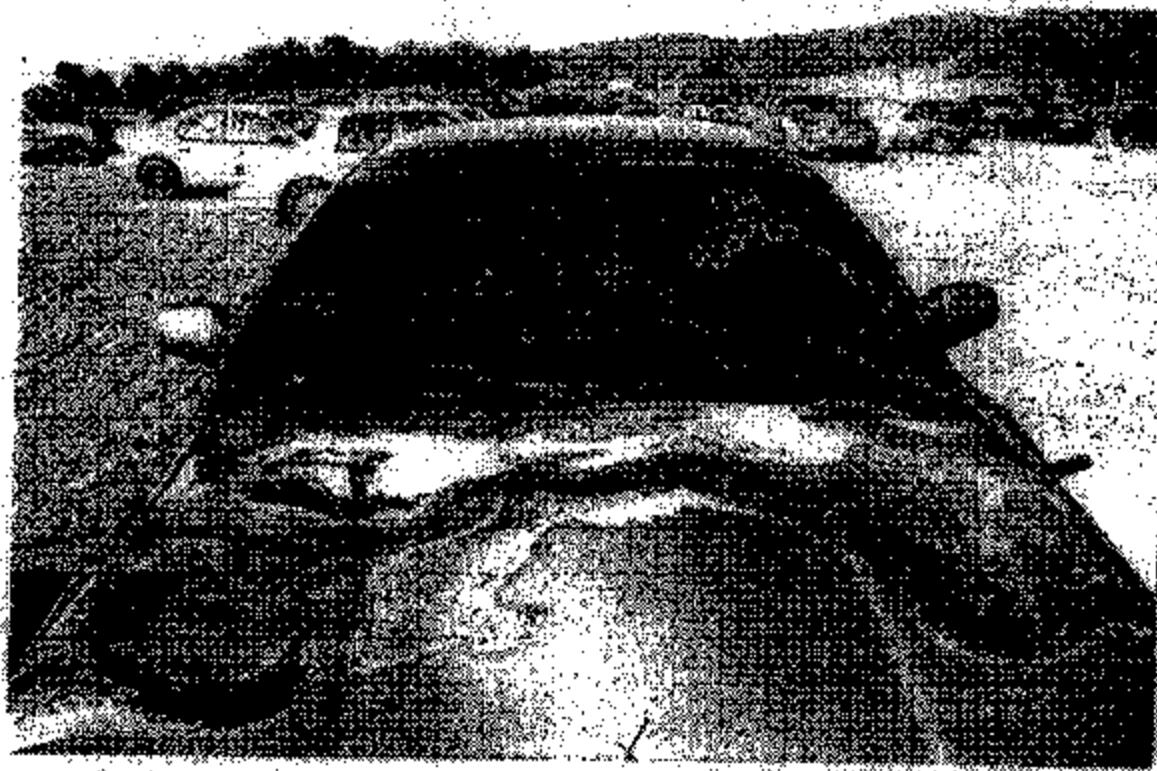
Photograph 2

This photograph is of the rear of the engine hood where extensive melting of the aluminum composition hood has occurred.

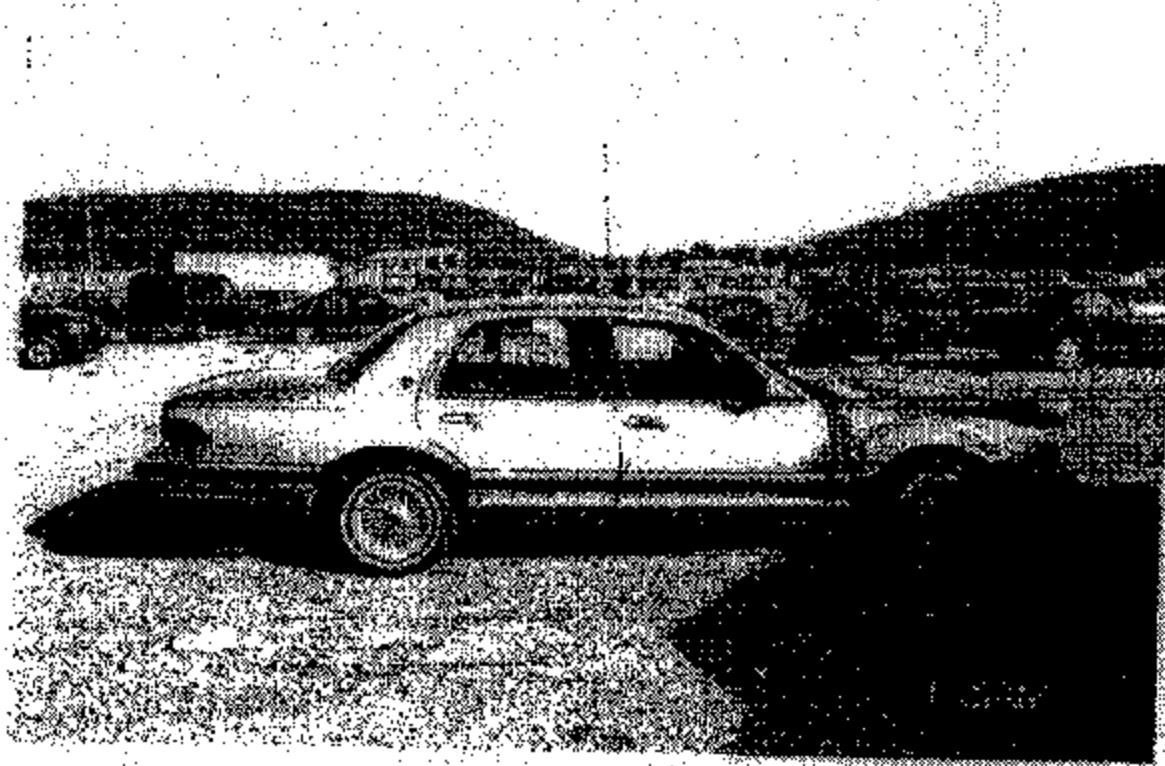
Photograph 3

This photograph is of the passenger side of the vehicle. Fire damage is apparent at the rear of the engine hood and front fender area. The vehicle displayed Northwest Penn Stock Number 420965P.

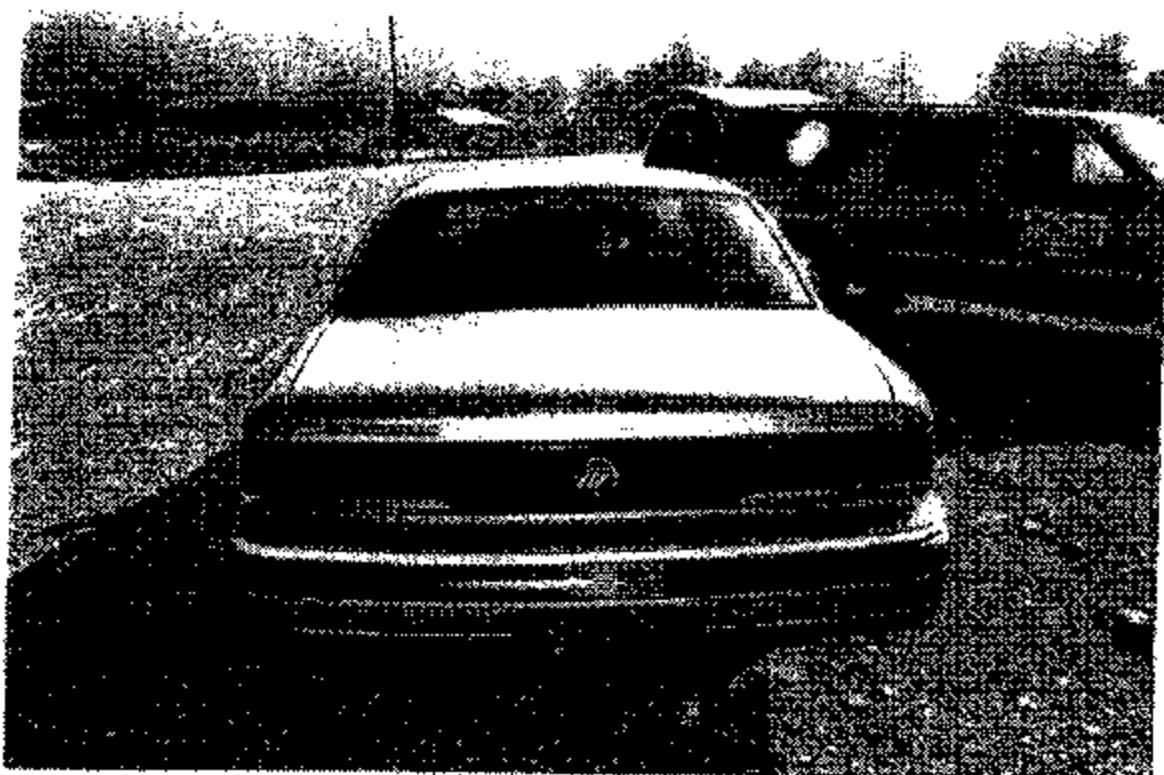
Photograph 4

This photograph is of the rear of the subject vehicle. No fire damage has occurred at the rear of the vehicle. A smoke film has accumulated at the interior glass area.

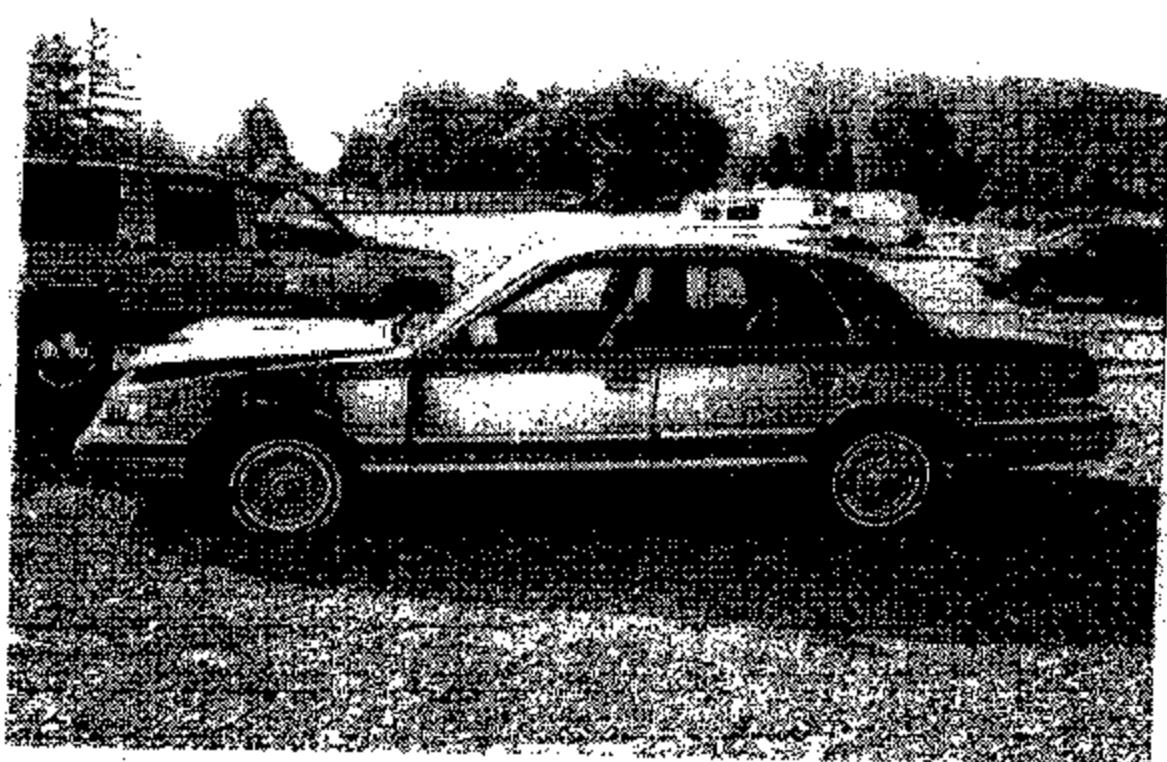
Photograph 5

This photograph is of the driver's side of the vehicle. Fire damage is apparent at the front of the vehicle. A lesser amount of fire damage has occurred at the driver's side as compared to the passenger side of the vehicle.

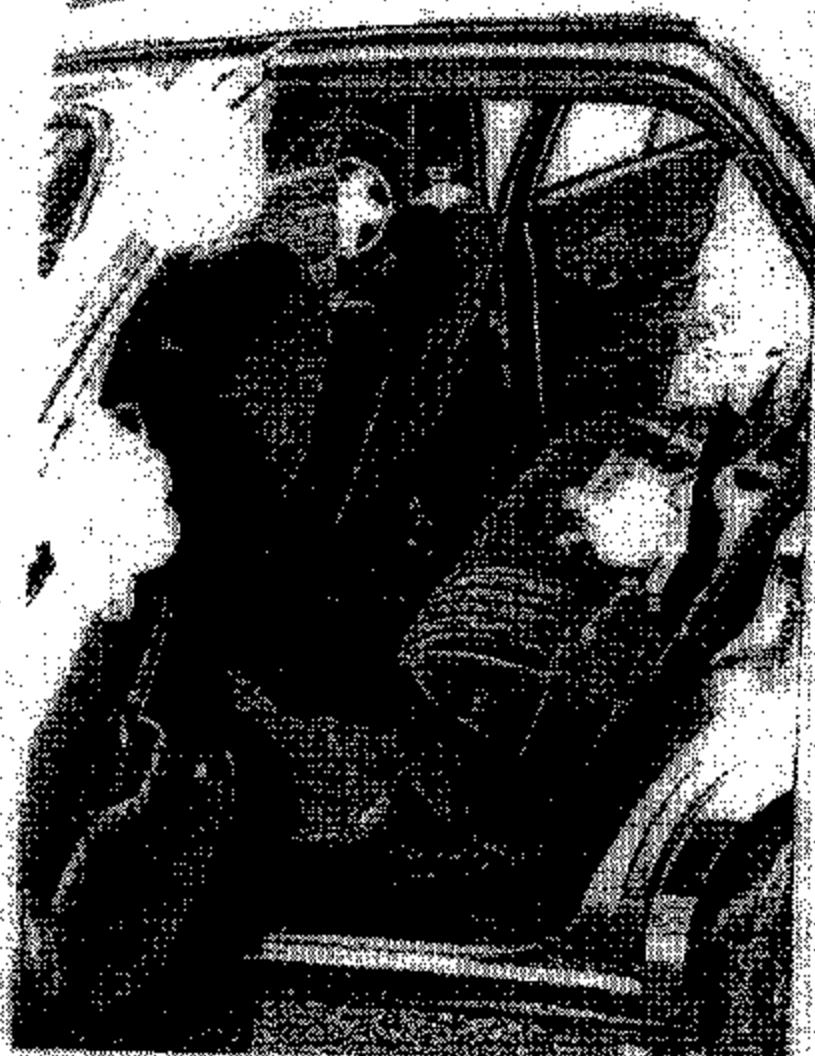
Photograph 6

This photograph is of the rear seating area of the vehicle. Only smoke damage has occurred at this location.

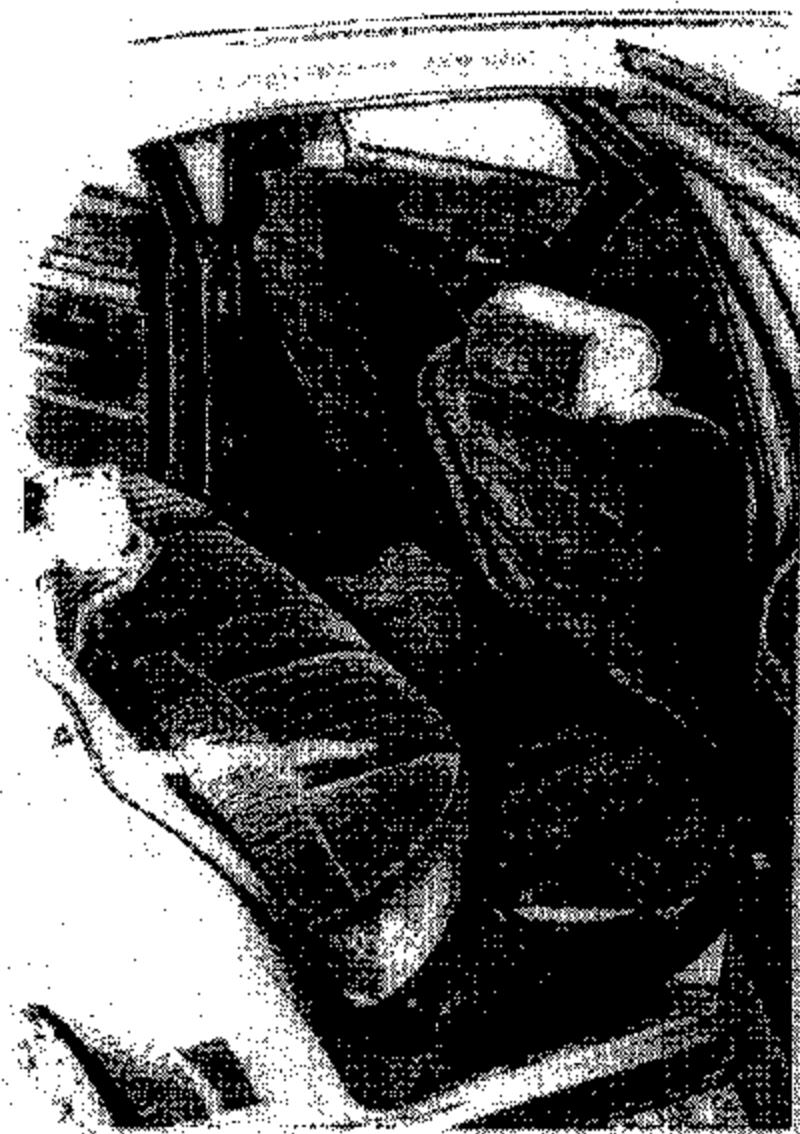
Photograph 7

This photograph is an additional view of the rear seating area of the vehicle. Only smoke damage has occurred at this location.

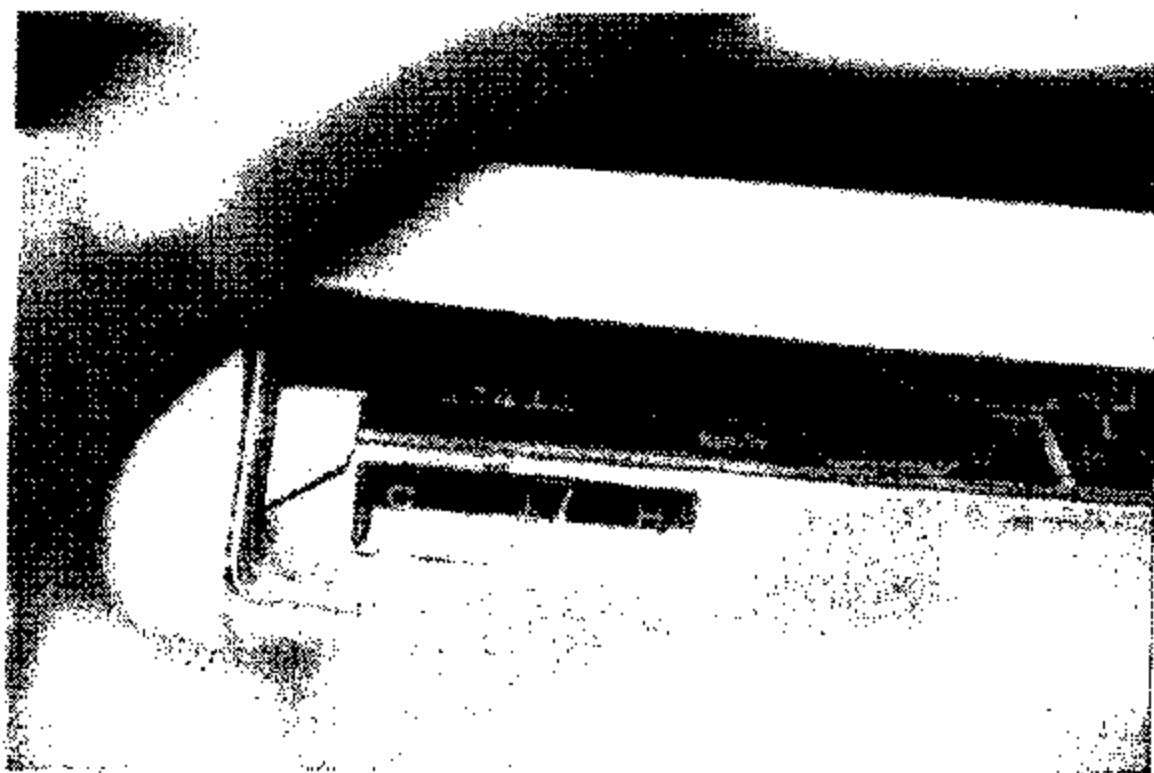
Photograph 9

This photograph is of the accumulative odometer, which displayed 74,486 miles traveled.

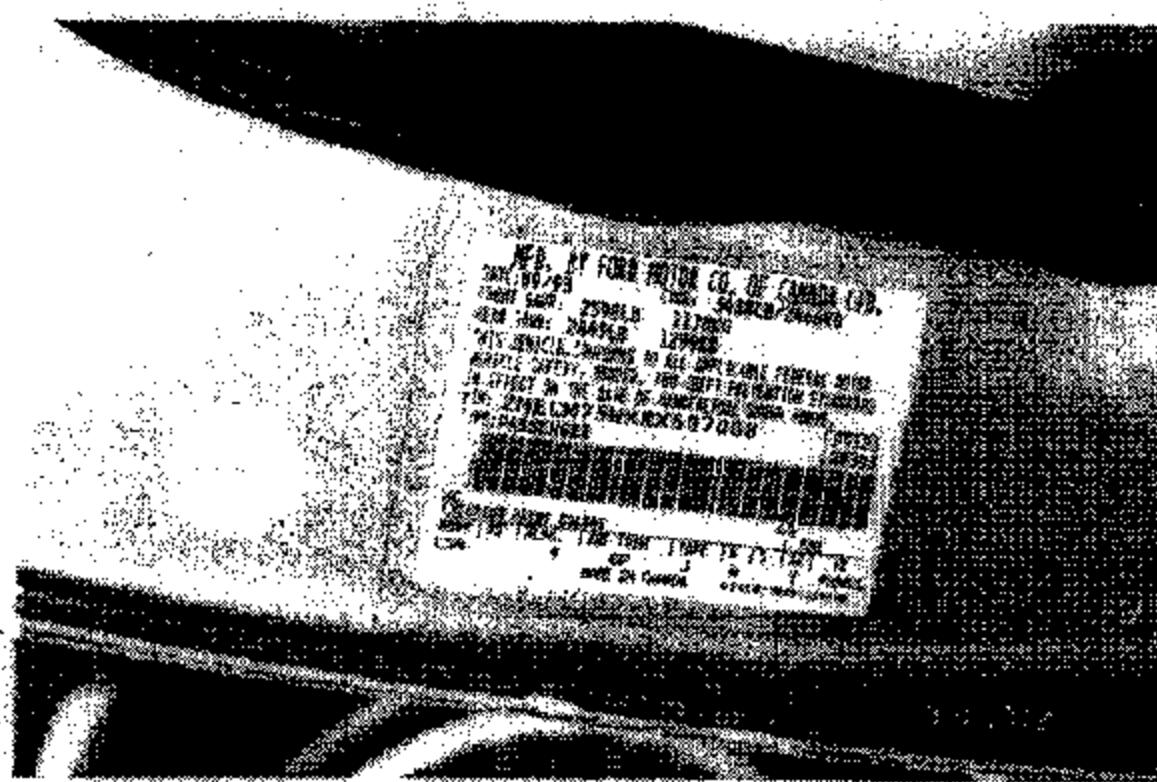
Photograph 10

This photograph is of the Federal Motor Vehicle Safety Standards label, which displayed a manufacture date of 9/93 and a vehicle identification number 2MELM75WXRX607088.

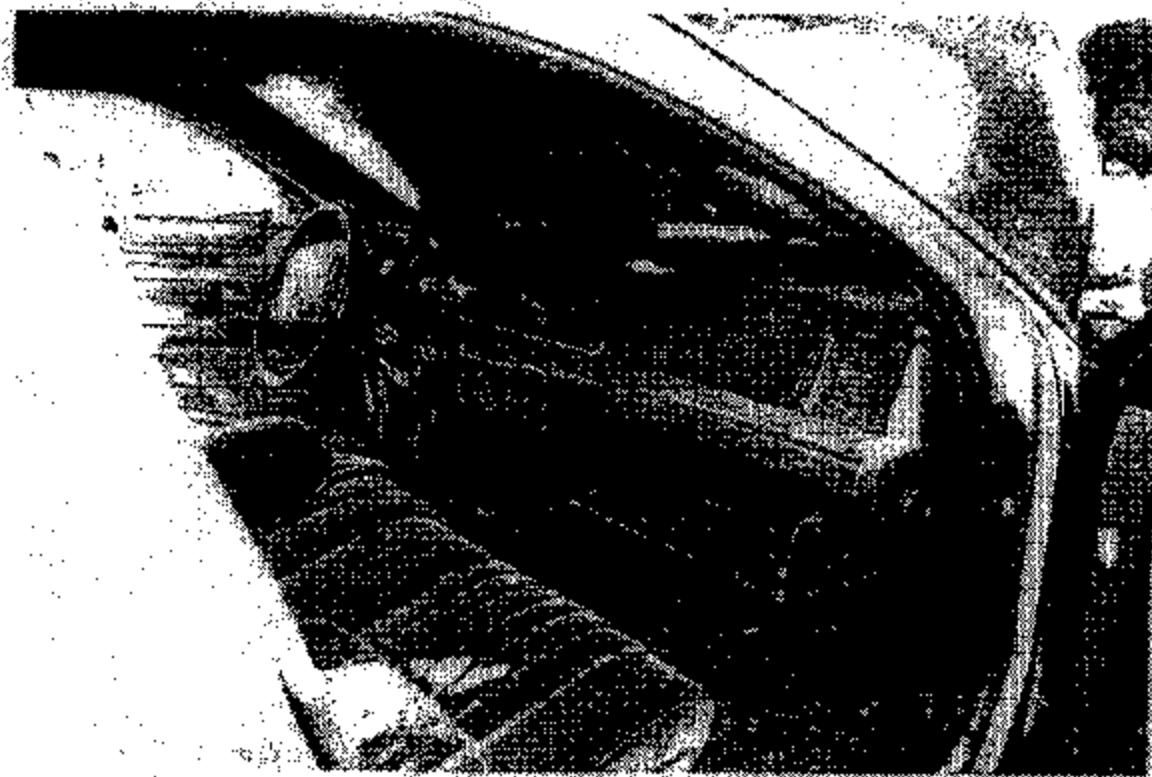
Photograph 11

This photograph is of the dash panel and front seating area. Extensive fire damage is apparent. The burn patterns present indicate a fire that originated at the engine compartment and progressed to the rear of the vehicle.

The burn patterns present at the interior of the vehicle clearly substantiate a fire that originated at the engine compartment and progressed into the interior of the vehicle through the heater and air conditioning ductwork. The electrical wiring throughout the interior and rear of the vehicle displayed no causation for this fire. The after market CD control panel and associated electrical wiring displayed no fire damage. The lack of any fire damage clearly eliminates this after market component as being the cause for the fire.

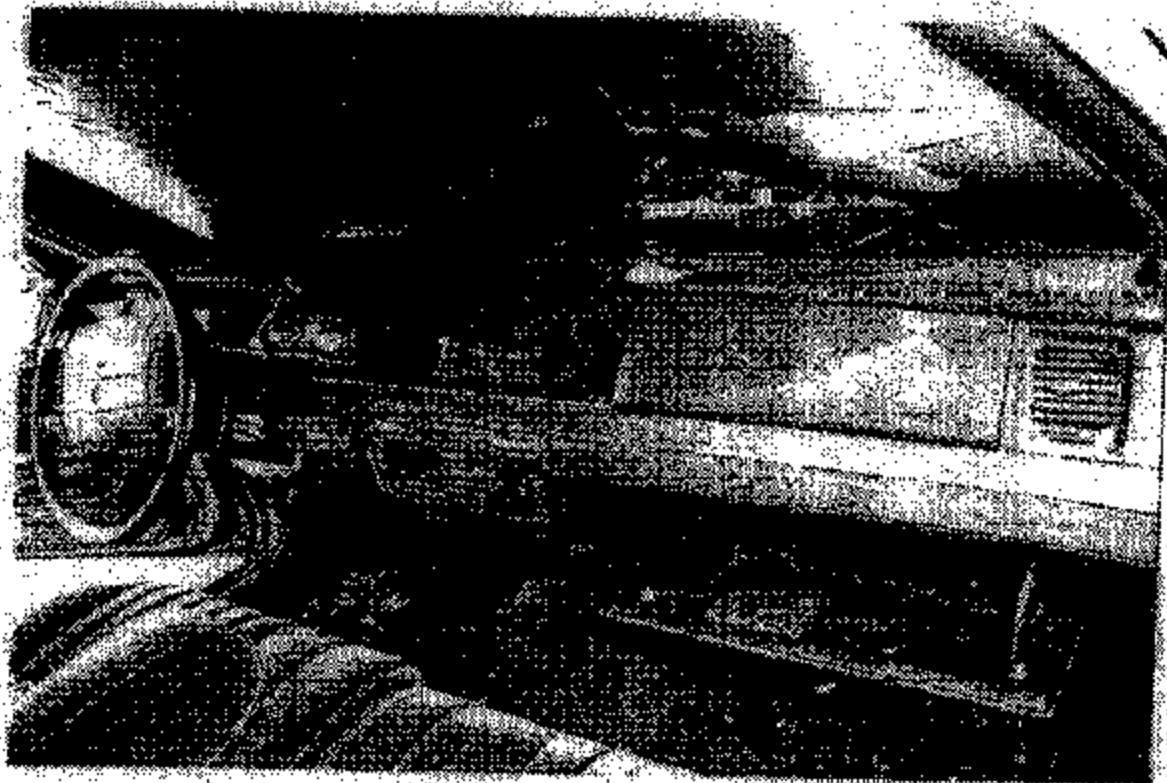
Photograph 12

This photograph is an additional view of the dash panel and front seating area. Extensive fire damage is apparent. The burn patterns present indicate a fire that originated at the engine compartment and progressed to the rear of the vehicle.

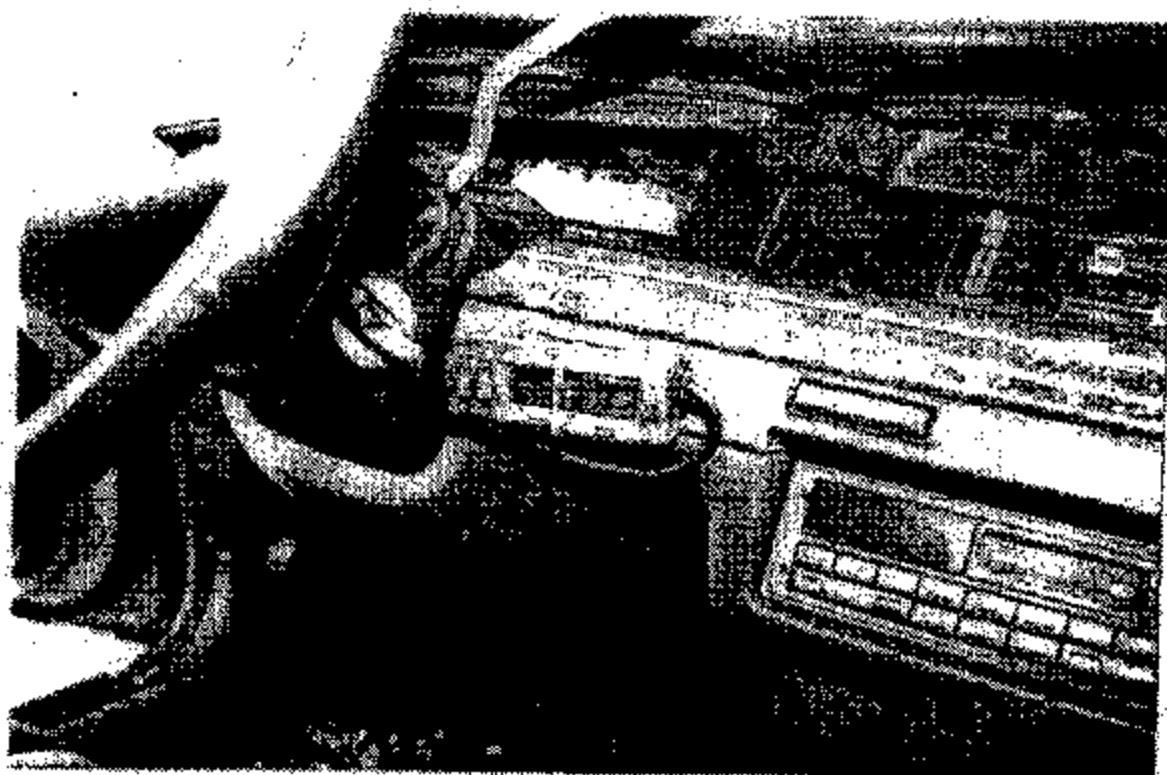
Photograph 13

This photograph is of the non-original Clarion CD changer control unit. The fire did not originate within component.

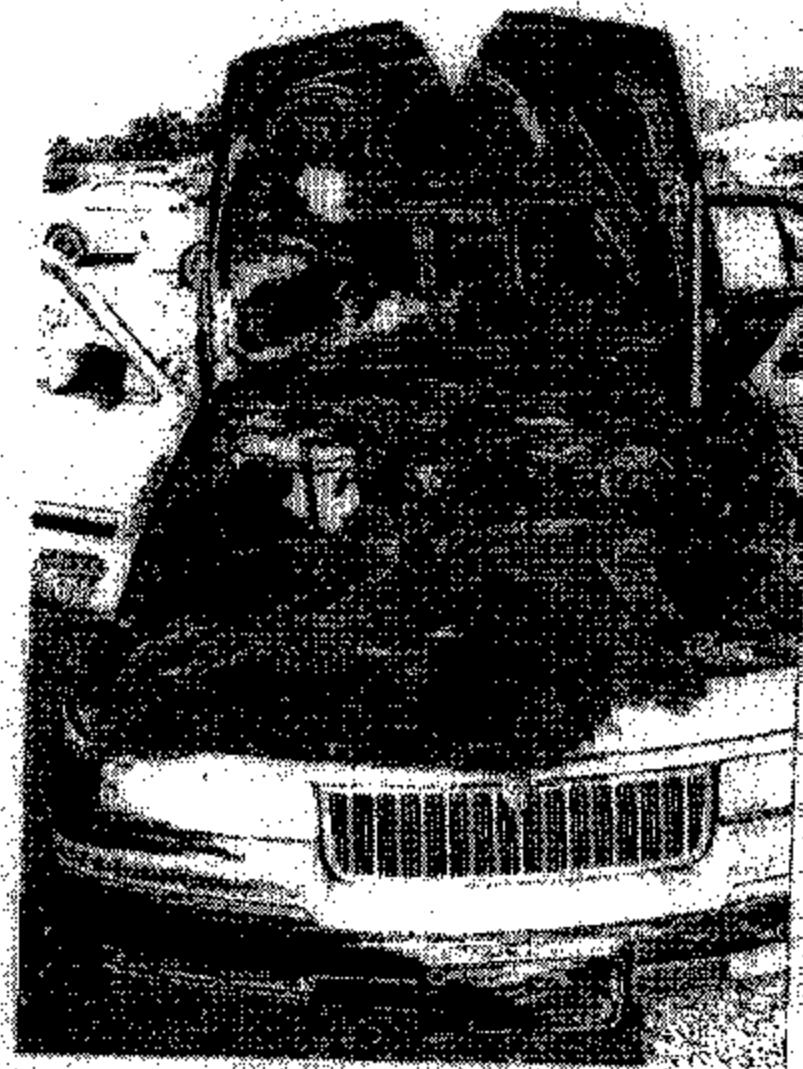
Photograph 16

This photograph is of the V/S engine and engine compartment. Extensive fire damage was observed at the area of the engine compartment. The most concentrated fire damage has occurred at the location of the heating and air conditioning ductwork at the passenger side, rear of the engine compartment.

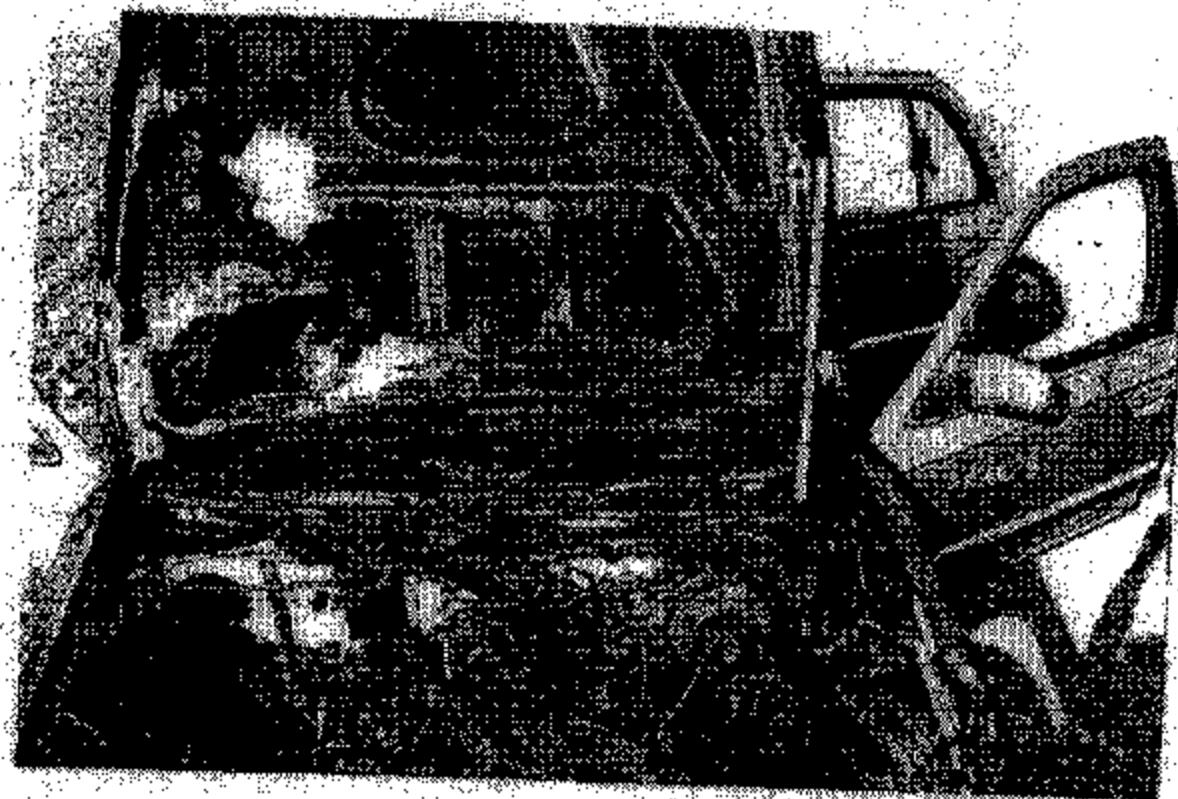
Photograph 17

This photograph is an additional view of the V/8 engine and engine compartment. The most concentrated fire damage has occurred at the location of the heater and air conditioning ductwork at the passenger side, rear of the engine compartment.

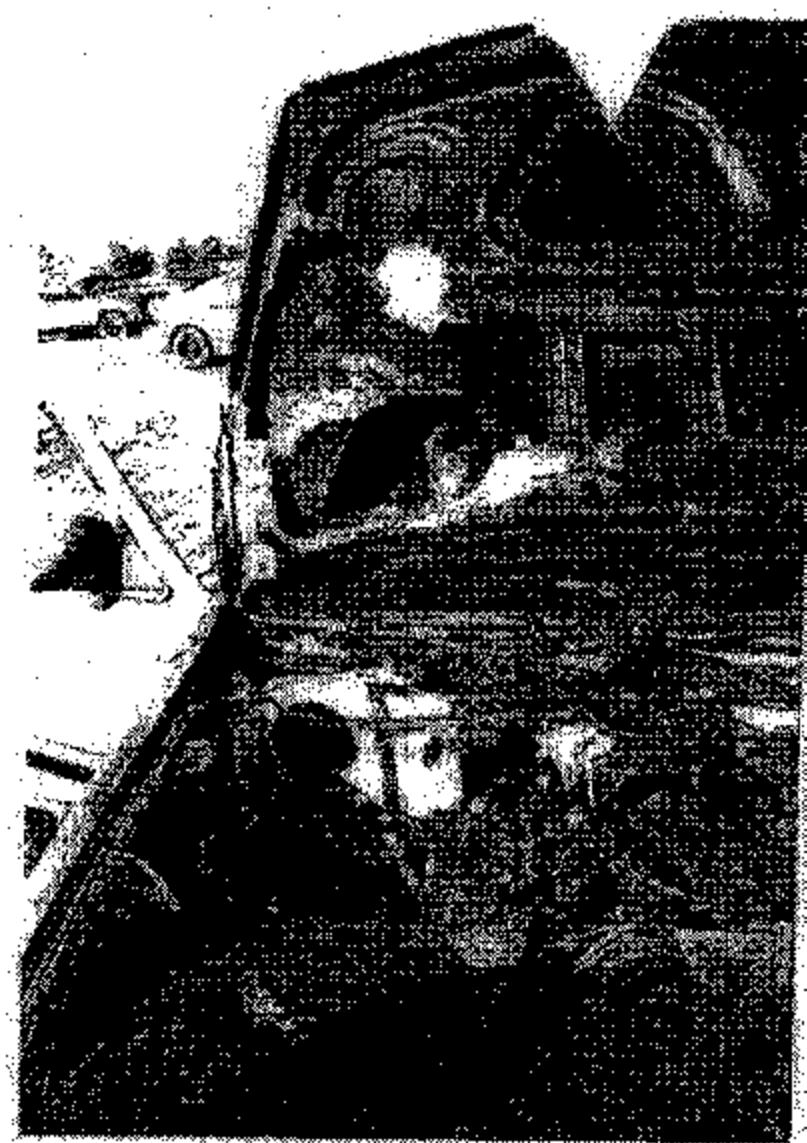
Photograph J.8

This photograph is of the concentrated fire damage that has occurred at the passenger side, rear of the engine compartment. This is the location of the heater and air conditioning ductwork.

This opinion is arrived at after examining the burn patterns throughout the vehicle, which clearly substantiate a fire that originated at the housing for the heater and air conditioning ductwork. This housing is of fiberglass/plastic composition and is the mounting for the blower motor. This housing has been completely consumed by the fire. The location for this housing is the passenger side, rear of the engine compartment.

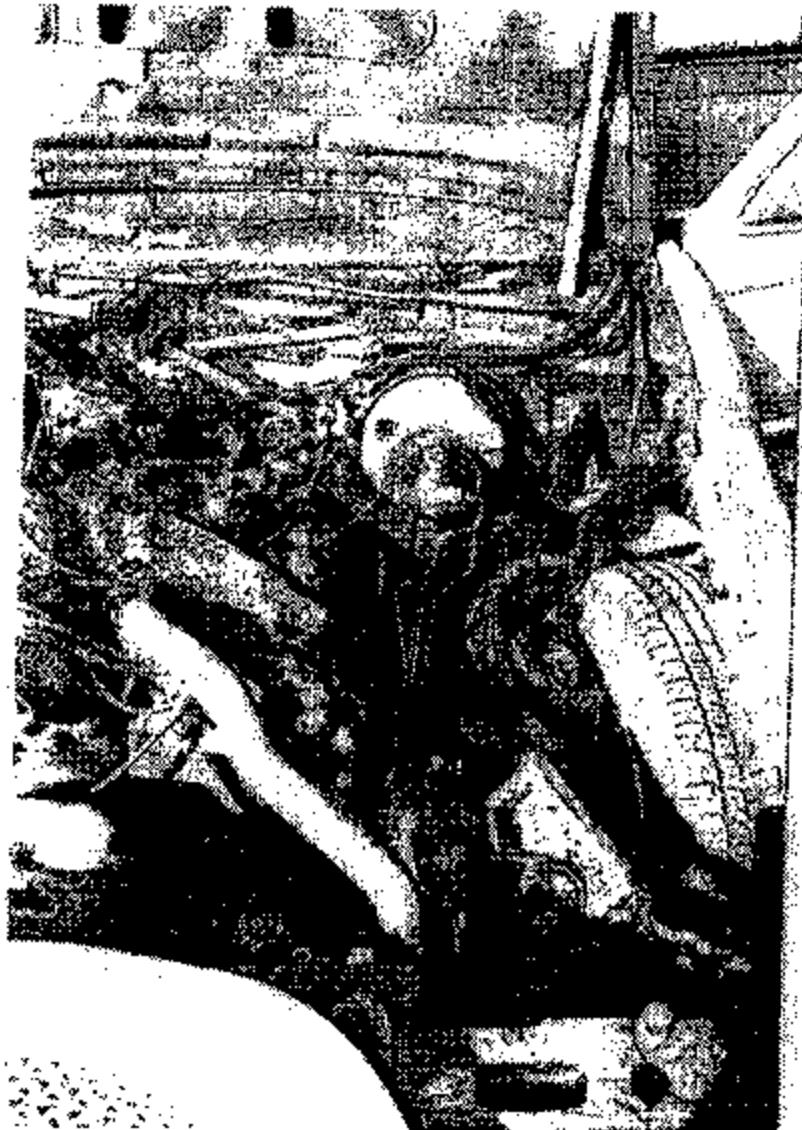
Photograph 19

This photograph is of the driver's side of the engine compartment. Extensive fire damage is apparent. However, a lesser amount of fire damage has occurred at the driver's side of the engine compartment as compared to the passenger side.

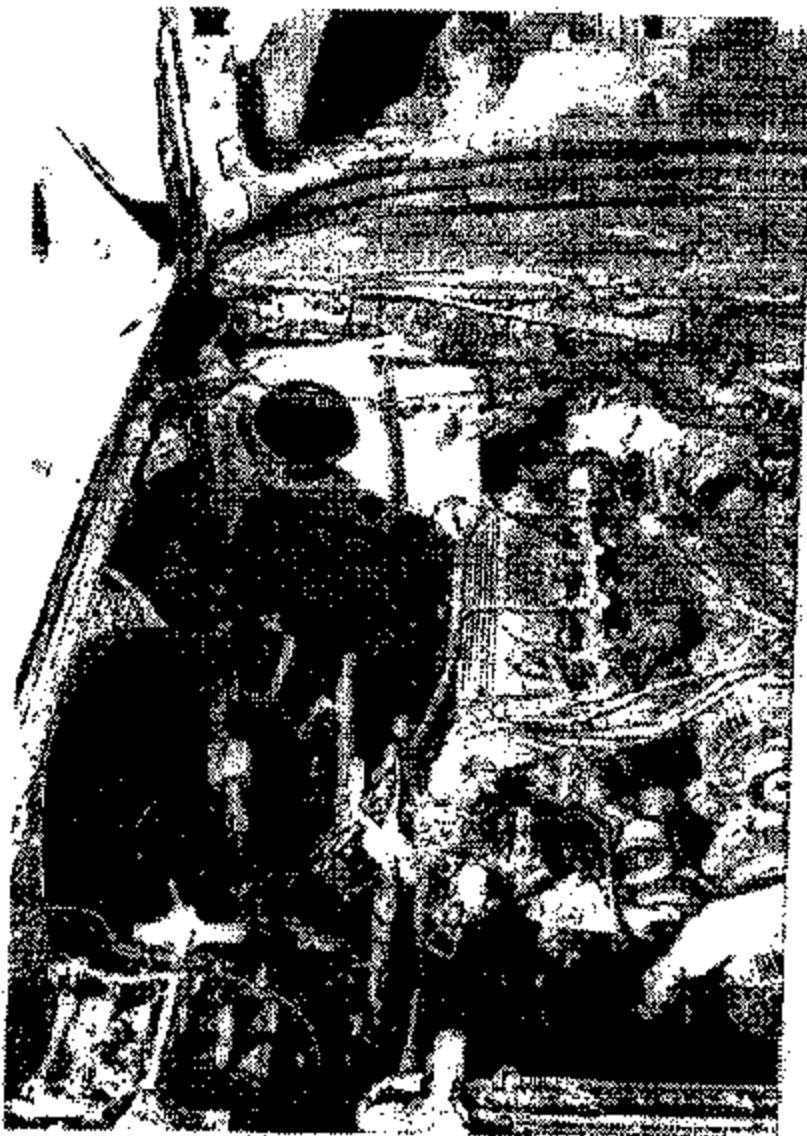
Photograph 20

This photograph is of the passenger side of the engine compartment where the most extensive and concentrated fire damage has occurred at the passenger side, rear of the engine compartment.

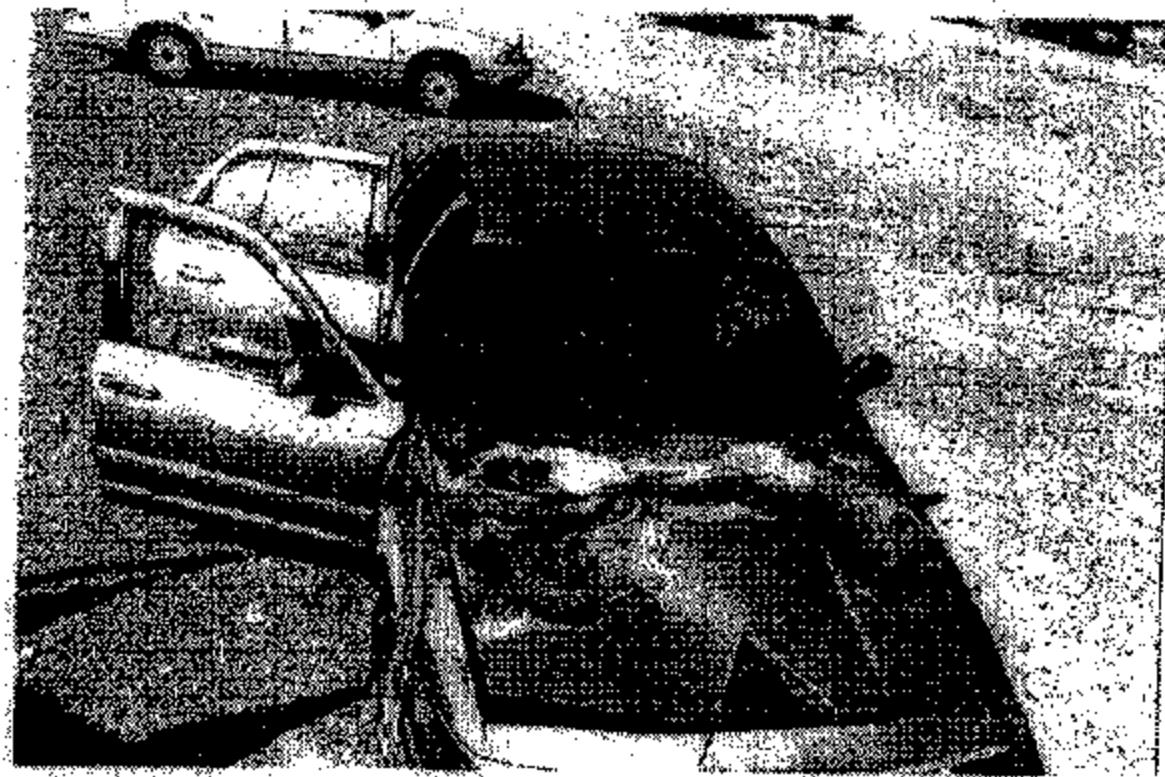
Photograph 22

This photograph is an overhead view of the engine compartment hood. The aluminum hood has sustained extensive melting at the area of the heater and air conditioning housing. This is the location of the blower motor.

The electrical wiring located at the front of the vehicle displayed very little fire damage, while the electrical wiring at the passenger side, rear of the engine compartment displayed extensive and concentrated fire damage. This is the location of the blower motor, blower motor resistors and HVAC ductwork. The aluminum engine hood has been completely melted through at this location.

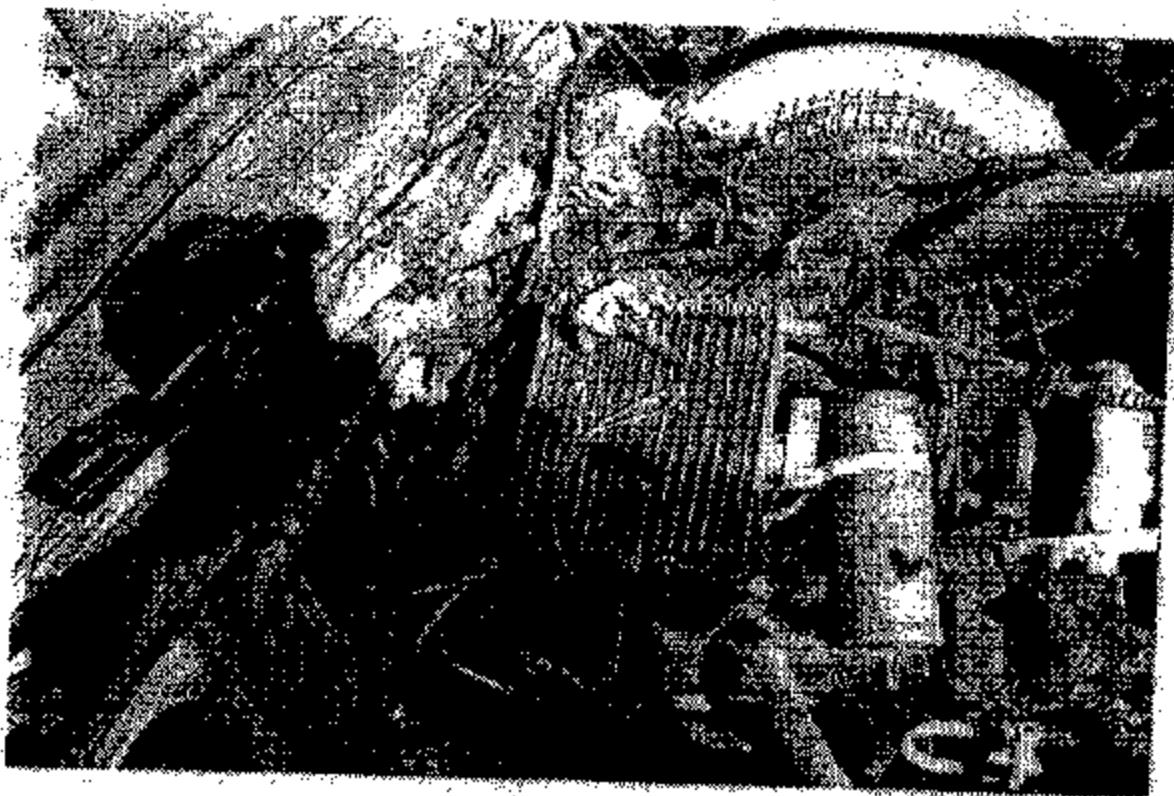
Photograph 24

This photograph is of the electrical wiring located at the heater and air conditioning housing area after the evaporator core was moved slightly for examination.

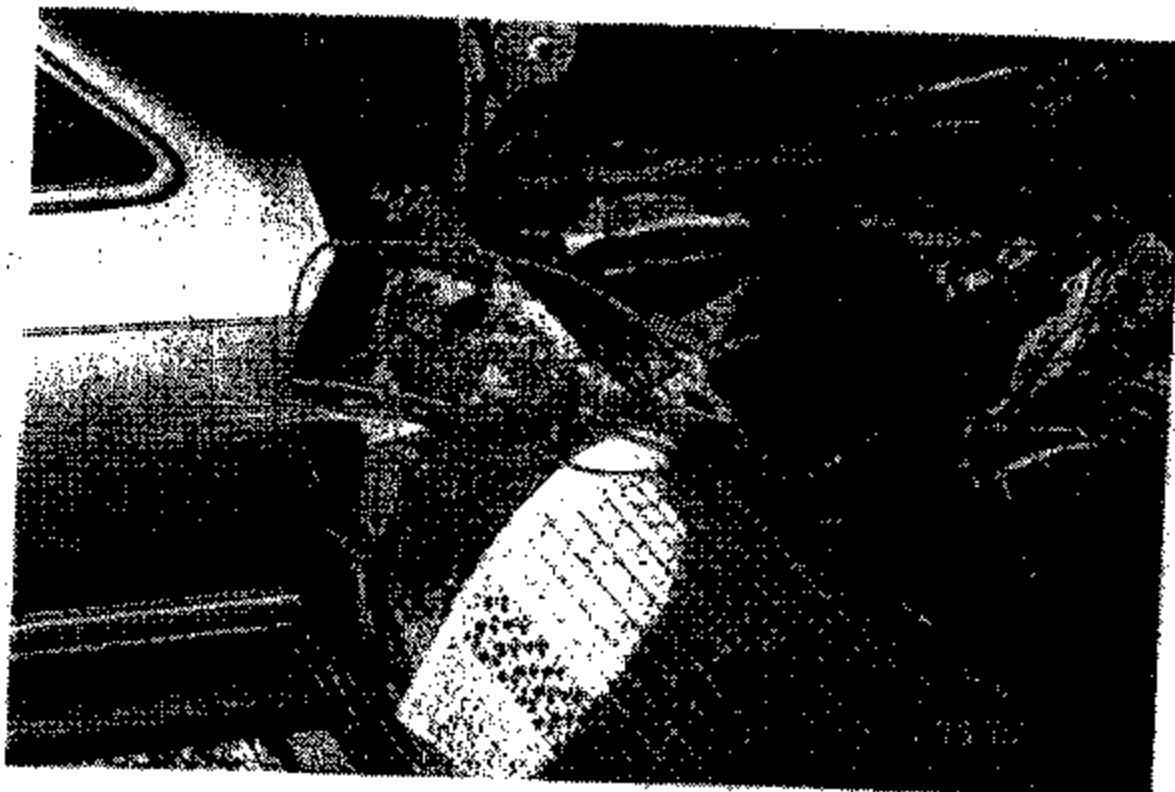
Photograph 25

This photograph is of a portion of the electrical wiring, which was routed through the engine bulkhead. The electrical wiring at the interior side of the engine bulkhead was virtually undamaged.

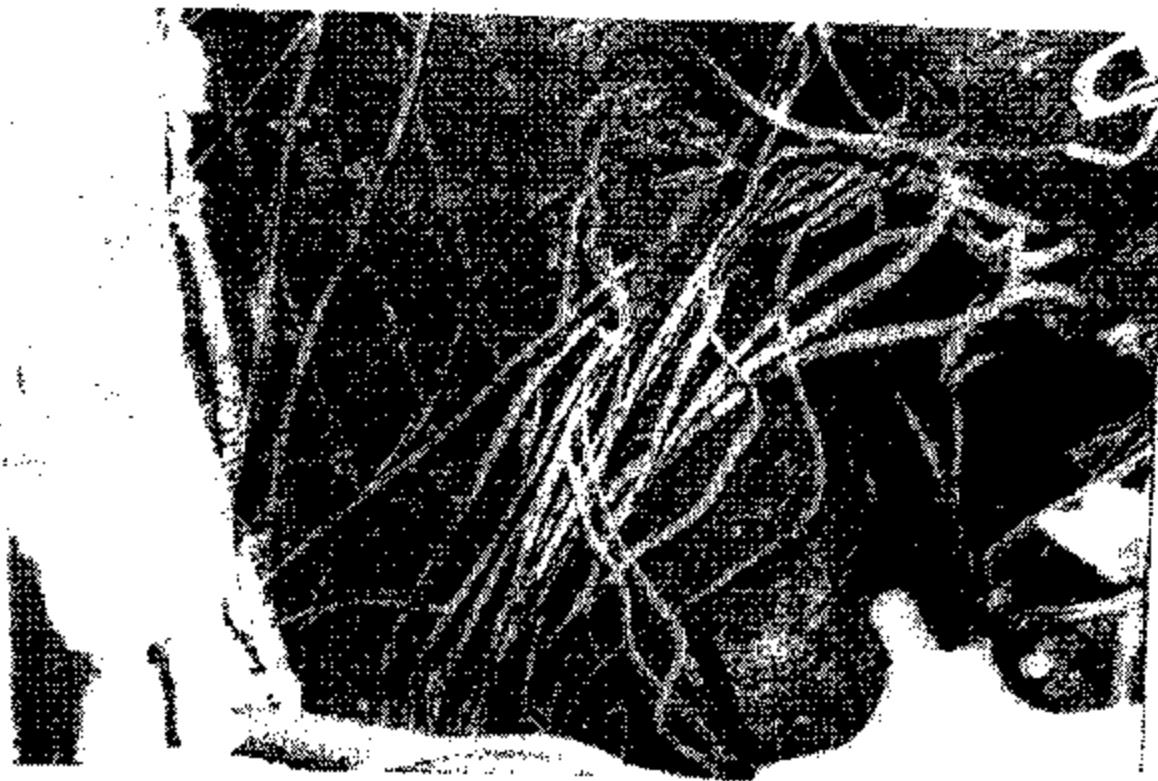
Photograph 29

This photograph is an additional view of the electrical wiring that was routed at the passenger side of the engine compartment. The most extensive damage to this electrical wiring was at the area of the heater and air conditioning ductwork. This is the location of the blower motor.

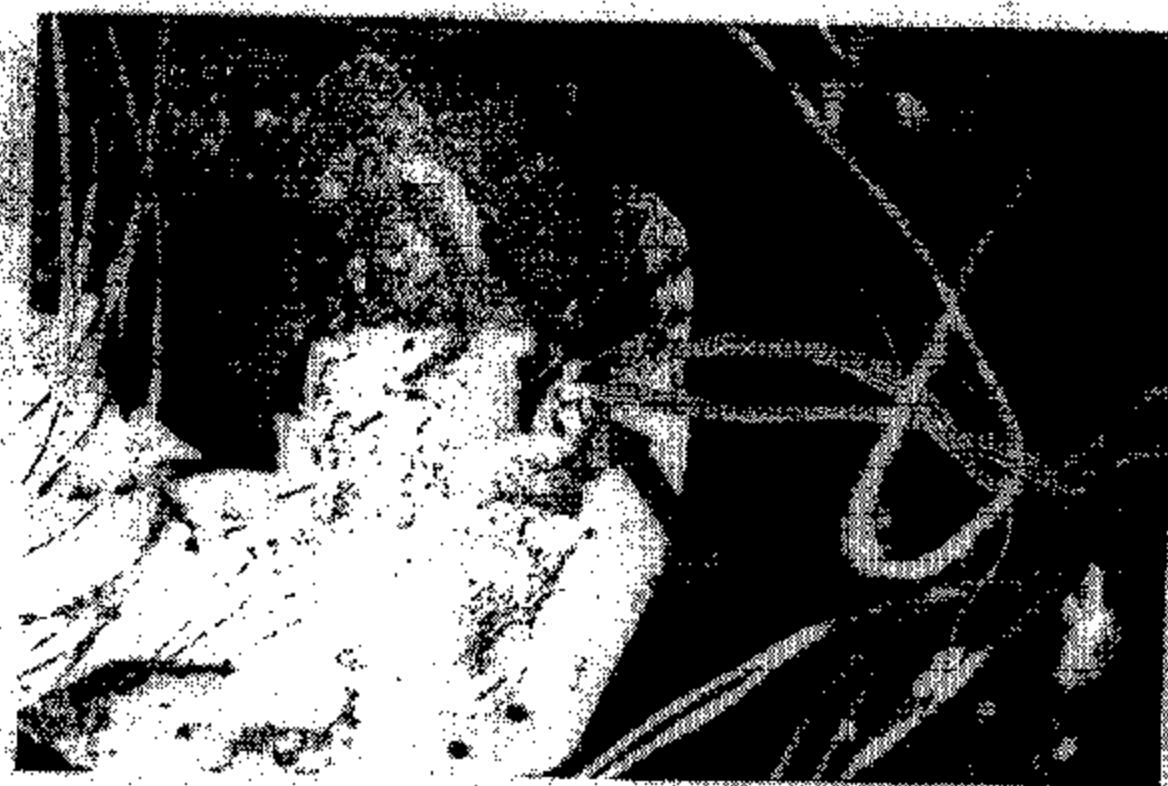
Photograph 31

This photograph is an additional view of the electrical wiring at the area of the blower motor. This large gauge electrical wiring displayed sleeving that is consistent with internal heating of this electrical wiring.

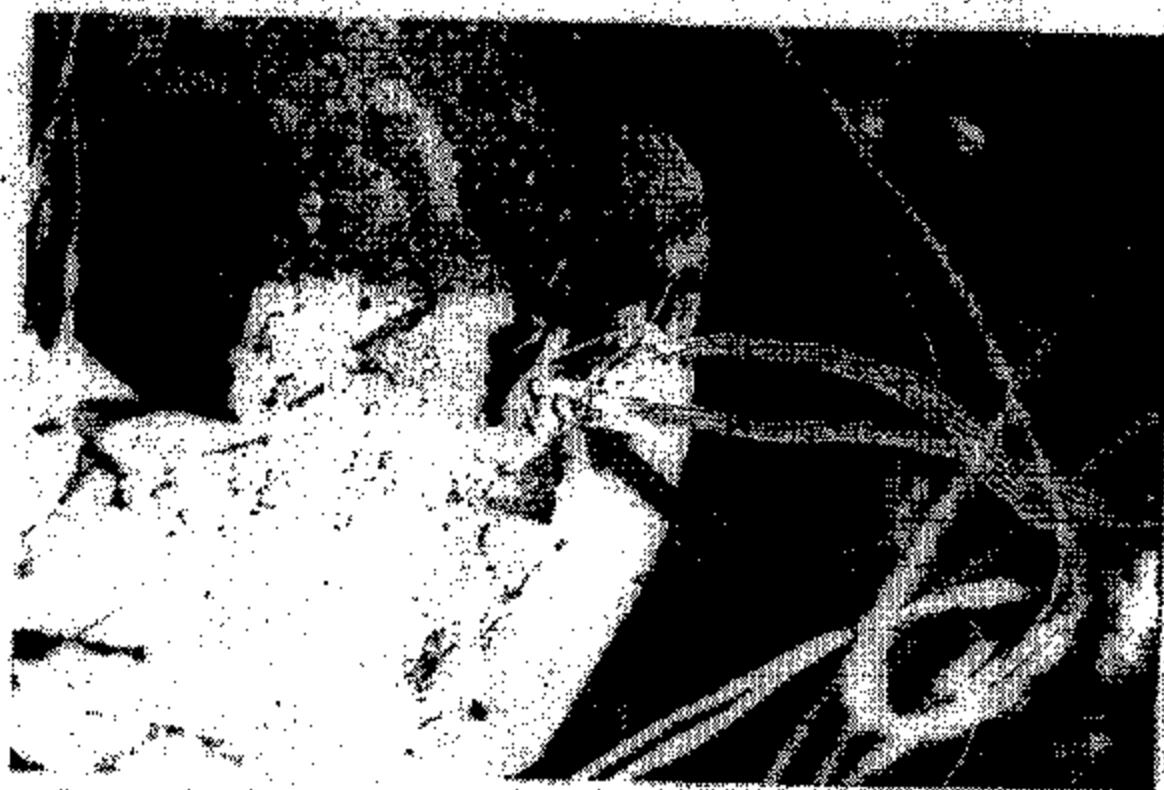
Photograph 32.

This photograph is an additional view of the electrical wiring at the area of the blower motor. This large gauge electrical wiring displayed steering that is consistent with internal heating of this electrical wiring.
