EA02-025

RE: Our Claim #: 38-J962-070
Our Insured: [REDACTED]
Date of Loss: June 18, 2002
Year, Make, and Model of Product: 1994 Mercury Grand Marquis
VIN: 2MELM75WXRX807088

*Forensic Mechanical Evaluation
Origin and Cause of Vehicle Fires*

The purpose of this examination was to determine the origin and cause of the vehicle fire, which occurred on June 18, 2002.

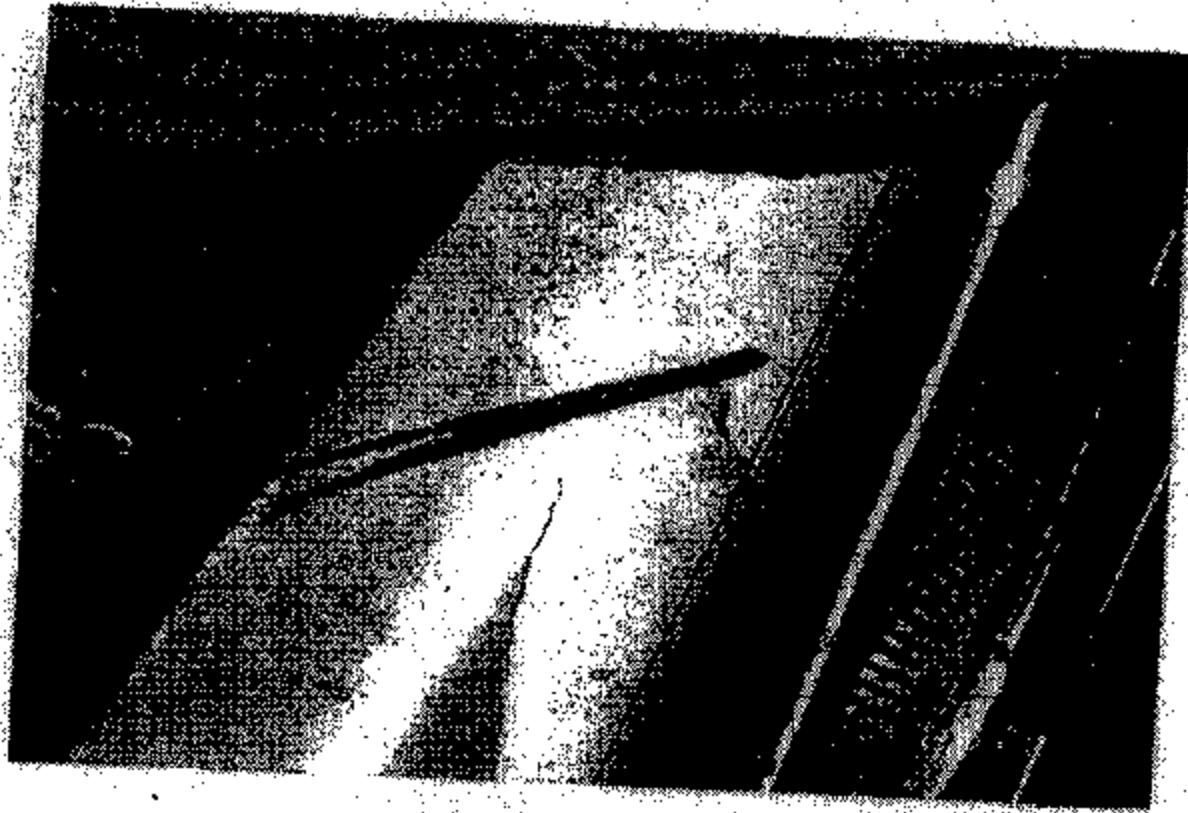
Photograph 33:
This photograph is of the automatic transmission dipstick, which displayed a normal, overfull condition.
