**EA02-025**

**APPENDIX N**

From: Rahman, Aziz  
Subject: Switch Log and Eval. Procedure

## Memphis Switch

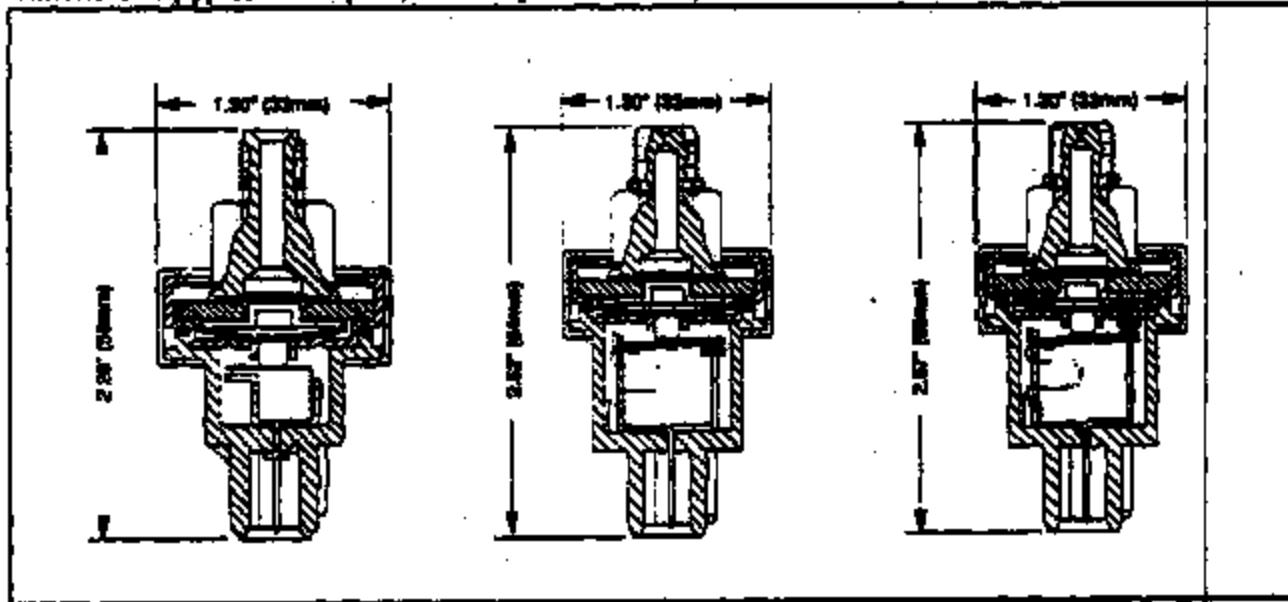
### Dimensions (typical examples, other styles available)

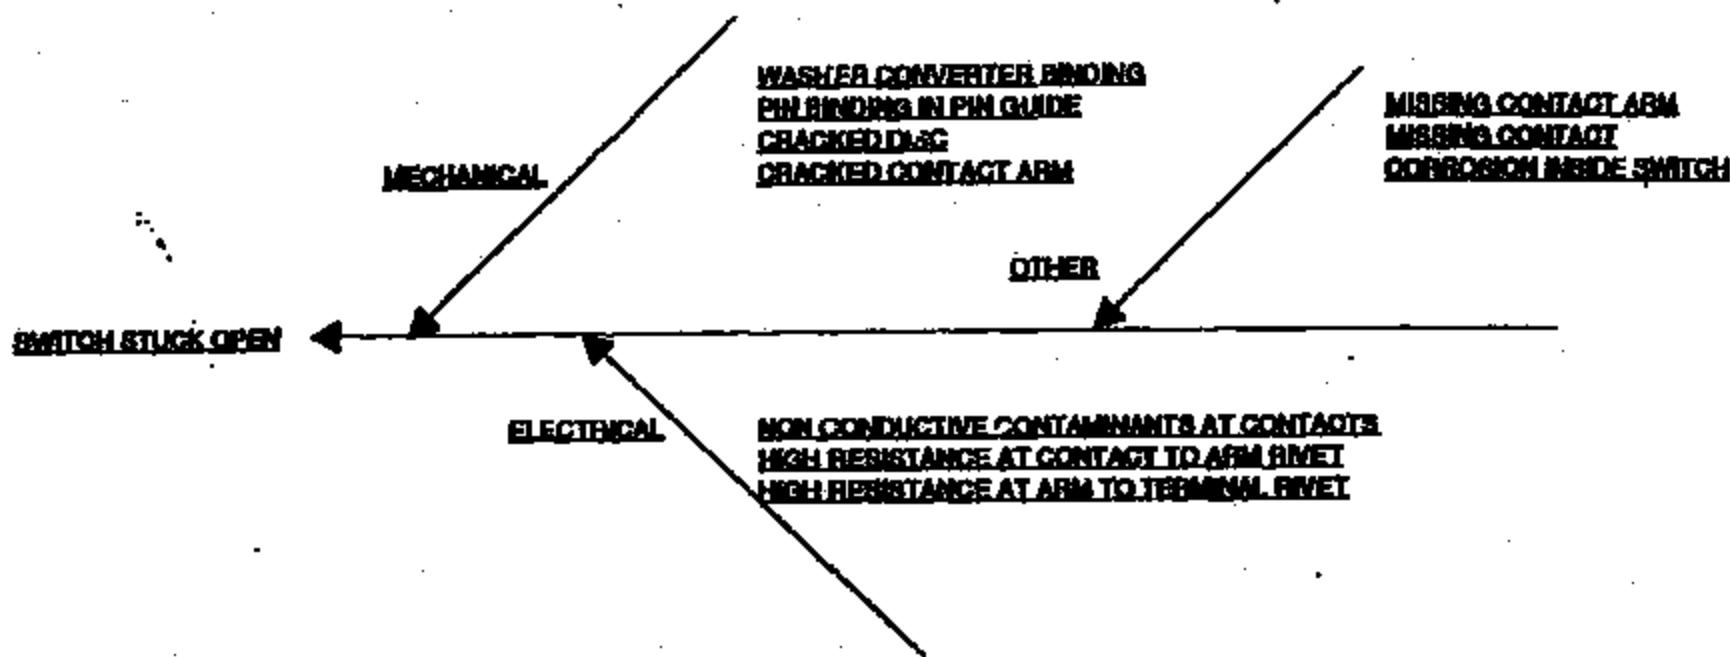
ATTACHMENT "B"

The switches analyzed were inoperative since there was no electrical continuity between the terminals. Attachment "B" shows the fishbone diagram for a stuck open switch. The lack of continuity was due to presence of large amounts of corrosion products inside the switch cavity and, in some cases, failure of contact elements due to corrosion. The large quantity of corrosion products is due to fluid that entered the switch cavity. Because of the severe amount of corrosion observed, it is believed that the corrosion is accelerated by the potential difference between the grounded body of the switch and current carrying members.

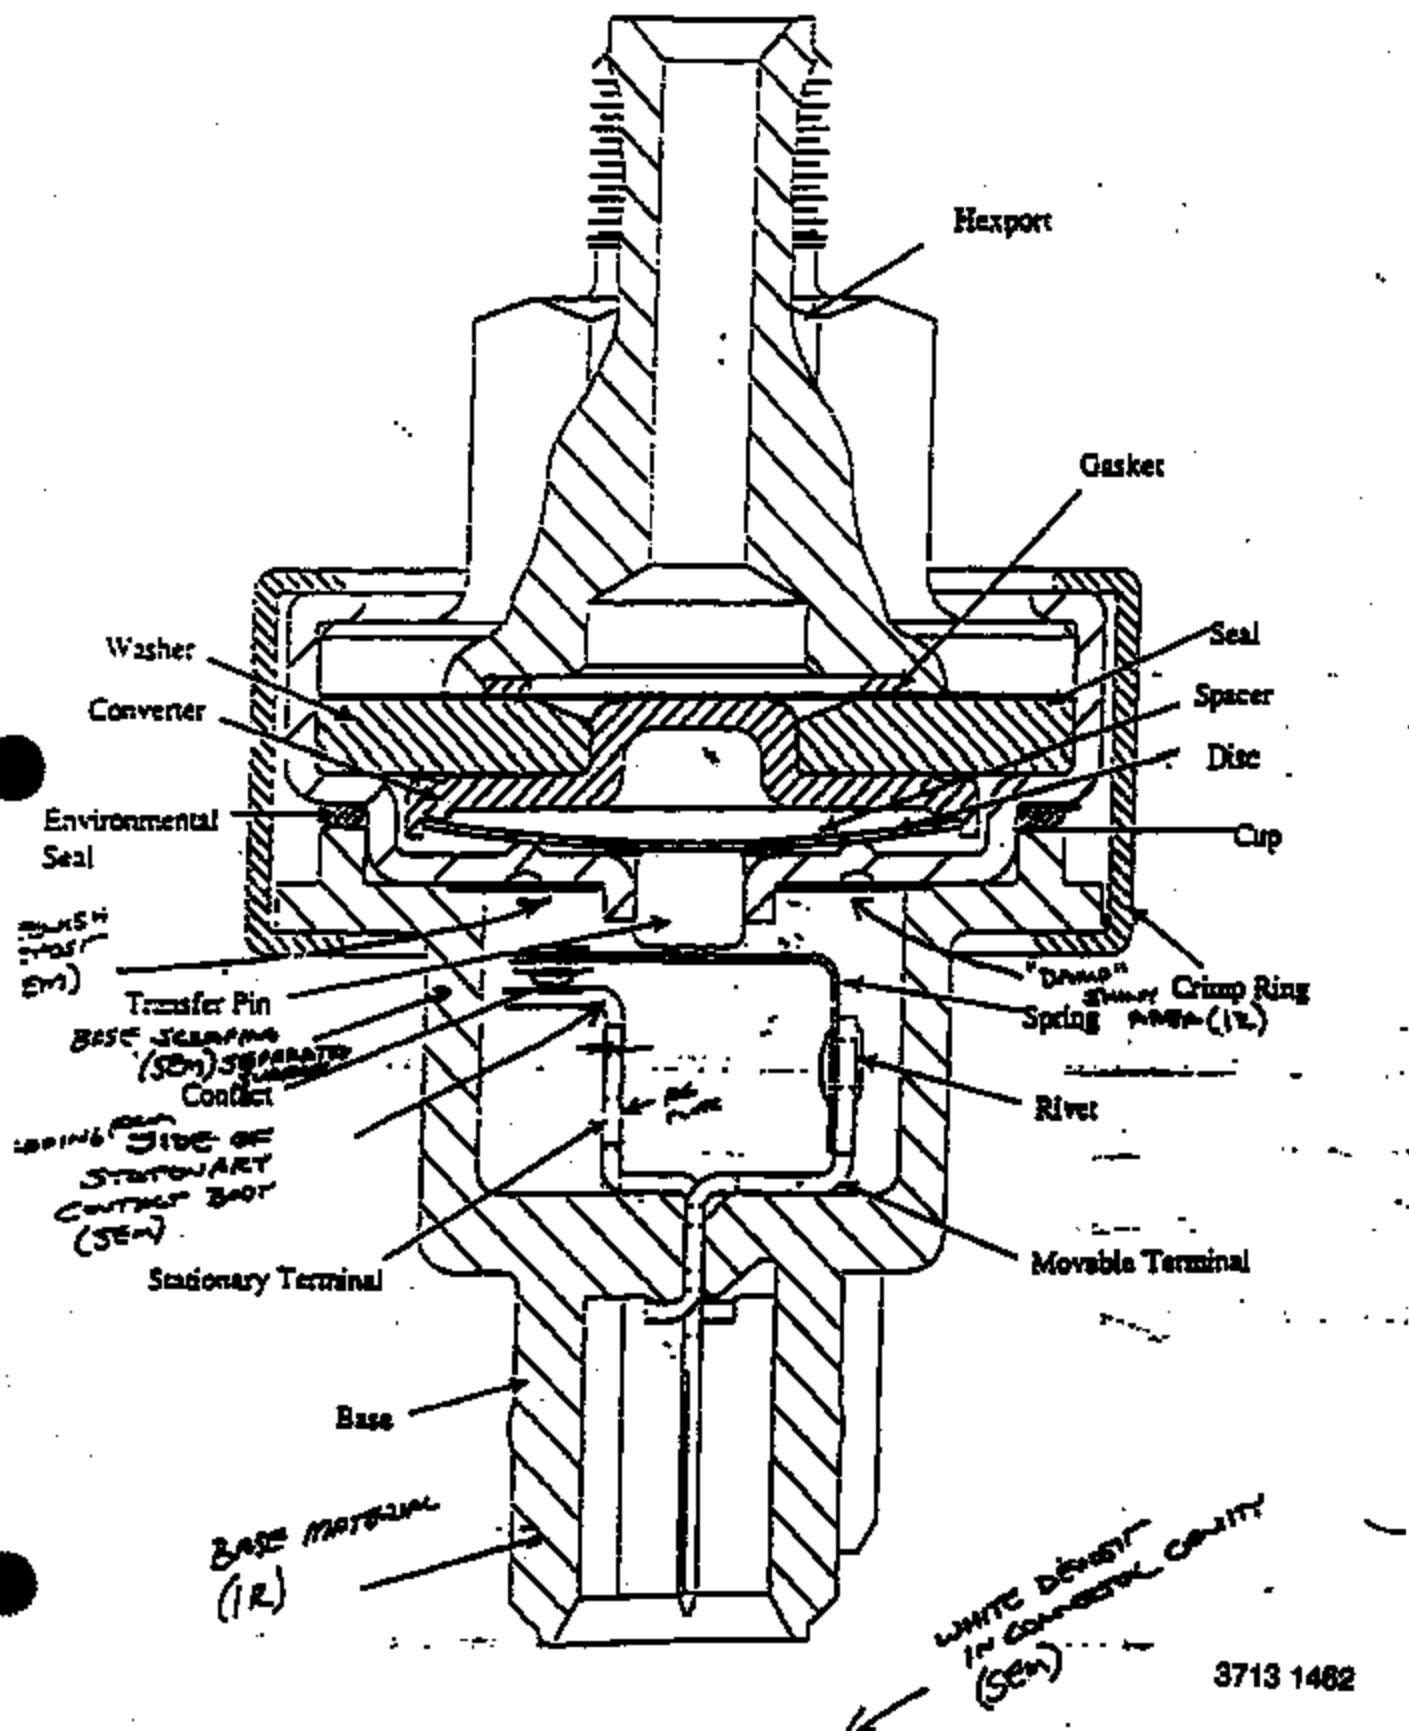
### Hydraulic Pressure Switch Cross Section

The cup is partially covered with a greenish residue. Residue appears to be primarily an oxide of the brass contact material with possibly a sulfur compound. This suggests transfer of oxide or corrosion product from the brass contacts to the cup.

The stationary contact exhibits intergranular cracks which indicate stress corrosion cracking (SCC). SCC is caused by combination of a specific corrosive environment and a sustained tensile stress (can be localized). Ammonia, ammonia compounds, sulfur compounds, and moisture are known to cause SCC in brass. The contact material has been reported to be 360 brass, which is highly susceptible to SCC.

All three diaphragms exhibit what appears to be mechanical damage. The damage does not match up with any melting parts of the switch. This suggests that damage may have occurred prior to assembly. The diaphragm has become brittle and cracked in the vicinity of the damage. Brake fluid has become entrained between the layers (Teflon and capton) of the diaphragm.

The post of the movable contact melted back into the bulkhead between the switch and terminal cavities of the base. There is also arc damage (localized melting) to one corner of the bridge of the stationary contact. This damage appears fresh (surfaces bright and shiny) which suggests that it may have occurred in the later stages of the thermal event.

The terminals exhibit deposits which appear to be primarily sulfur compounds of the terminal material (tin plated brass). Although these deposits appear visually similar to the deposit found on the cup, they appear to be of different composition.

The white residue found in the connector cavity contains elements found in dry chemical fire extinguishers (Muscovite and phosphorus)

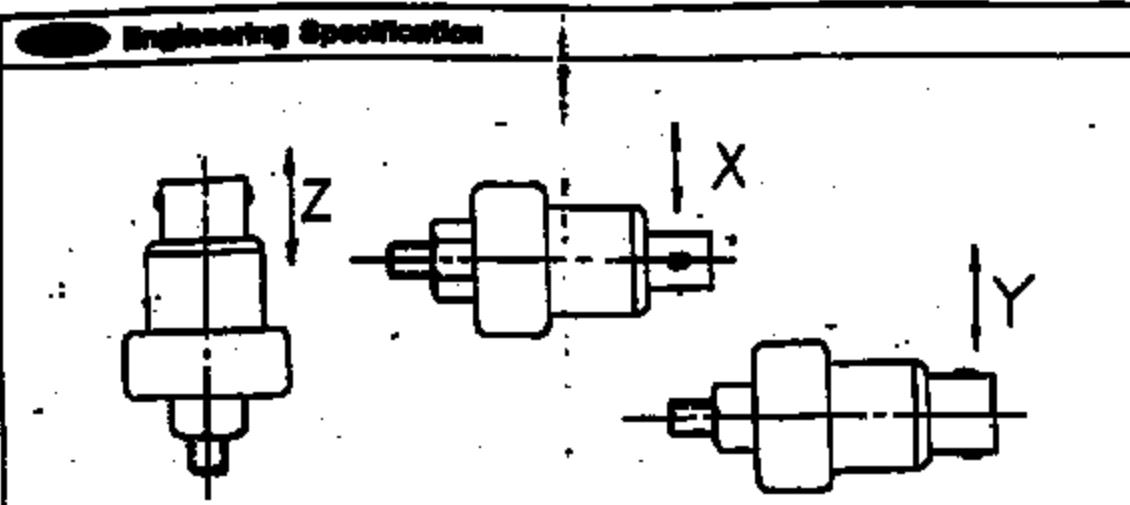
FIGURE 1.

VIBRATION TEST - SWITCH ORIENTATION

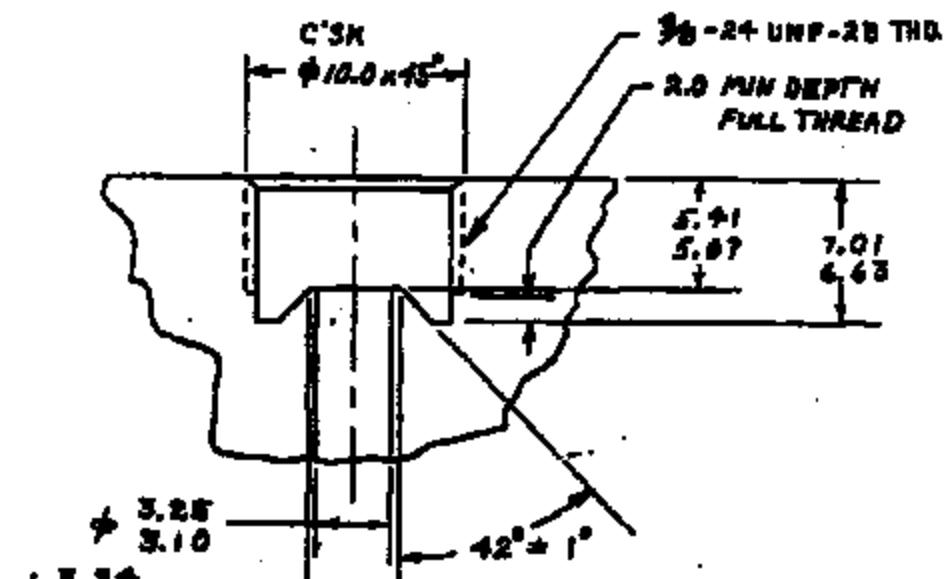
Reference  
SAB J512 OCT 80  
Figure 5A

TEST FIXTURE PORT CONFIGURATION

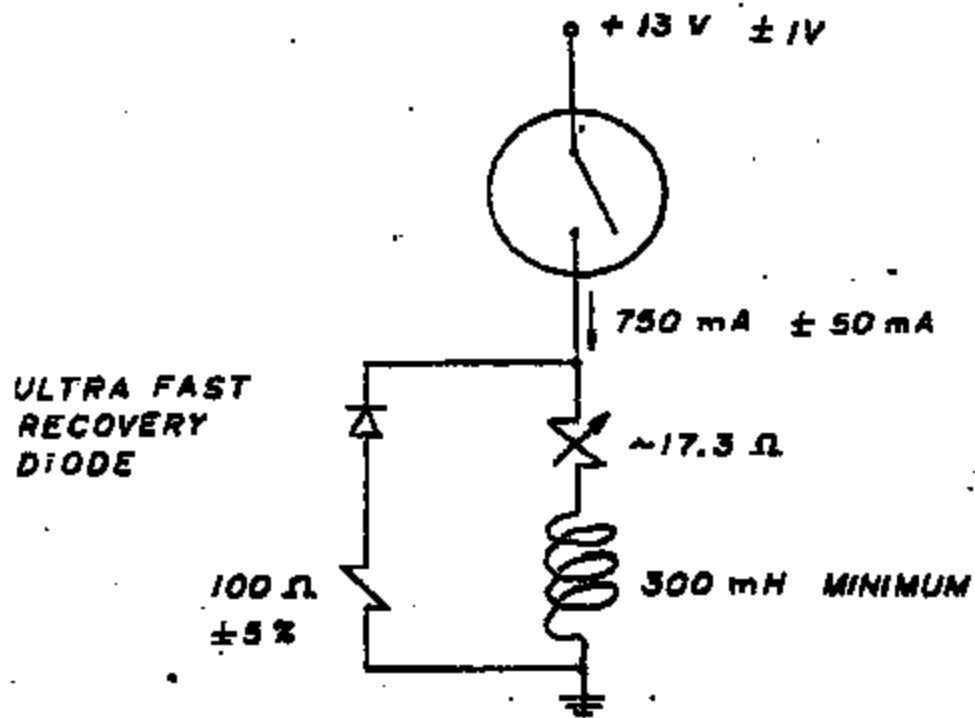
FIGURE 4

DEACTIVATE SWITCH  
TEST SET UP
