**EA02-025**

**APPENDIX N**

## Potential Failure Mode and Effects Analysis (Design FMEA)

Texas Instruments Incorporated  
8-D Problem Resolution Report # PS/CAR/93-3

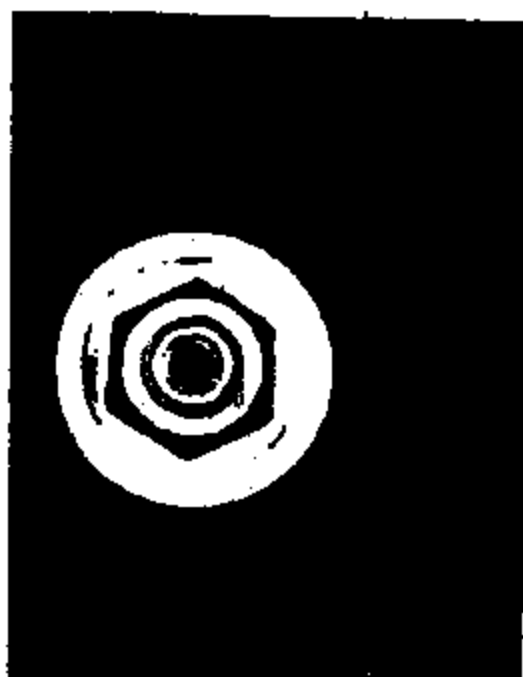
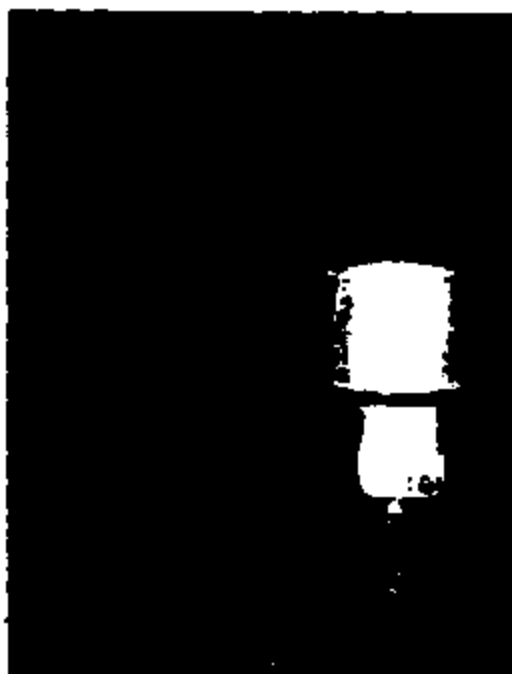
The shower test was halted on 10/6/93, when non-normal insulation resistance readings were observed on rocked switches. Upon removal of the connectors, water ingress was observed on all switches with rocked connectors. There was no ingress on correctly latched switches. The attached Table 1 summarizes the matrix of parts and visual observations. The ingress in vertical switches was of a magnitude higher than in horizontal switches. Photographs of the switches were sent to Ford Light Truck Engineering for review. The switches were calibrated for functionality. The attached Table 2 confirms the effect of ingress as seen in the reduction of insulation resistance and intermittent operation of the switches. The switches were then disassembled for internal inspection. It was observed that the ingress had proceeded through the connector cavity into the contact zone. Photographs are attached.

Thorough visual observation concluded the fluid entry to be through the mating connector end of the switch as evidenced by brass corrosion products along the terminal blades in the connector cavity (see attached photographs). Two of the switches exhibited blue/green corrosion by-products covering more than one half of the connector cavity. The others showed similar corrosion products but in lesser amounts. None of the switches showed any evidence of fluid ingress by the environmental seal.

The ingress activity on the rocked switches was similar to that observed on parts returned from the field, albeit of a lesser magnitude. It is believed that, given sufficient time (to allow current to pass through the contacts), the ingress on the rocked switches would exhibit exactly the same failure as that observed on the warranty parts.

The shower test detailed above, leads to the conclusion that a "rocked" connector was the most probable root cause of the observed problem. The impact of the problem is magnified in the Econoline platform due to the mounting location and vertical mounting position, both of which are unfavorable from an ingress point of view.
