EA02-025

FORD 10/27/03

Subject: Speed Control Cut-Off Switch
Part Number: F2VY-BF24-A
Source: Customer Vehicle

Object: Determine cause of thermal event.

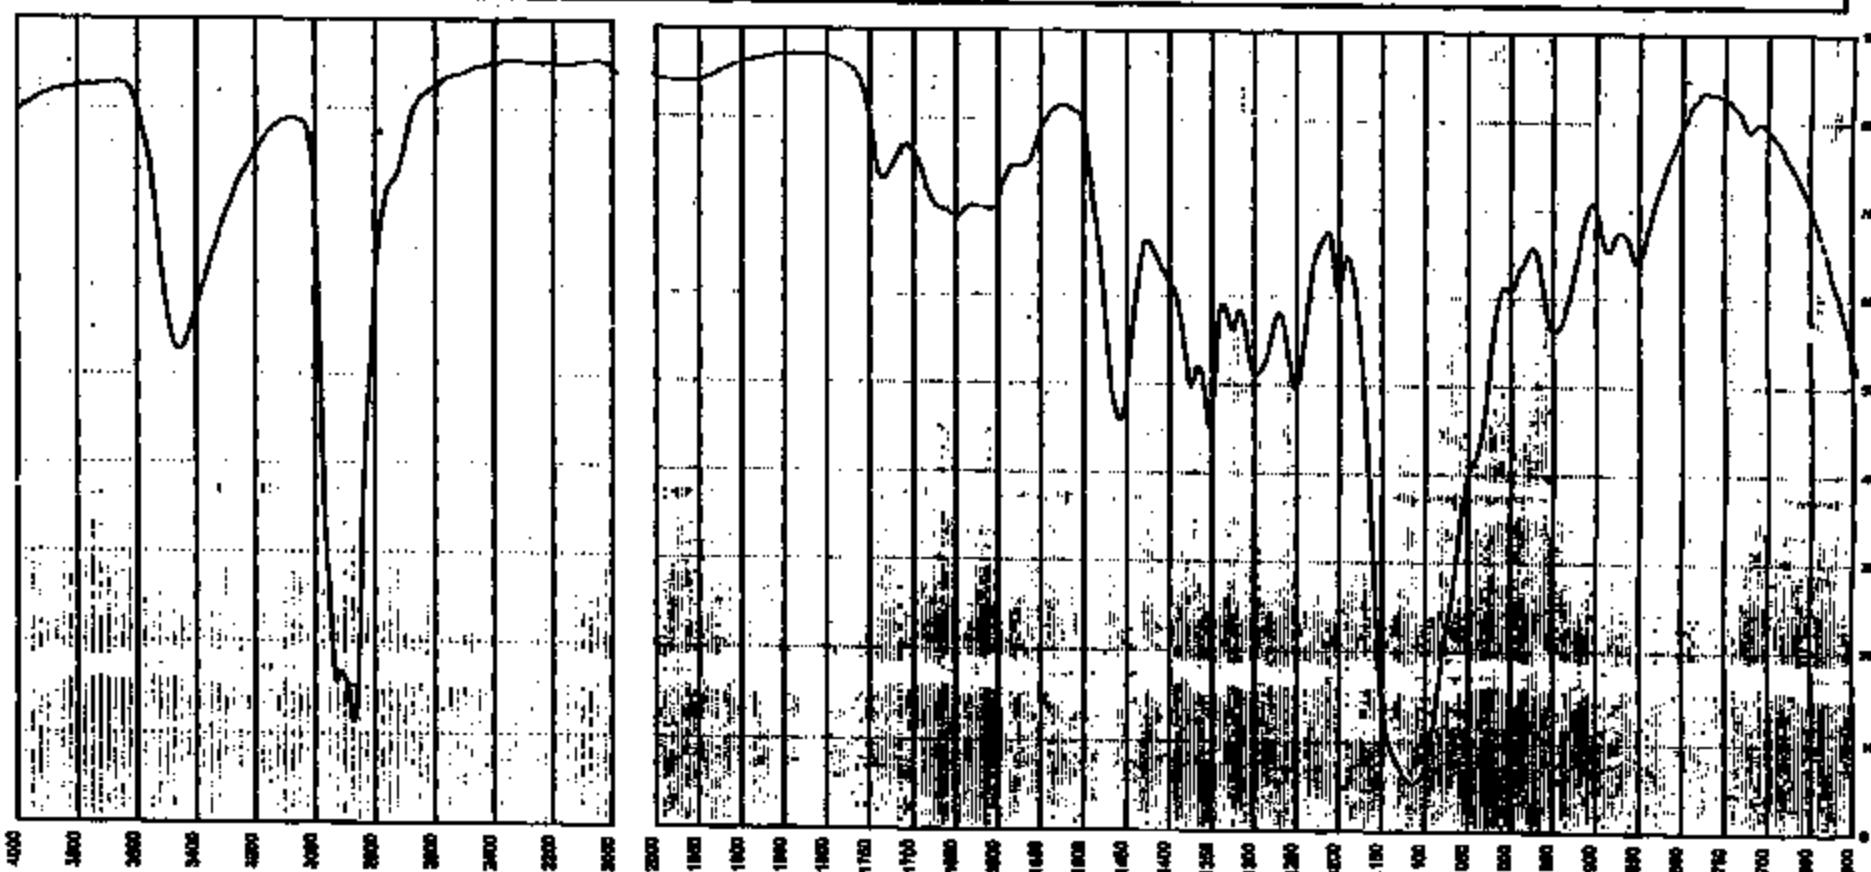
9804105 CONVERTOR

glutaric acid + Al powder, melt, cool, + after material

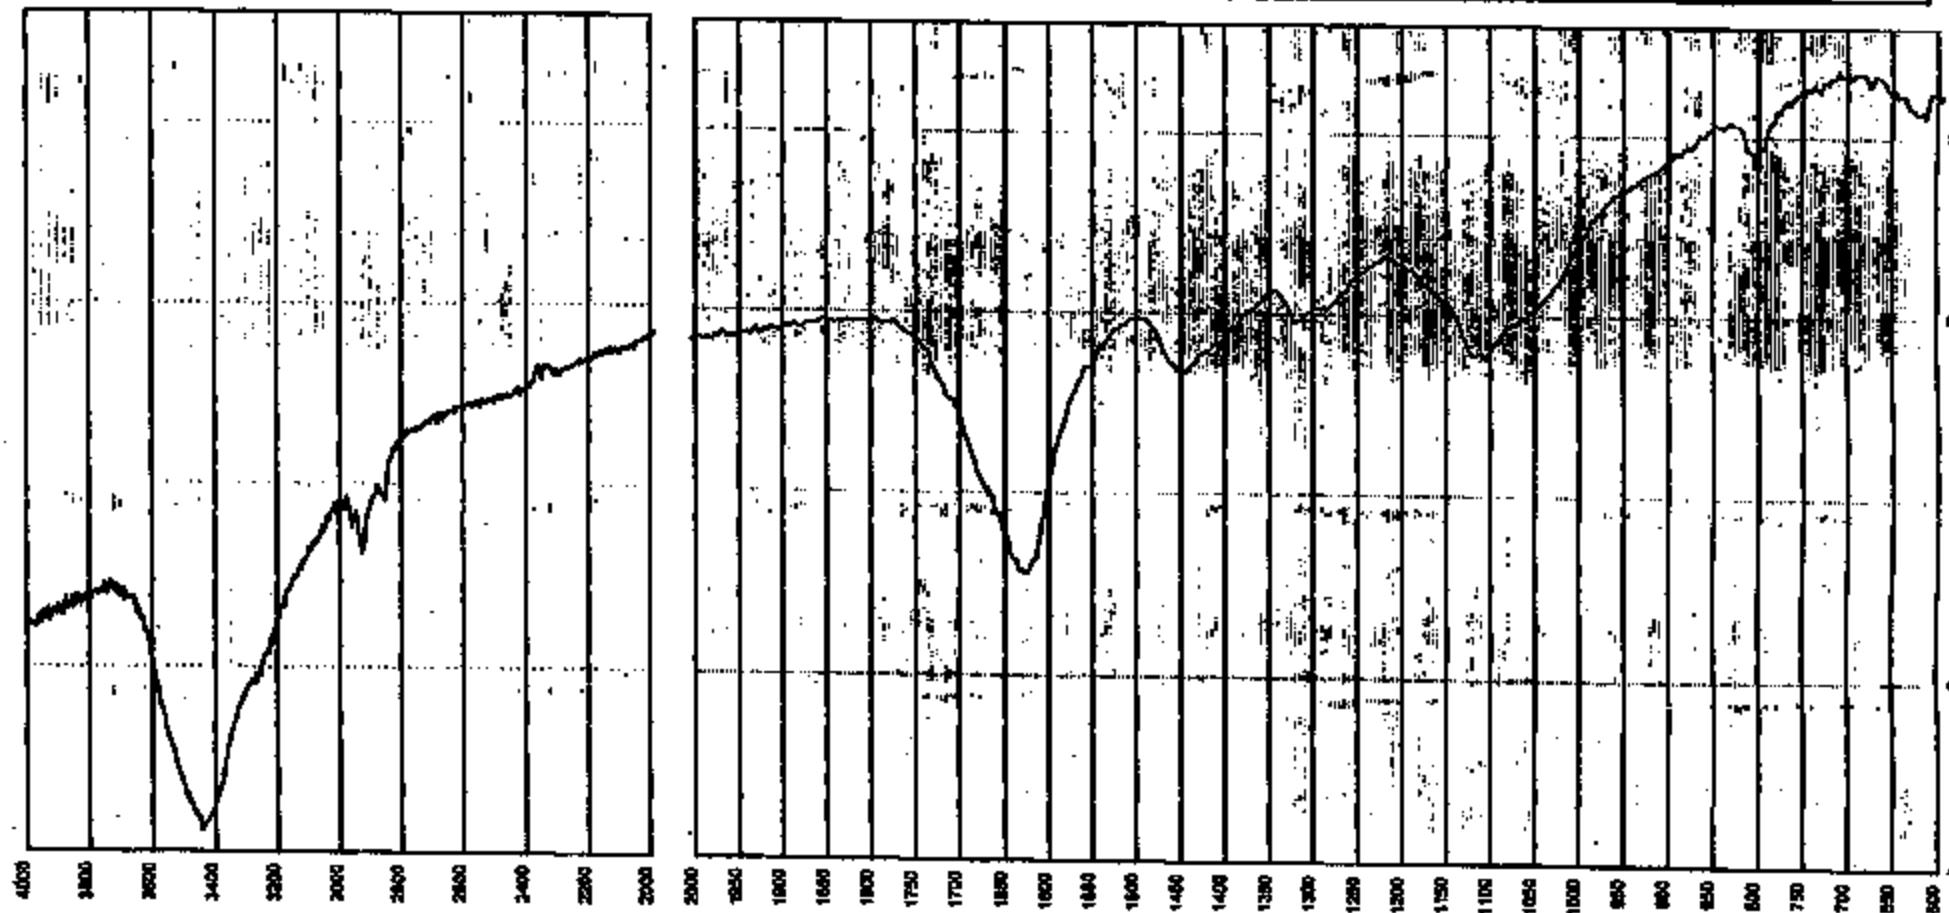
9804105 HEXPORT

anhydrous salt (possibly manganite)

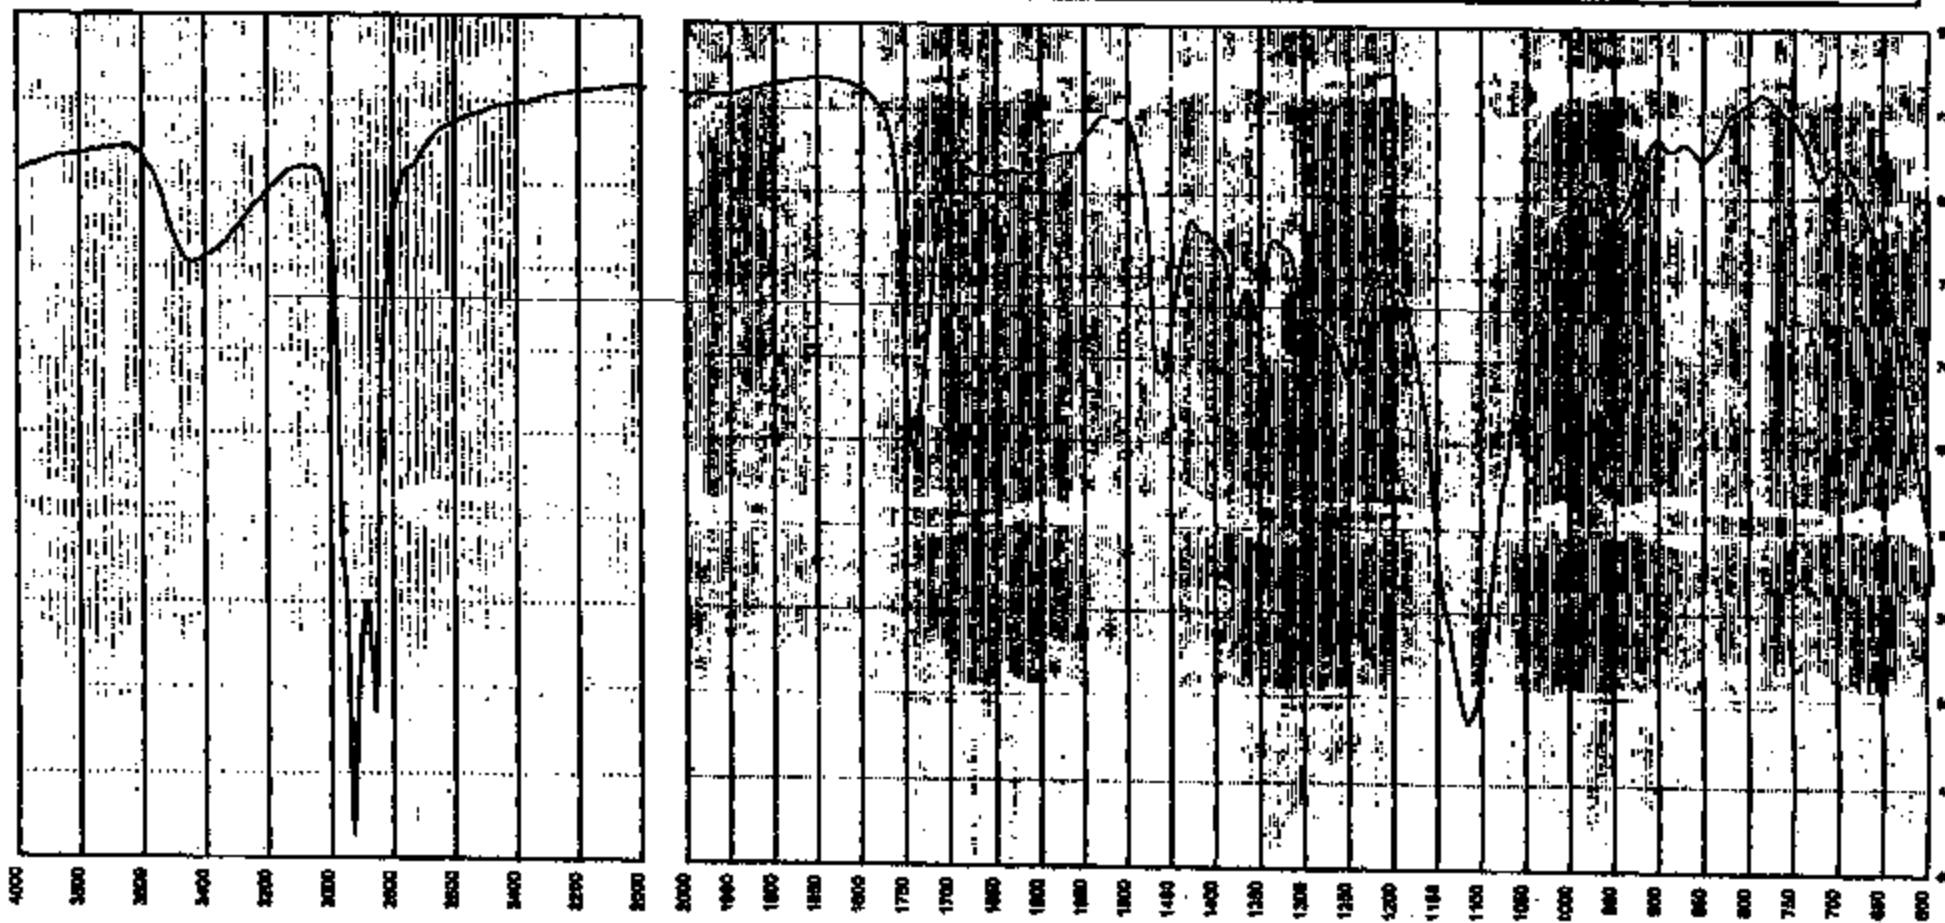
9804105 HEXPORT

glycol and malonate (probably brata (1,3)) + water

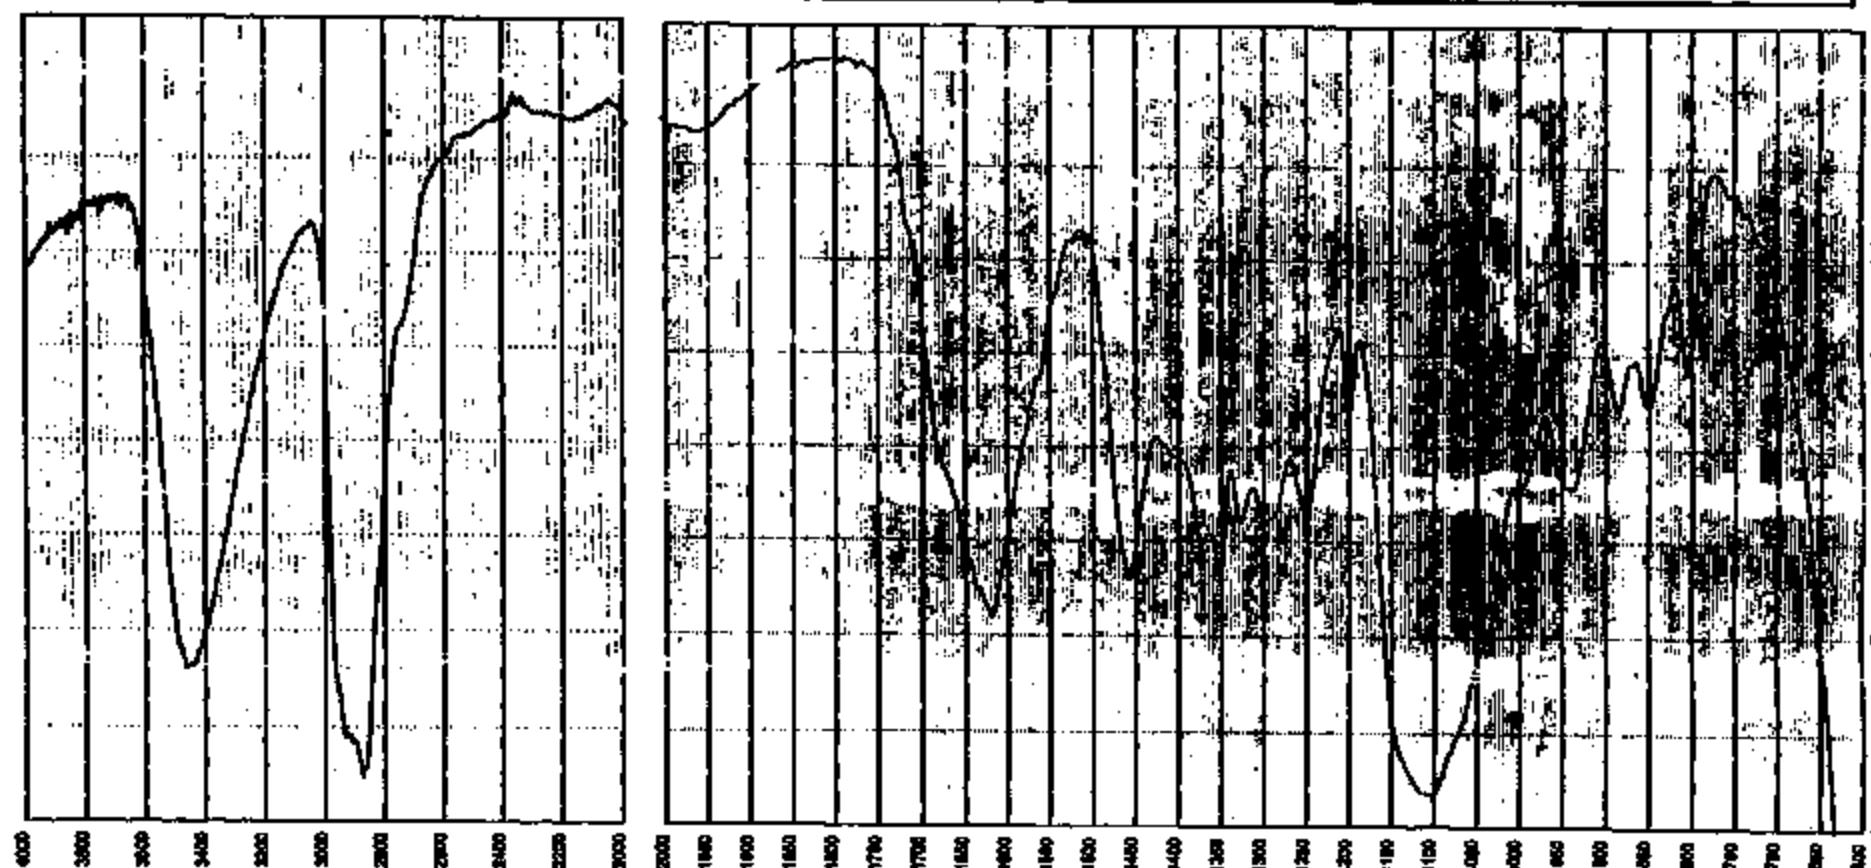
9804105 HEXPORT, DEPOSIT

Slight broad mband (possibly antifreeze) - metal salt (possibly oxalate)
