**EA02-025**

**APPENDIX N**

## Brake Pressure Switch Questions

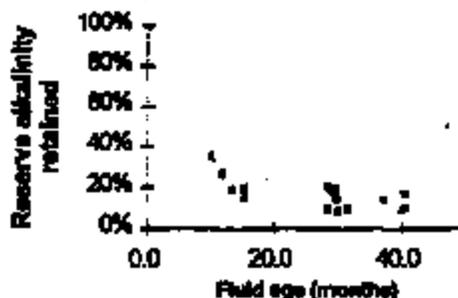
Figure 1 shows the residual RA (as % of initial value) of a brake fluid in matched vehicles 0-3.5 years old, plotted as a function of the age of the fluid. By 30 months (about 50,000 km) the RA has dropped to as low as 9% of its initial value, and about half of this small residual RA arises from components other than the amines. The titration data therefore suggest a 20-fold reduction in primary inhibitor concentration over 2-3 years of service.

Figure 1: Decrease in reserve alkalinity of a brake fluid during vehicular use.

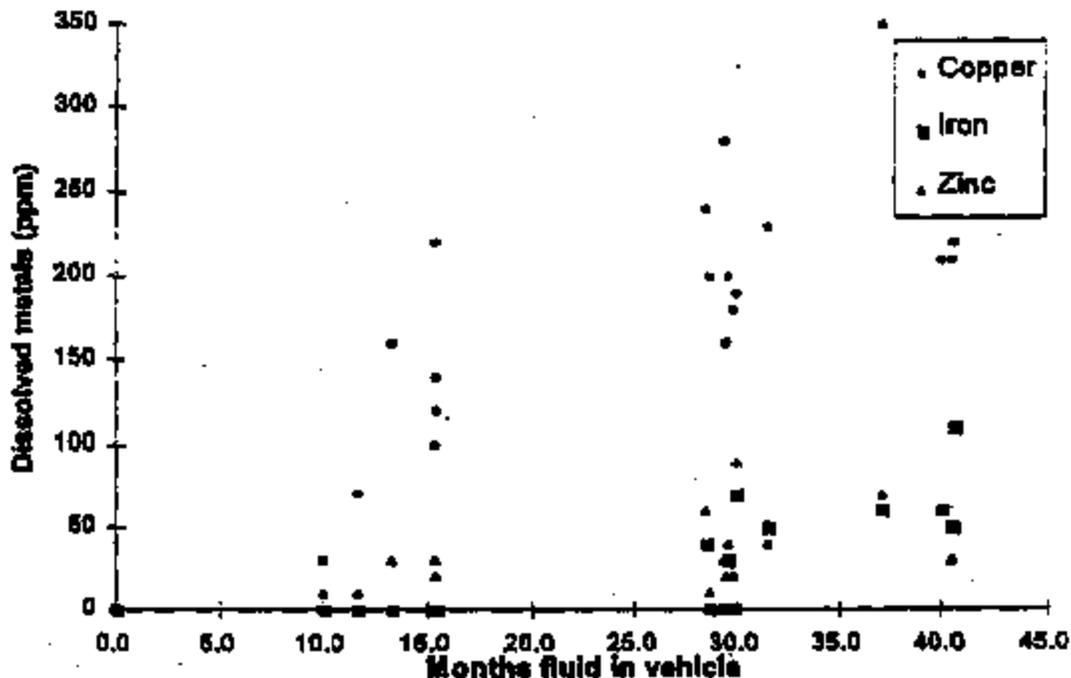
Dissolved iron appears in the brake fluid after the initial zinc corrosion inhibitors are significantly depleted and dissolved copper levels rise to around 200 ppm. The apparent induction period for iron corrosion has presented difficulties in testing technological changes designed to maintain this effect; no test protocol employing fresh brake fluid had succeeded in reproducing the iron corrosion observed at times in vehicles after several years' service. Later sections of this paper will show that attention to the chemical changes in brake fluid during use has led to test procedures which reproduce the field vehicular effects within 6 months.

The dissolved zinc levels in Figure 2 show no evidence of the induction time seen for iron. Since testing for corrosion protection of zinc in brake fluid is known to be problematic even in fresh brake fluids<sup>11</sup> (it is not yet a requirement of FMVSS116), it would not be entirely surprising if some Zn corrosion is occurring even after relatively short service. Another possible source of the observed zinc is extraction of Zn compounds from hoses.

Figure 2: Dissolved metals in a fluid as fraction of time of use.

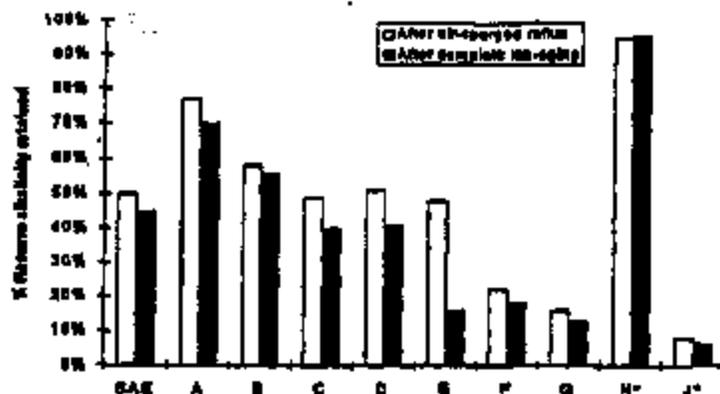
Figure 3: % Reserve alkalinity retained after thermal oxidation and after complete lab-aging procedures were applied to SAE compatibility fluid RM-66-04 and commercially available fluids (\* indicates DOT 4 fluid).

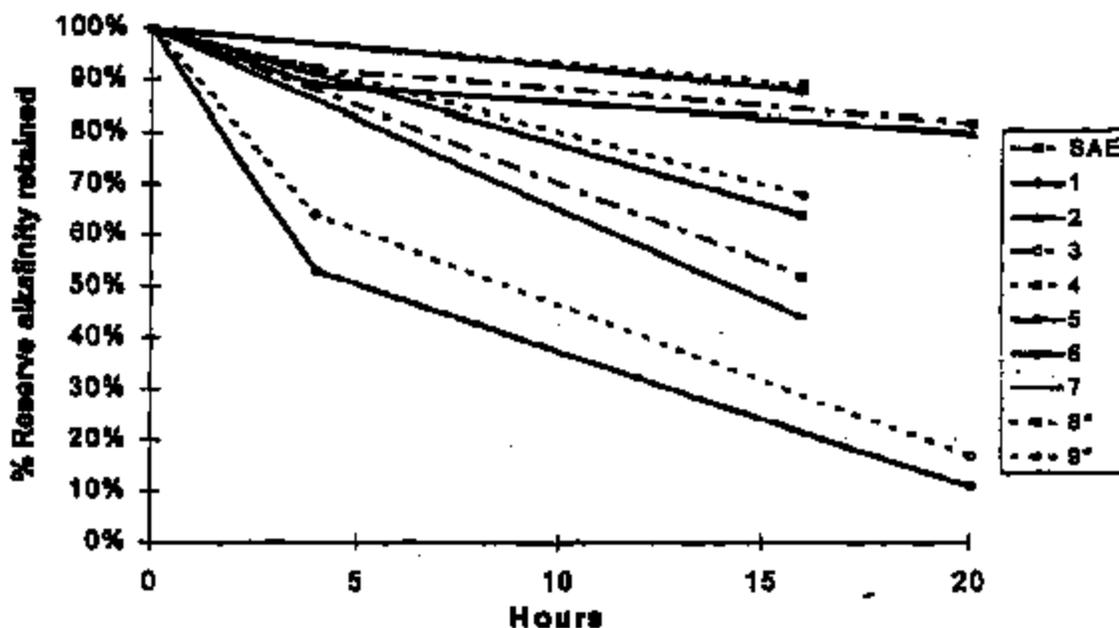
Figure 4: Reserve alkalinity retention as function of heating time (uncovered) at 100° C for SAE compatibility fluid RM-66-04 and various commercially available fluids (\* indicates DOT 4 fluid).

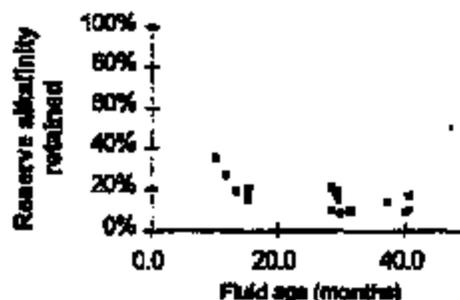
Figure 1 shows the residual RA (as % of initial value) of a brake fluid in matched vehicles 0-3.5 years old, plotted as a function of the age of the fluid. By 30 months (about 50,000 km) the RA has dropped to as low as 9% of its initial value, and about half of this small residual RA arises from components other than the amines. The titration data therefore suggest a 20-fold reduction in primary inhibitor concentration over 2-3 years of service.

Figure 1: Decrease in reserve alkalinity of a brake fluid during vehicular use.

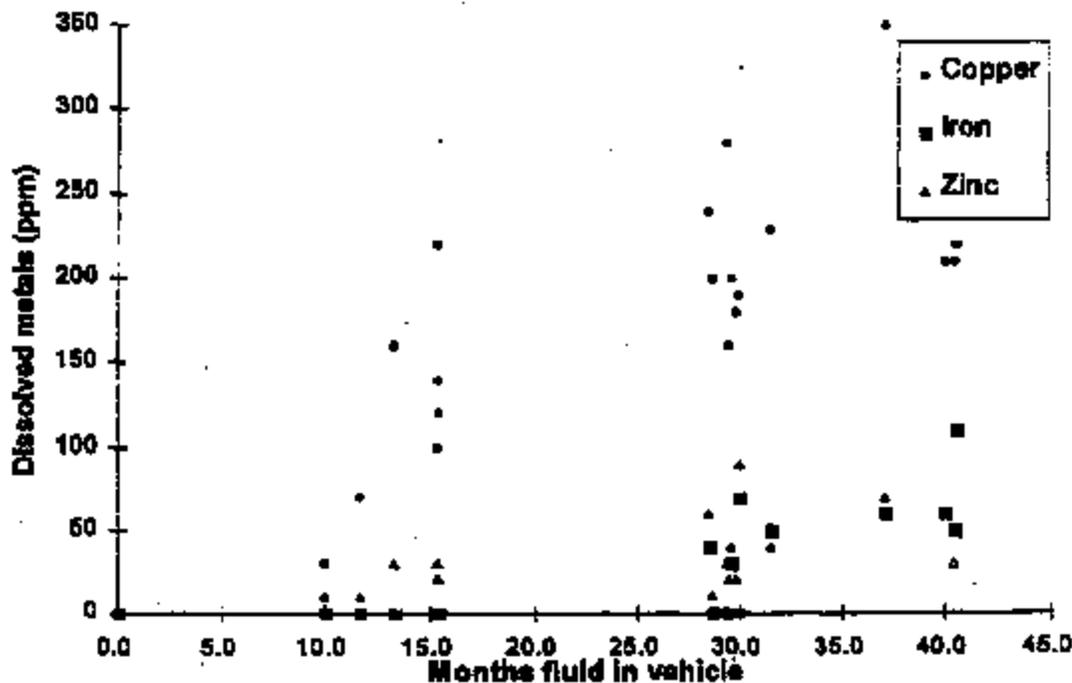
Figure 3: Dissolved metals in a fluid as function of time of use.

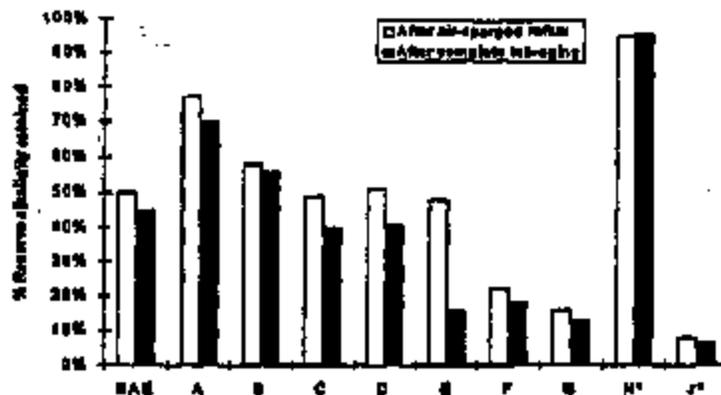
Figure 3: % Reserve alkalinity retained after thermal oxidation and after complete lab-aging procedure were applied to SAE compatibility fluid RM-66-04 and commercially available fluids (\* indicates DOT 4 fluid).

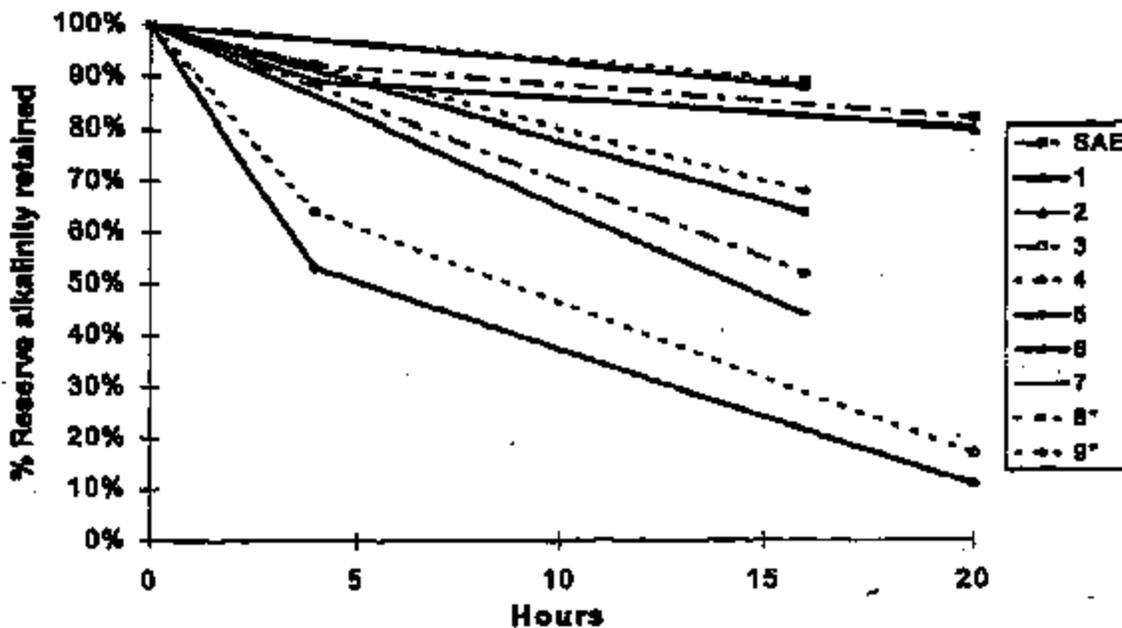
Figure 4: Reserve alkalinity retention as function of heating time (uncovered) at 100° C for SAE compatibility fluid RM-66-04 and various commercially available fluids (\* indicates DOT 4 fluid).
