**EA02-025**

**FORD**

YES E7SC-2B091-AA

## ENGINEERING SPECIFICATION

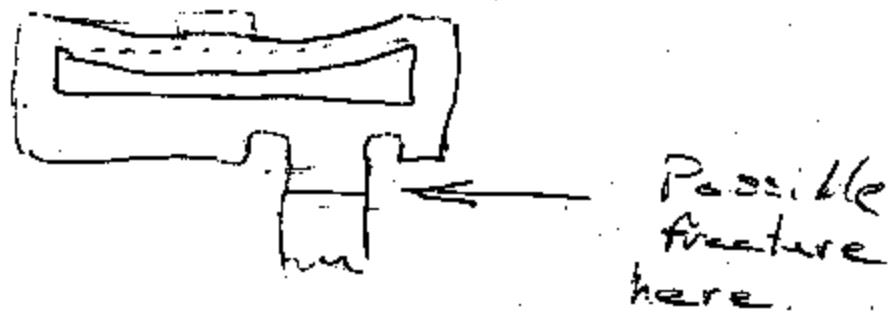
- No obvious contamination.
- Possible fracture in Boxed Area.
- ALSO noted, Slot long edges are not parallel as in drawings.

SW DATE CODE  
2003  
erratic elec. reading

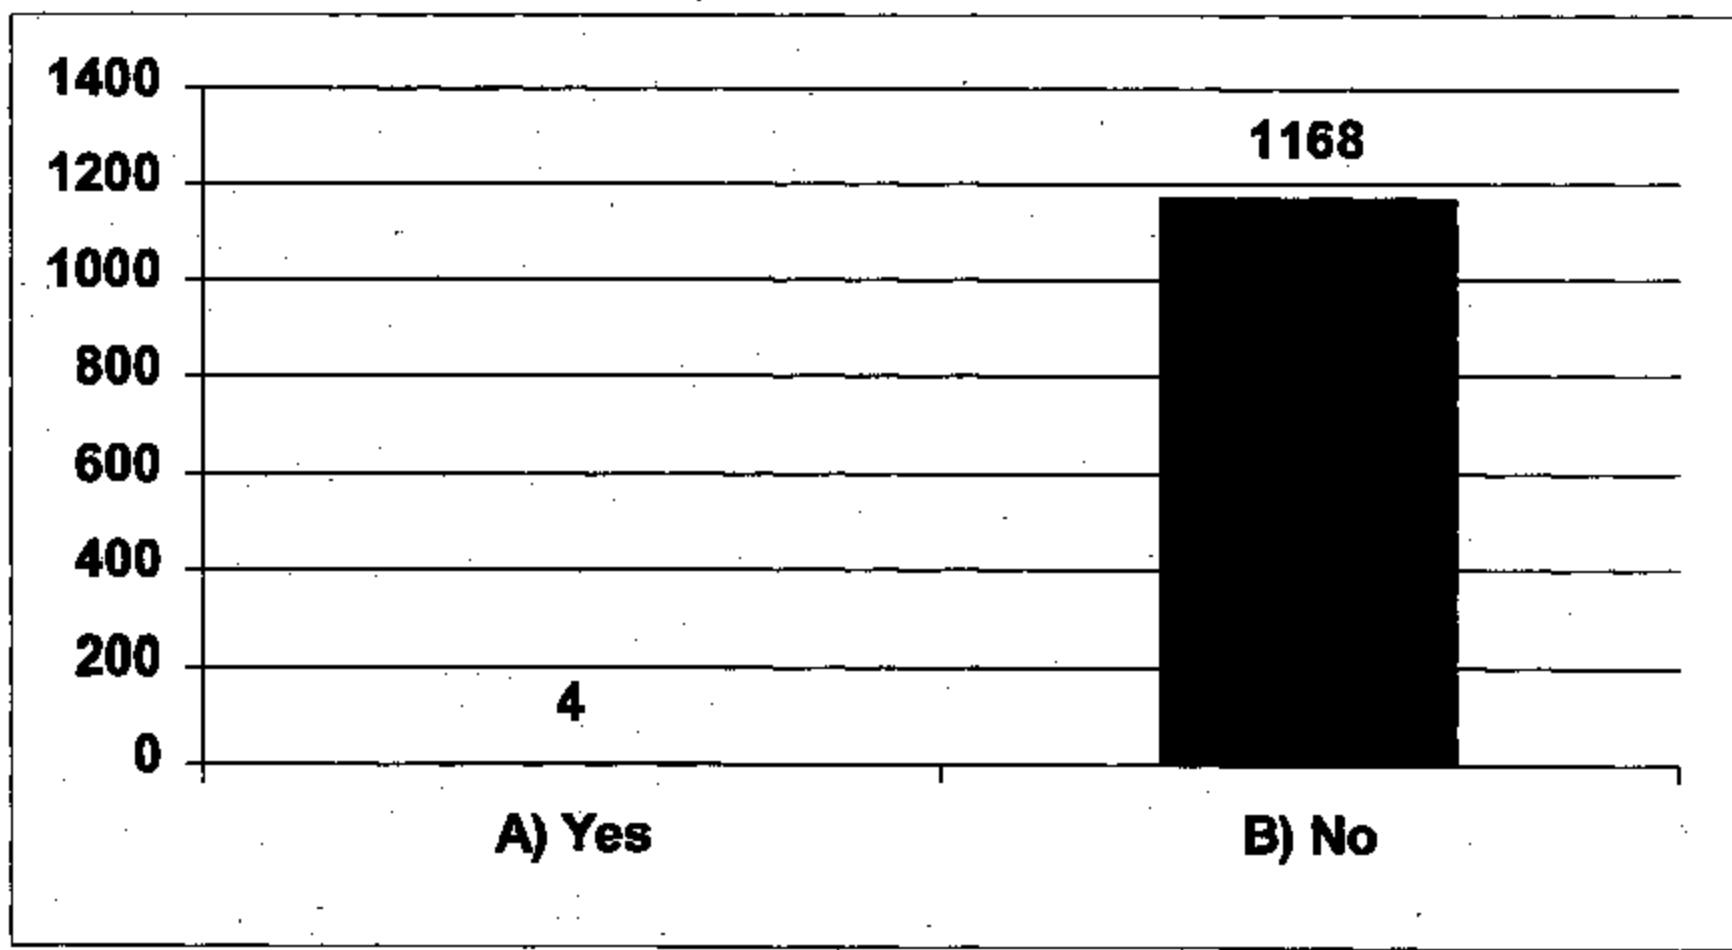
## *Summary of Parts by External Signs Exhibited*

<i>Did Part Exhibit External Signs of a Problem ?</i>	<i>Number of Parts</i>
A) Yes	4
B) No	1168

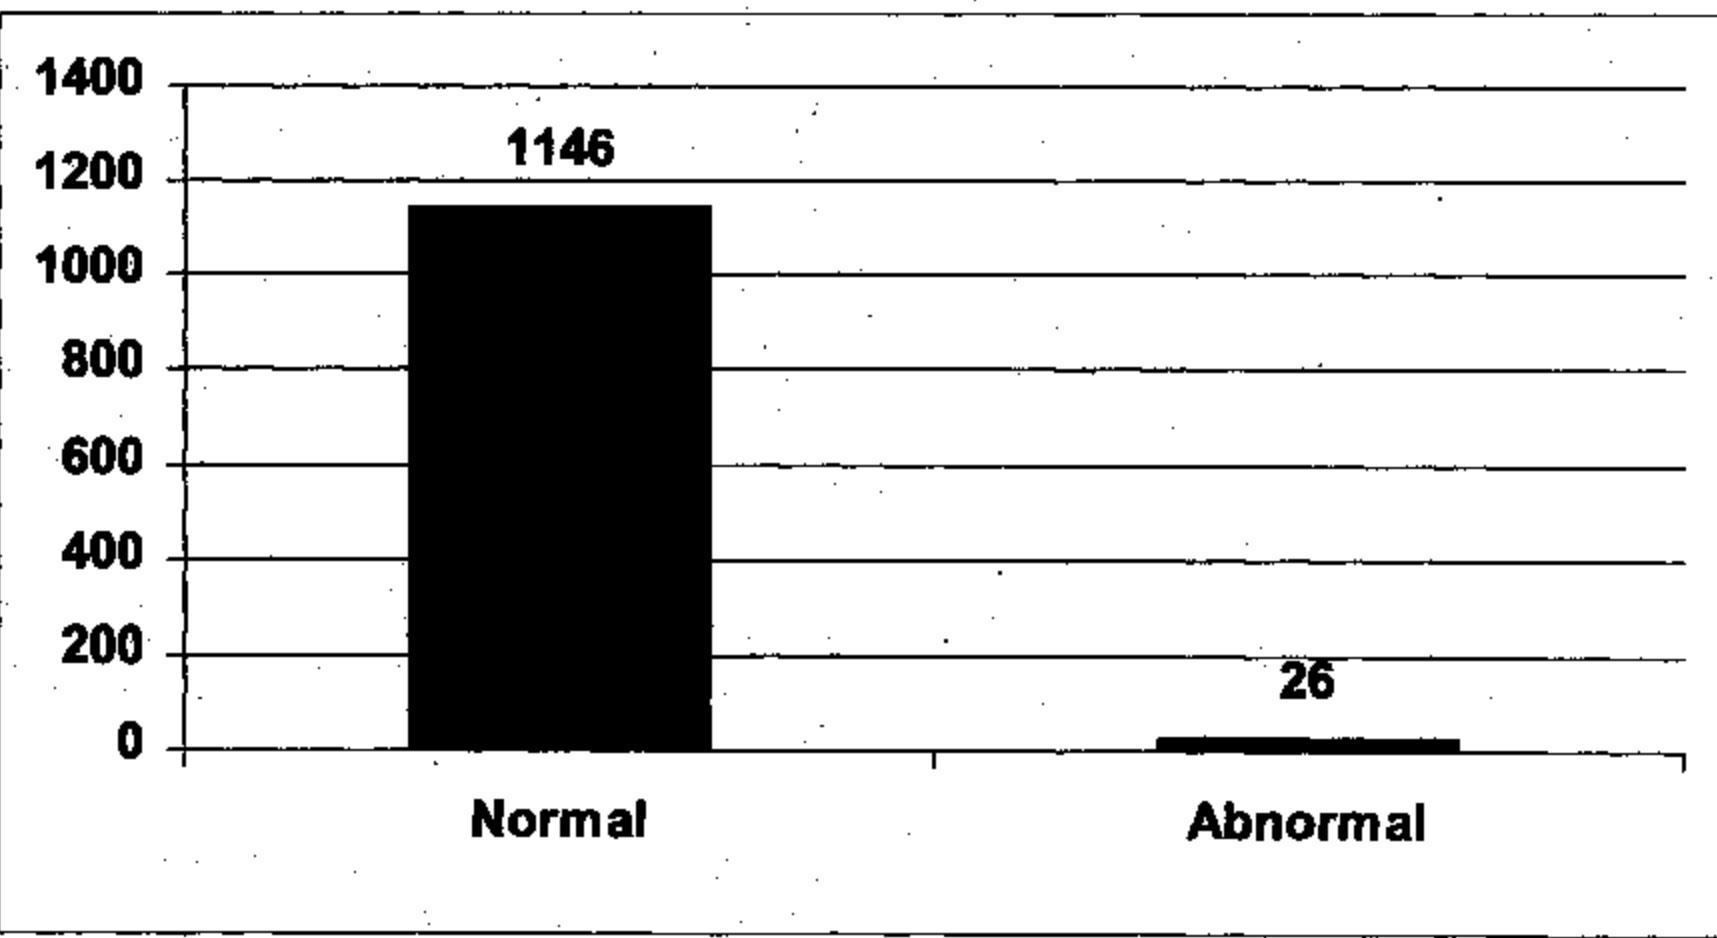
### *Part Summary by Stationary Terminal to Hex Port Resistance*

<i>Resistance Value</i>	<i>Number of Parts</i>
Normal	1146
Abnormal	26

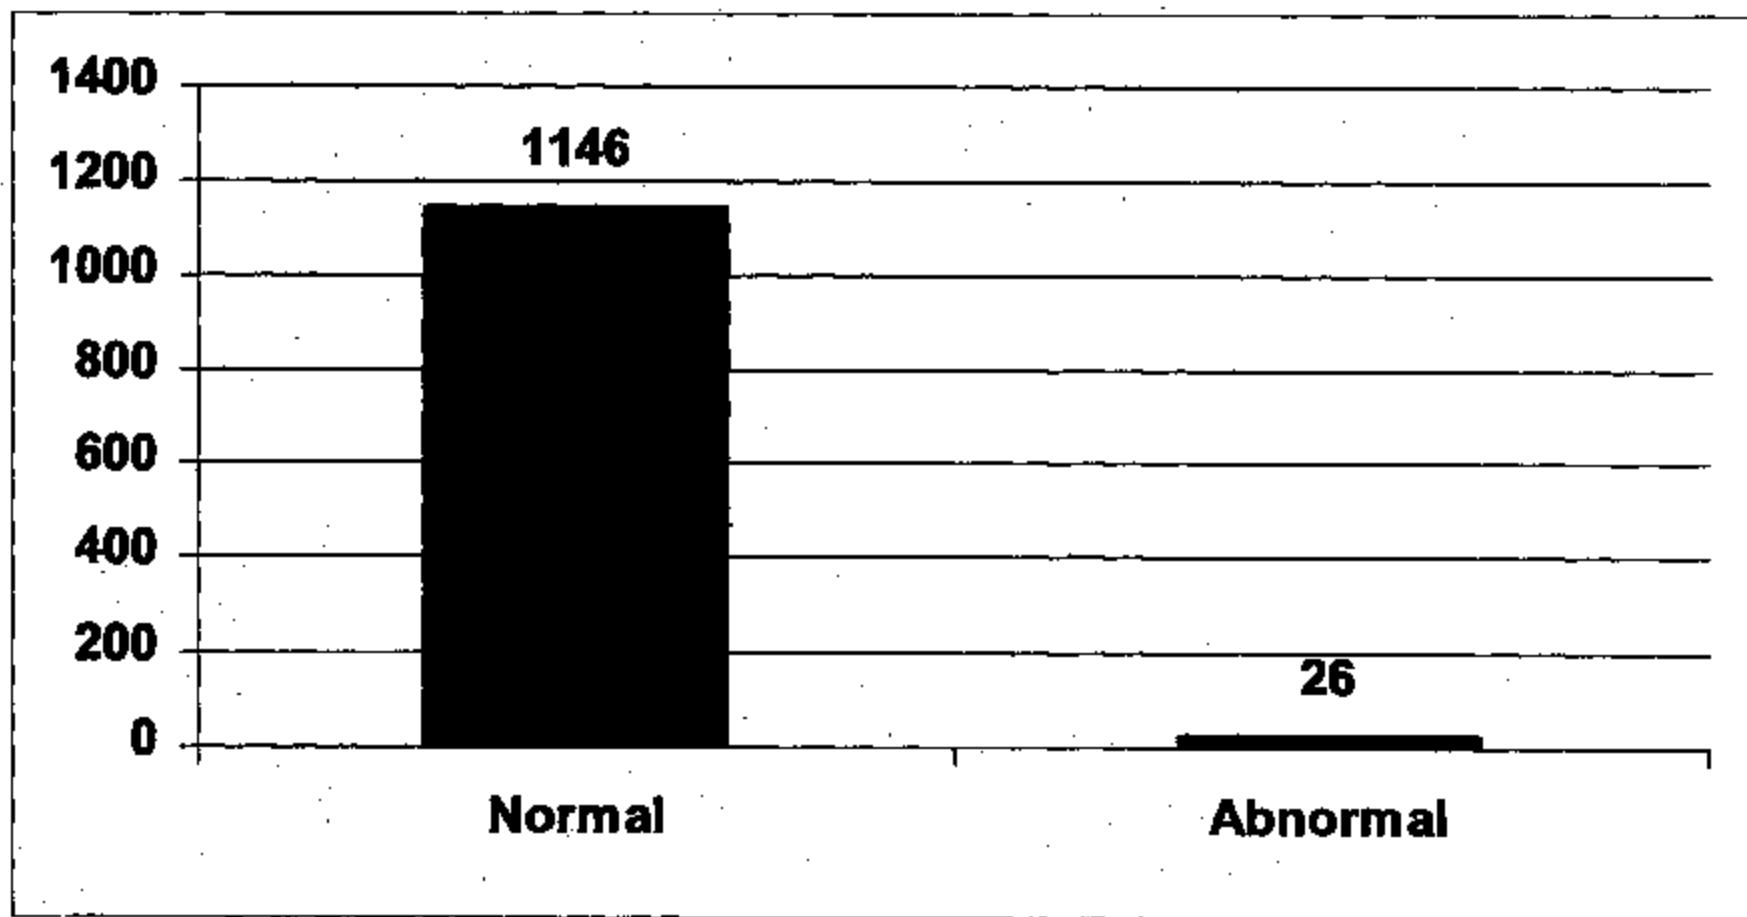
*Part Summary of Moveable Terminal to Hex Port Resistance*

<i>Resistance Value</i>	<i>Number of Parts</i>
Normal	1146
Abnormal	26
