EA02-025

APPENDIX N

Subject: Brake Switch Analysis Project
Project No. DT55052

Hydraulic Pressure Switch Cross Section

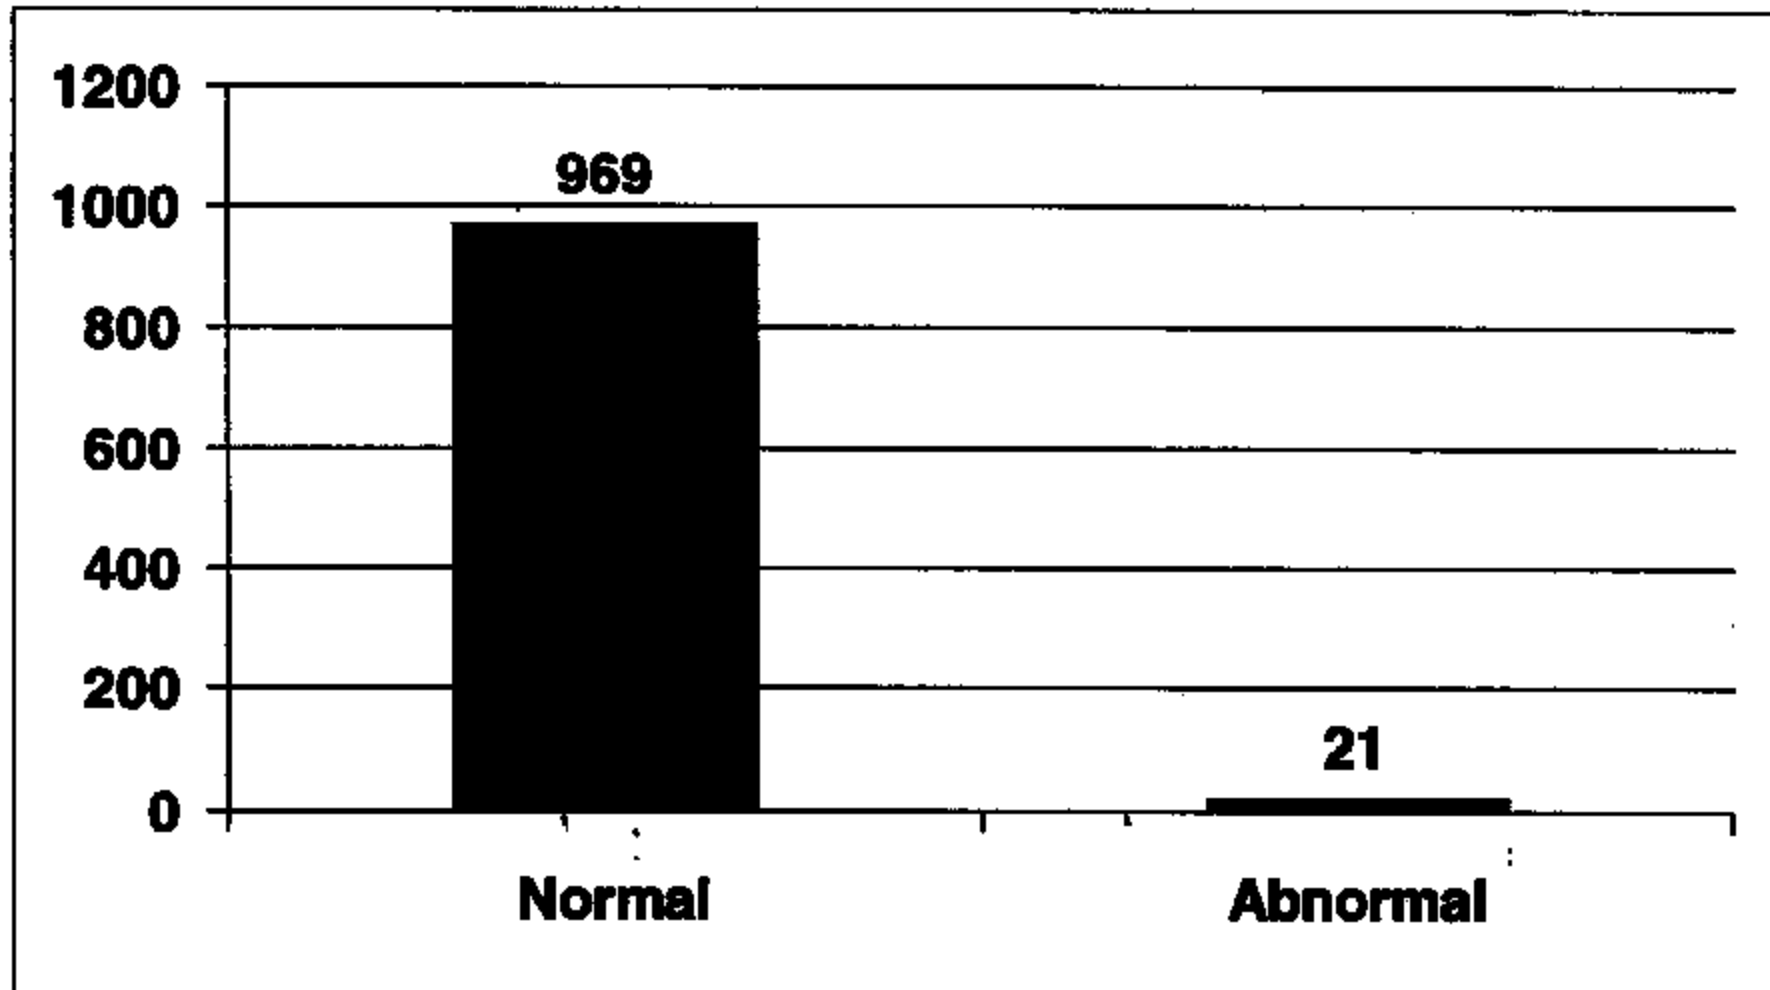
Part Summary by Terminal to Terminal Resistance

Normal	969
Abnormal	21

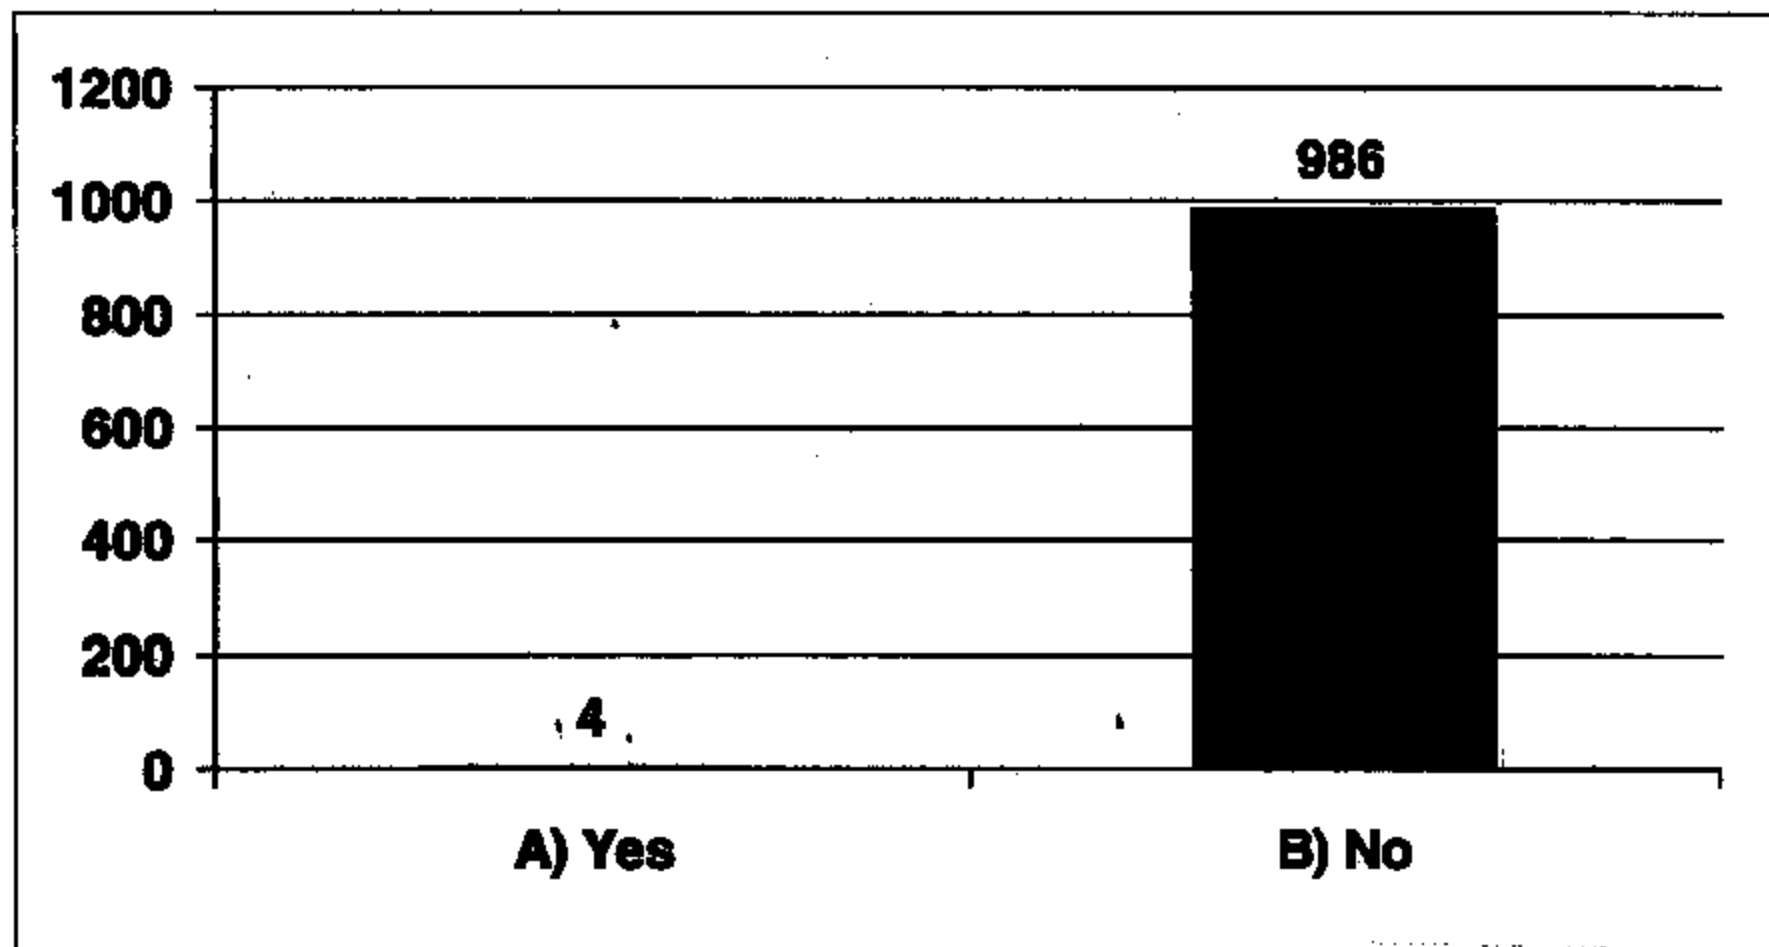
Summary of Parts by External Signs Exhibited

Did Part Exhibit External Signs of a Problem ?

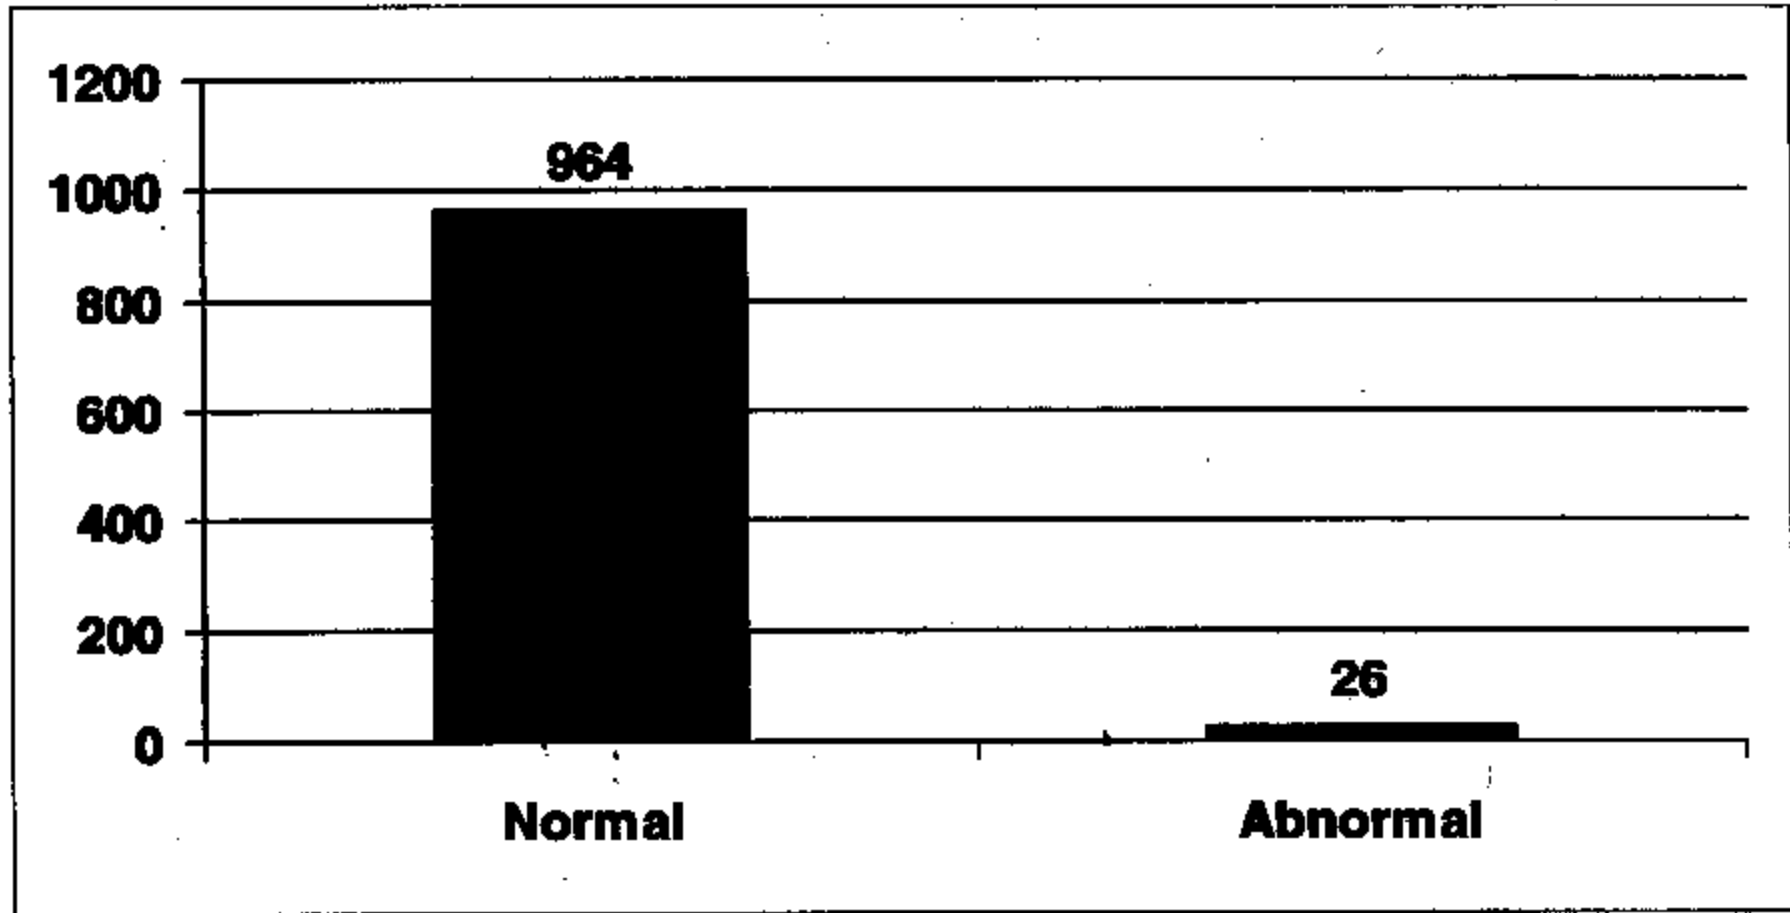
Part Summary of Moveable Terminal to Hex Port Resistance

<i>Resistance Value</i>	<i>Number of Parts</i>
Normal	964
Abnormal	26
