**EA02-025**

**APPENDIX N**

**Object:** Determine the cause of the short-circuit.

**Conclusion:** The short-circuit was caused by a buildup of copper-rich material on the face of the cup, which formed a bridge between the cup and movable contact. The buildup of copper-rich material most likely resulted from electrolytic deposition of movable contact material on the cup. A cell was probably set up in which the contact acted as the anode, the cup acted as the cathode, and the brake fluid served as the electrolyte.

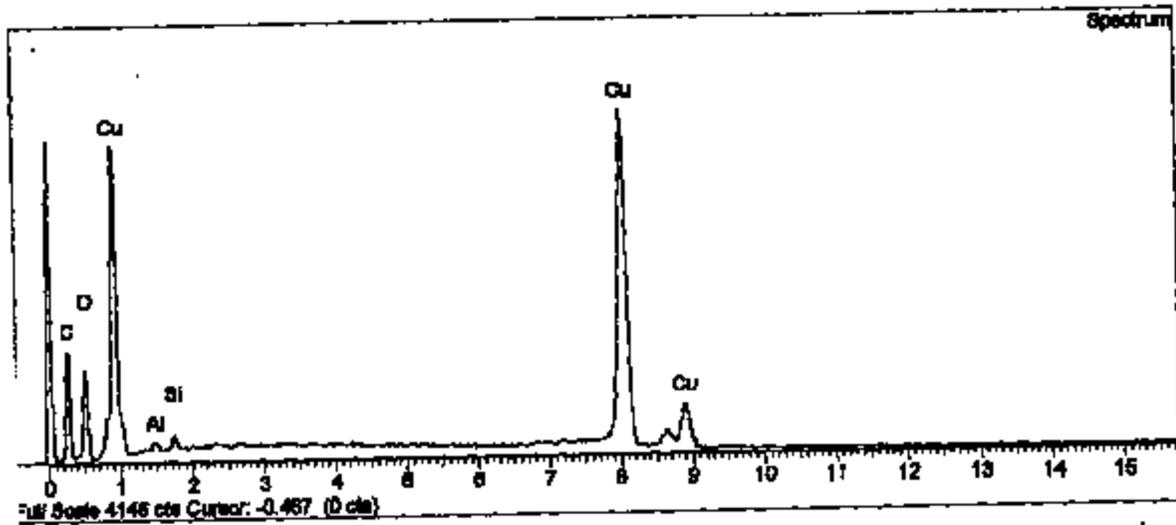
Figure 5: SEM photomicrograph and EDS spectrum of deposit removed from face of cup.

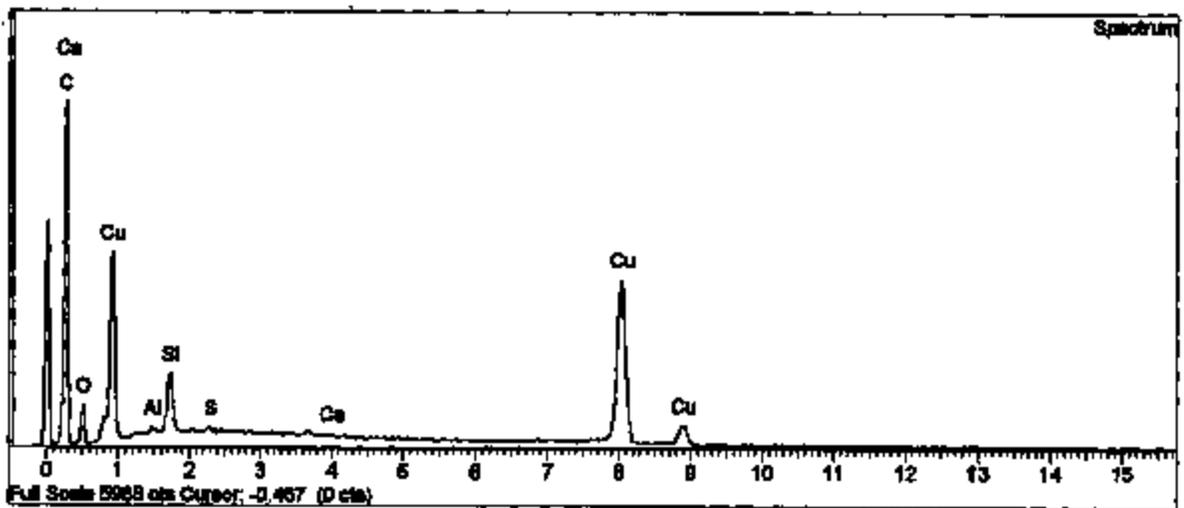
Figure 6: SEM photomicrograph and EDS spectra of deposit removed from face of cup.
