**PE03-044**

**FORD**

**APPENDIX I**

**7.31L 2001-2003 MY Super Duty F-Series / Excursion  
-1C3Z 9F836- Pedal Claims**

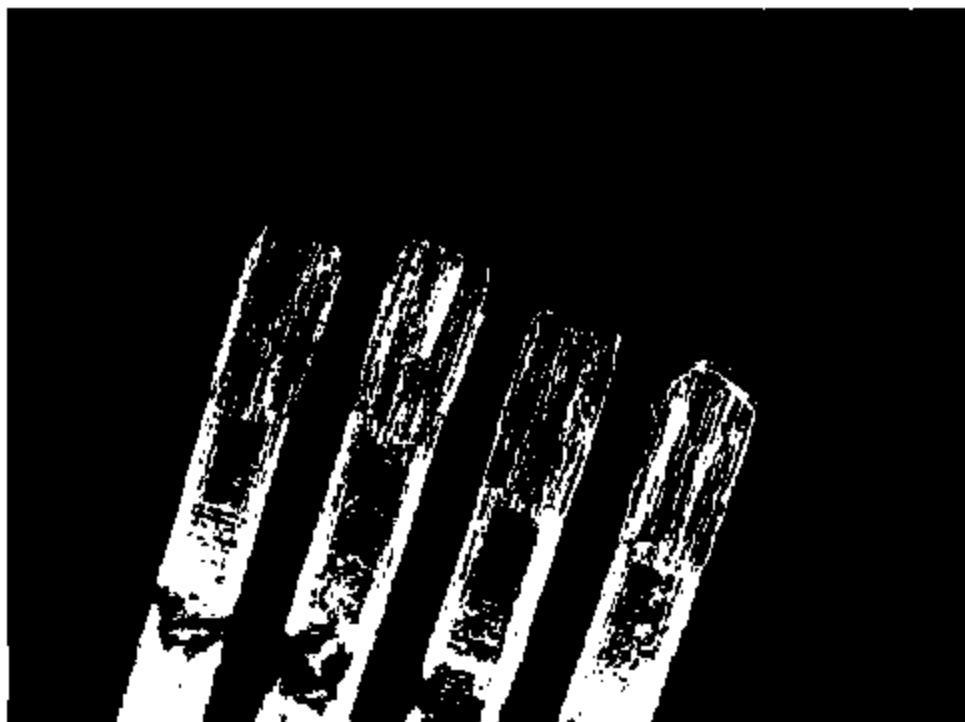
## U 137 Field Failures - #95 Potentiometer Track Contacts

- All of the potentiometer contact fingers were worn off. This was the worst. Possibly due to the lowest rotor height.

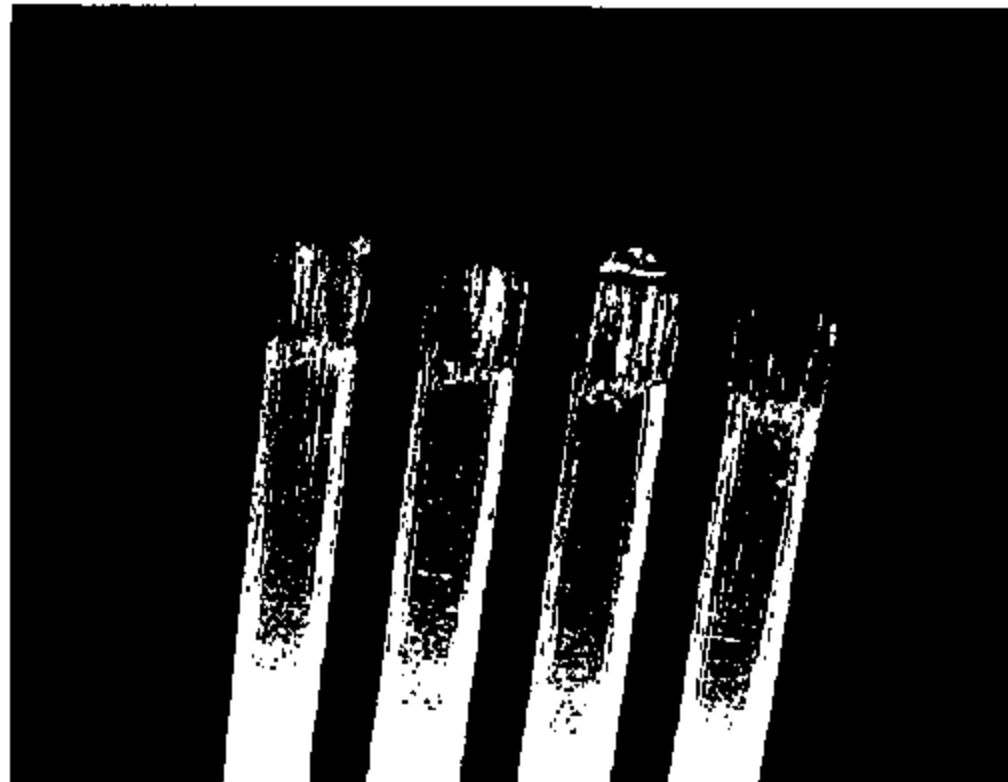
## U 137 Field Failures - #111 Potentiometer Track Contacts

- This was about the least worn. Notice the pieces of the finger material loosely attached.

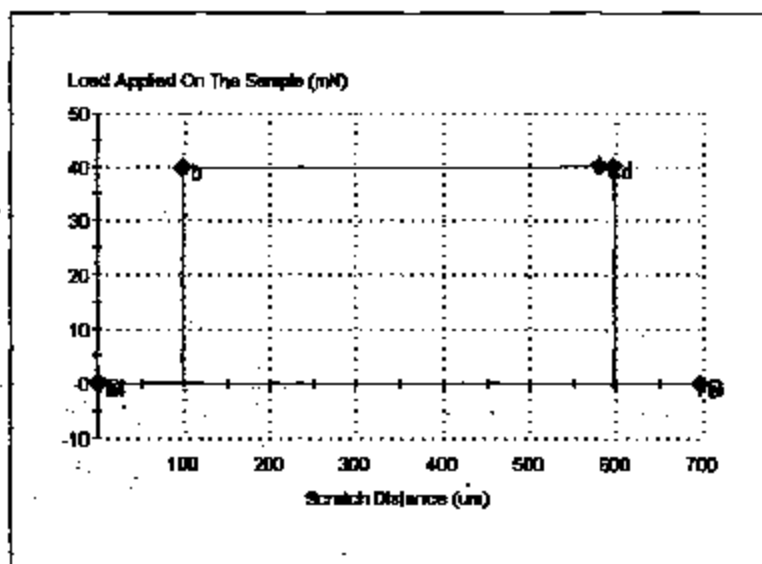
Figure 1: Load profile used during the initial scratch test

The initial tests on Samples 1 and 3 were to scratch the sample with a fine pyramidal tip (scratch motion with apex leading) with a load of 40 mN to form a scratch 500 microns long. The instrument records load and depth profiles. The initial scratch is at nominal load to record the start profile. The second scratch is under the specified load and the third scratch repeats the process at nominal load to indicate the new profile showing permanent damage to the surface. The resulting data is shown in Figures 1 to 3.

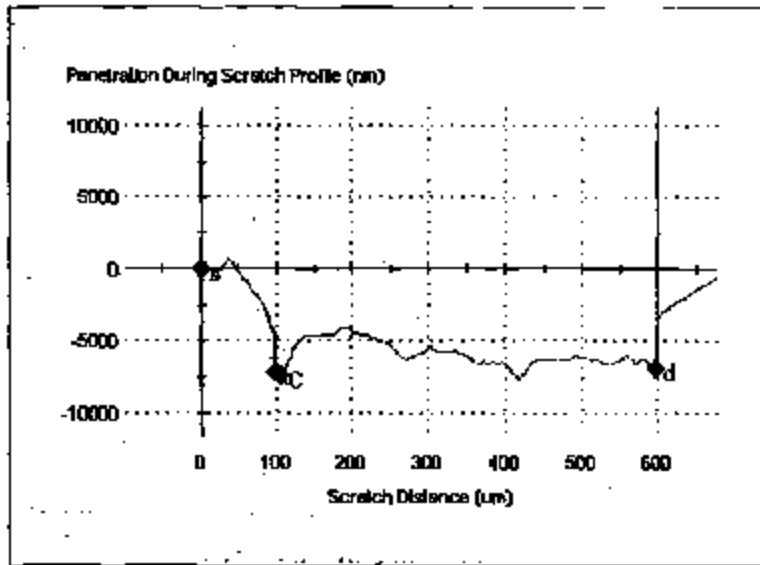
Figure 2: Penetration curve for the "good" sample

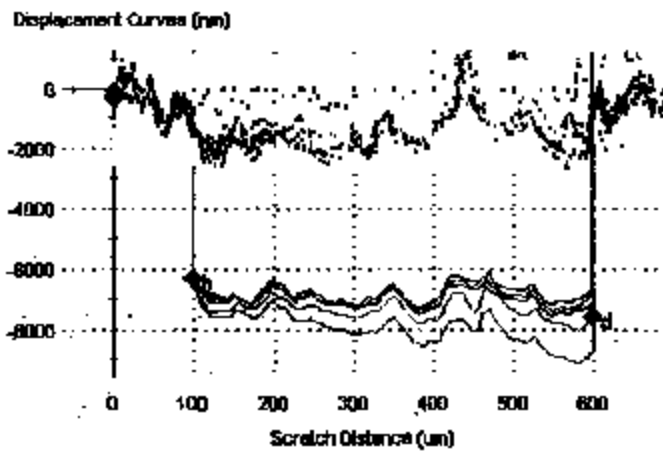
Figure 9: Bad Sample 45978 -- Five scratches at the same location —This includes initial and final morphologies and the scratch displacement corrected for the slope only.

The indenter shows that the initial indentation is about seven microns and the plastic component is about one or two microns with the bad sample appearing a little higher. In spite of this large deformation, the five strokes of the diamond do remarkably little damage and high points which might be associated with the filler particles are largely unchanged. Some smaller particles, may be moved around or lost but not to any catastrophic extent for either film. If there is any significant difference, it lies in plastic deformation of the matrix.
