**PE03-044**  
**FORD**  
**5/13/2005**  
**APPENDIX I**  
**BOOK 23 OF 28**  
**PART 2 OF 4**

Re: MY02/03 P131/U137 ETC Accelerator Pedal Field Action #03B03

Teleflex raised a theory that an electrical issue related to wiring, not a pedal concern, was the cause for unacceptable failure rate on 2002 Model Year F-Series Super Duty and Excursions equipped with ETC pedals. We took your ideas seriously and conducted a very thorough warranty data review and product reviews to determine the contribution of the wiring concern to the extremely high warranty repair data. Our reviews and analyses included not only the Teleflex pedal assembly, but also the related wiring components. We would like to share our conclusions from our analysis with you.

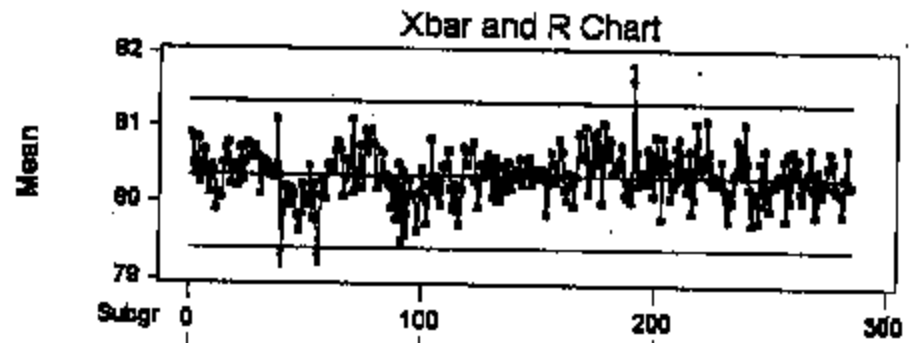
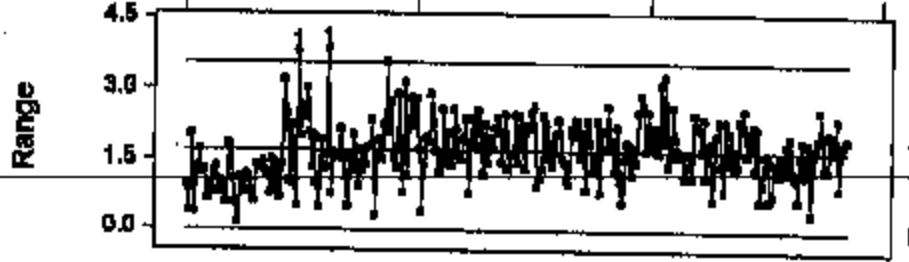
# TRACK 1 IDLE MIN. % VOLTAGE

UCL=81.33  
Mean=60.36  
LCL=79.38

UCL=3.574  
R=1.690  
LCL=0

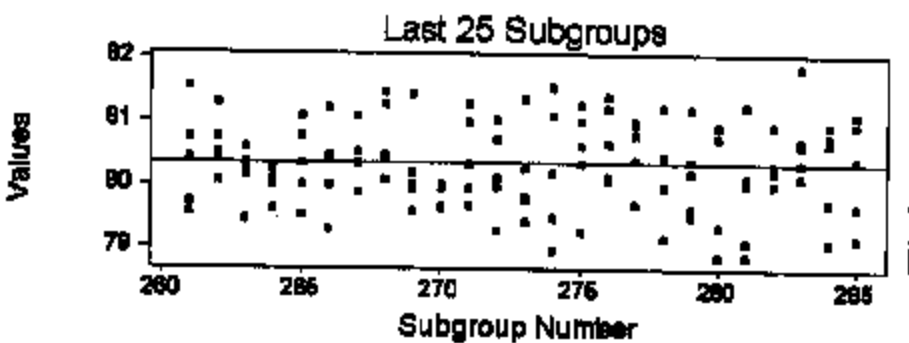
Within  
StDev: 0.726623  
Cp: 1.15  
Cpk: 0.97

Overall  
StDev: 0.730204  
Pp: 1.14  
Ppk: 0.96

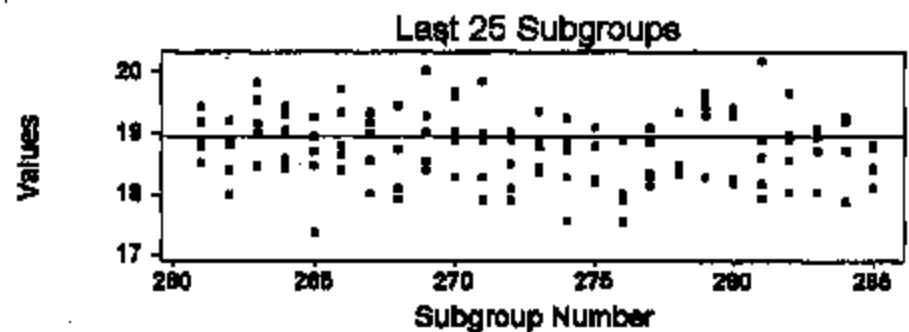
Within  
 StDev: 0.608785  
 Cp: 1.37  
 Cpk: 1.23 -

Overall  
 StDev: 0.688185  
 Pp: 1.21  
 Ppk: 1.09

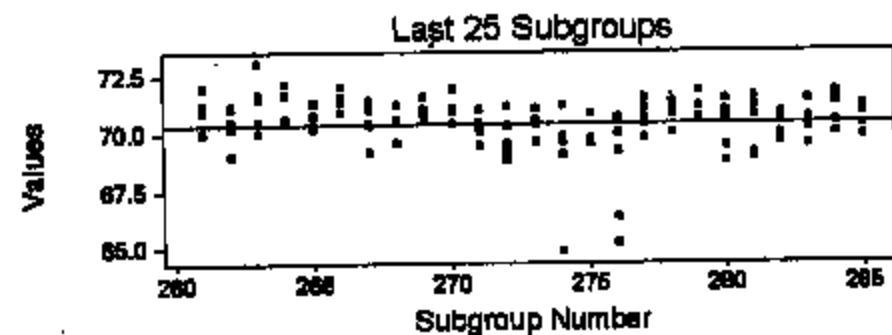
Within  
 StDev: 1.14833  
 Cp: 0.73  
 Cpk: 0.62

Overall  
 StDev: 1.51550  
 Pp: 0.55  
 Ppk: 0.47

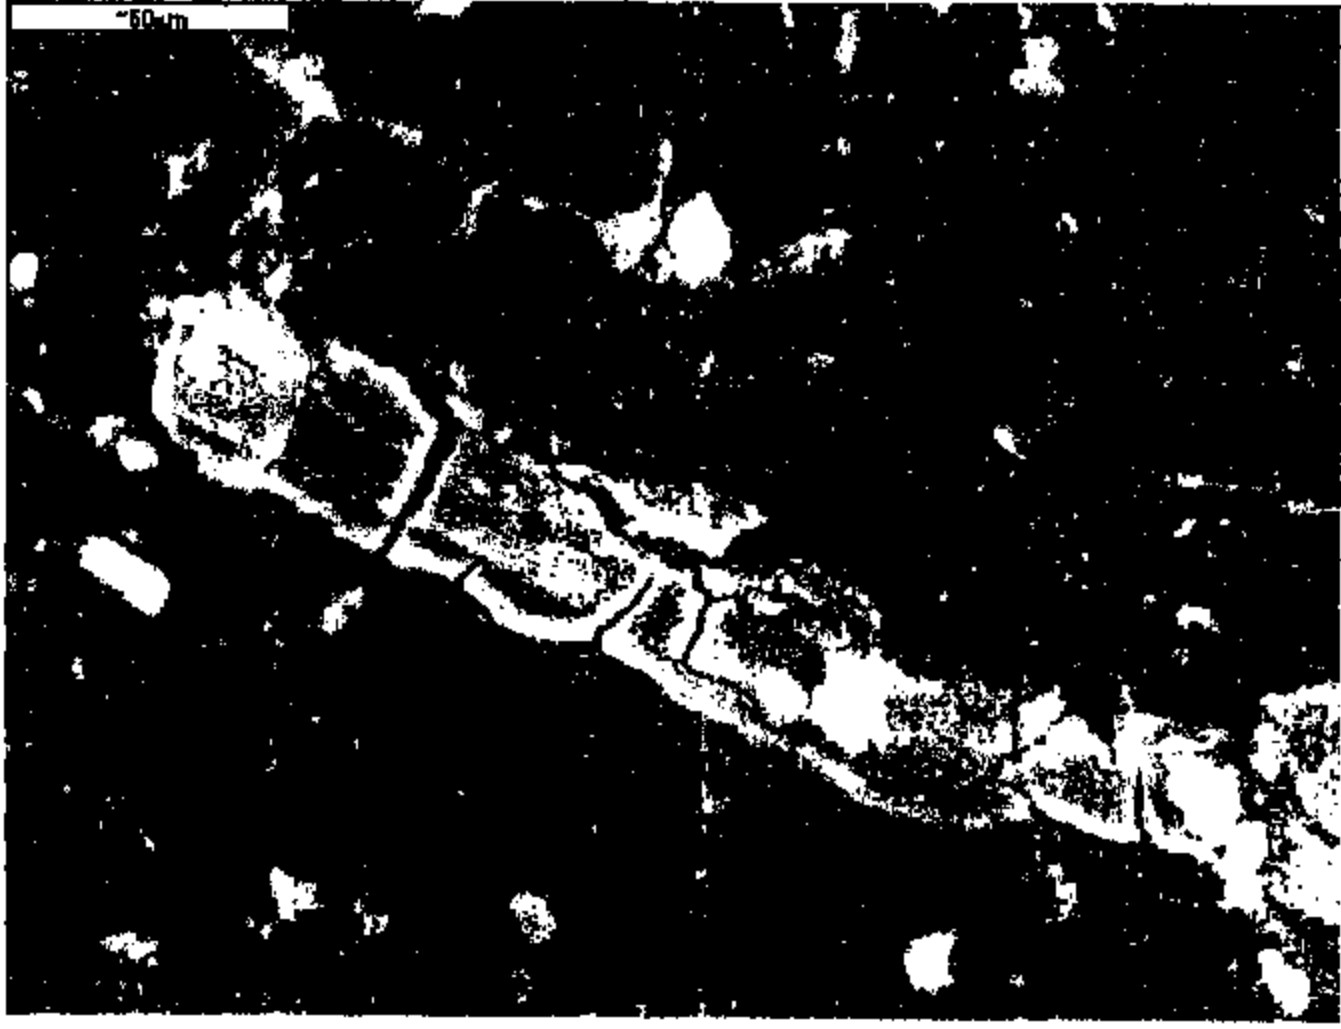
Label: DEW trace #2 area 1

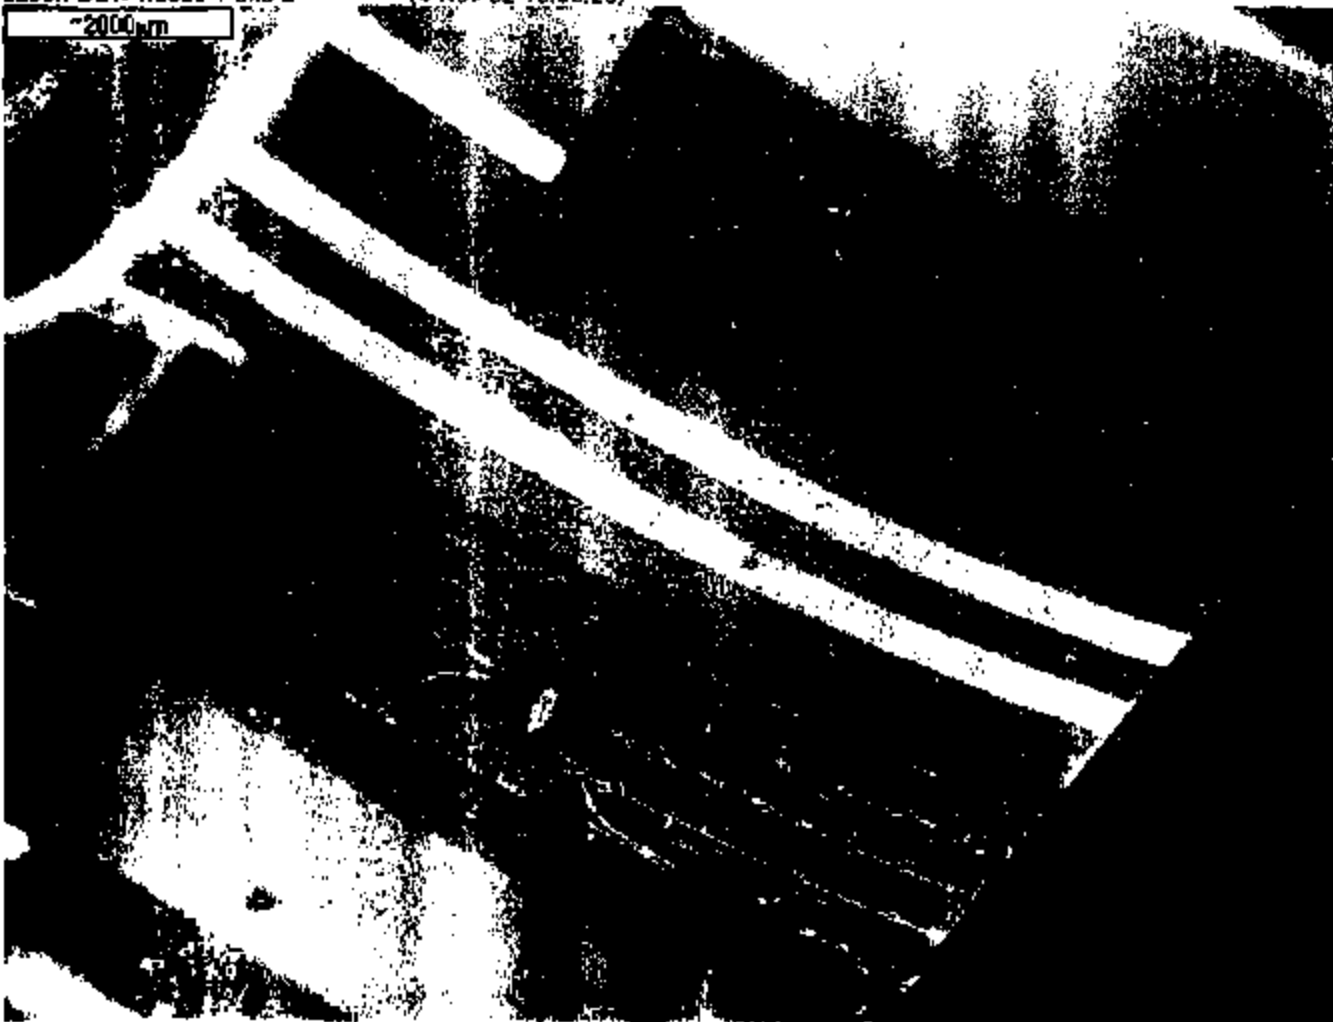
Operator: Steve Simko  
Client: [REDACTED]  
Job: ETC Sensors  
Ree: Ultraline  
Label: DEW traces 1 and 2

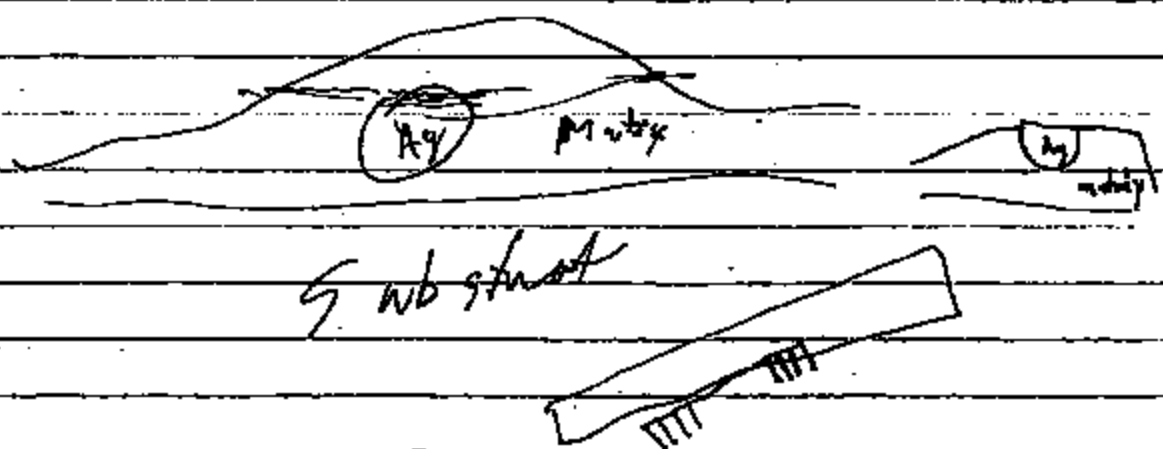
1. DEW fingers look fine. Wear is trace wear.
2. Drastically different wear on DEW ~~finger~~ <sup>traces</sup>
3. Wear appears mechanical. (No electrical wear)
4. ~~Wear is trace wear~~ Mild wear on all transit
5. Initial wear is damage to rough high ~~spots~~ <sup>spots</sup>
6. Chemistry some material transfer from fingers to flat

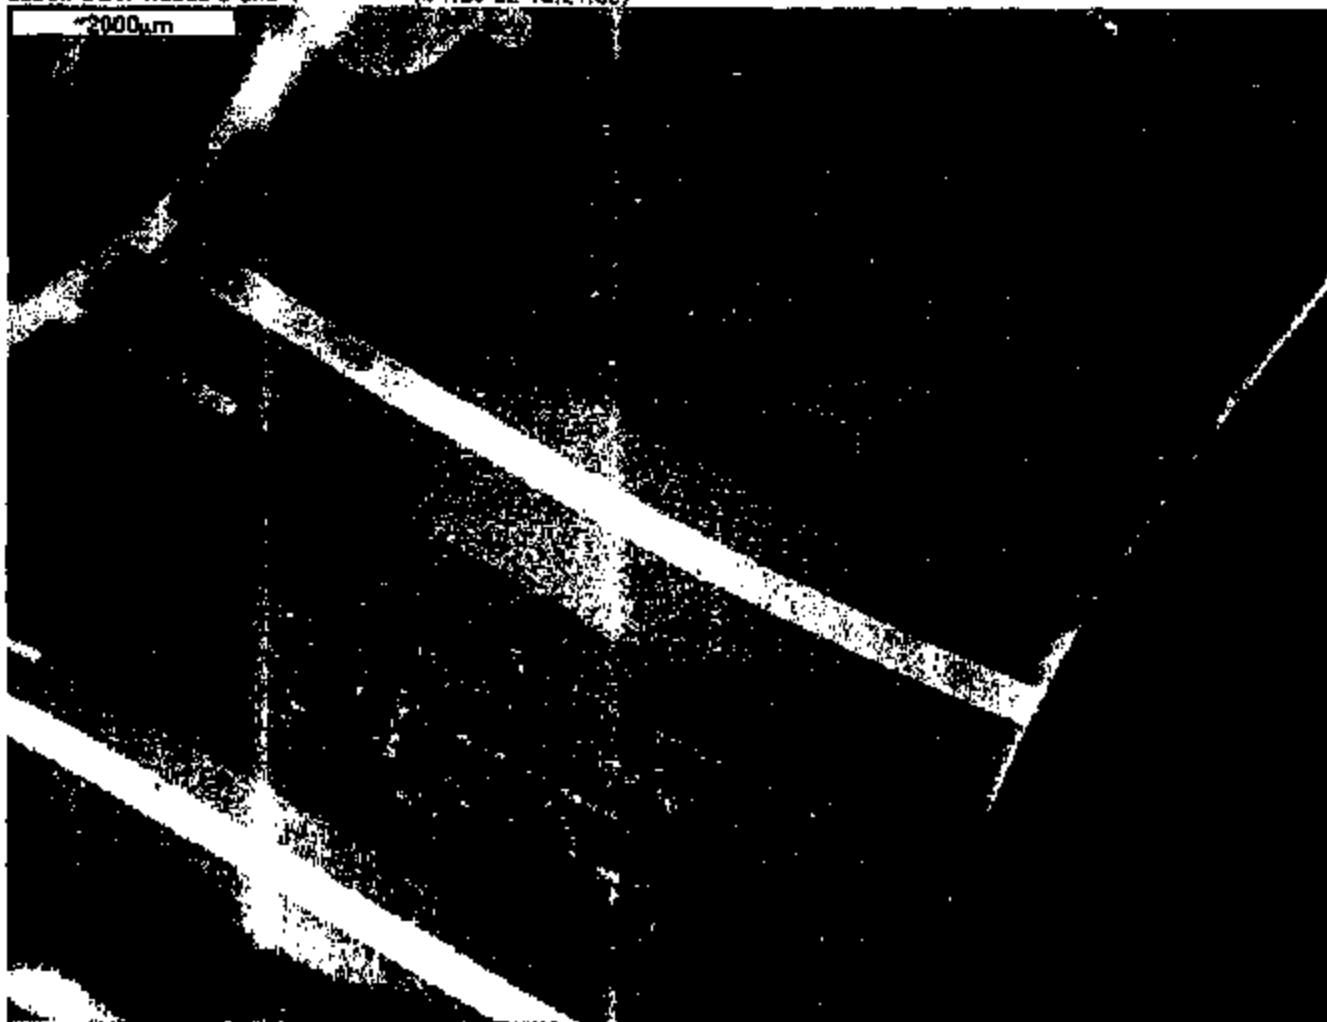
Operator: Steve Simko  
Client: [REDACTED]  
Job: ETC sensors  
Rea: Ultraline  
Label: DEW traces 3 and 4

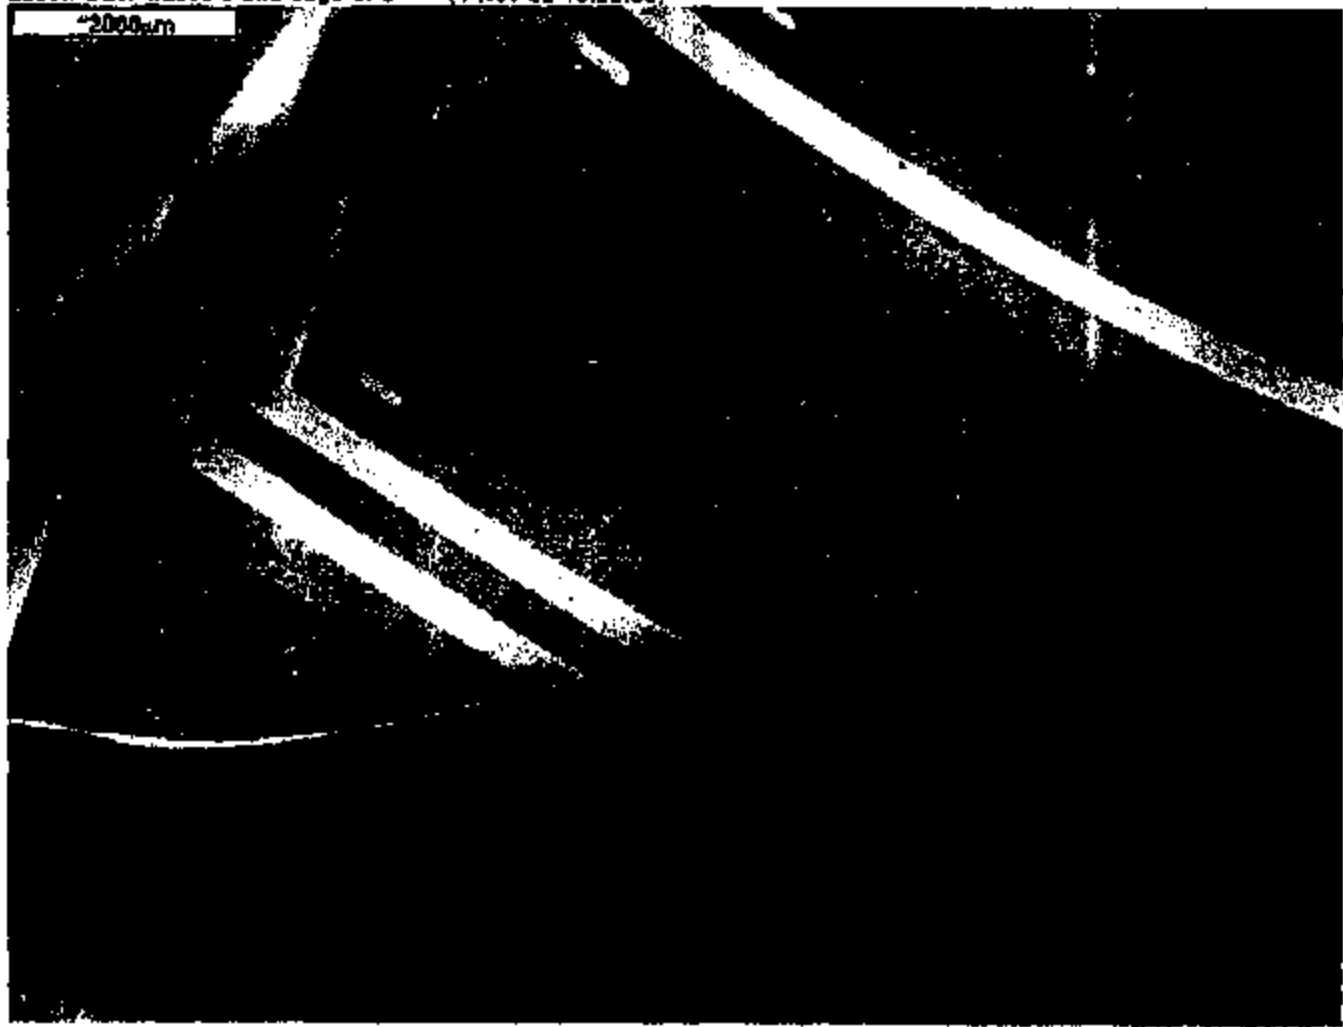
Operator: Steve Simko  
Client: [REDACTED]  
Job: EVO sensors  
Res: Ultraline  
Label: DEW traces 5 and edge of 6 (4 Nov 02 16:22:36)

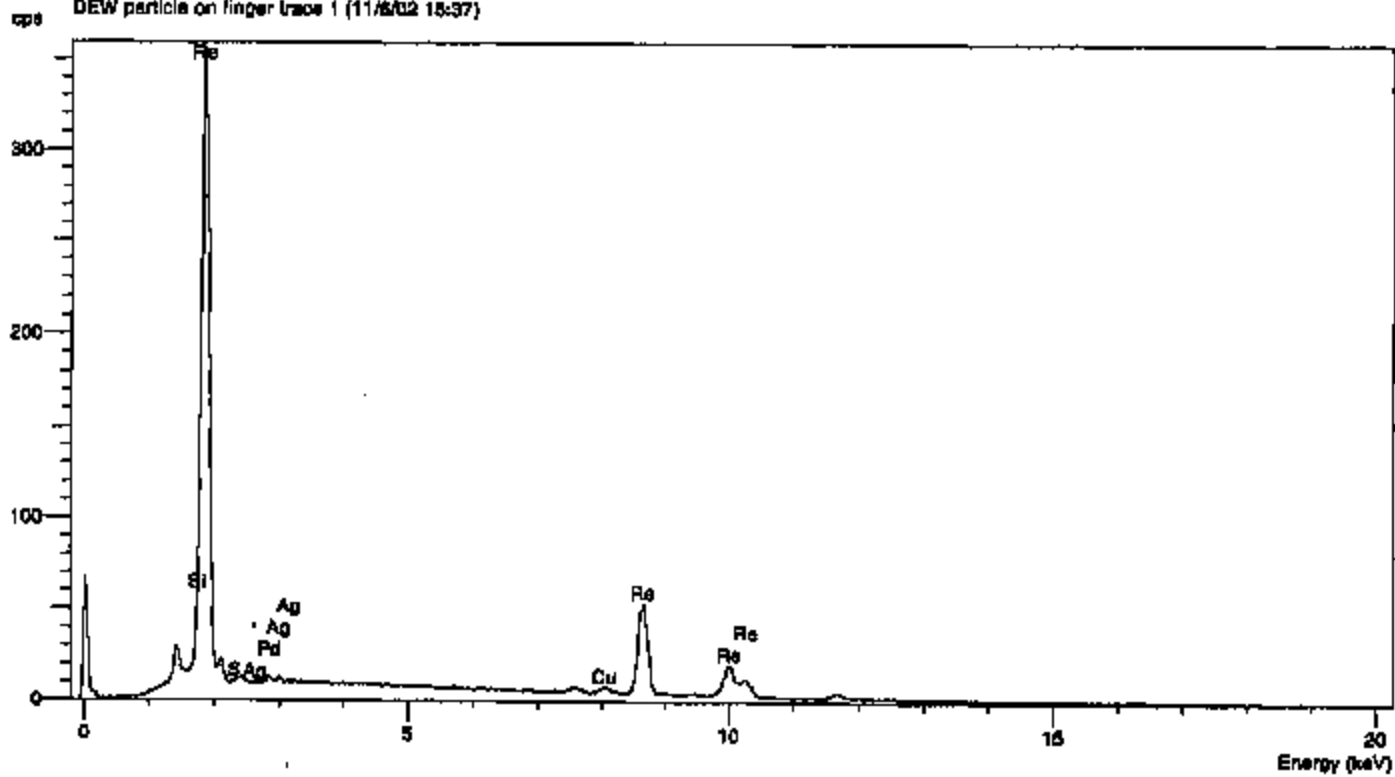
Operator: Slava Simko  
Client: [REDACTED]  
Job: ETC sensors  
DEW particle on finger trace 1 (11/6/02 15:37)

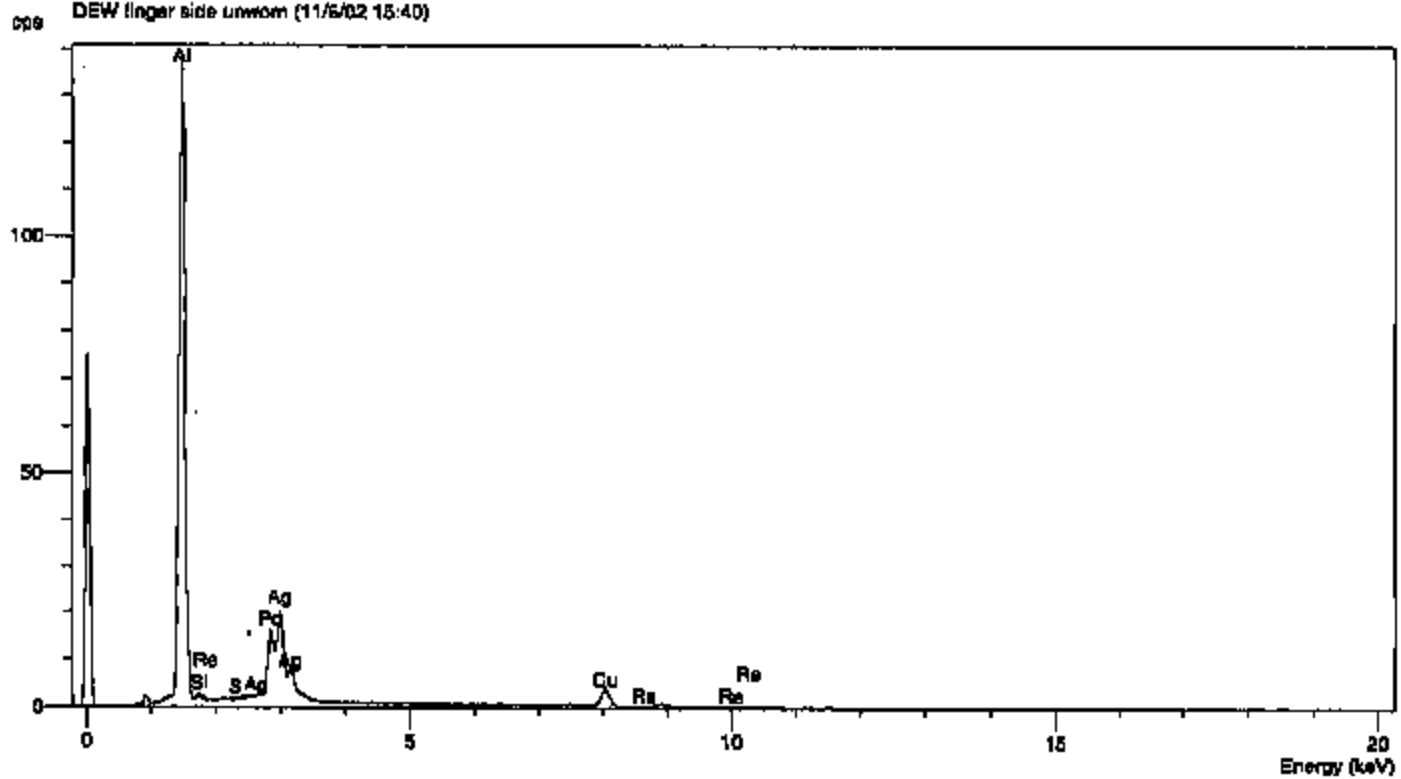
Operator: Steve Simko  
Client: [REDACTED]  
Job: ETC sensors  
DEW finger side unworn (11/5/02 15:40)

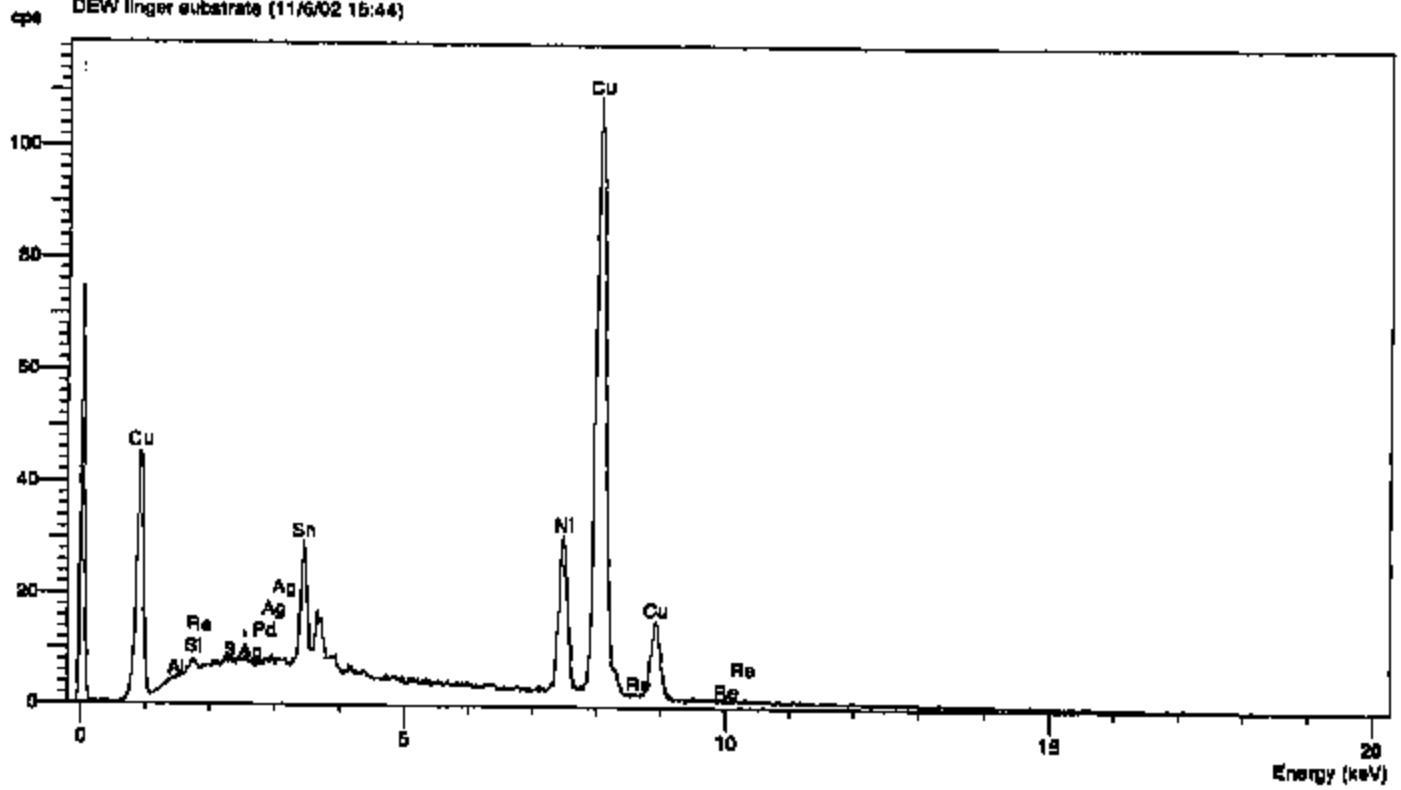
Operator : Steve Simko  
Client : ██████████  
Job : ETC-████████  
DEW finger substrate (11/6/02 15:44)
