**PE03-050**

**ATTACHMENT 2D**

On June 27, 2000, [REDACTED] went out to start her car in her driveway. She turned the ignition key, heard a "pop" and noticed smoke coming from under the hood. The smoke was the result of a fire that eventually consumed the engine compartment. Our C&O report pinpoints the cause of the fire as a fault seal or gasket in the area of the fuel injection rail for cylinders #1 and #3 allowed fuel on top of the engine, which ignited due to a spark or heat from the ignition coils or spark plugs. Since there had been no service to the seals and gaskets, and the car was less than 3 years old and with about 30,000 miles on it, it appears that the seal/gasket failure was a manufacturing defect and therefore GMC's responsibility.

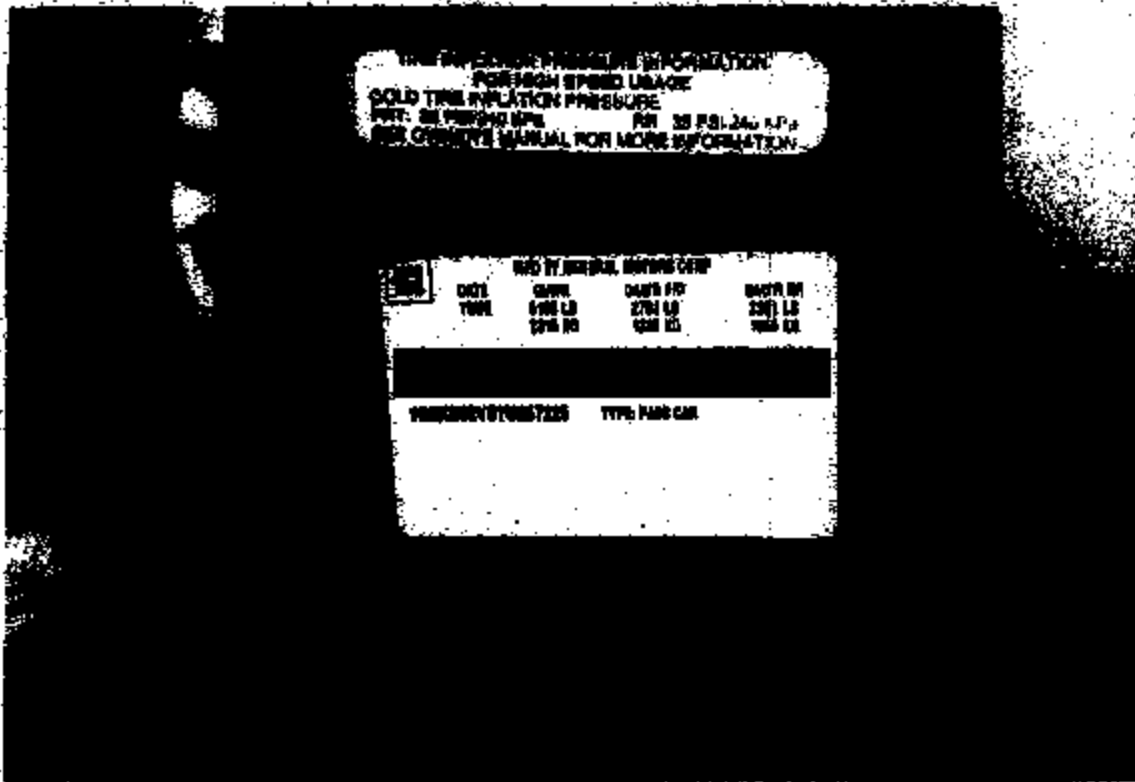
1. A close-up view of vehicle identification number 1G6R052Y8TU257225, identifying the 1996 Cadillac Deville.
2. An overall view of the front.

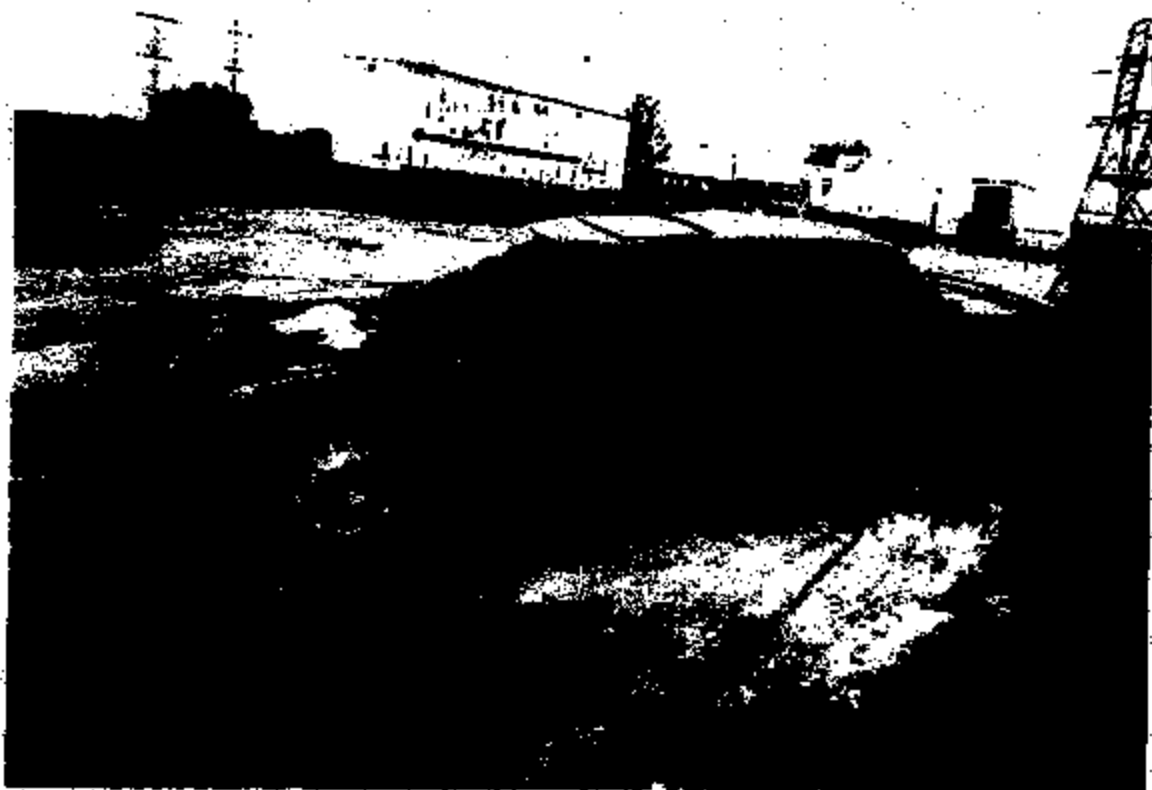
4. A view of the rear.

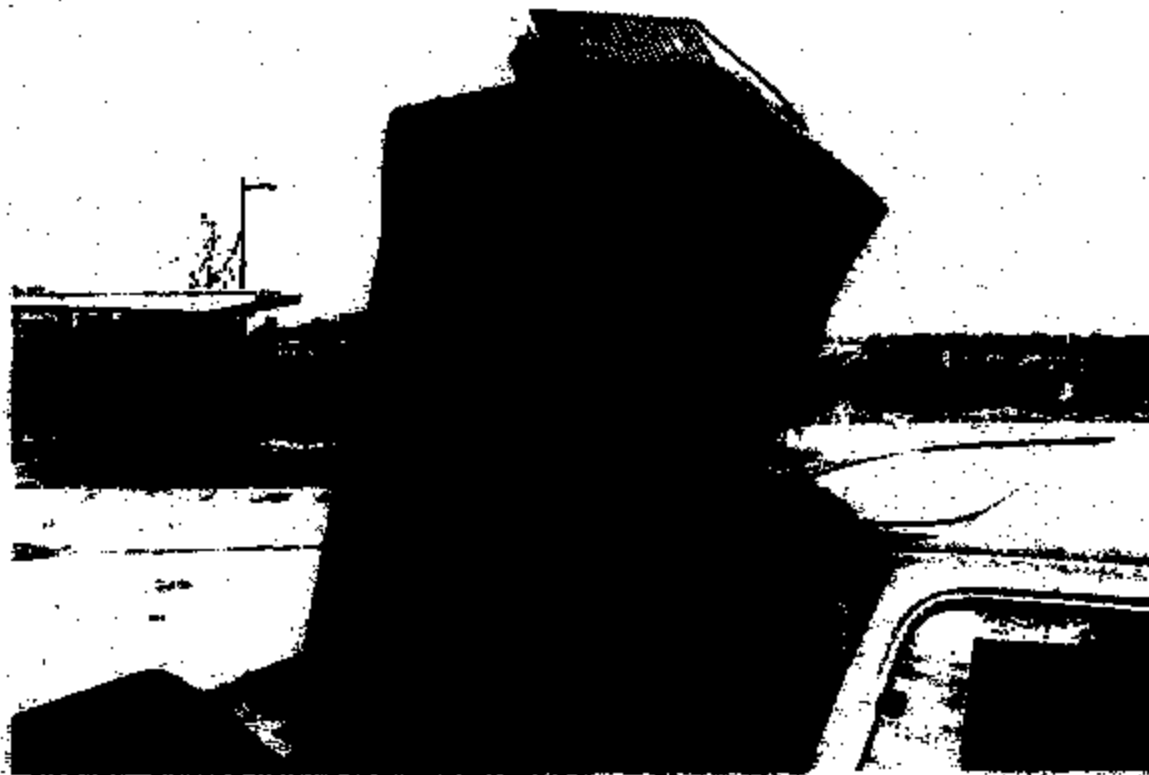
11. A view of fire damage to the underside of the hood.
