**APPENDIX 1 TO RESPONSE OF KIA MOTORS AMERICA, INC. TO REQUEST FOR
INFORMATION - RECALL QUERY**

**Sephia/Sportage Warranty Returned Seatbelt
Buckle Analysis Result**

Sephia/ Sportage Seatbelt Buckle Countermeasure

◆ **Seat Belt Buckle Specification for Sephia and Sportage**

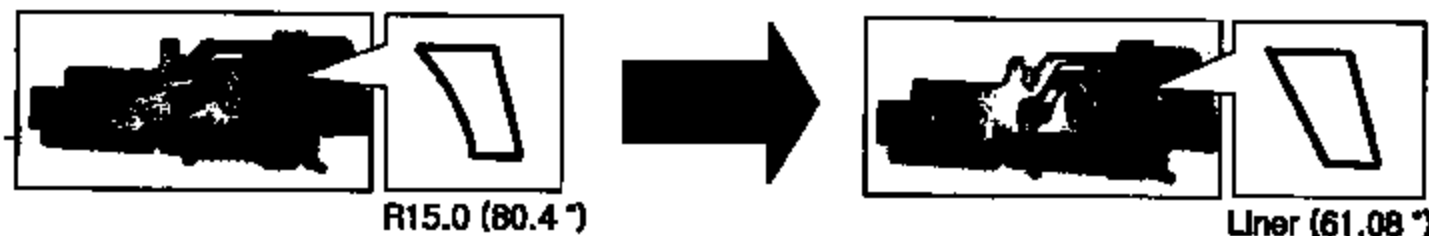
1. During inserting latch, Lock Plate is stuck intermittently by interference with buckle embossing guide so that locking is not done properly. → Buckle Base Embo. Shape Change (Aug. 19, 1996)

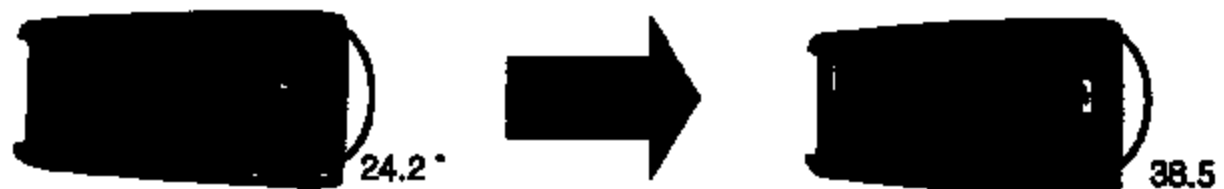
2. During Inserting latch, angle of the buckle cover guide for the latch is not enough so that the latch moves upward and locking is not done properly. → Angle change (Dec.23, 1996)

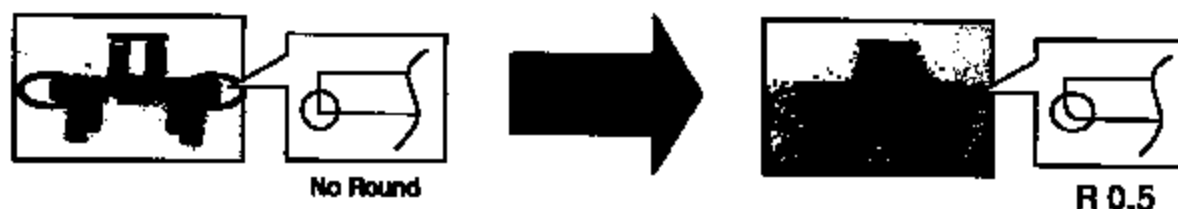
3. When Lock Plate is moving down for locking, Intermittent interference by buckle base embossing plate → Lock Plate shape change (Jan.30,1997)

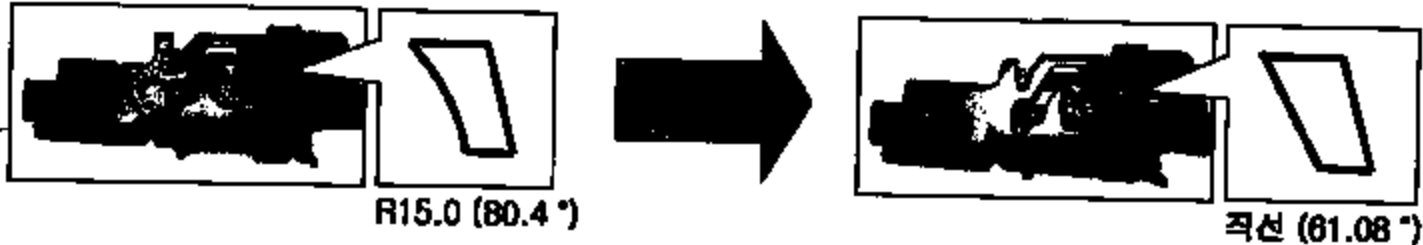
- 1. Tongue 삽입시 간헐적 Lock Plate가 Buckle Embo. 면에 걸림
→ Buckle Base Embo. 면 형상 변경 (96.8.19)

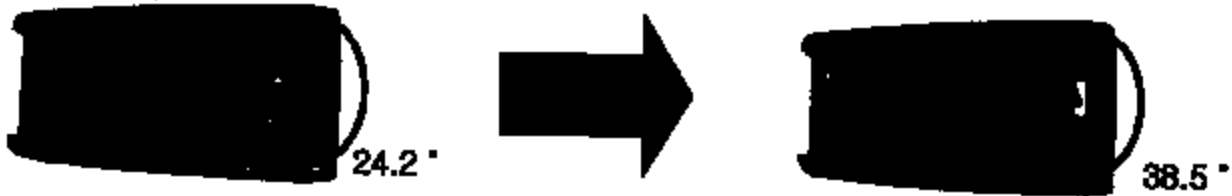
- 2. Buckle Cover에 Tongue 삽입부 각도가 작아 Tongue 삽입시 Latch 를 상방향으로 밀어 올려 Lock 방해 → Tongue 삽입부 커버 형상 개선 (96.12.23)

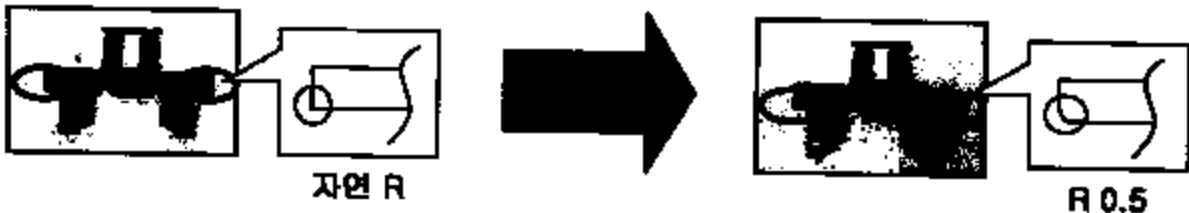
- 3. Buckle 작동시 Lock Plate 작동시 "R" 미흡으로 인해 Buckle Base Embo.면에 걸림
→ Lock Plate 작동부 형상 변경 (97.1.30)

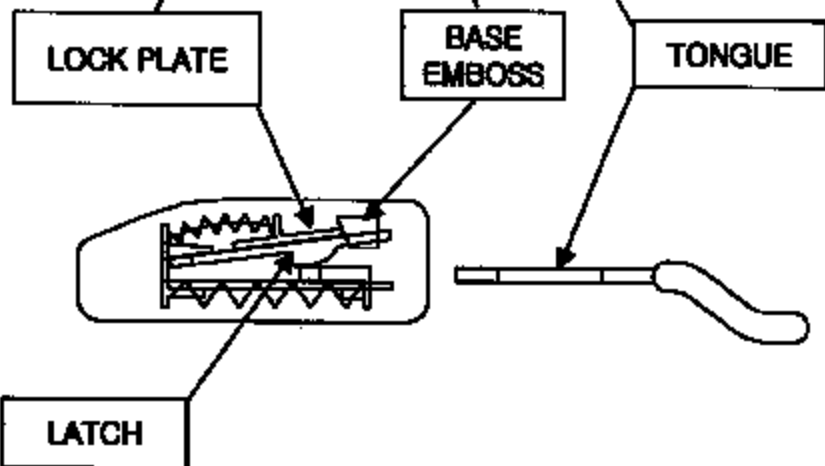
미체결 상태

1. PRESS BUTTON을 누르면 BUTTON이 LOCK PLATE를 뒤로 밀어냄
2. LOCK PLATE가 BASE EMBOSS면을 타고 상측으로 이동함
3. EJECTOR SPRING에 의해 EJECTOR가 앞측으로 이동하며 LATCH는 상측으로 이동하여 TONGUE과 분리되어 TONGUE이 뒤로 밀리면서 해리됨
