PE04-078

FORD

ATTACHMENT F

DETERMINATION OF ORIGIN AND CAUSE

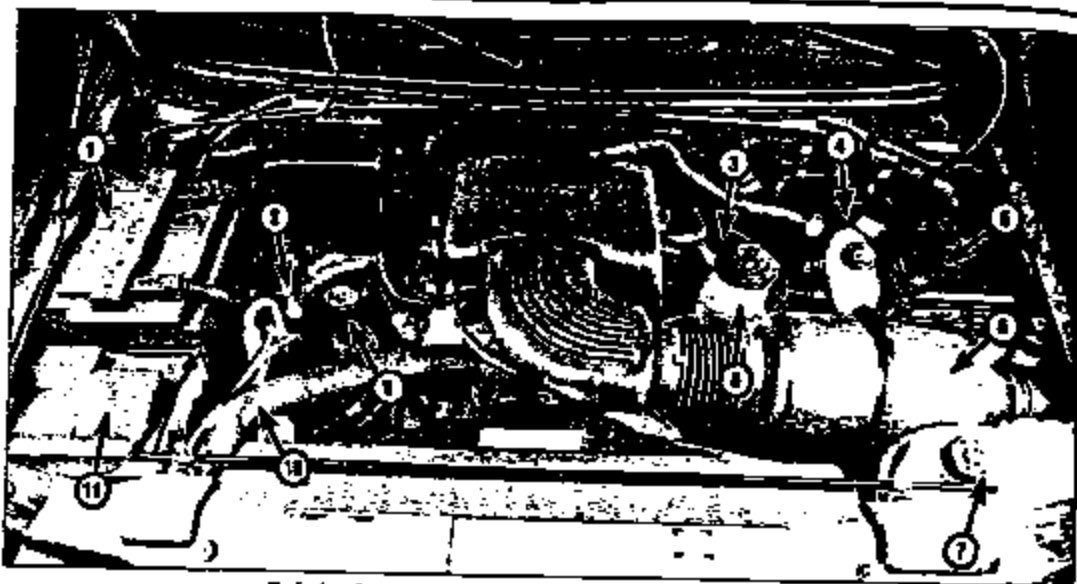
Typical engine compartment components (4.0L and 5.0L V8 engines)

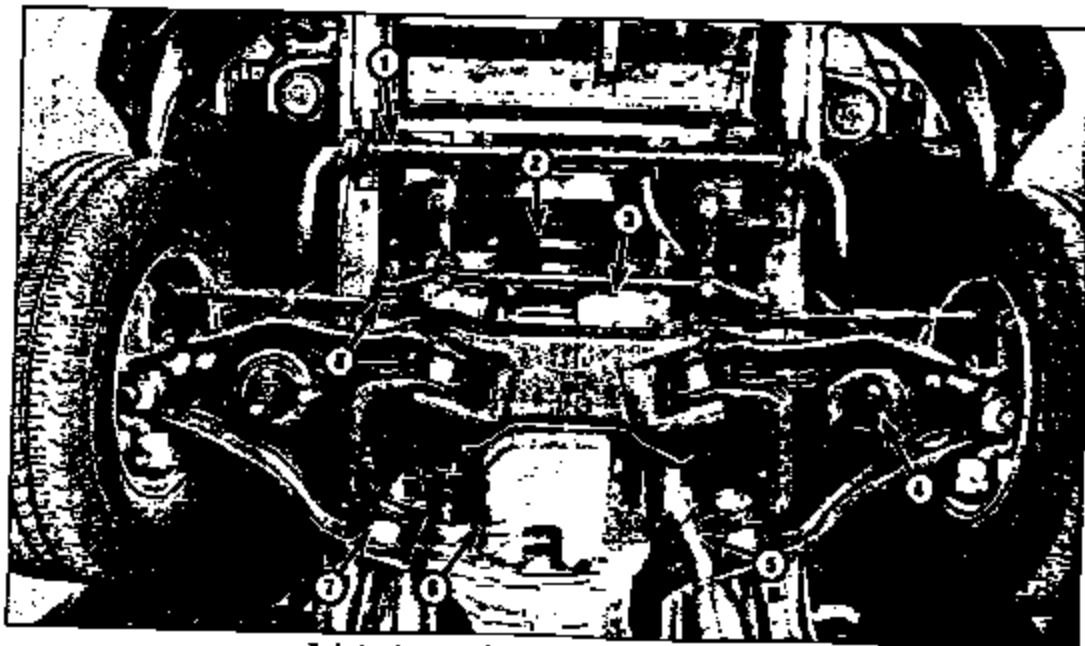
Typical engine compartment underside components (2WD)

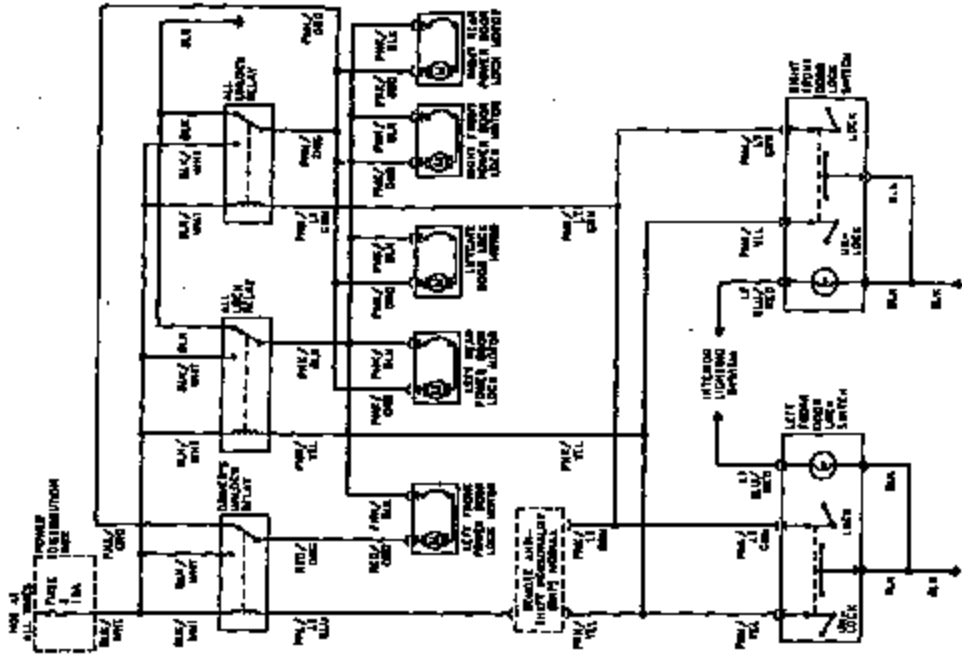
Power door lock system - with Resistor Anti-theft Personality module

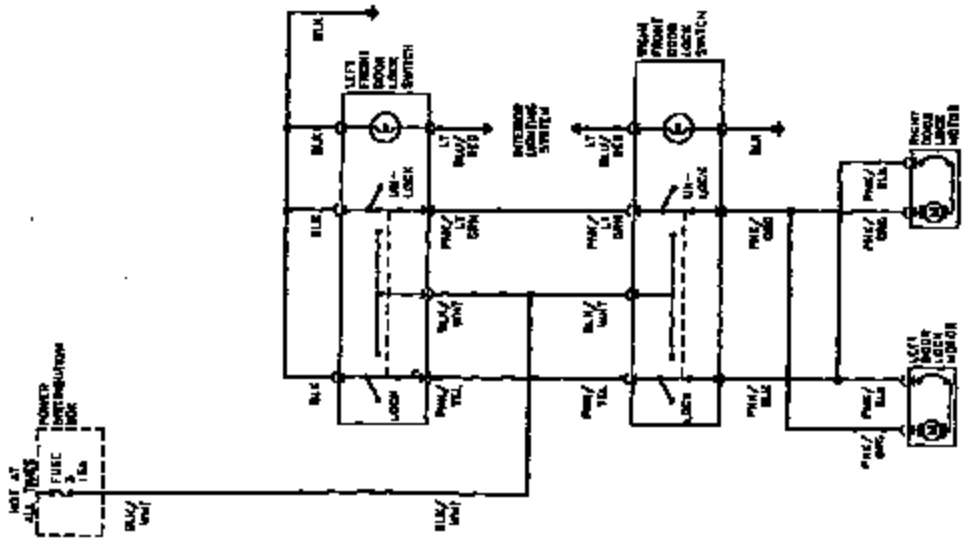
Power door lock system - without Resistor Anti-theft Personality module
