PE04-078

ATTACHMENT F

ORIGIN AND CAUSE INVESTIGATION:

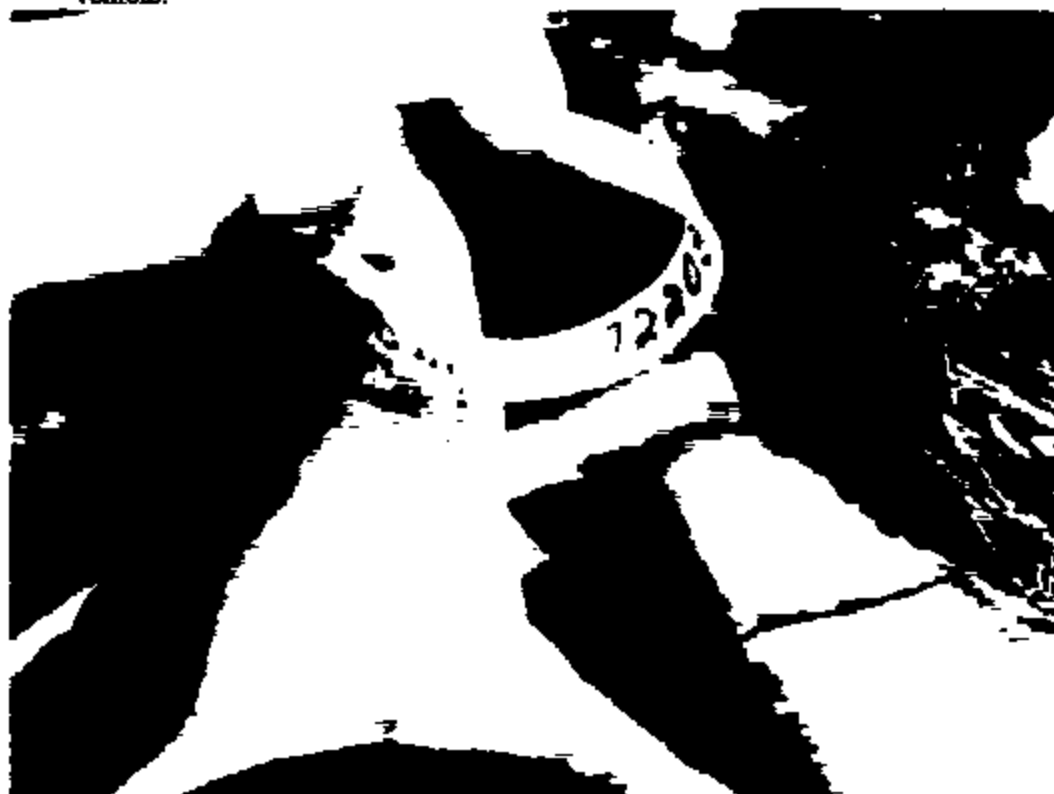
19. A view of the radiator opening with the air-conditioning condenser and radiator fire damaged.

The investigation is now focused to the front underside, where the radiator air conditioning condenser has been consumed on the right or passenger's side, however, is still present on the left or driver's side. The examination is now focused to the underside of the engine compartment, where oil is leaking and is present on the underside, to include the oil pan. The investigation continues, and there is no evidence of any spraying of combustible fluid along the underside.
