REPORT OF FINDINGS

Claim No: 100 525 1781-1-2

VEHICLE FIRE EVALUATION

INSURED: [REDACTED]
2001 FORD F150 LARIAT

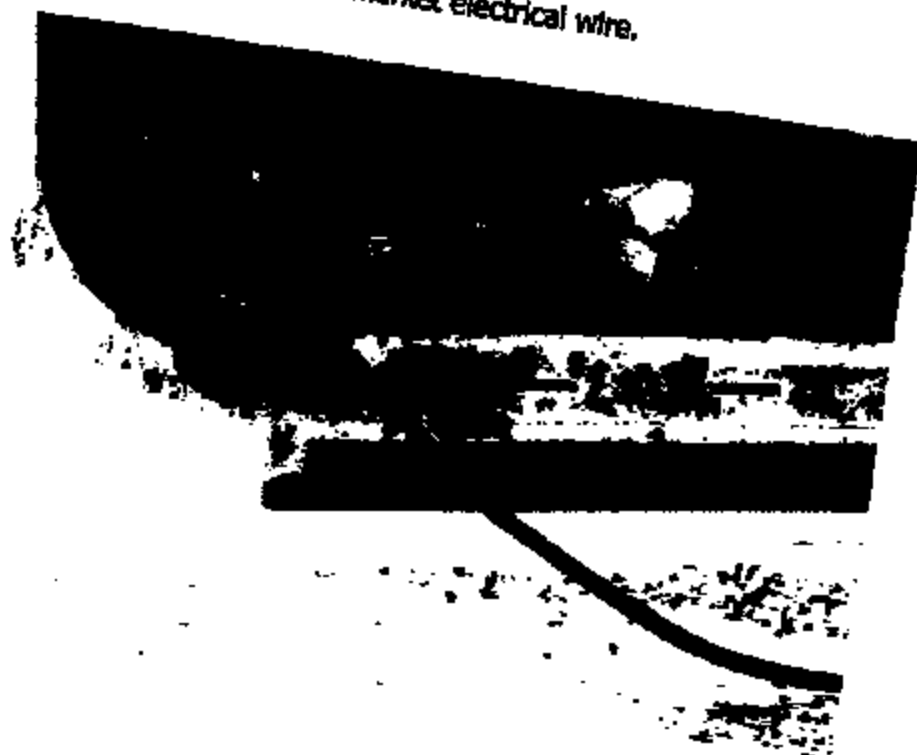
35. Another view of the aftermarket electrical wire.

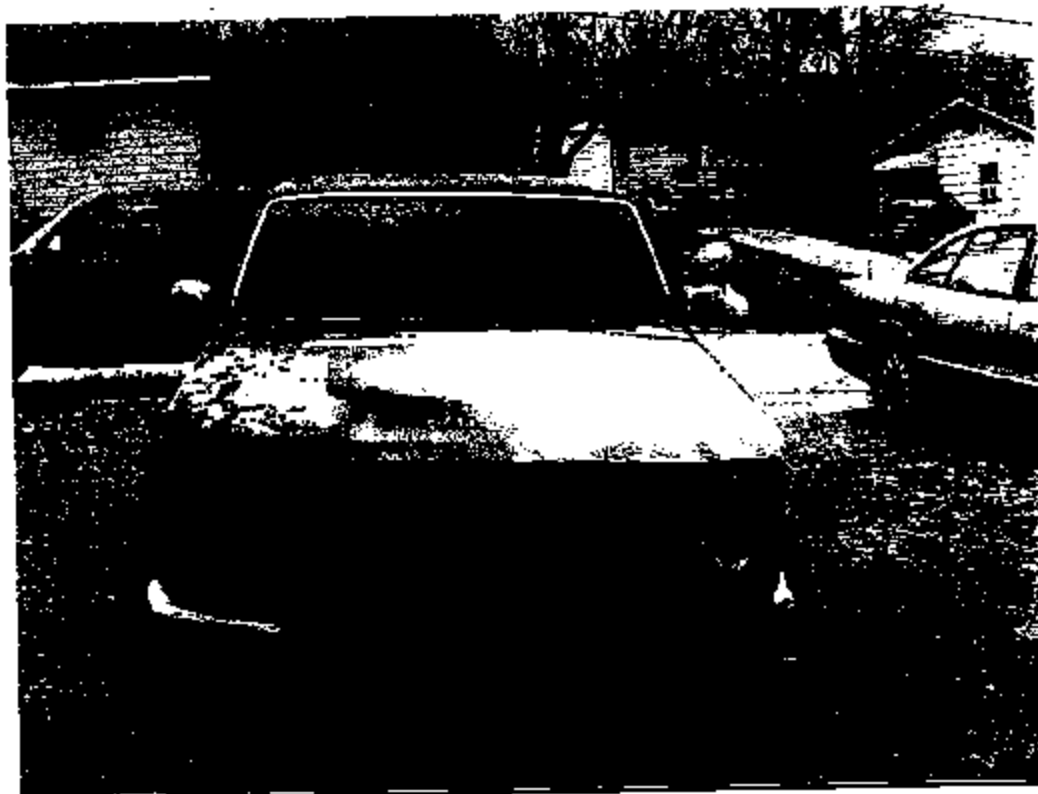
Figure 1 is a front to rear view of the front of the vehicle. Note that the heaviest damage occurred on the driver's (left) side of the vehicle.

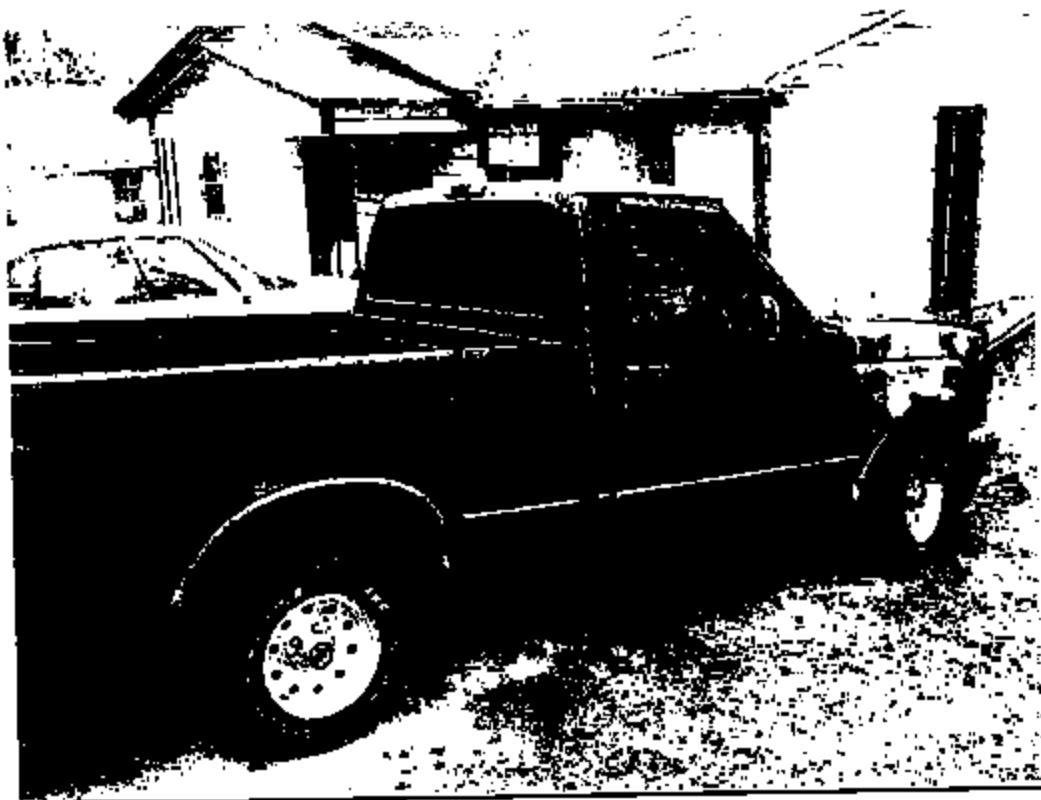
2.3.4 Figure 4 is a view of the passenger (right) side of the vehicle.

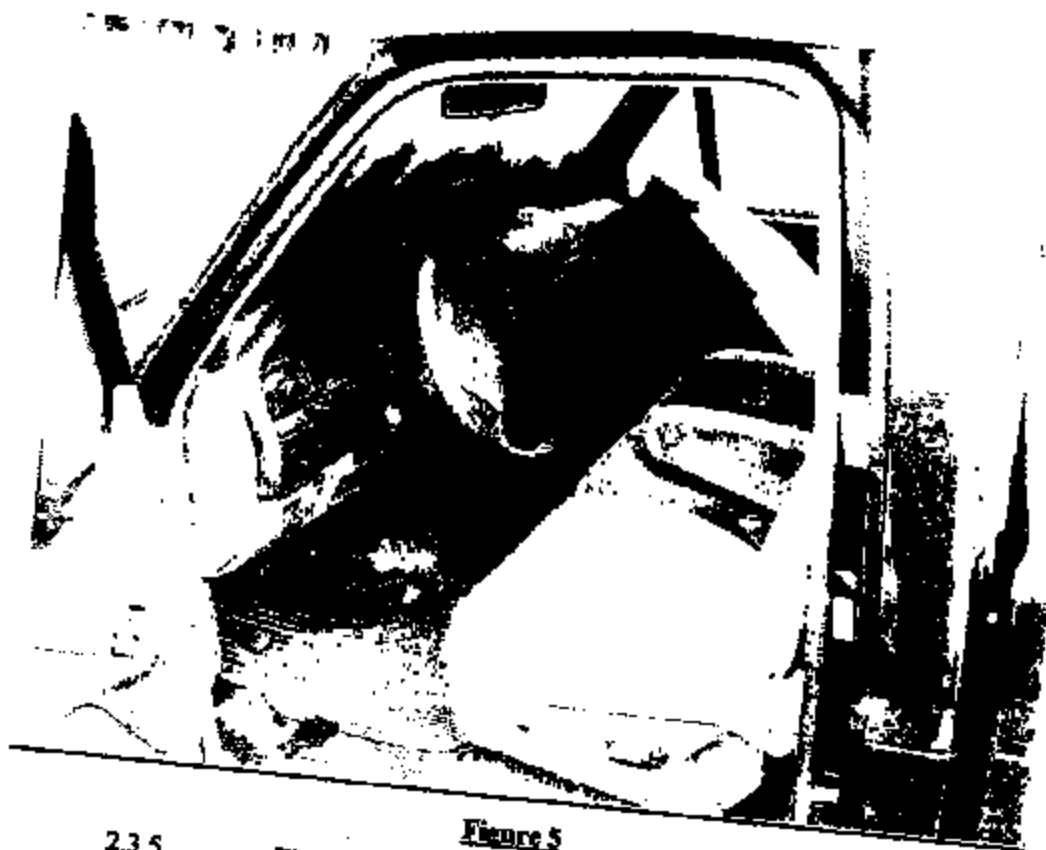
2.3.5 Figure 5 is a driver's side to passenger side view of the passenger compartment. The heat patterns indicate that the fire traveled into the passenger compartment.

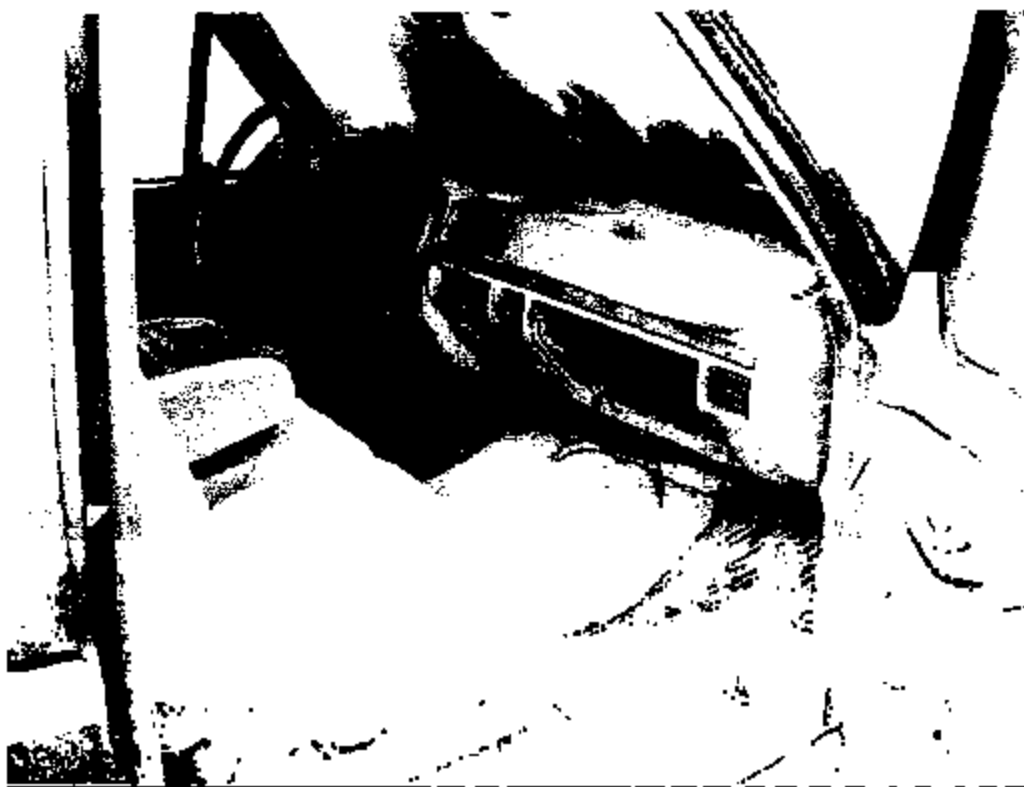
2.3.6 Figure 6 is a passenger side to driver's side view of the passenger compartment.

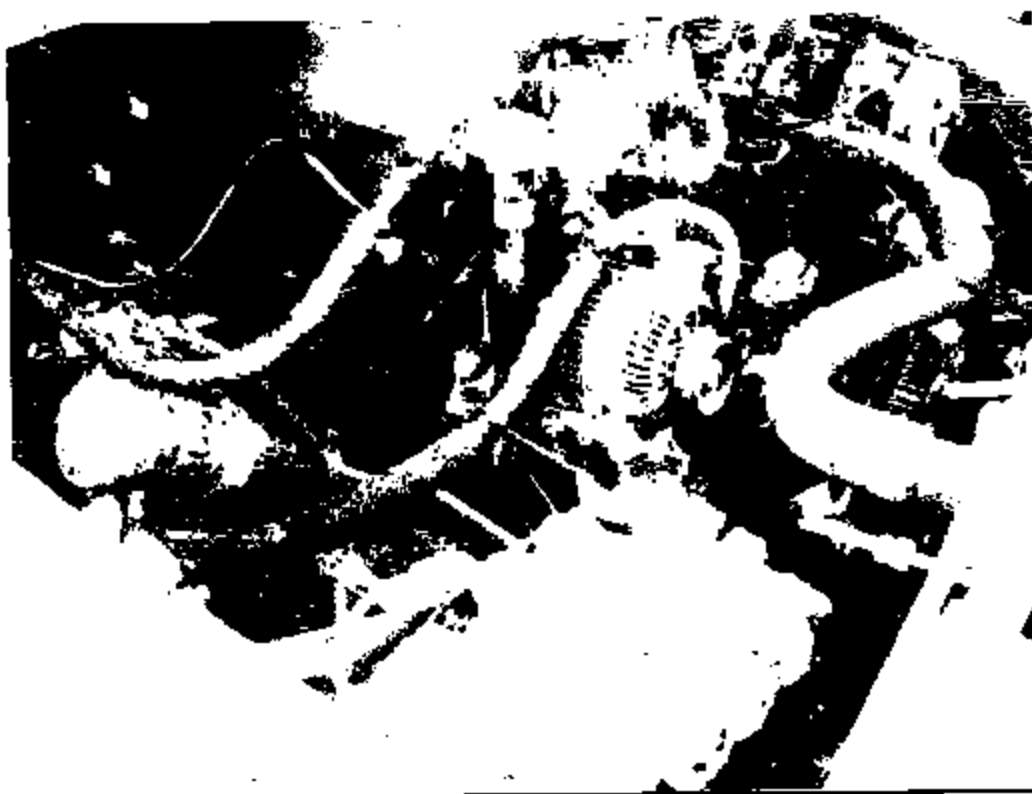
Figure 16 is a passenger side to driver's side view of the passenger side of the engine compartment. The battery, alternator and other combustible items are in this area. The burn patterns indicate that the fire did not originate in this side of the engine compartment.

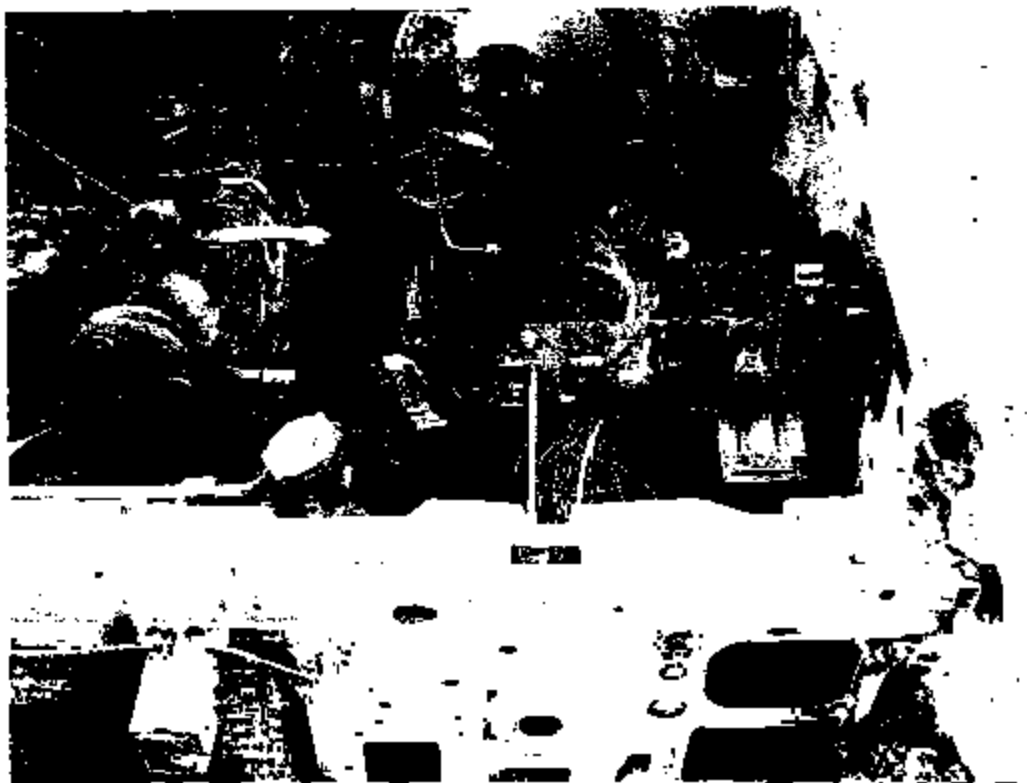
- 2.3.14 Figure 17 is a front to rear view of the driver's (left) side of the engine compartment. The burn patterns indicate that the fire originated in this area. The cruise control disconnects and the electrical junction box area the potential heat producing items in this area.

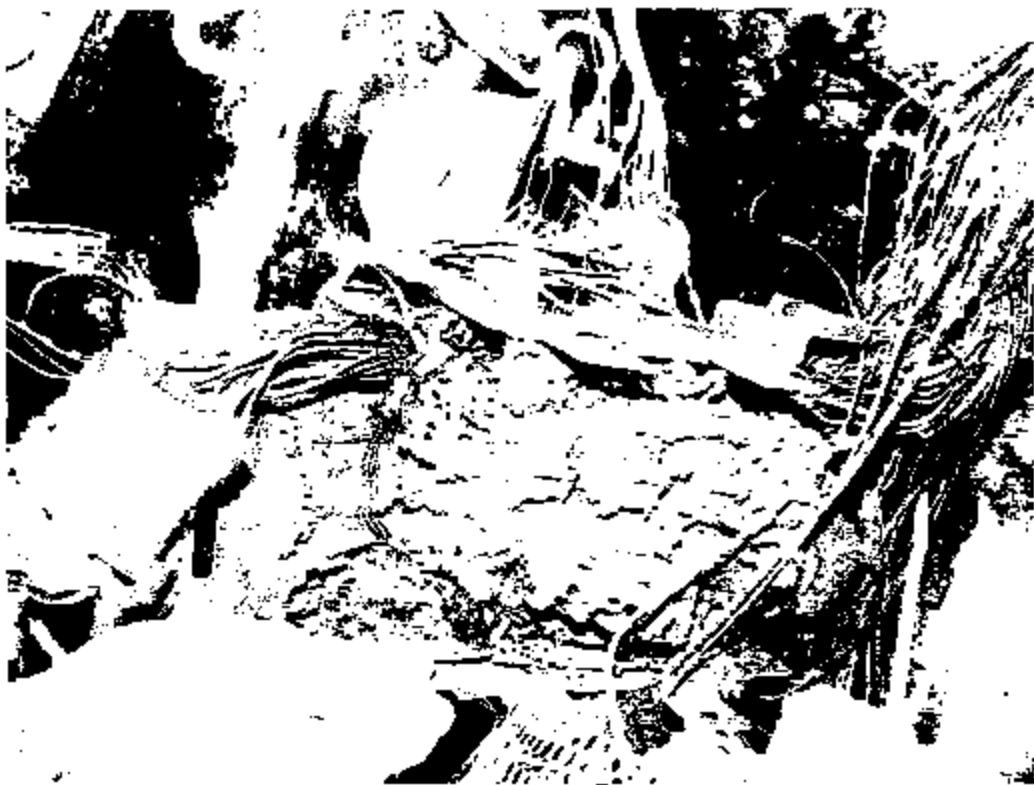
Figure 19 is a close-up view of the electrical junction box found in the origin area. This box was not disassembled due to possible subrogation potential.
