COMPLAINT AND JURY DEMAND

W. L. Davison Forensic Services, Inc.
Forensic Mechanical Evaluation
Origin and Cause of Vehicle Fires

The purpose of this examination was to recover the alternator and electrical wiring that was the cause of the vehicle fire, which occurred on January 8, 2000.

The purpose of this examination was to determine the origin and cause of the vehicle fire, which occurred on January 8, 2000.

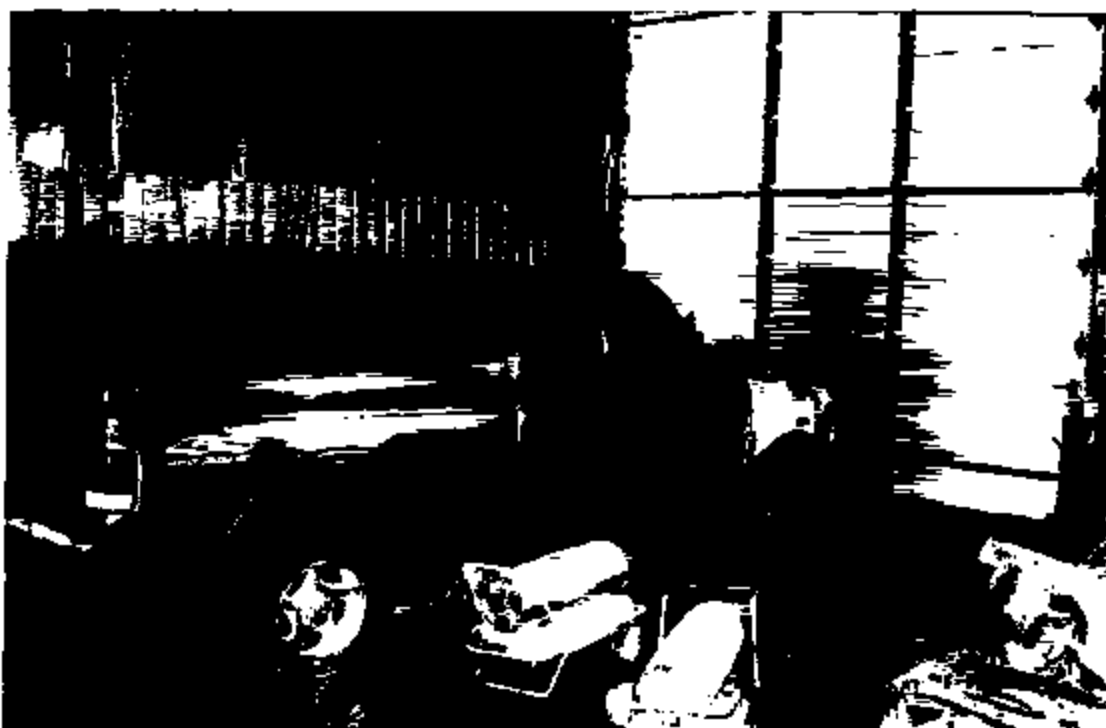
Photograph 2

This photograph is of the passenger side of the vehicle. Extensive fire damage is apparent at the engine compartment area. Smoke film has accumulated at the interior, floor to an

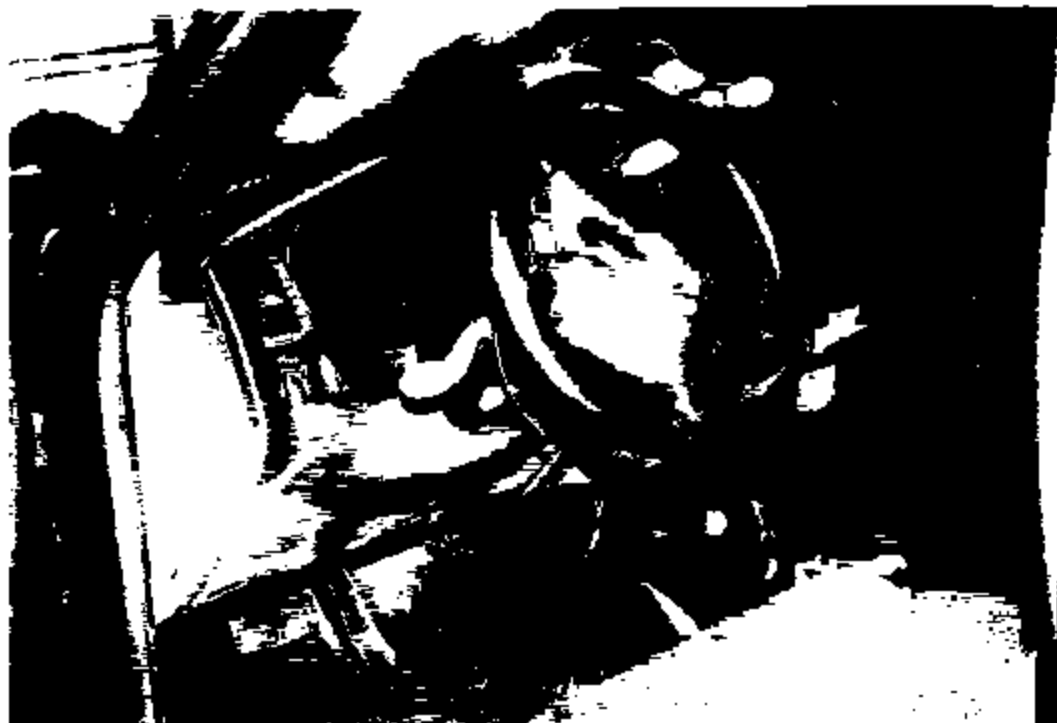
Photograph B

This photograph is of the dash panel and engine bulkhead as viewed from the driver's side of the vehicle. The burn patterns present clearly indicate a fire, which originated in the area of the engine compartment.
