The vehicle is a 2002 Ford F150, Super Cab, King Ranch Edition with a VIN of 1FTRW08L82K [REDACTED] which had an engine fire on November 20, 2002. The owner purchased the vehicle 3 months prior to the fire and it only had 3100 miles on the engine.

This assignment was received on November 6, 2002 from Sherry Flynn who is a Claims Representative with Nationwide Insurance Company in Winston-Salem, North Carolina. The specific request was for a cause and origin investigation into a fire that damaged a 2002 Ford F-150 Ford truck. The insured is [REDACTED]

ORIGIN AND CAUSE INVESTIGATION:

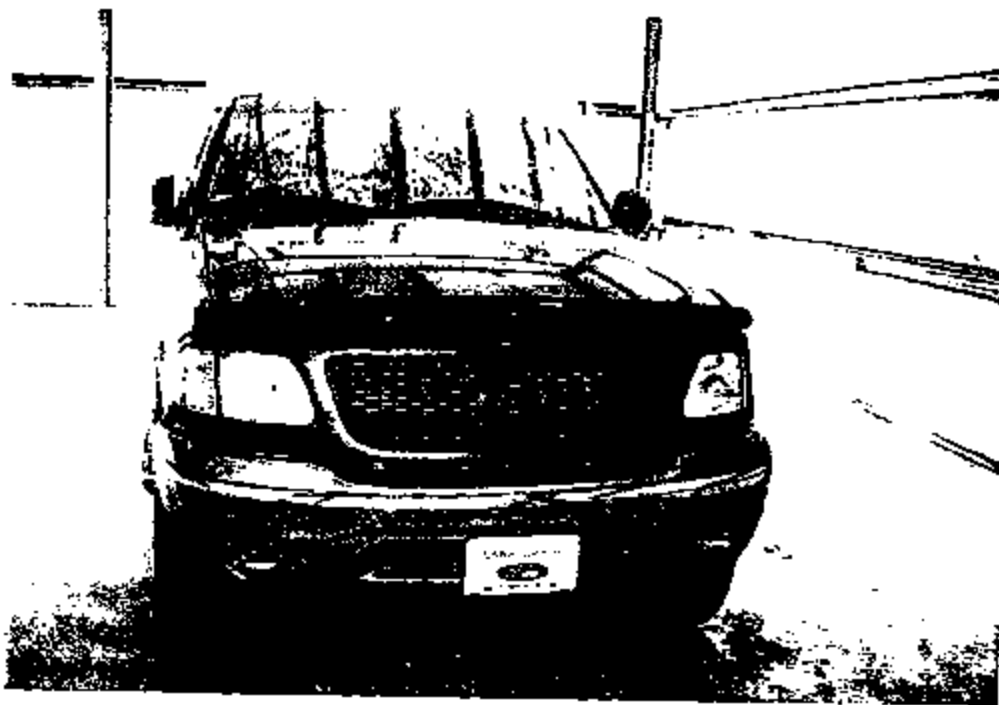
Photograph 1: Photo of the front of the Ford Expedition.

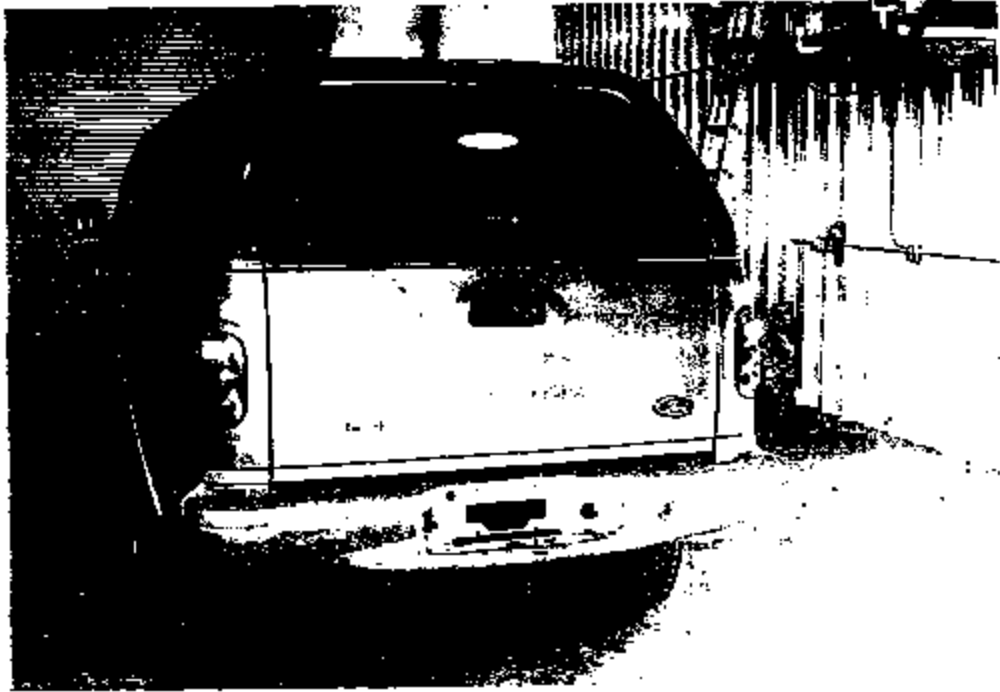
Photograph 3: Photo of the rear of the vehicle.

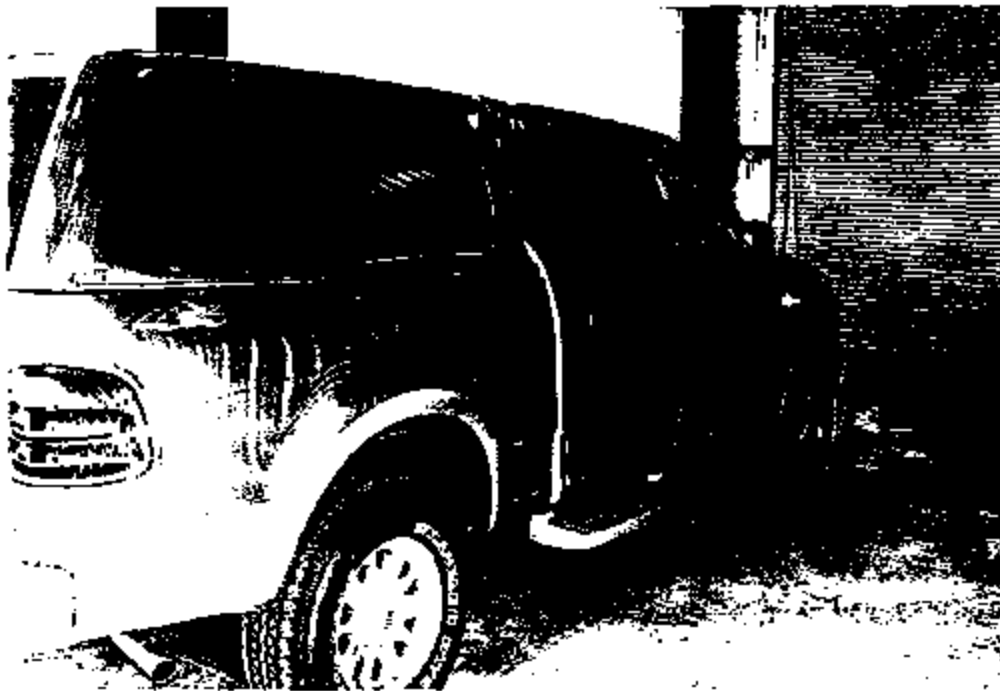
Photograph 4: Photo of the front and right side of the vehicle.
