OCA Consultants, Inc. was requested on February 2, 2000, by Ms. Lisa Spencer of Grange Mutual Casualty Company, to examine and determine the cause of a fire that occurred in a Ford truck owned by [REDACTED]. The fire occurred on January 28, 2000, at about 4:30 AM. [REDACTED] was travelling to his place of employment and had been on the road for only a few miles.

On July 6, 2000, S.E.A. Inc. was requested by Ms. Beverly Skelton of Cotton States Insurance Company, Atlanta, Georgia, to investigate the June 28, 2000 fire which damaged a 1999 Ford Expedition. This investigation was conducted by Mr. Bill Buckley, C.F.I., Director of Fire Investigations, as S.E.A. Project No. 420427.

Specifically, S.E.A. was requested to render a professional opinion regarding the origin and cause of the fire.

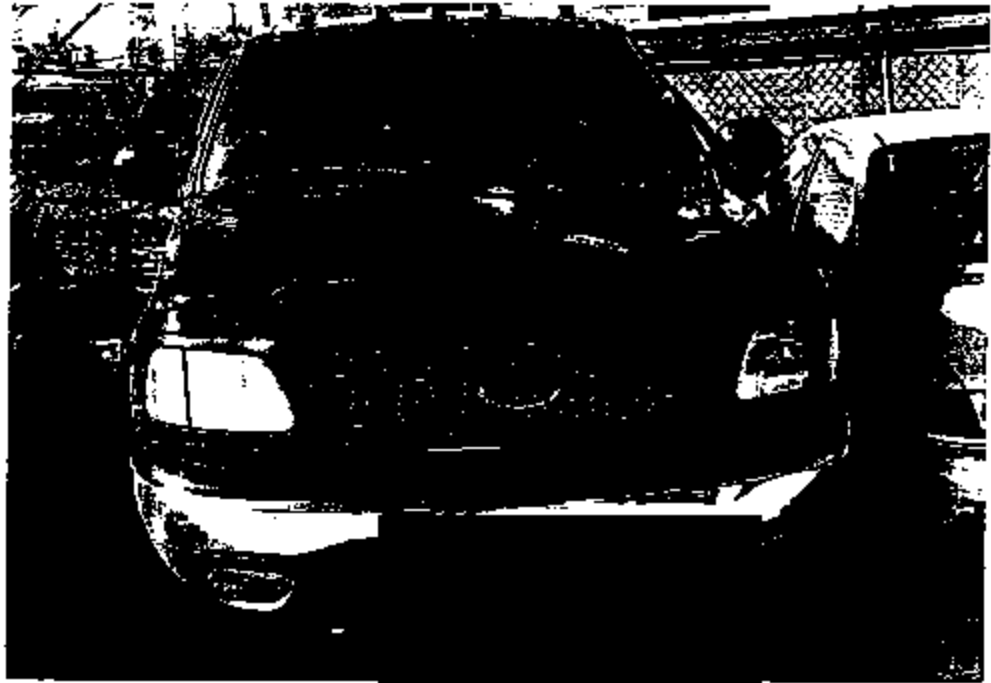
Figure One  
Truck (Front)

The examination of the truck started with verification of the VIN, that number was found to be 1FTZF1827XA [REDACTED]. The truck was a 1999 Ford model F-150. It had a standard cab and eight-foot bed. The exterior of the vehicle is shown in Figures 1

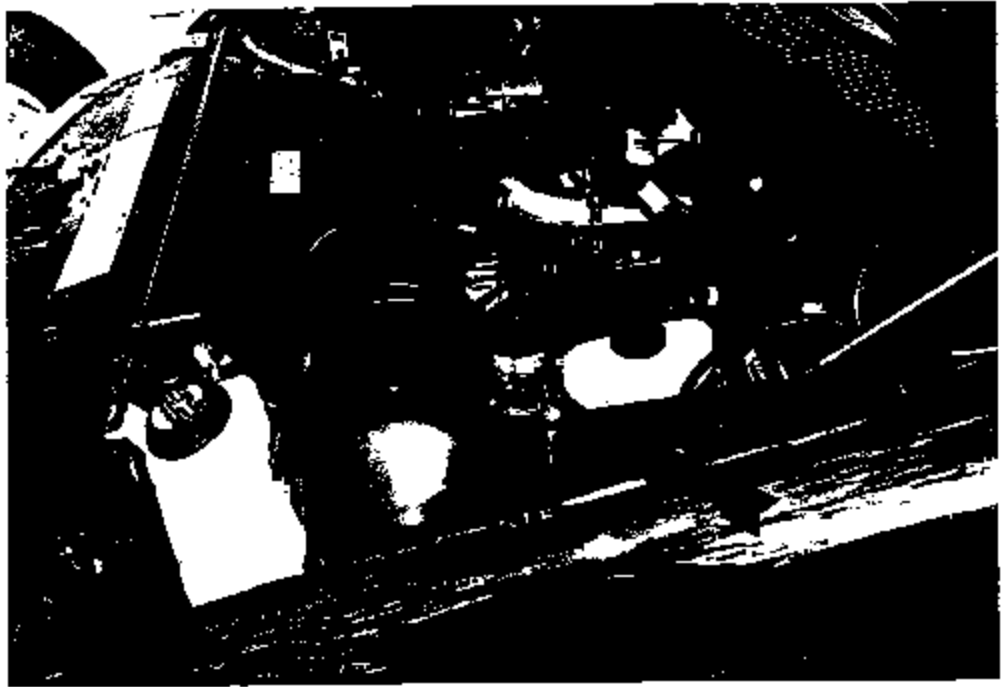
Figure Thirteen  
Engine Compartment of Exemplar Truck

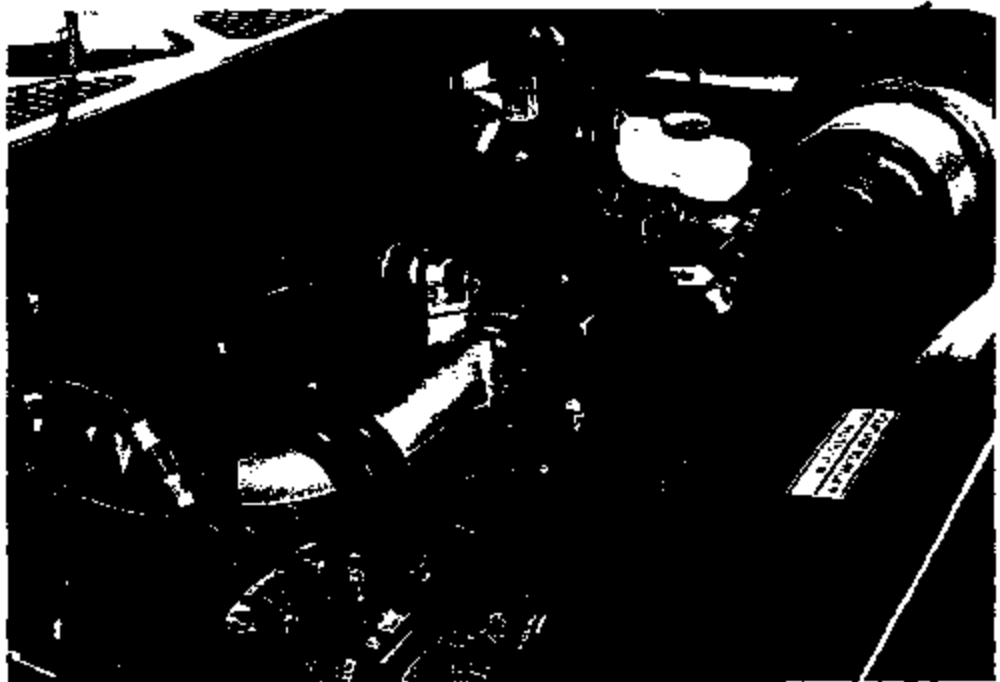
Figure Fifteen

Engine Compartment of Exemplar Truck

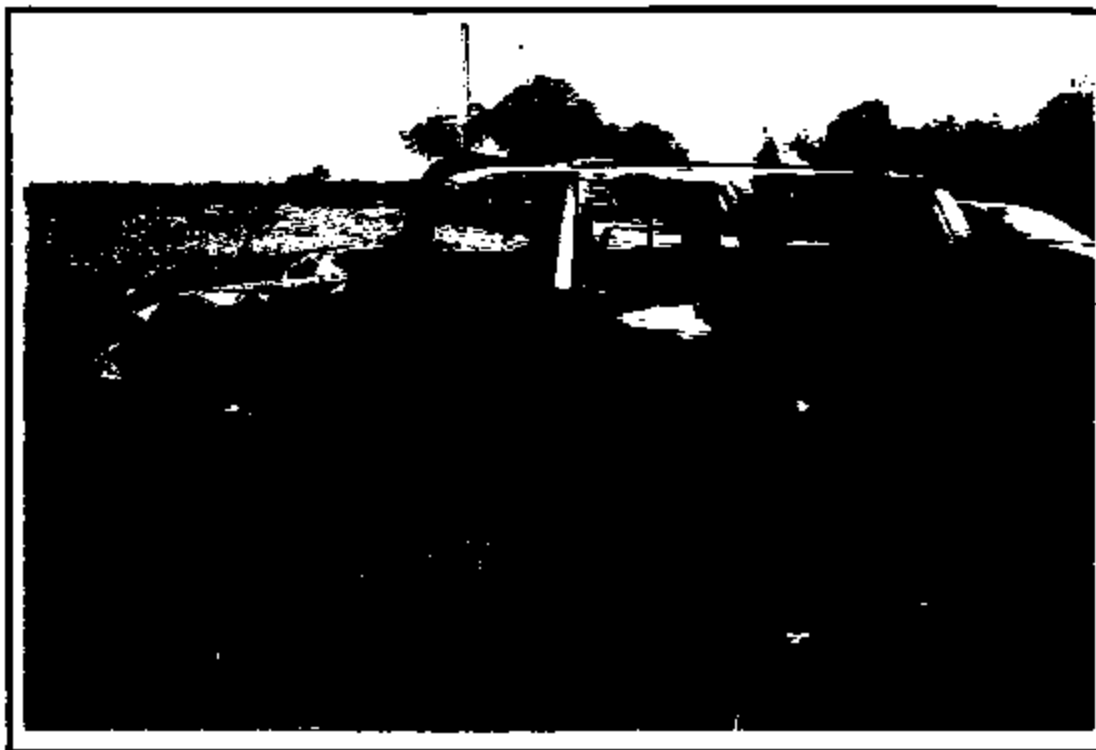
Exterior examination of the vehicle revealed extensive fire damage, as shown in Figures 1 through 4. The most severe damage occurred in the front portion of the vehicle. The two front tires suffered fire damage and were deflated. Most combustible components on the vehicle appeared to have been consumed during the fire. All of the glass in the vehicle was missing and the aluminum hood was melted. The vehicle identification number plate was destroyed in the fire. The license plate was found within debris in the rear of the vehicle (Figure 5). The license number was found to be XBB 57X.

**FIGURE 2:** Driver's side of vehicle.

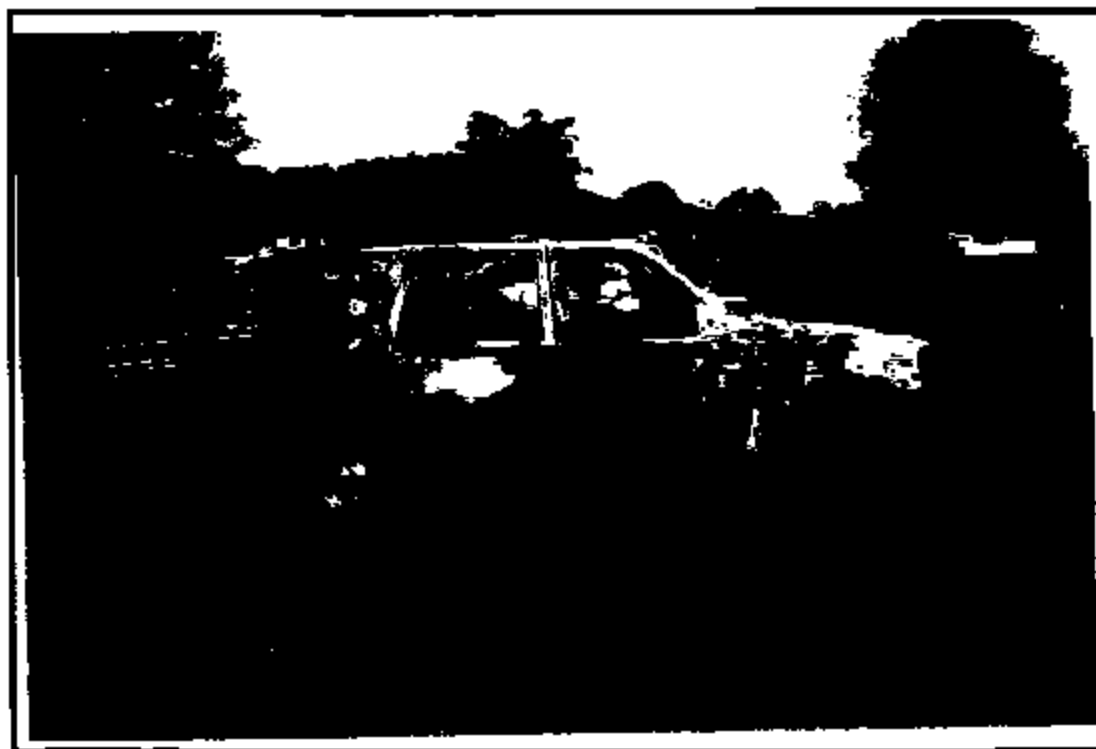
**FIGURE 3:** Passenger side of vehicle.

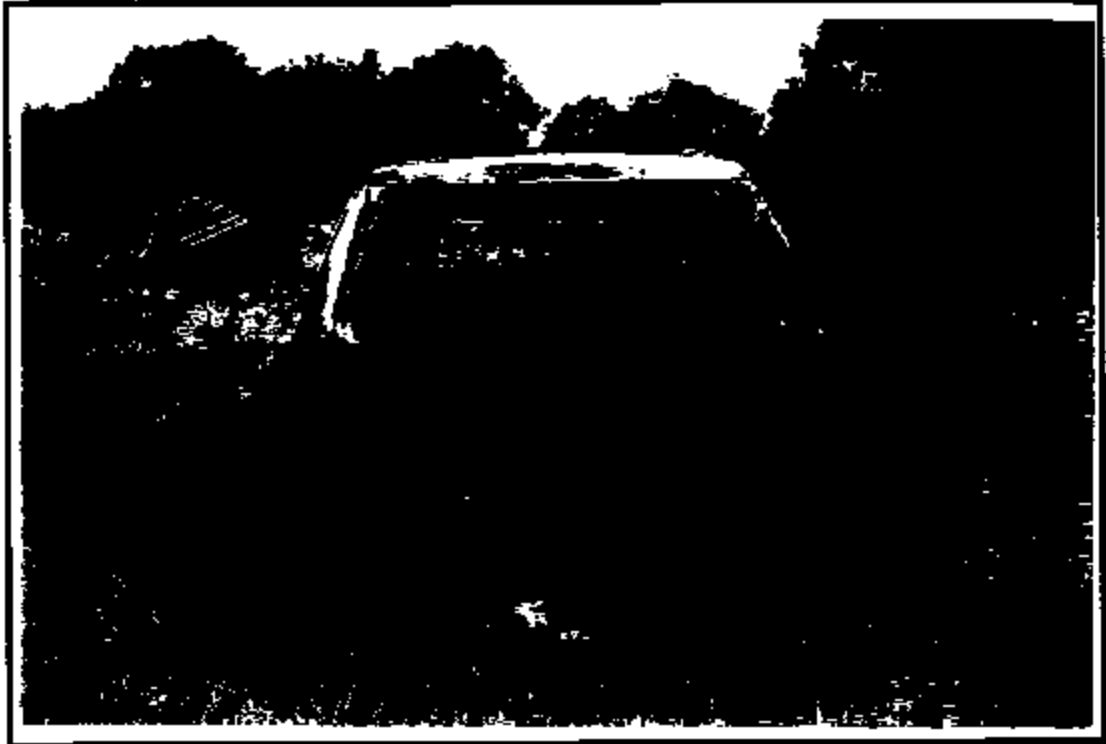
**FIGURE 4:** Rear of vehicle.

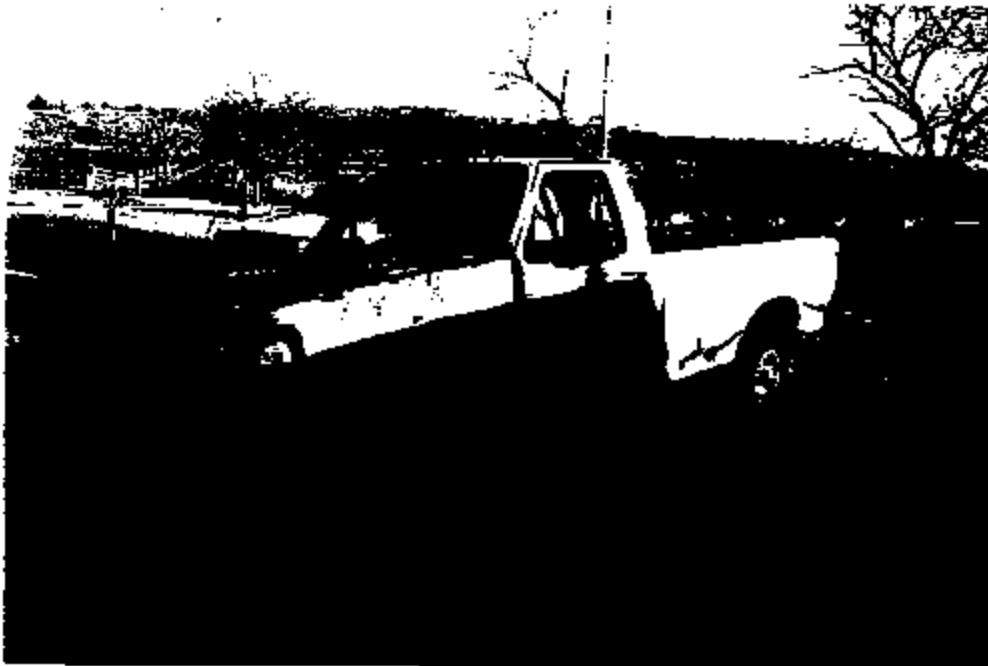
1 This photo shows the vehicle in the location in which the fire occurred. The insured's nephew's residence is to the right or west of the vehicle, and the camera was unable to completely adjust between the dark shadow and the reflected sunlight from the white paint on the vehicle. A-1

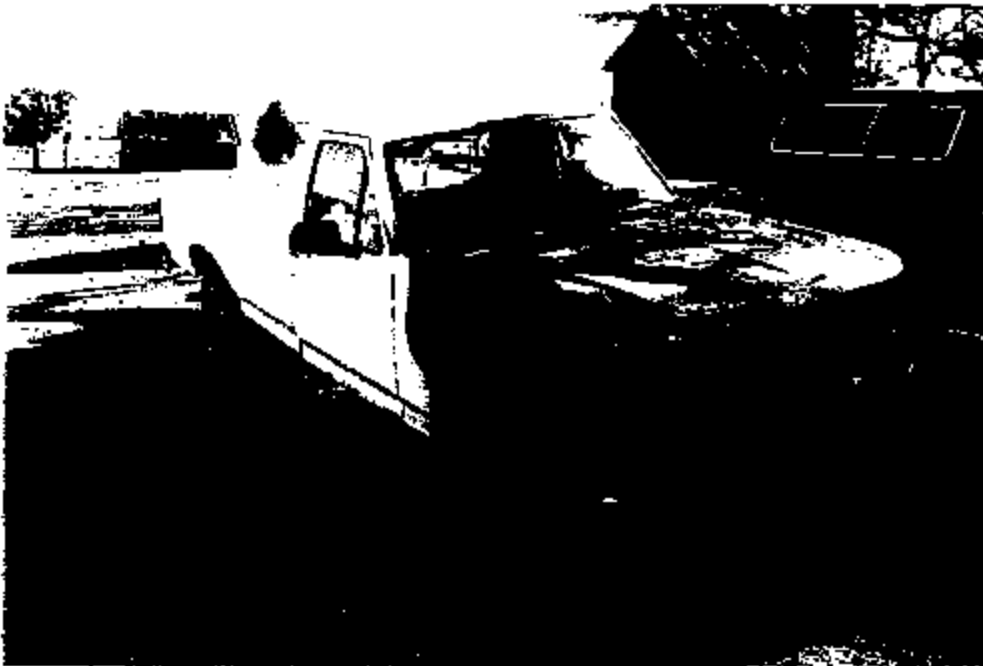
2 The fire patterns indicate the greatest damage to the exterior surfaces are located on the right front fender, the hood, and to the right side of the grille and front bumper. The right front tire was extensively burned by the fire. A-3

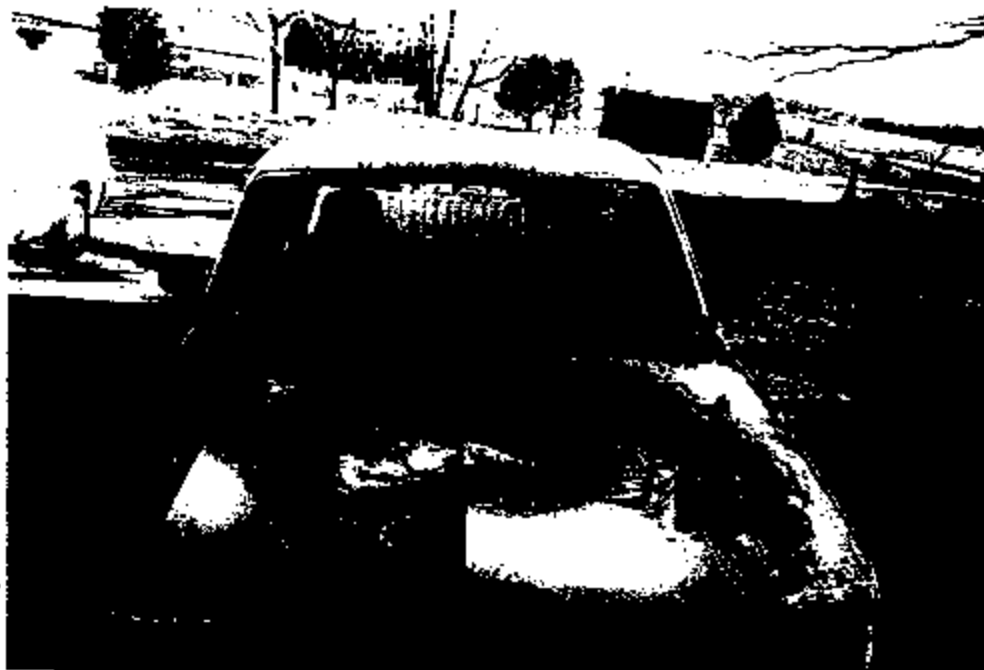
3 The greatest damage to the hood's upper surface was in the right half. The cowl is burned more extensively over the right one-third. The windshield is burned completely on the right side, and the right windshield wiper arm is burned much more than the left arm.

From the exterior — without raising the hood — it is evident the fire caused much more damage in the right half of the engine compartment area. A-8

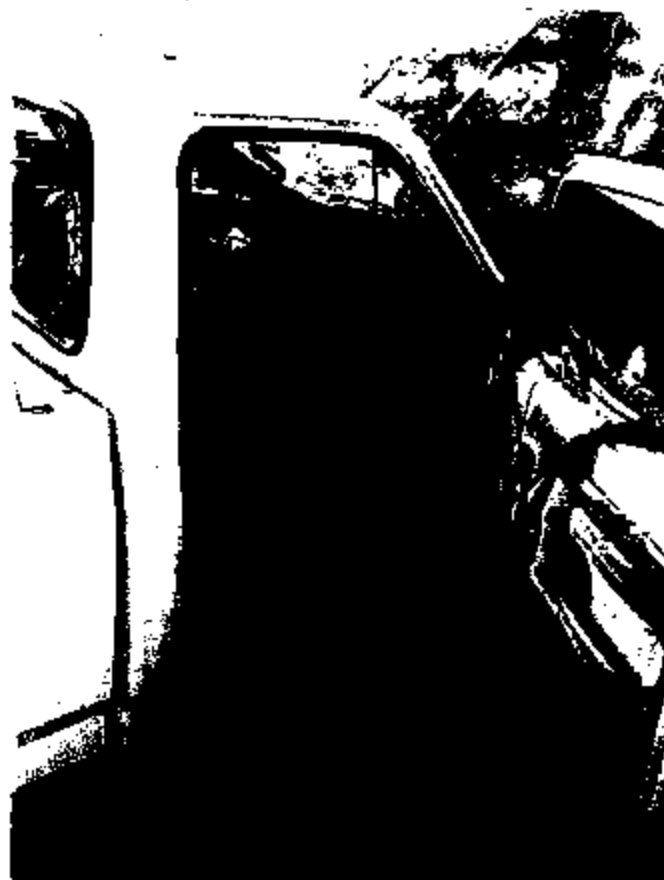
7 The fire damage to the right half of the cab was much greater than the damage to the left half. An odor like that of gasoline was detected while examining the right side floor area. A-11

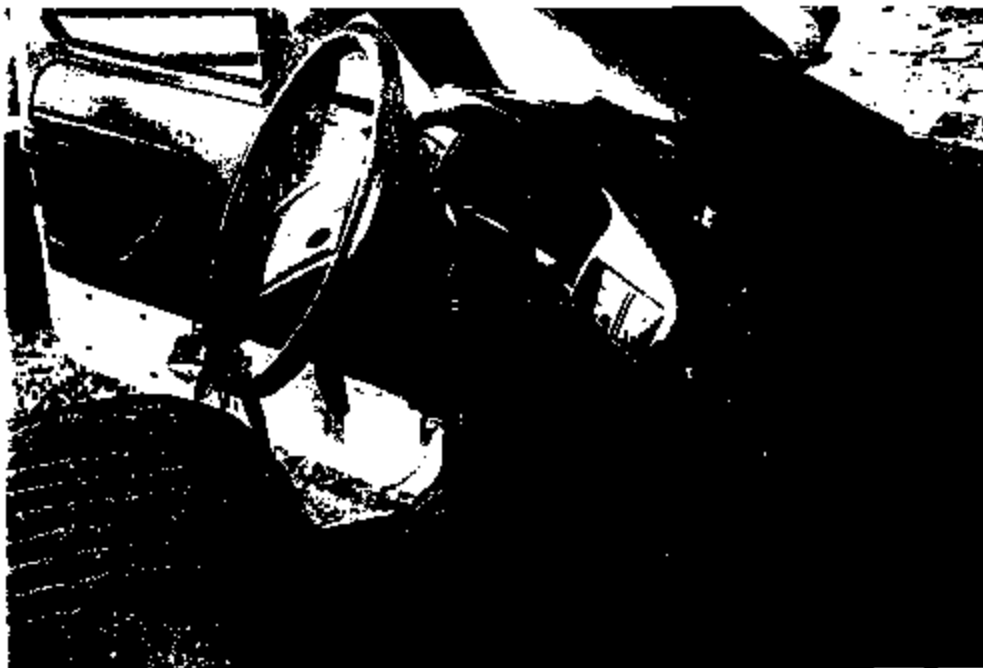
8 The contrast in damage between the left and right areas of the dash is quite evident. The ignition key was still in the switch. A-15

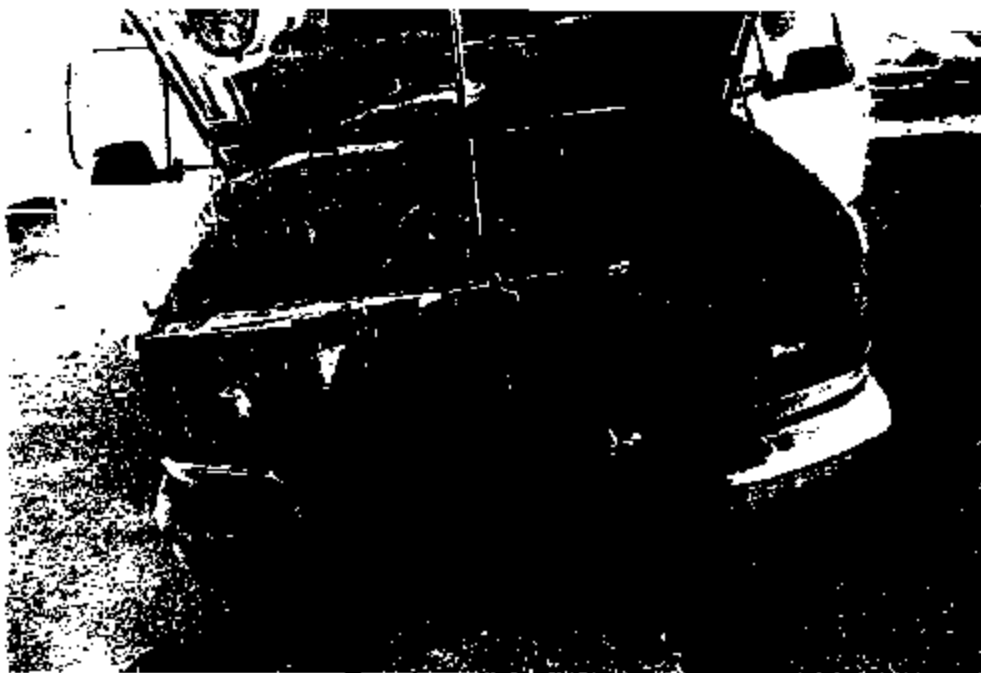
10 The fire caused more extensive damage to the right side of the engine compartment than to the left. The owner of this property is the assistant fire chief of the local fire department. He was operating a tractor on the west side of the highway near this location when he observed smoke behind the insured's nephew's rental house. When he drove to the scene, the assistant fire chief saw flames falling to the ground along the right side of the firewall. The arrow points to the most intensely burned section of the firewall. This area is over the location in which the assistant fire chief observed flames. A-23

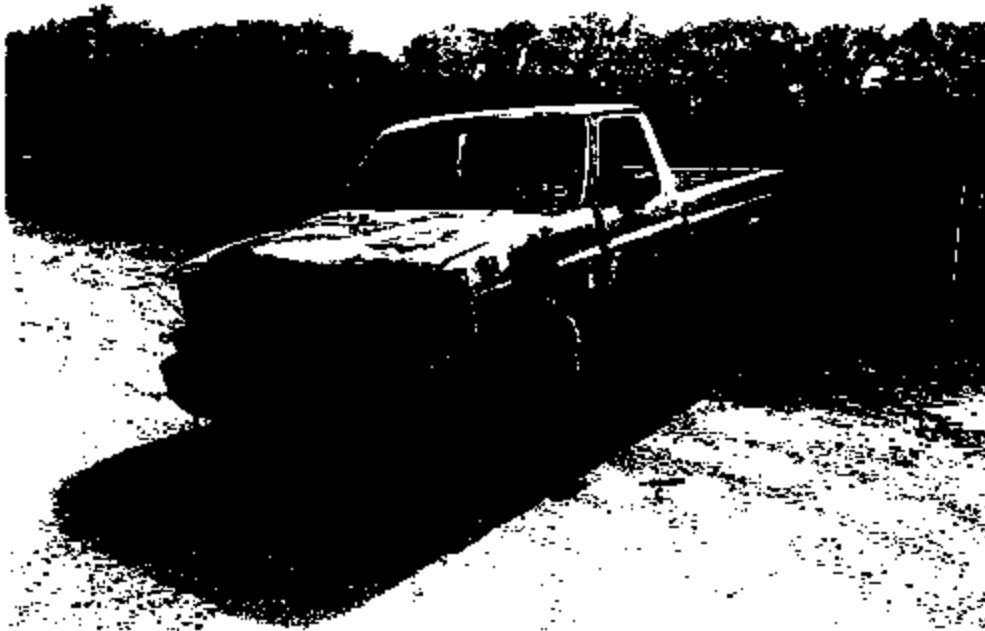
20 The vehicle was initially examined at the fire scene — the insured's nephew's property. The vehicle was later transported to the Southern Missouri Insurance Pool where it was again examined during better lighting. C-1

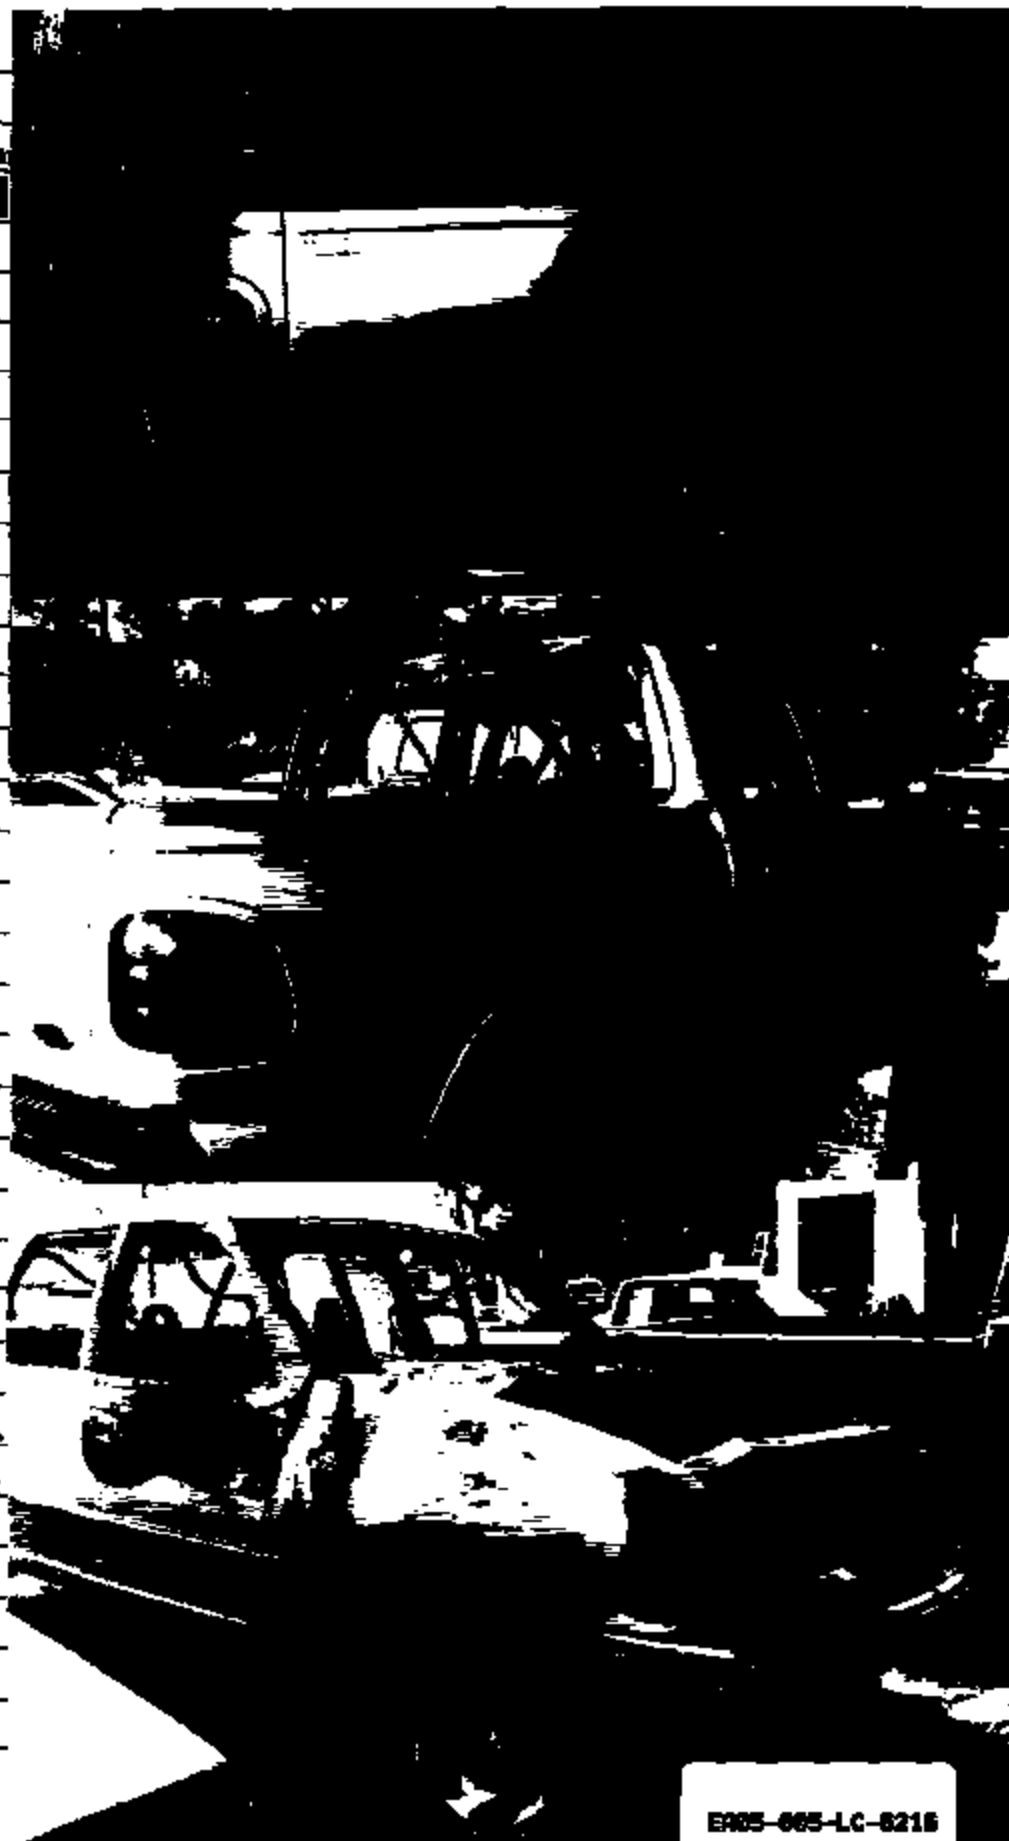
#3

Exterior, right, front quarter panel indicates burn patterns coming from interior engine compartment area & fire of fire.
