**PE05-067**  
**HEIL TRAILER**  
**12/19/2005**  
**EXHIBIT 1, 2, 3, 4, & 5**  
**PART 1 OF 3**

## TECH SERVICE FIELD REPORT

| <b>SUBJECT:</b> | California Pull trailer failures, USA Transport - Flo crack, Leaning trailer at Diamond, Beneto - Frame, cabinet & bumper cover cracks |

**Re: Pull Trailer Frame Improvement**

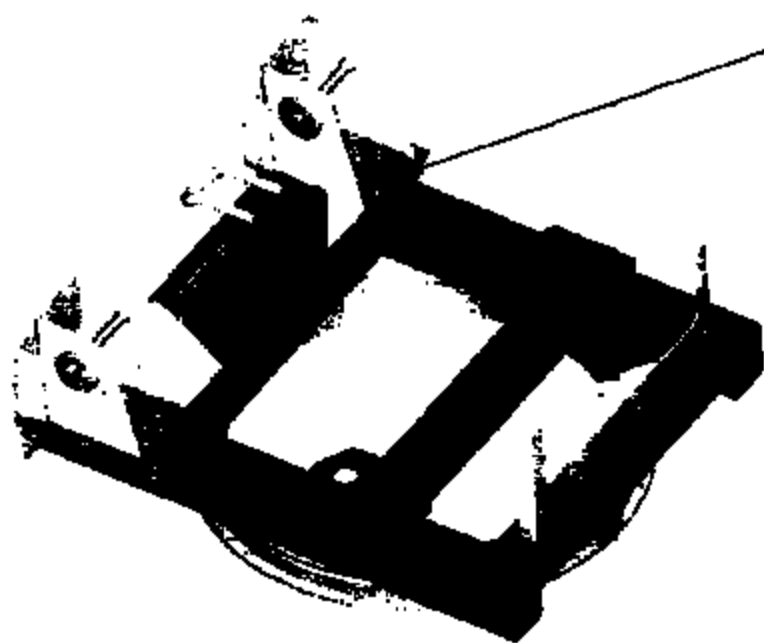
**Mark plate at  
 $\frac{3}{4}$ in from end.  
Both Sides.**

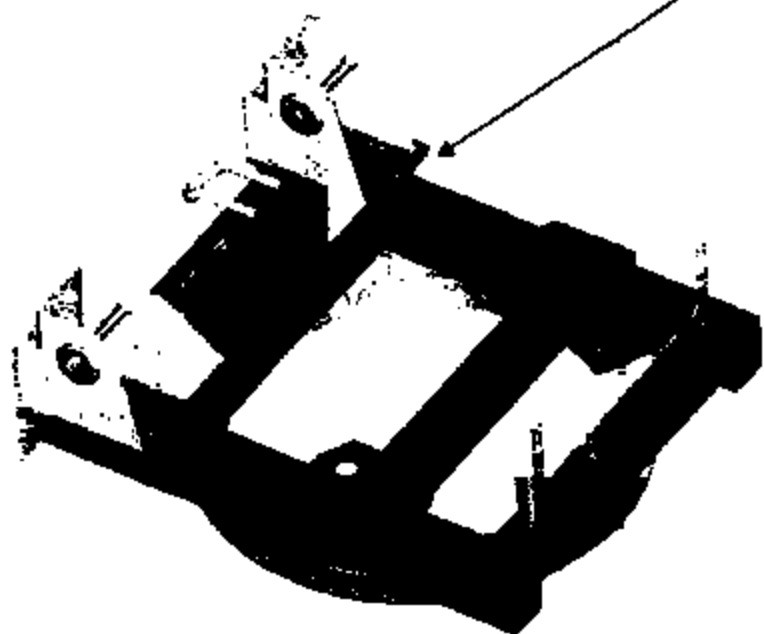
**Cut and remove end  
of plate at mark.  
Both Sides.  
Grind off existing  
weld.**

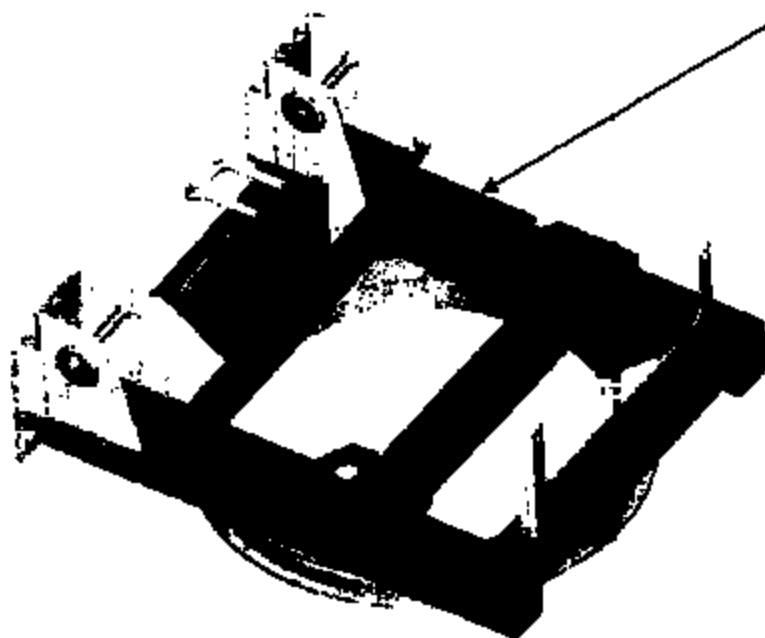
Locate 5in X 12in X  
 $\frac{1}{4}$ in steel bar on  
frame rails.  
Both Sides.

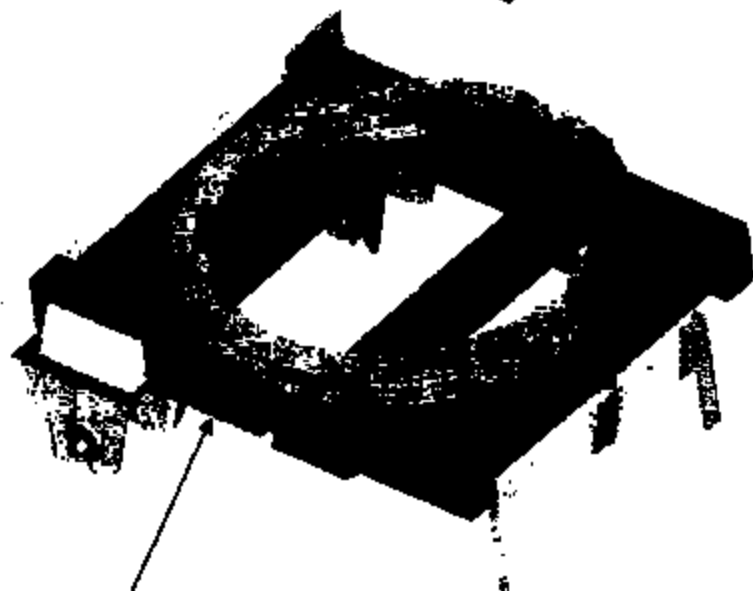
Weld, length-wise.

Both Sides.

(4) Places, total.

Weld the new plate to the existing mounting plate  
for the suspension tower.

**DO NOT Weld across the frame rail.**
