**FLUID LEAKAGE FROM BRAKE RESERVOIR CAP**

## APPLICABLE MODEL(S)/VINS

2001-2002 Tributes

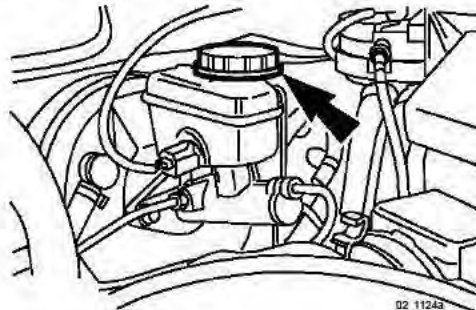
Some vehicles may exhibit fluid leakage from the brake reservoir cap. This may be caused by the insufficient sealing of the cap.

To improve the sealing, a new brake reservoir cap is available to prevent this condition.

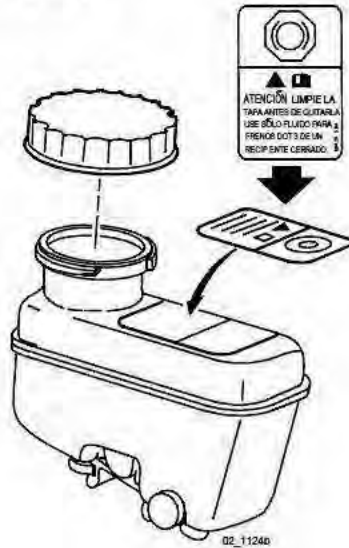
1. Verify concern.
2. Remove the brake reservoir cap by turning counterclockwise.
3. Install a new cap and turn it clockwise to secure.

**NOTE:** Turn the cap until it completely stops.

4. Replace Caution Label with a new one. (You can attach the new label over the old one.)

- Be aware of the direction of the label: the text part faces toward the front of the vehicle.
- To prevent the label from peeling off, wipe the leaked fluid or dust completely off the tank.
- You can use brake cleaner to degrease if necessary.
