Service Action Circular

Code: M9

**Subject: 2004-2005 MY Touareg
Inspect Driver's and Passenger's Side Impact Airbag
Connectors and Install Wiring Harness Kit(s), if Necessary**

December 2006

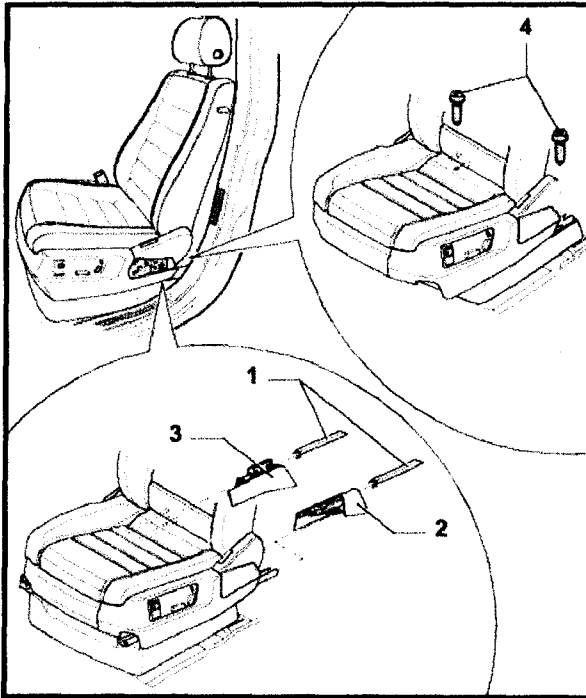
- Move front passenger seat fully forward and upward
- ⇐ Use a small screwdriver and pry rear spindle covers -1- out of mounts (comfort seat only)
- ⇐ Remove covers -2- and -3- from rear of seat rails
- Remove bolts -4- from rear of seat rails

Note: If the inner parts of seat rail covers remain stuck on rails during removal, remove inner parts from rails and reinstall on covers before cover reinstallation

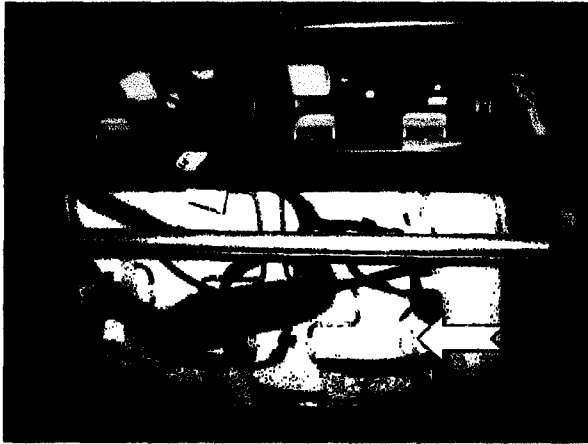
← Illustration (as viewed from the footwell area) shows position of yellow connector -arrow- on vehicle with standard seat

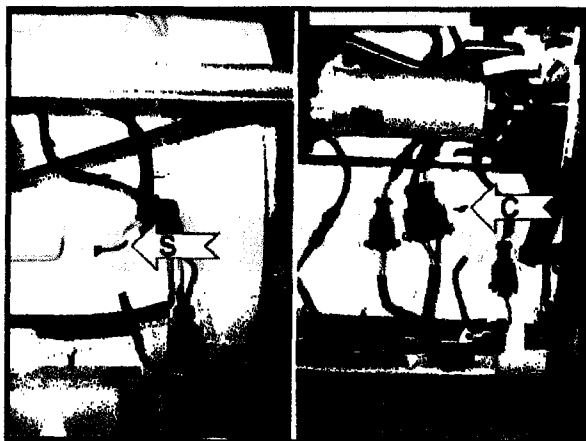
- Heat crimp connection using hot air blower lengthwise from center outward until it is sealed completely and adhesive comes out of ends
- Wrap repair points with yellow adhesive tape to indicate a repair
- ⇐ Use tie wrap (N 020 904 8) and secure repaired wire to bracket on bottom of standard seat -arrow S- or comfort seat -arrow C-
- Remove airbag adapter VAS 5232/1 from yellow connector -2- and reconnect connector
- Clip wiring harness retaining clips into hole tabs of seat frame crossmember
- Repeat this procedure for other seat unless repair has been previously completed, then, go to Section D
