Odelzhausen, 2 May 2007

Analysis conducted for W164 seat heaters failure parts

Concerned part is 1st row backrest (WET 110003589 / JCI 330131).

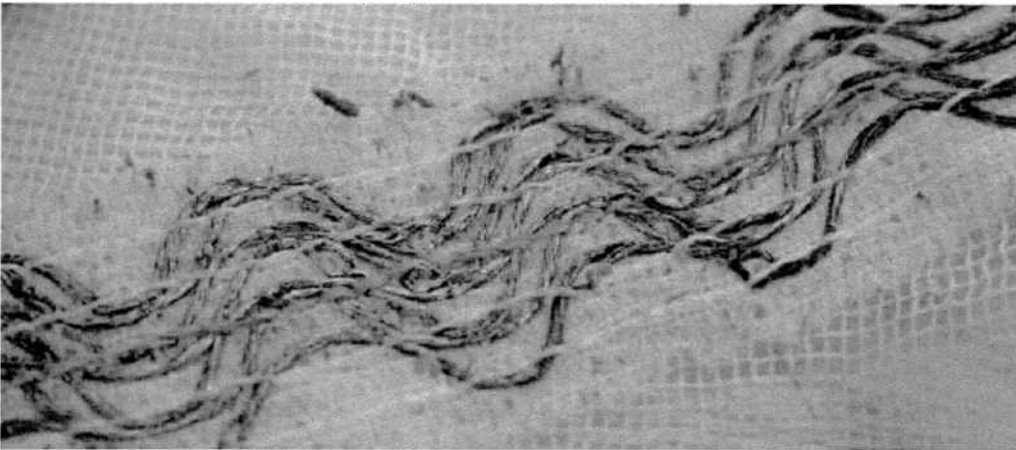
Middle - electrode of W211 from testreport 1632/1 page 24 - 28 after NOS-RUSH-TEST

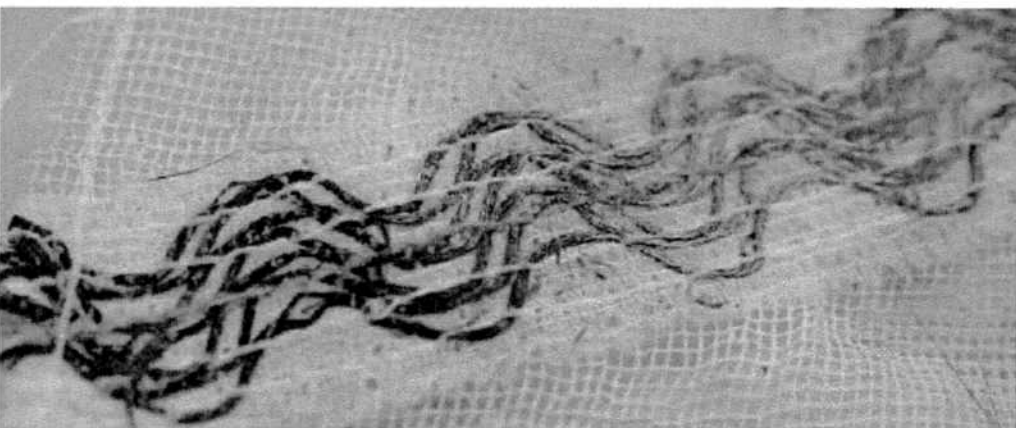
After a weak rub out with the soft white side of rubber remains a reddish shimmer. This indicates a corrosion.

before: left untreated, after: right reddish shimmer after a weak rub out

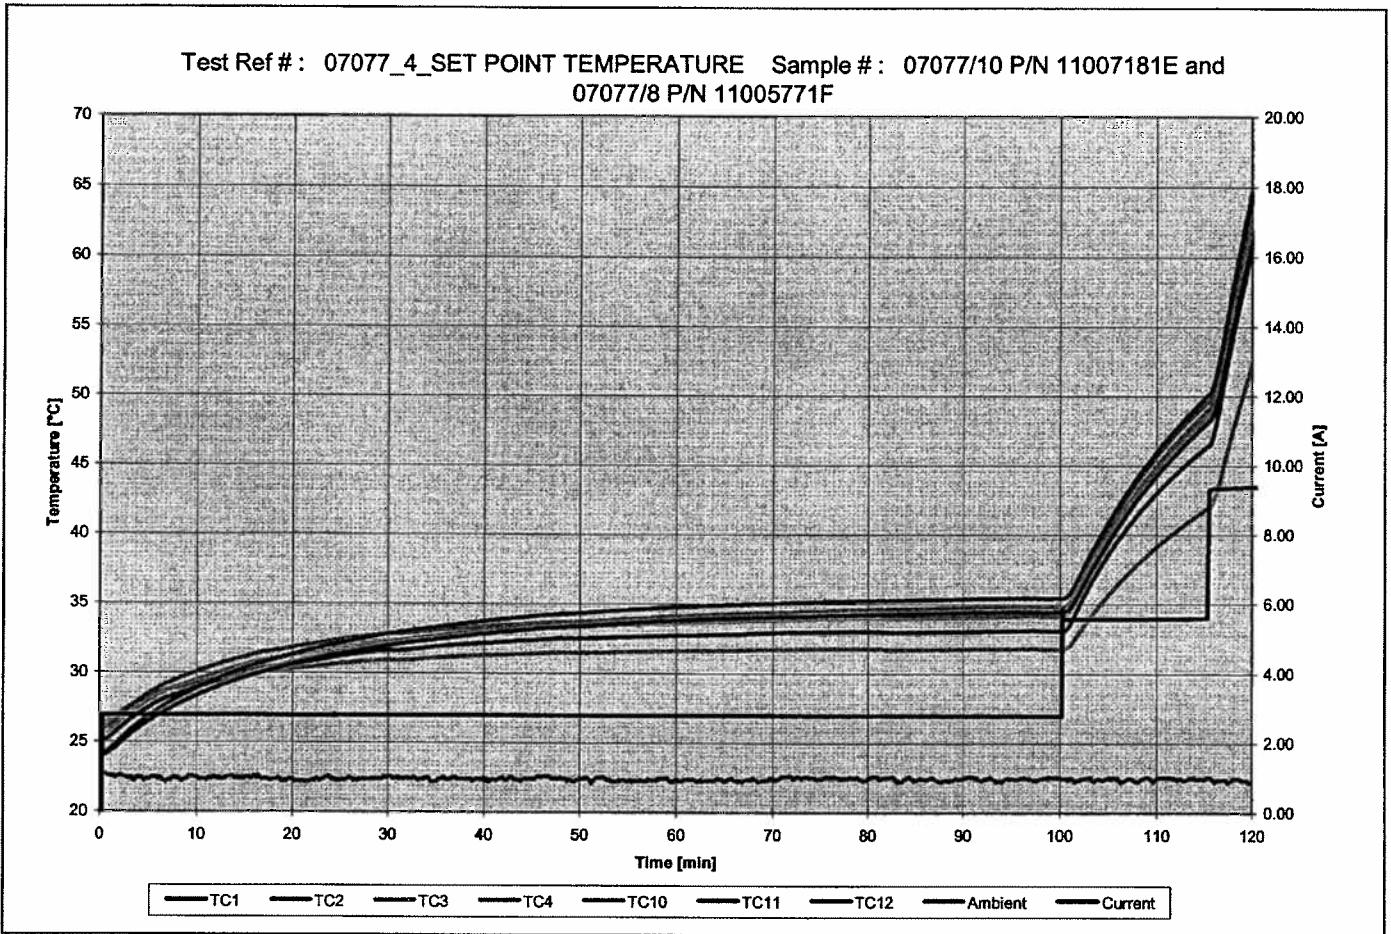
Image 7: Shows individual thermocouple temperatures and current draw for samples 07077/10 P/N 11007181E and 07077/8 P/N 11005771F.

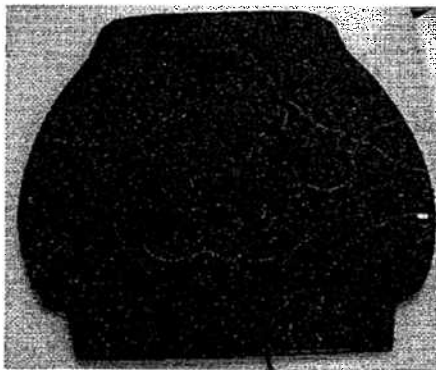
Image # 2: Sample # 07077/11 – no damage to the heater after the test

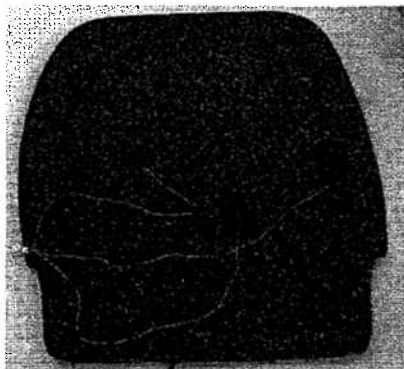
Image # 3: Sample # 07077/8 – no damage to the heater after the test

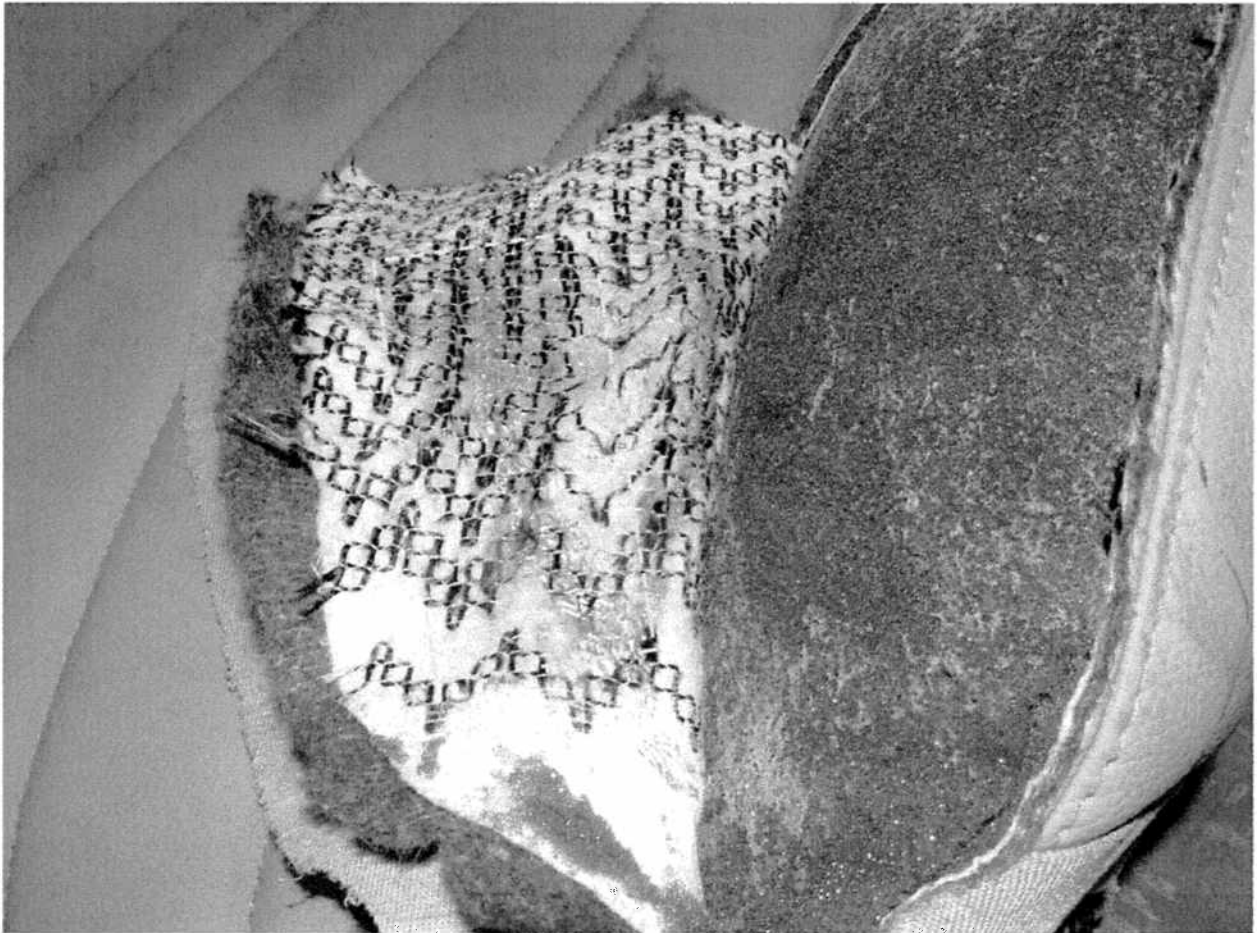
Image #6: rubbed off Carbotex fibres in the contact area of the test form.

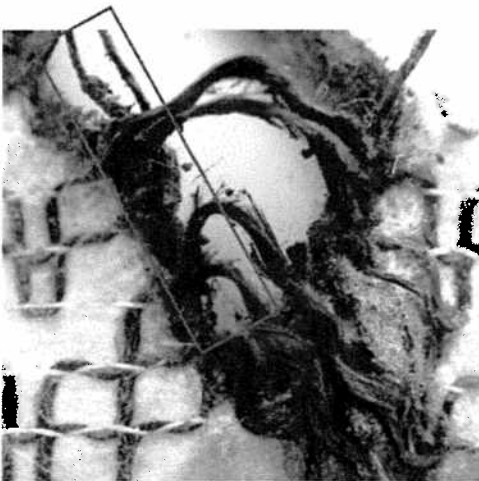
Fig 11: detail point 1 (from fig. 10); electrode looks at the first view unbroken

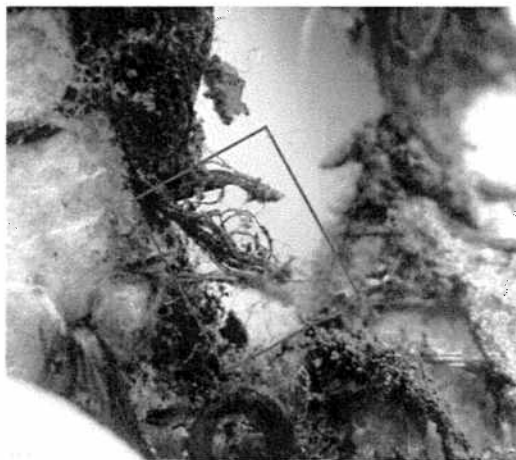
Fig 12: under the carbon the point of rupture was visible

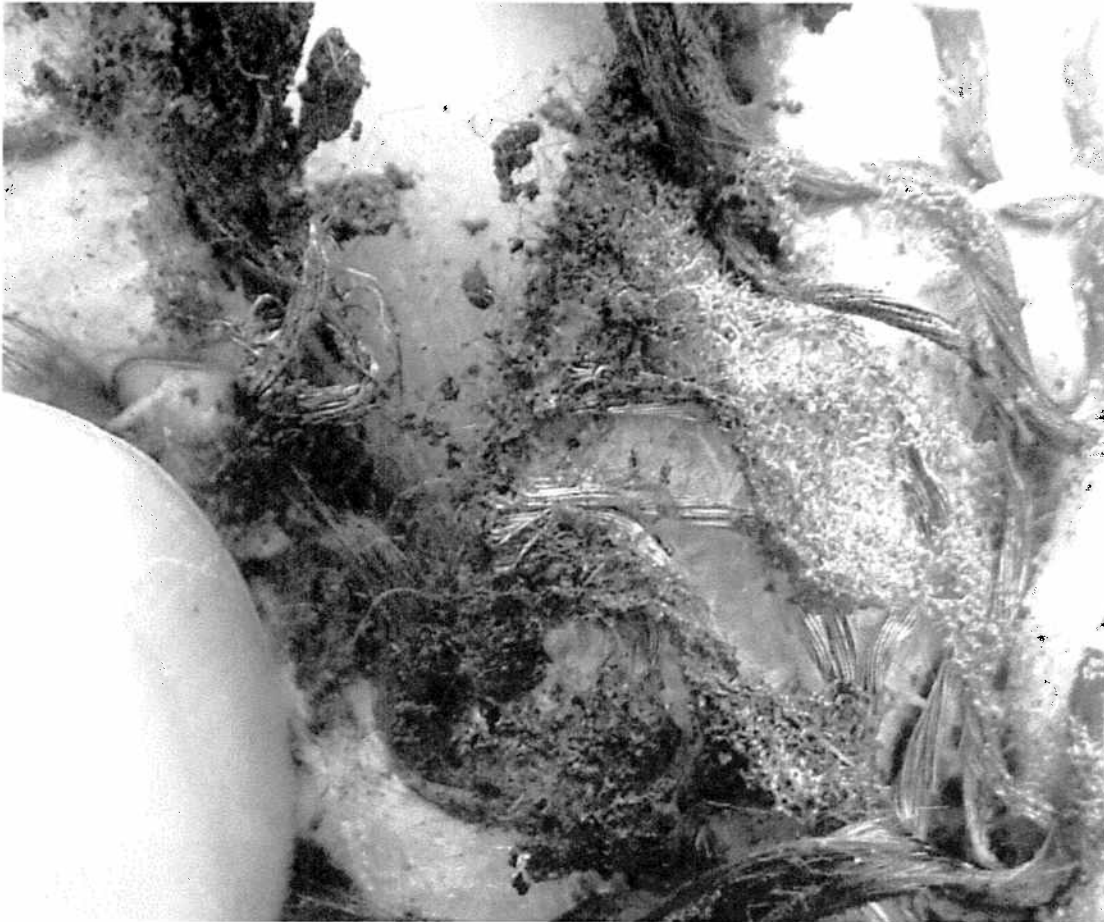
Fig 13: detail of the broken electrodes

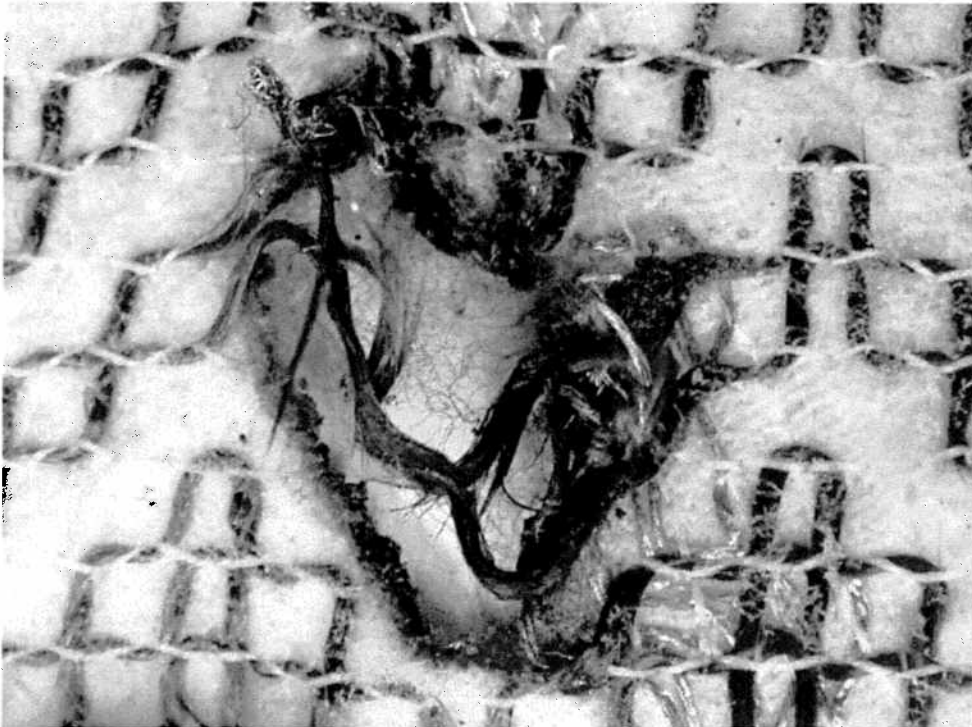
Fig 26: detail of the broken electrodes
