VRTC-DCD 9142
EA08-015

Investigation of Liftgate Strut Failure

On 2005 Honda Odyssey

FINAL REPORT
NOVEMBER 2009

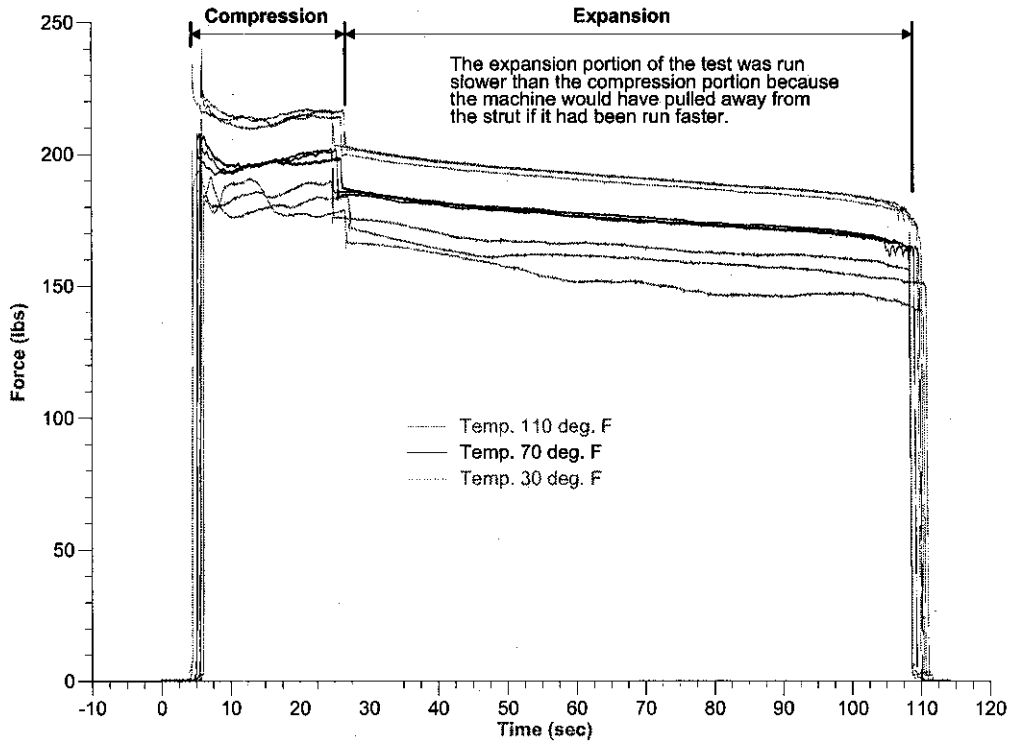
The test results showed that the force exerted by each strut was greatest after a 110° soak and least after a 35° soak. This was found to be true throughout the entire range of travel for each of the struts. The average reduction in force between 110° and 35° was approximately 15%. Generally, the force that each strut exerted was greatest when the strut began to be compressed. The force then decreased as the strut was compressed and usually increased somewhat as the strut reached full compression (see Appendix III).

**Typical Force/Time Plot
For Compression Testing
At Three Temperatures
(Strut A shown)**
