# Brake Assembly Update

February 11, 2009

# **Kenworth Safety Committee Review And Notification to NHTSA**

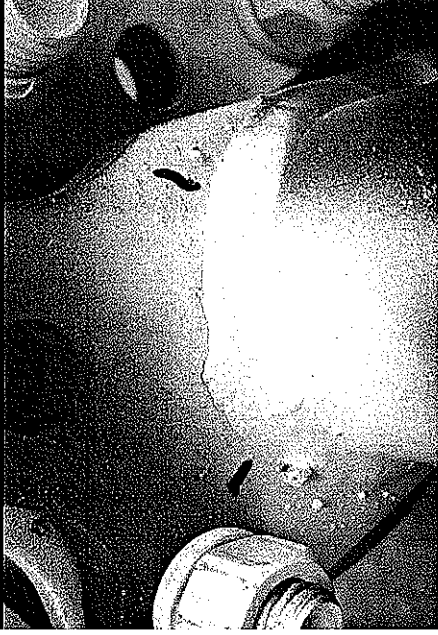
1.4" Crack @ 351K Miles

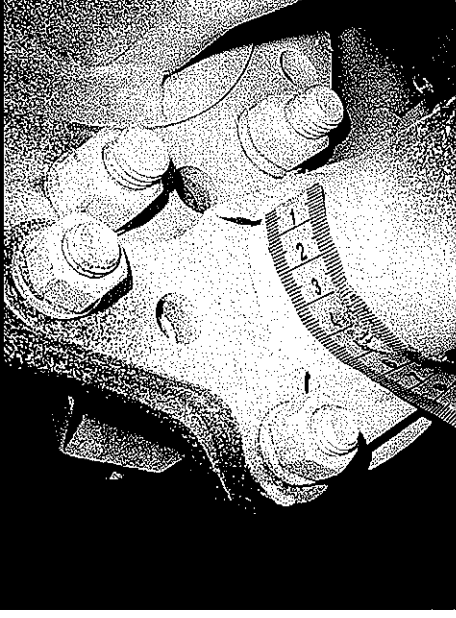
1.7" Crack @ 420K Miles

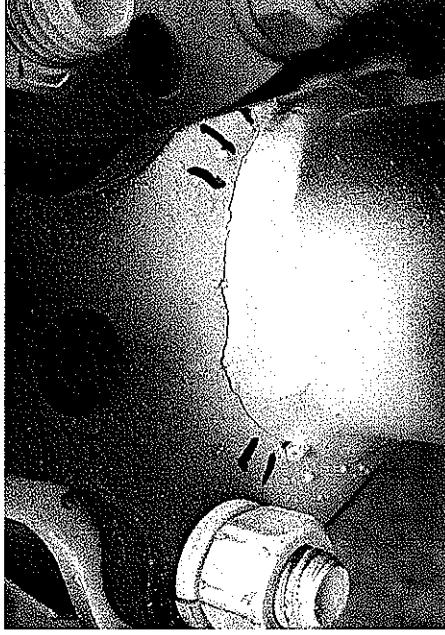
2.4" Crack @ 450K Miles

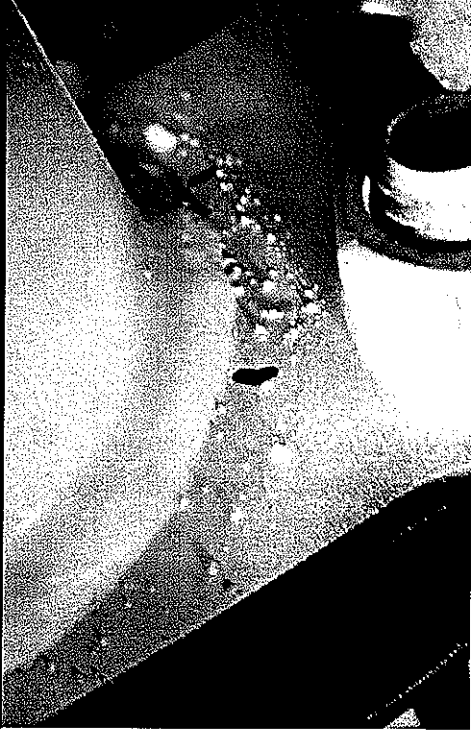
0.9" Crack @ 670K Miles

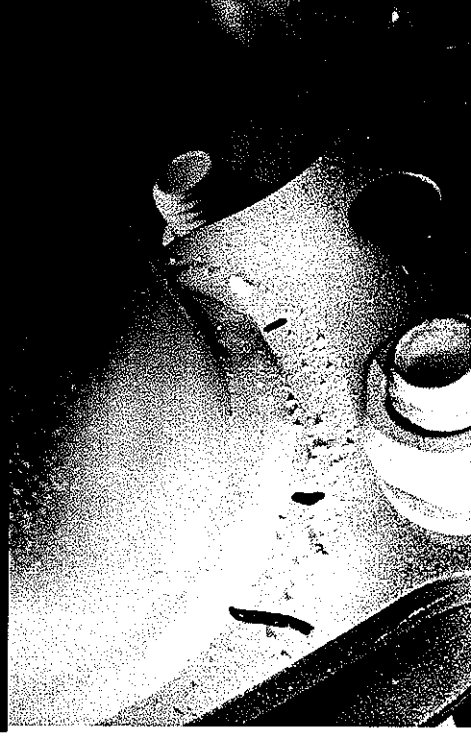
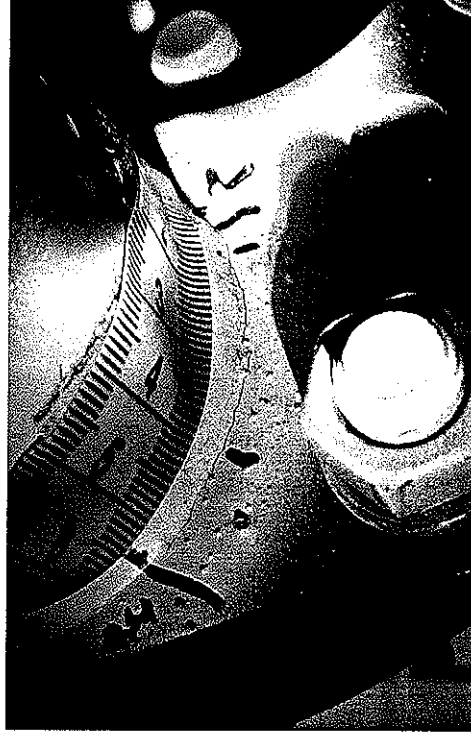
1.0" Crack @ 748K Miles

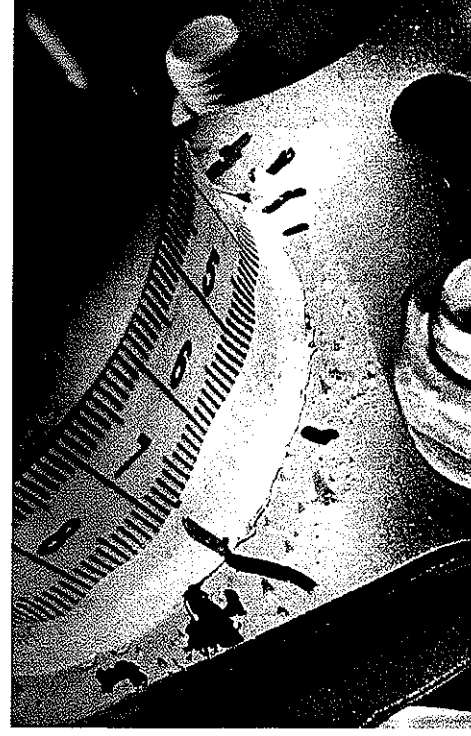
2.1" Crack @ 816K Miles

3.4" Crack @ 1,784K Miles Qty

No Effect On Stopping Distance

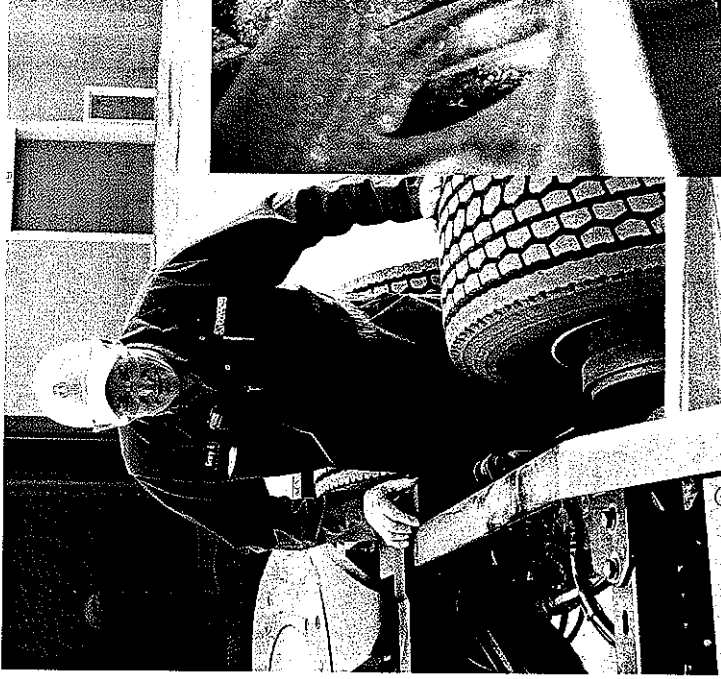
## Top View

Areas Of Inspection

Lube Point Fitting

- No Effect On Stopping Distance; Therefore A Safety Related Defect Does Not Exist
- Inspection Campaign And Extended Warranty
