The Wanderlodge 450 LXi

ON CERTAIN MY 2005-2007 WANDERLODGE 450 LXI MOTOR HOMES EQUIPPED WITH ARVIN MERITOR AND TRW TIE ROD ENDS, THE TIE ROD ASSEMBLIES WERE PRODUCED WITH STEEL TUBING THAT DID NOT MEET DESIGN SPECIFICATIONS WHICH COULD RESULT IN FAILURE OF THE TIE ROD ASSEMBLY WHEN COACH MILEAGE APPROACHES OR EXCEEDS 100,000 MILES. ALSO THE FRONT AXLE CURB WEIGHT MAY EXCEED THE SPECIFIED 16,000 POUNDS WEIGHT RATING.

LXI 450 Defect Investigation -Closing Report

ANALYSIS OF THE POTENTIAL FIRE HAZARD INSPECTION

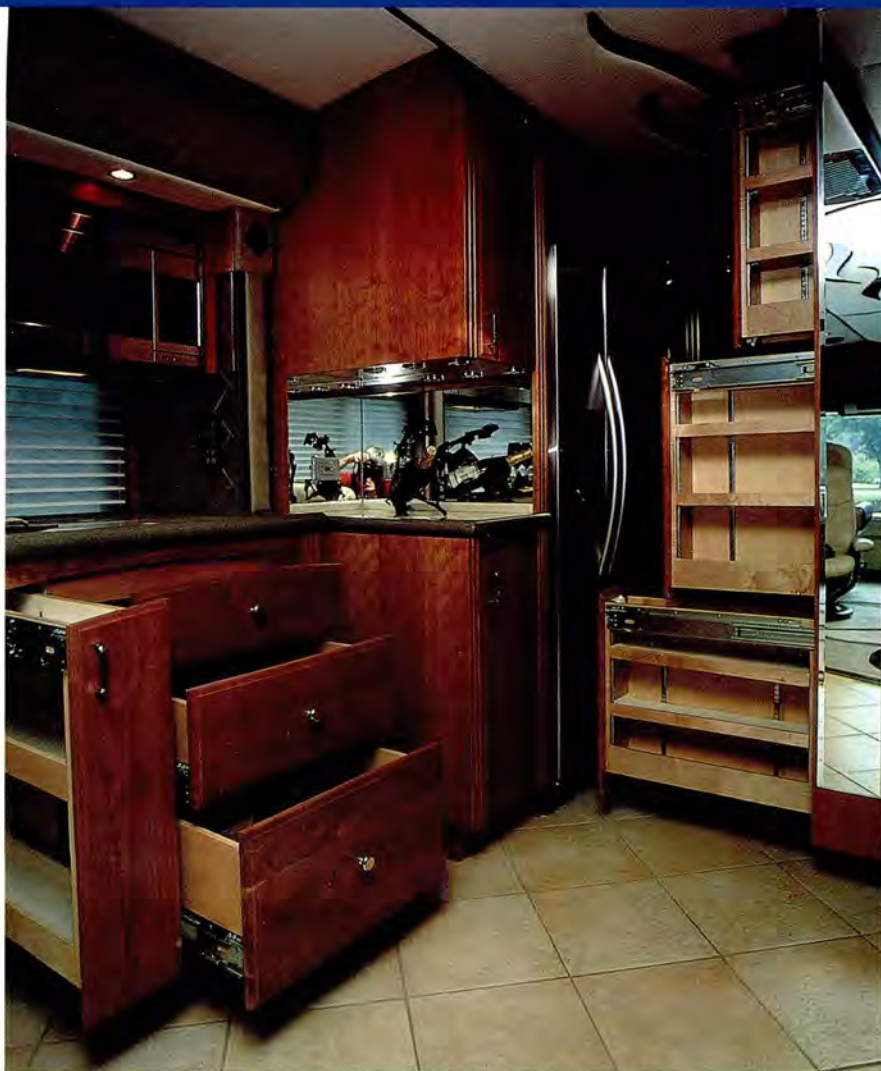
The LXi I tested came with three slideouts: one encompassing the curbside galley; another, the streetside dinette and sofa bed; and a third, the head of the bed. Designed and built by Blue Bird, these slides are powered off the inverters and are simple to operate. Each of these structures is designed to handle 8,000 pounds, although it's not likely that anyone will ever put that kind of weight in a slideout. In the future, Blue Bird engineers might want to consider adding a feature that either defeats movement of the galley slideout if the passenger captain's chair is in the way, or automatically articulates

the passenger chair forward and out of the way.

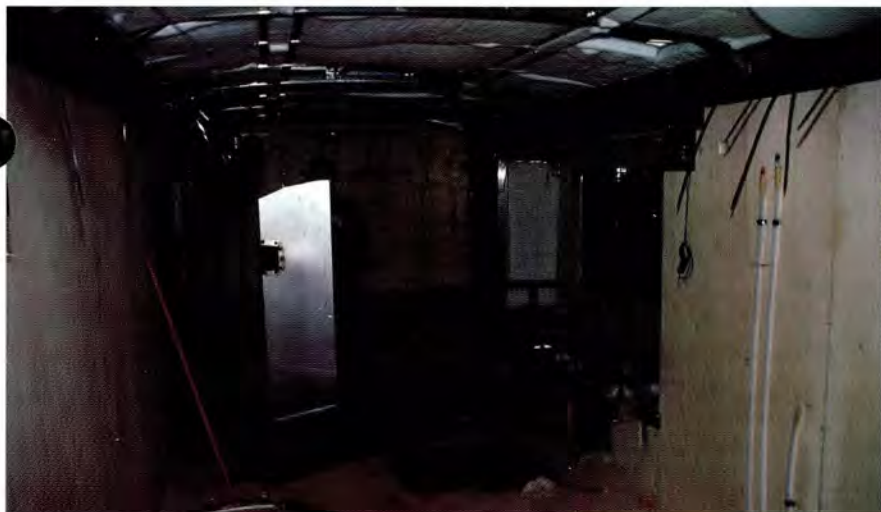
Inside the Blue Bird manufacturing plant, stainless-steel foundations await finishing with insulation, electrical work, and slideout mechanisms, as well as Caterpillar diesel engines.

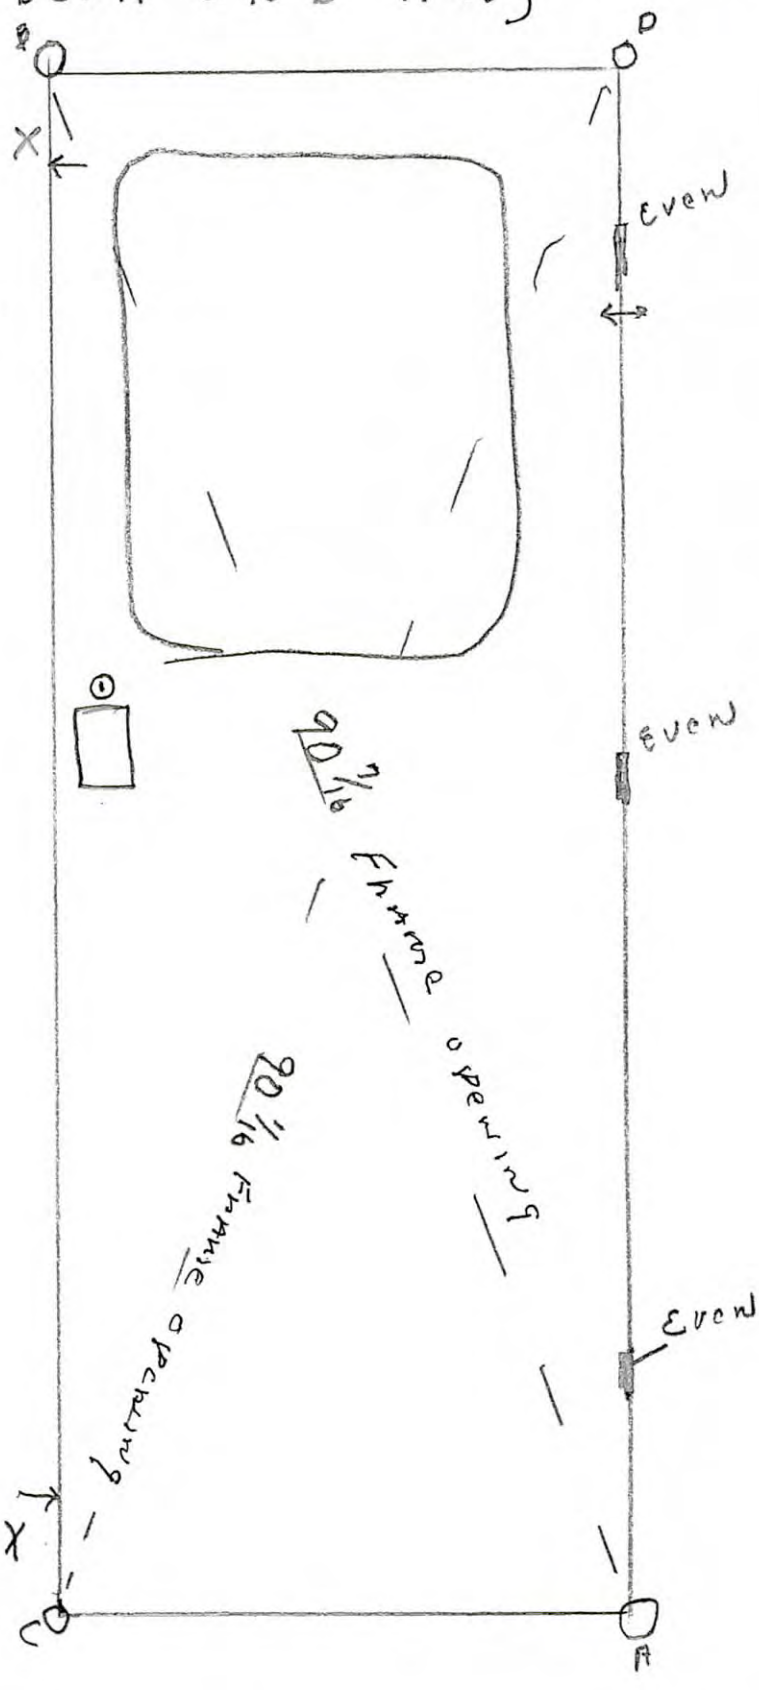
- ✓ Frame A to B $90 \frac{7}{16}$ } out of square
- ✓ Frame C to D $90 \frac{1}{16}$ } square
- DOOR A to B $91 \frac{5}{8}$ } square
- DOOR C to D $91 \frac{5}{8}$ }

$\times \frac{1}{8}$ " in from
 frame
 photo enclosed
 when closed
 & so is into frame
 $\frac{1}{8}$ "

Front
 of
 B.V
