# **PE08-067 Q45/M45 Side Airbag Information Sharing**

NNA Technical Compliance

題目 F50, '02 Year Model, F.M.V.S.S. No.214 Self-Certification Test

題目 Y34 . 03 Year Model, F.M.V.S.S. No.214 Self-Certification Test

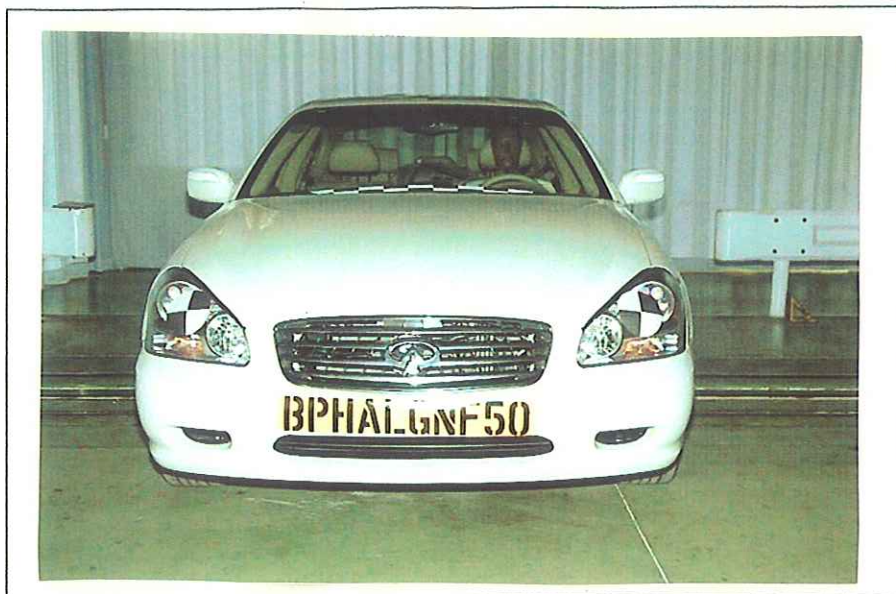
Photo. No.3                      PRETEST

SUBJECT :    Front    view

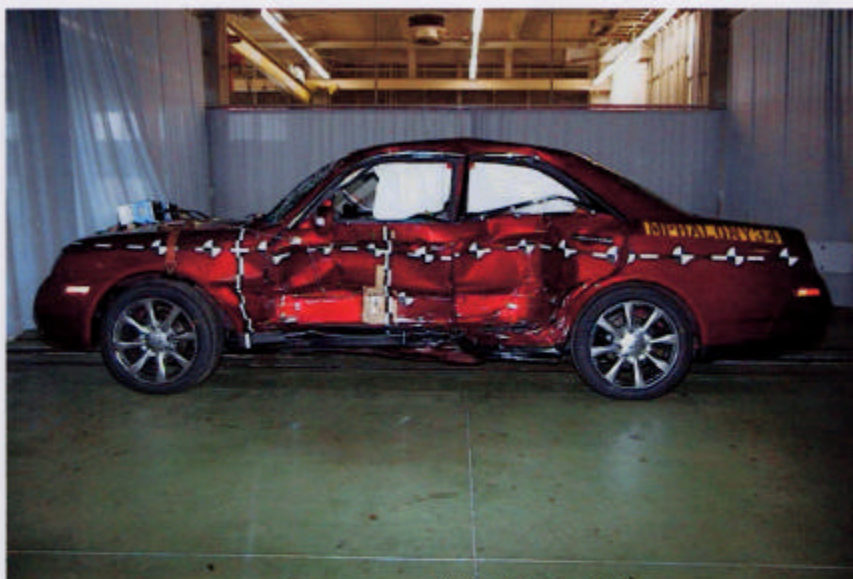
Photo. No.2 POSTTEST

SUBJECT : Side view

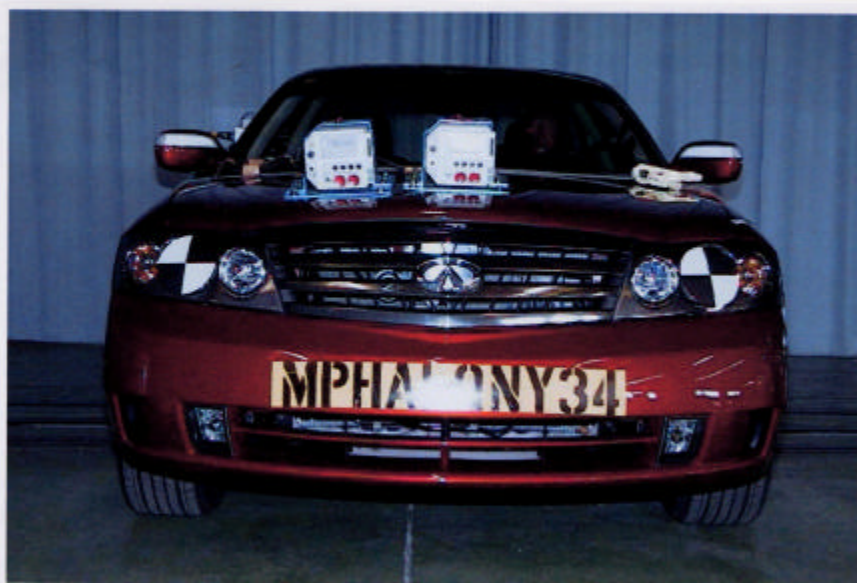
Photo. No.3                      PRETEST

SUBJECT :    Front    view

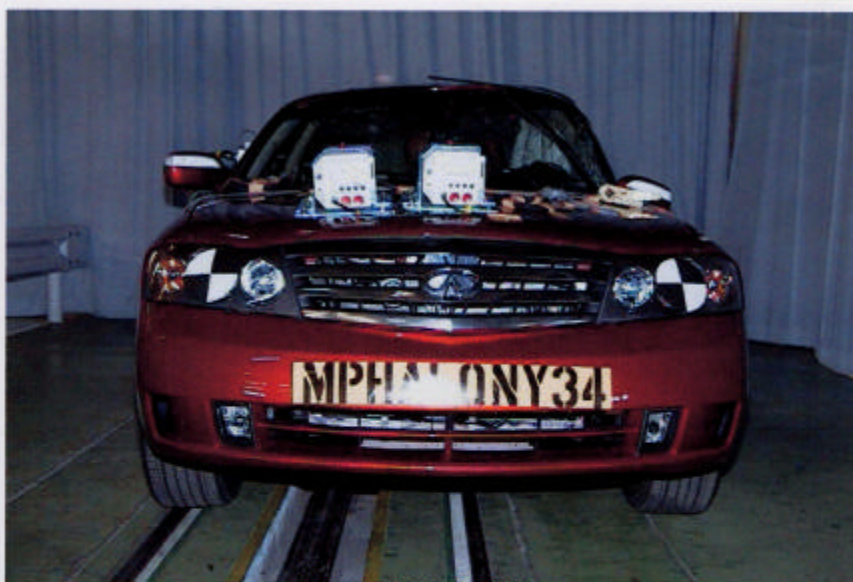
Photo. No.4                      POSTTEST

SUBJECT :    Front    view

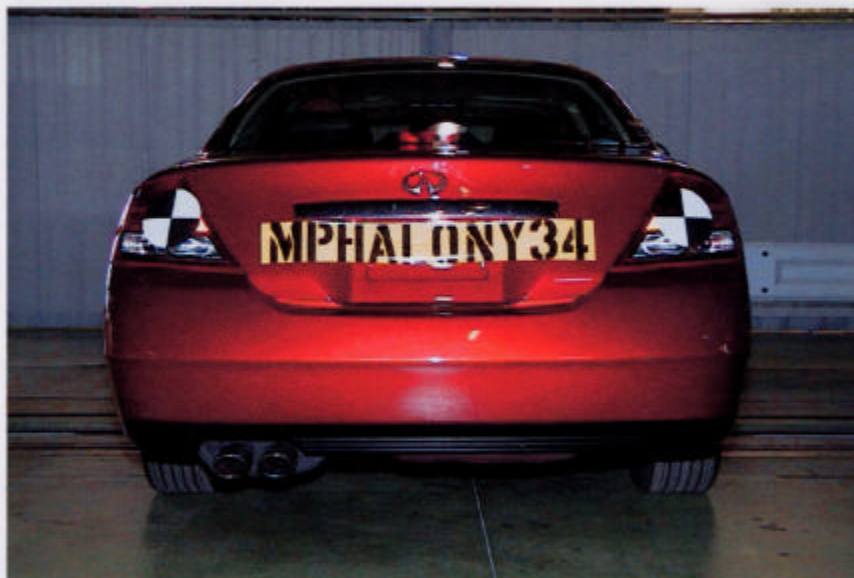
Photo. No.5                      PRETEST

SUBJECT :    Rear    view

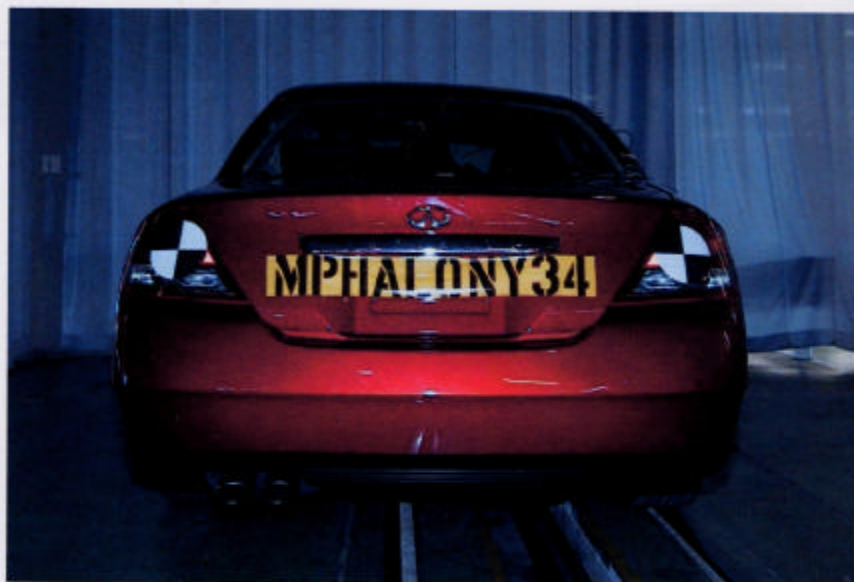
Photo. No.6                      POSTTEST

SUBJECT :    Rear    view

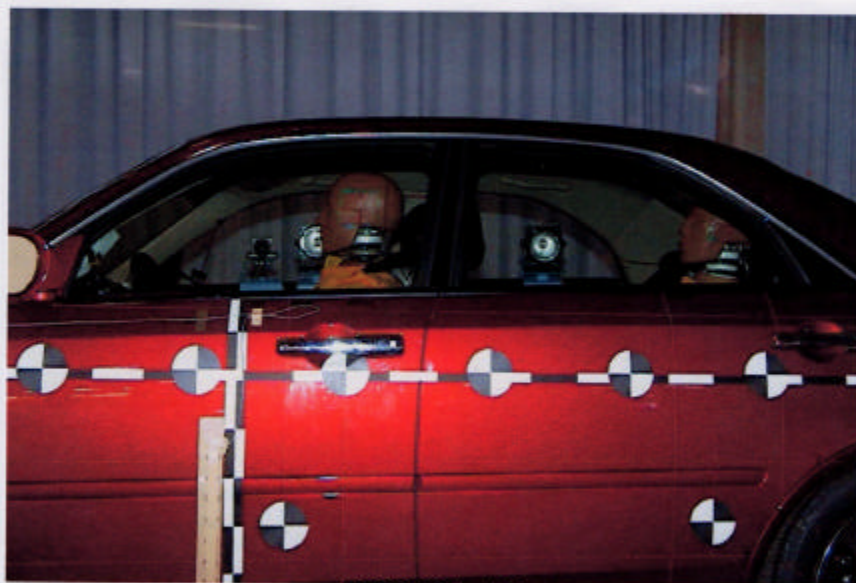
Photo. No.7

PRETEST

SUBJECT : Front dummy, Rear dummy, Position view

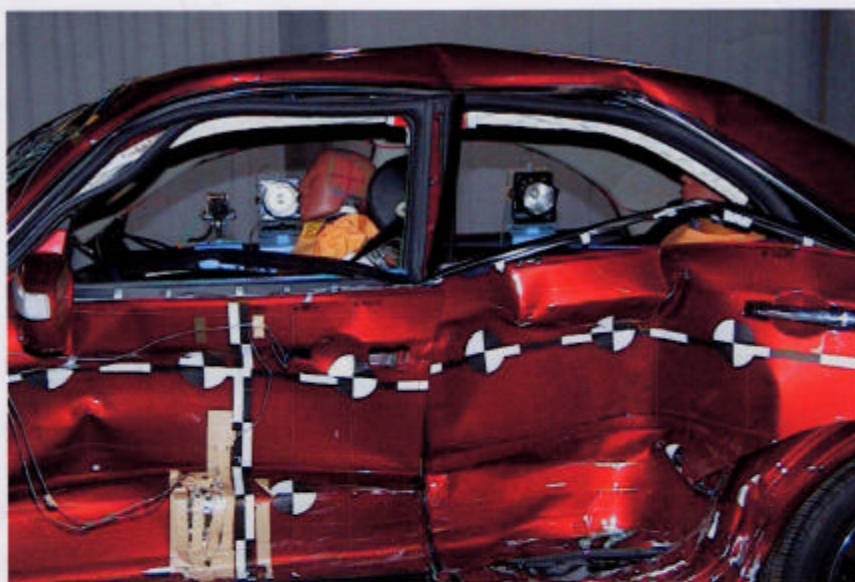
Photo. No.8

POSTTEST

SUBJECT : Front dummy, Rear dummy, Position view
